## 6155 Bevis Green, Bury - EA Bespoke Permit - Risk Assessment (Issue 1 - February 2021)

Environmental management system for the realignment/diversion of the un-named tributary of Pigs Lee Brook and the treatment of associated silts.

**Former Tetrosyl Works,  
Walmersley Old Road,  
Bury.  
BL9 6RG**

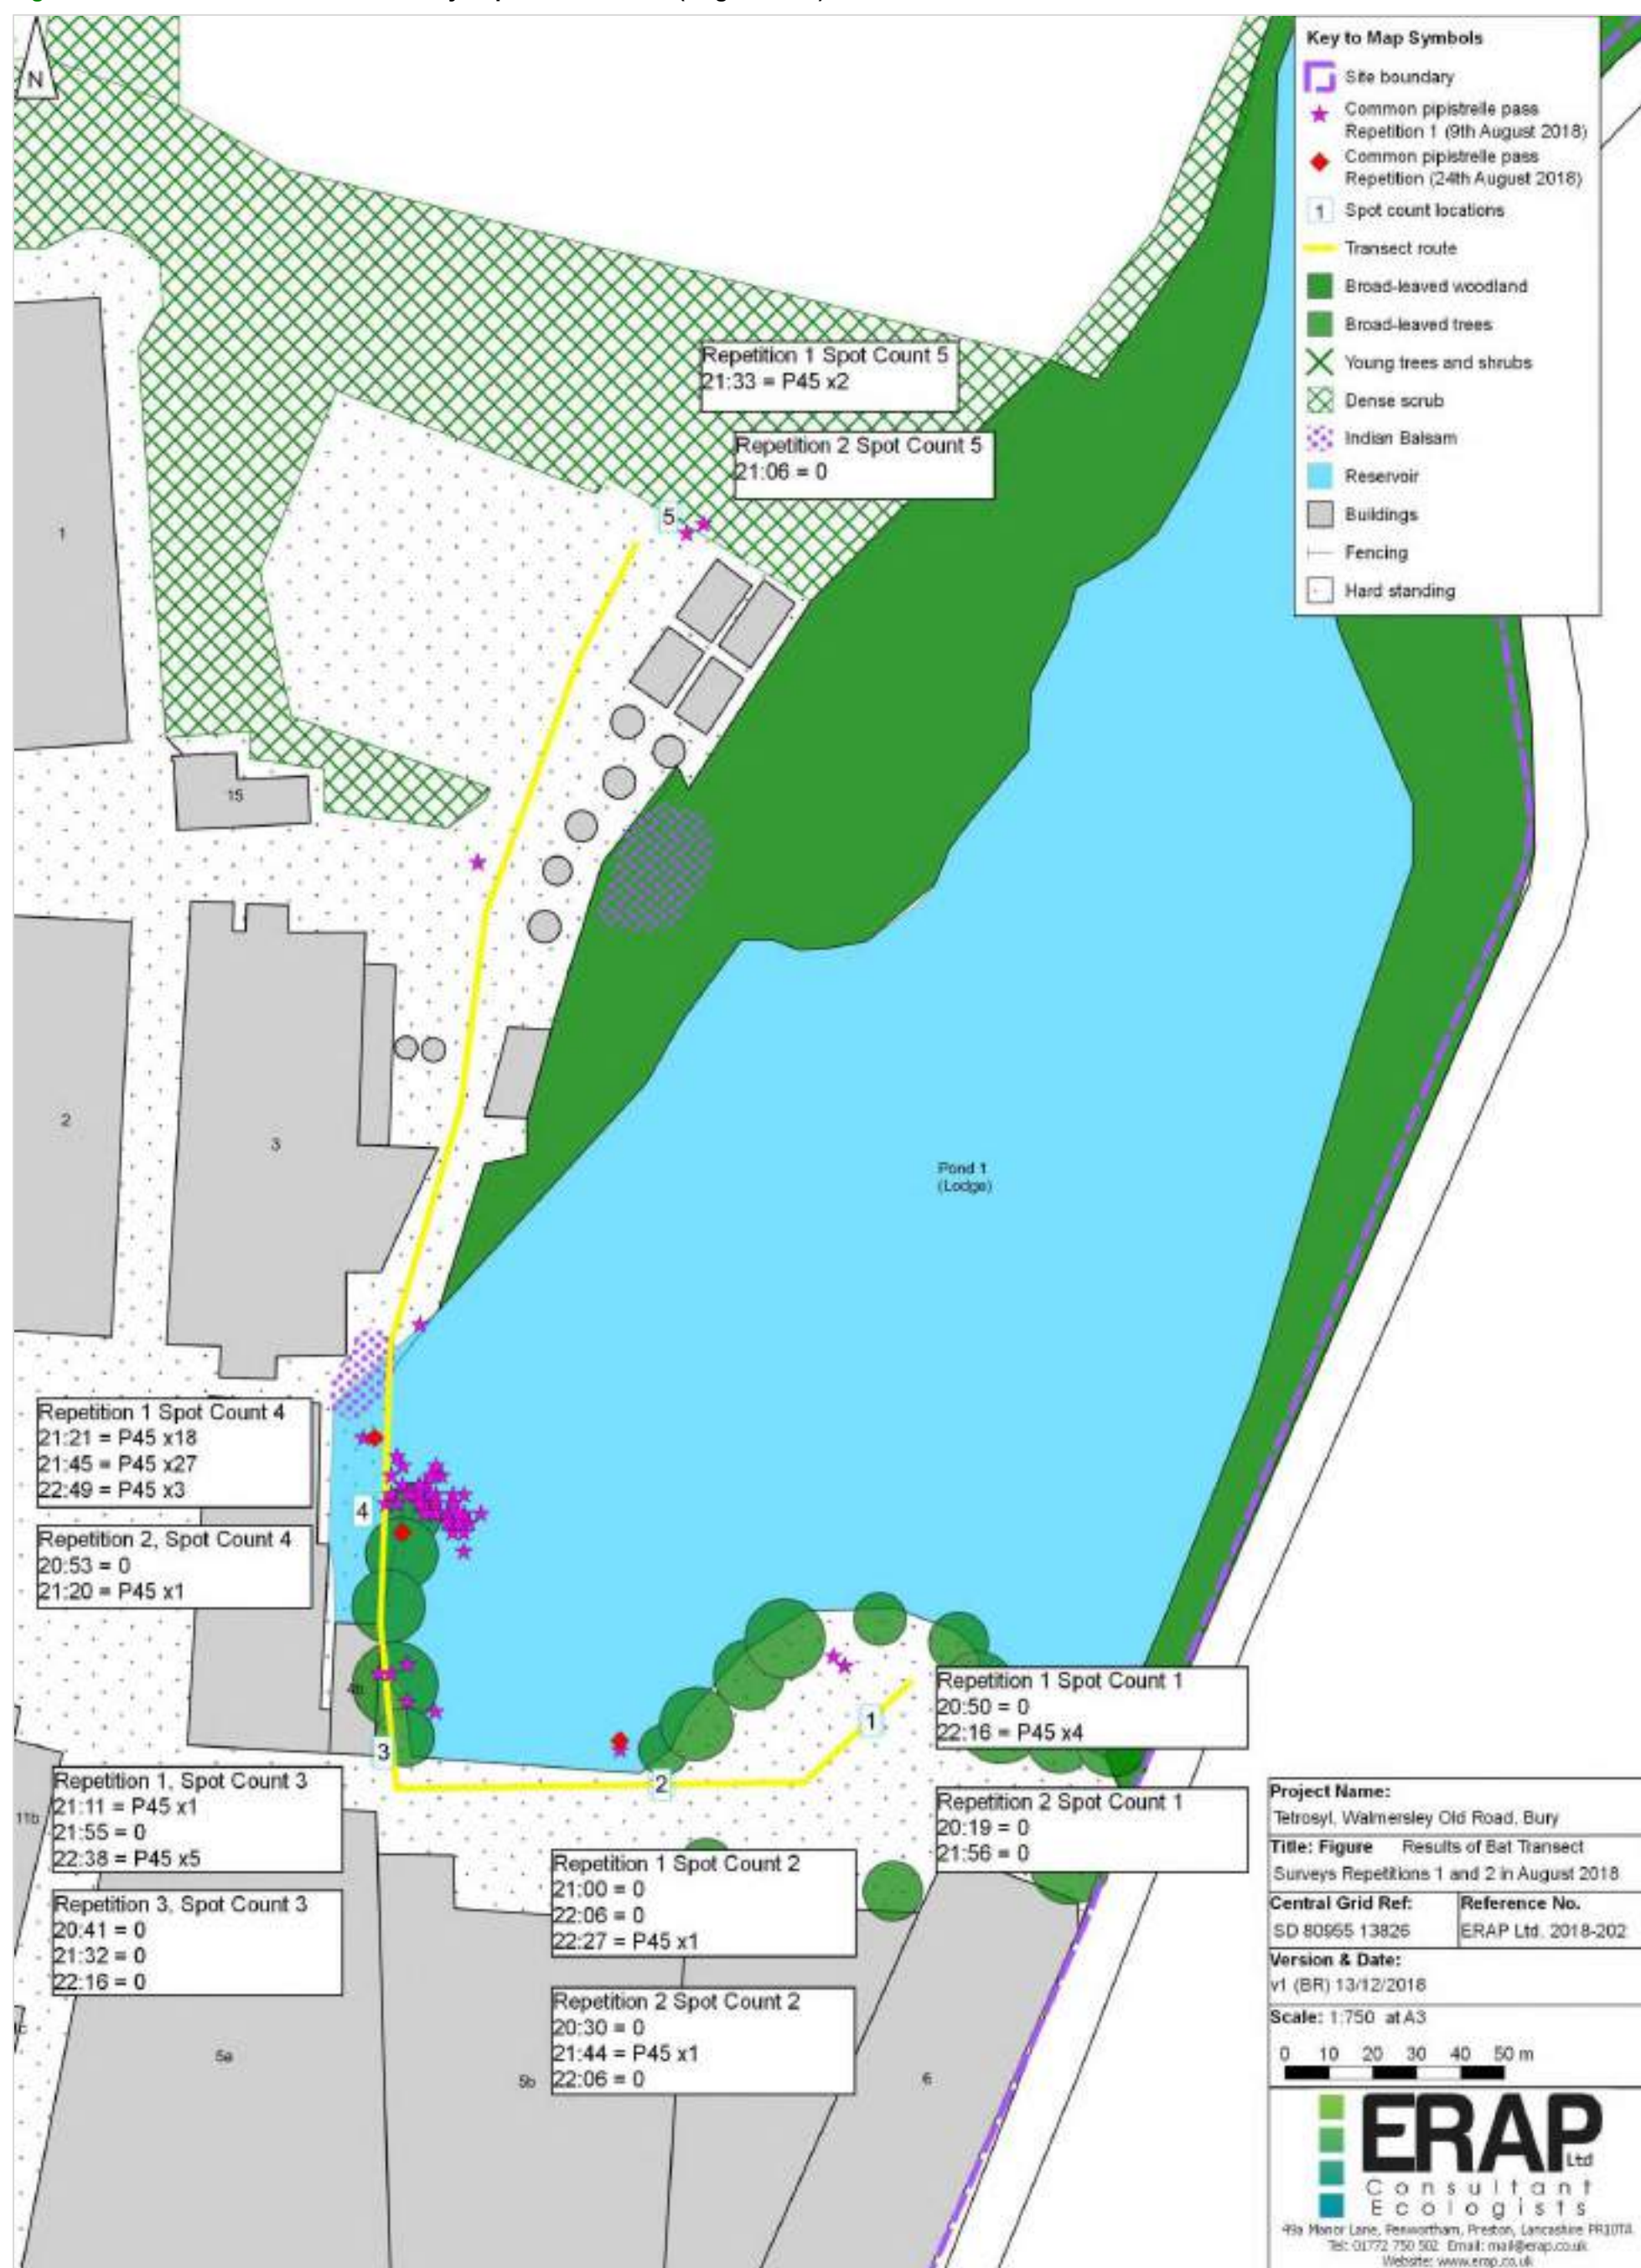
Figure 8.3: Results of Bat Transect Survey Repetitions 1 and 2 (August 2018)

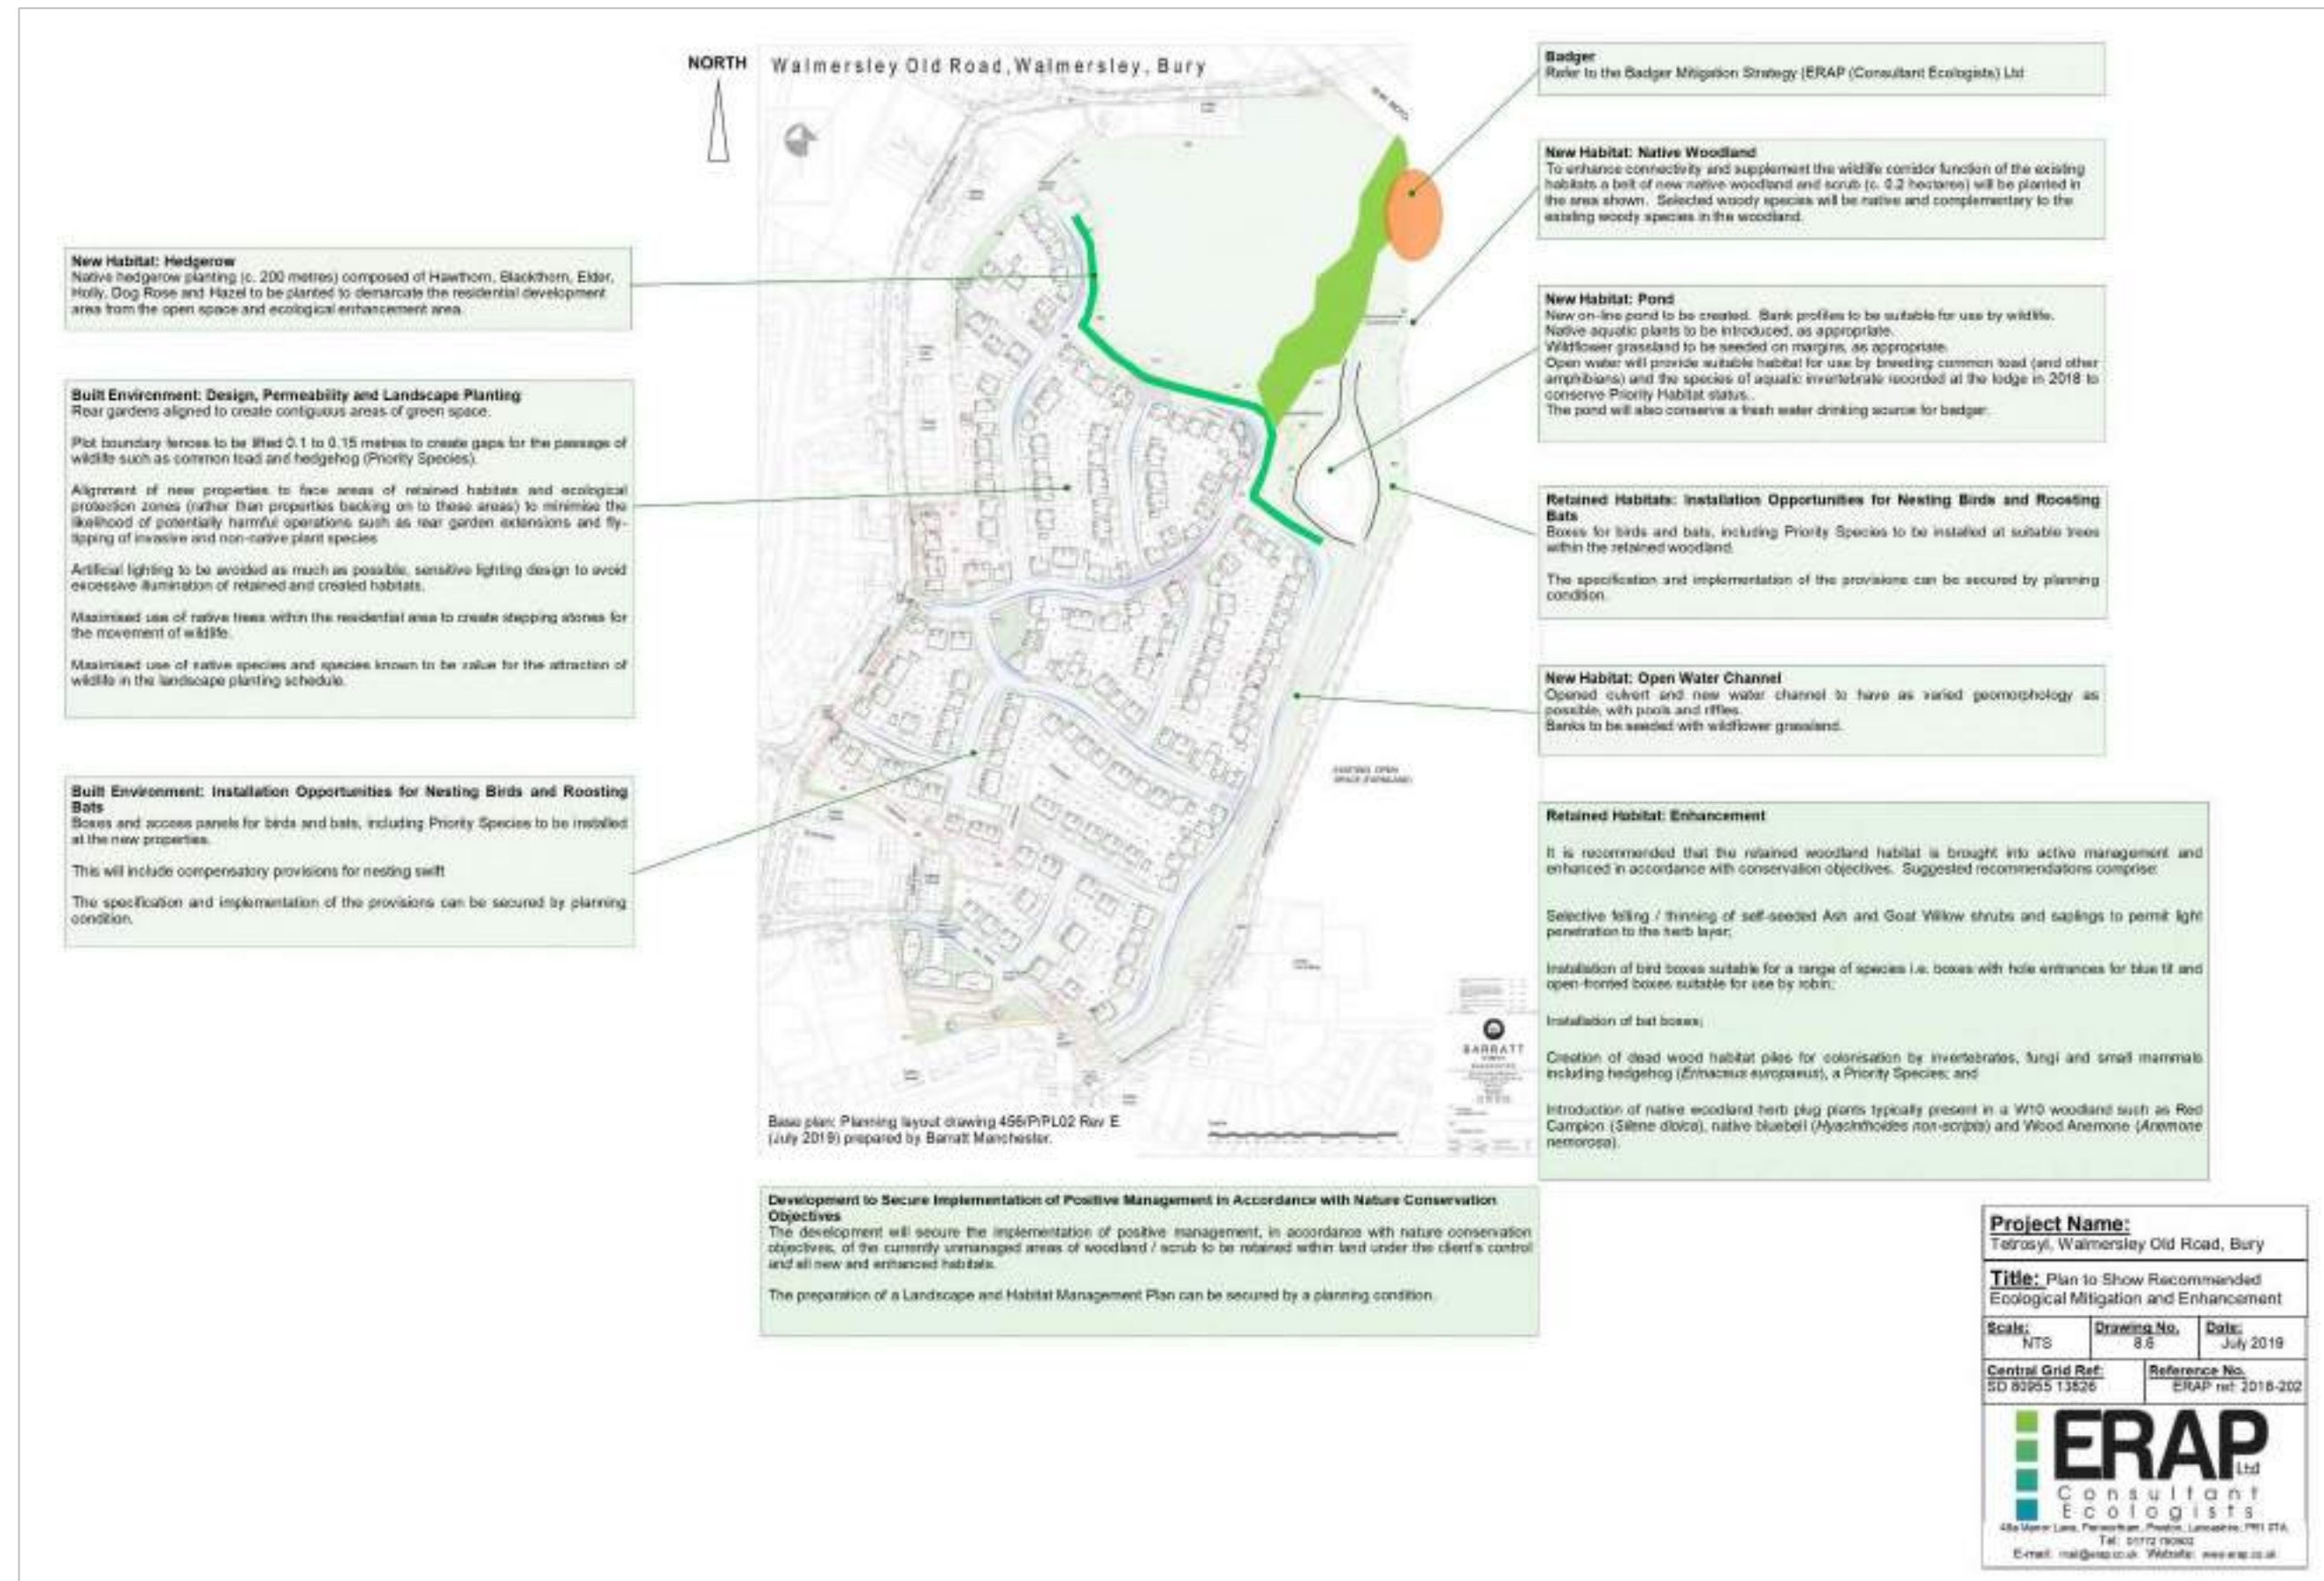
Figure 8.6: Plan to Show Recommended Ecological Mitigation and Enhancement

- 4.5.1 The proposals can be achieved with no adverse direct or indirect effect on designated sites for nature conservation.
- 4.5.2 The presence of two Priority Habitats (Pond and Lowland Mixed Deciduous Woodland) is capable of being a material consideration in connection with a planning decision. The essential re-grading of the banks of the lodge and creation of a functioning drainage system at the redeveloped site will result in the temporary loss of the open water habitat from the site, however, in the long-term open water suitable for use by breeding common toad and invertebrates will be retained at the site, refer to **Figure 8.6**.

- 5.11.3 As annotated on **Figure 8.6**, the woodland belt between the new pond and the M66 motorway will be planted with native trees and shrubs to complement the existing habitats and enhance and supplement the wildlife corridor function.

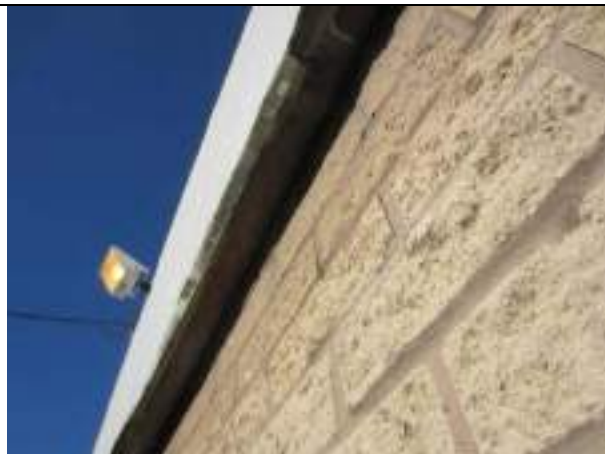
**Photo 2:** No gaps present beneath the cladding or in the blockwork at Building 1

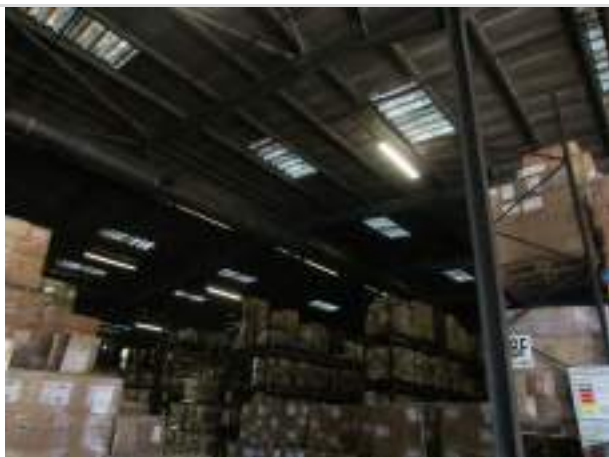
**Photo 3:** Interior of Building 1 showing steel frame and skylights

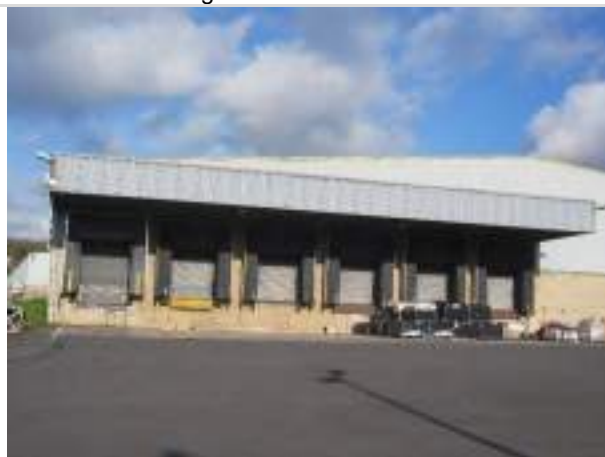
**Photo 4:** South elevation of Building 2

- 9.3.6 Building 2 is the same construction as Building 1 with an additional loading bay canopy on the south elevation, refer to **Photo 4**.
- 9.3.7 No gaps or opportunities for use by roosting bats were found at Building 2; the building is assessed to have negligible suitability for use by roosting bats.

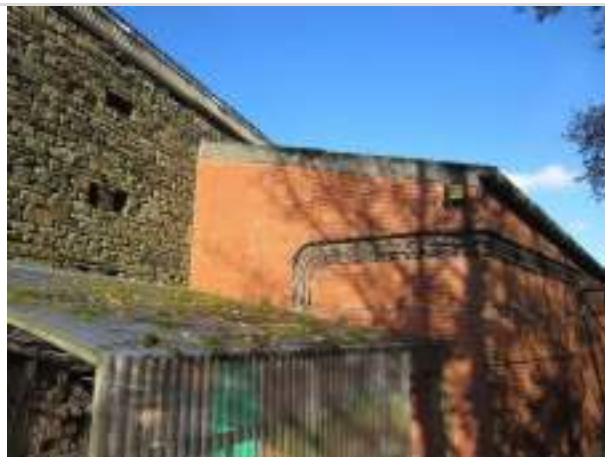
**Photo 6:** East elevation of Building 3 showing holes in stone elevation wall and cement sheeting fascia at a brick annex

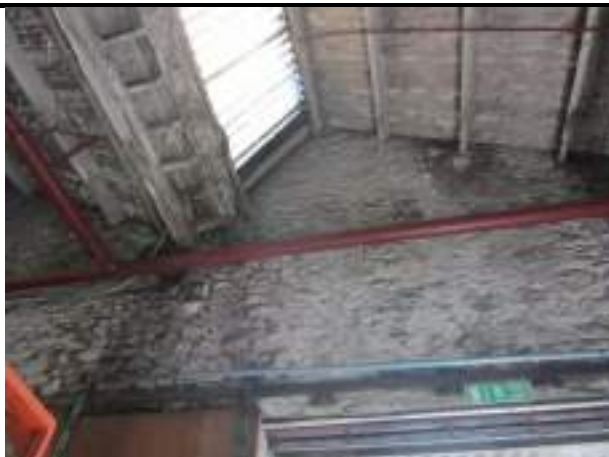
**Photo 7:** Interior of Building 3 showing sarking, north lights and exposed stone walls

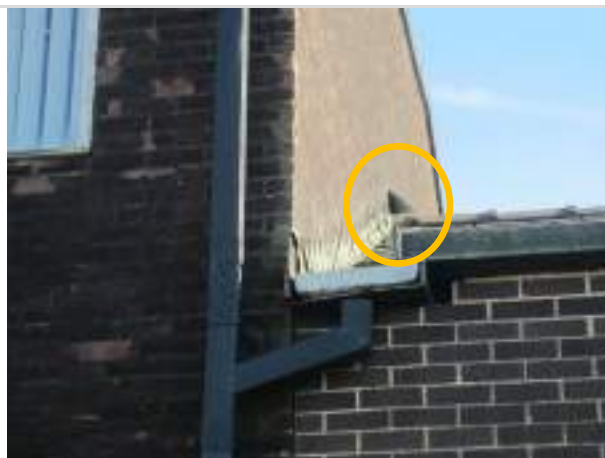
**Photo 10:** Minor gaps at lifted lead flashing on Building 4

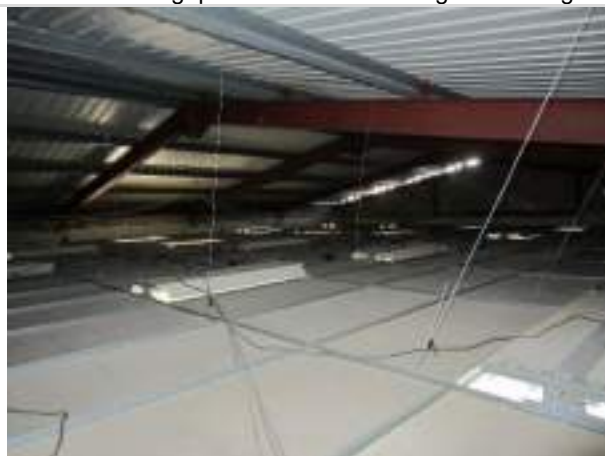
**Photo 12:** Roof void above suspended ceiling at two-storey section of Building 4a

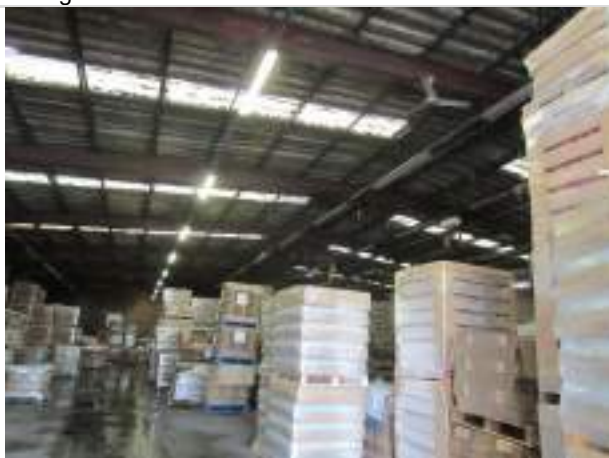
**Photo 22:** North and west elevation of Building 8

- 9.3.25 Building 8 is a single storey steel framed and brick warehouse with a shallow pitched corrugated sheeting covered roof, refer to **Photo 22**. Fascia over hang the gable ends at the east and west elevations and a gap is present above the doorway at the west elevation but closer inspection did not detect any evidence of use by roosting bats.
- 9.3.26 An internal inspection confirmed that the roof is unlined and a large hole is present in the roof, refer to **Photo 23**. Evidence of use of the building by feral pigeon was recorded.
- 9.3.27 Building 8 has negligible suitability for use by roosting bats.

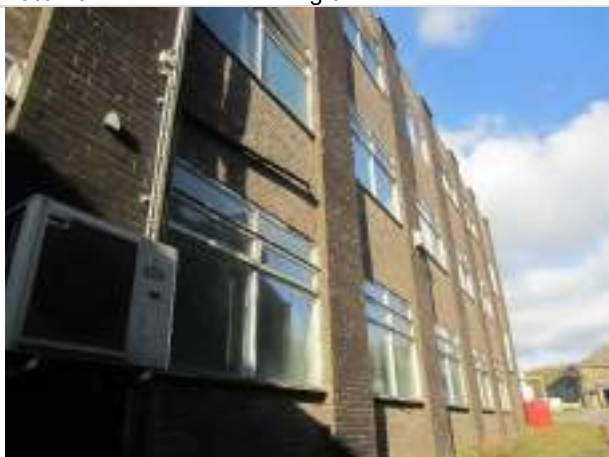
**Photo 26:** North and west elevation of Building 10

- 9.3.32 Building 10 is a two-storey brick building with a flat roof and timber and pvc framed windows, refer to **Photo 26**. No opportunities for use by roosting bats were found and the building is assessed to have negligible suitability.

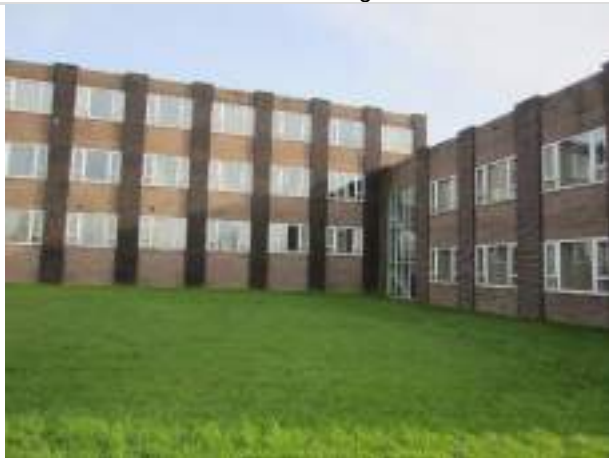
**Photo 28:** South elevation of Building 11c (11d to the left)

- 9.3.33 Building 11 is divided into four parts. Buildings 11a and 11b are similar in construction to Building 10 and have no suitability for use by roosting bats, refer to **Photo 29**.
- 9.3.34 Building 11d, refer to **Photo 28**, comprises a single storey timber cabin with a pitched tile covered roof. No opportunities for use by roosting bats were found and the building is assessed to have no suitability.
- 9.3.35 Building 11c is a stone built structure with a pitched slate covered roof with parapet walls at the south facing gable end (the north elevation keys into Building 11b). Gaps are present in the stone elevation wall and where 11c meets 11b at the east elevation. Building 11c is assessed to have a moderate suitability for use by roosting bats.

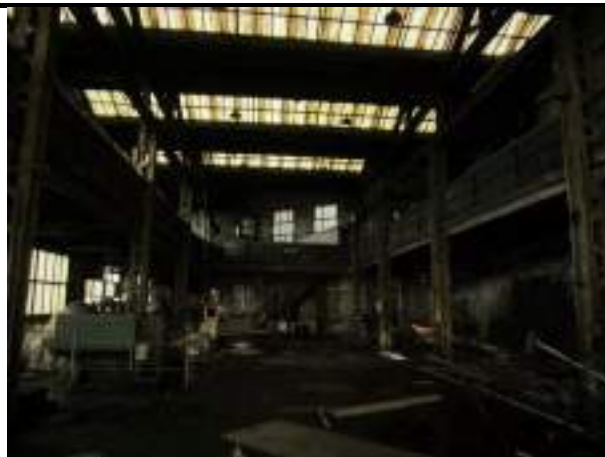
**Photo 31:** West elevation of Building 13

- 9.3.37 Building 13 is a single storey stone building with a slate covered north lights roof, refer to **Photo 31**. The building is very dilapidated and holes are frequent at the broken window panes and roof. A brief internal inspection confirmed that the internal stone walls are well-sealed; no gaps of opportunities for bat access were found.
- 9.3.38 Owing to the presence of a slate covered roof and ridge copings, Building 13 is assessed to have a low suitability for use by crevice roosting bats owing to the draughty and exposed conditions present.

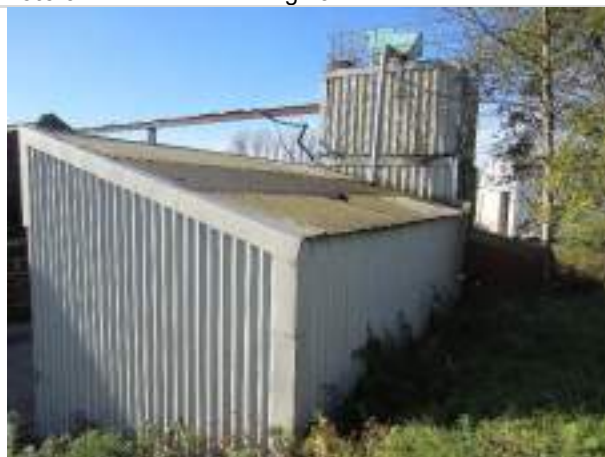
**Photo 33:** North and west elevation of Building 14

- 9.3.39 Building 14 is a brick built store with a pitched corrugated sheeting covered roof with skylights, refer to **Photo 33**. Steel lintels are present on the elevation walls. The window apertures along the east elevation are bricked up. A gap is present at the top but closer inspection confirmed the gap only extends approximately 0.03m to 0.08m and does not lead into a deeper cavity and has no opportunity for bat access.
- 9.3.40 Building 14 is assessed to have a low suitability for use by crevice roosting bats owing to the limited value of the features present.

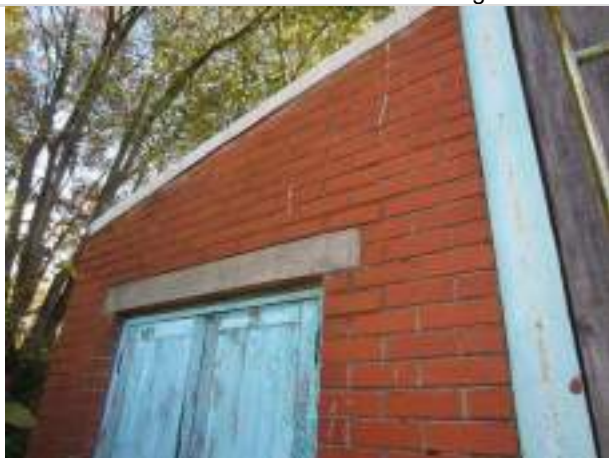
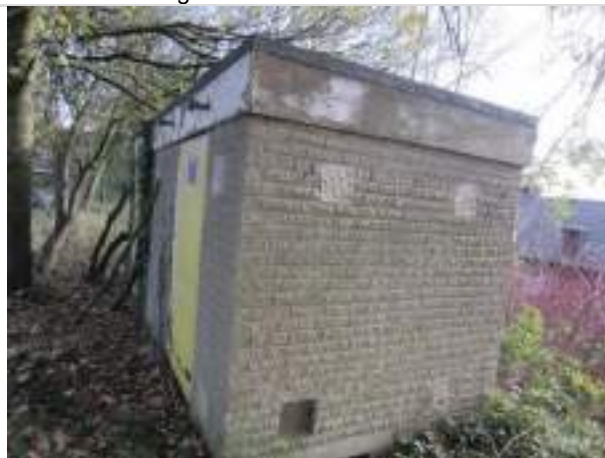
- 9.3.41 Building 15 is a metal hopper with a brick outbuilding with a single pitched roof at the western side, refer to **Photos 34 and 35**. No opportunities for use by roosting bats were found.

**Photo 34:** Building 15

**Photo 35:** West elevation of Building 15

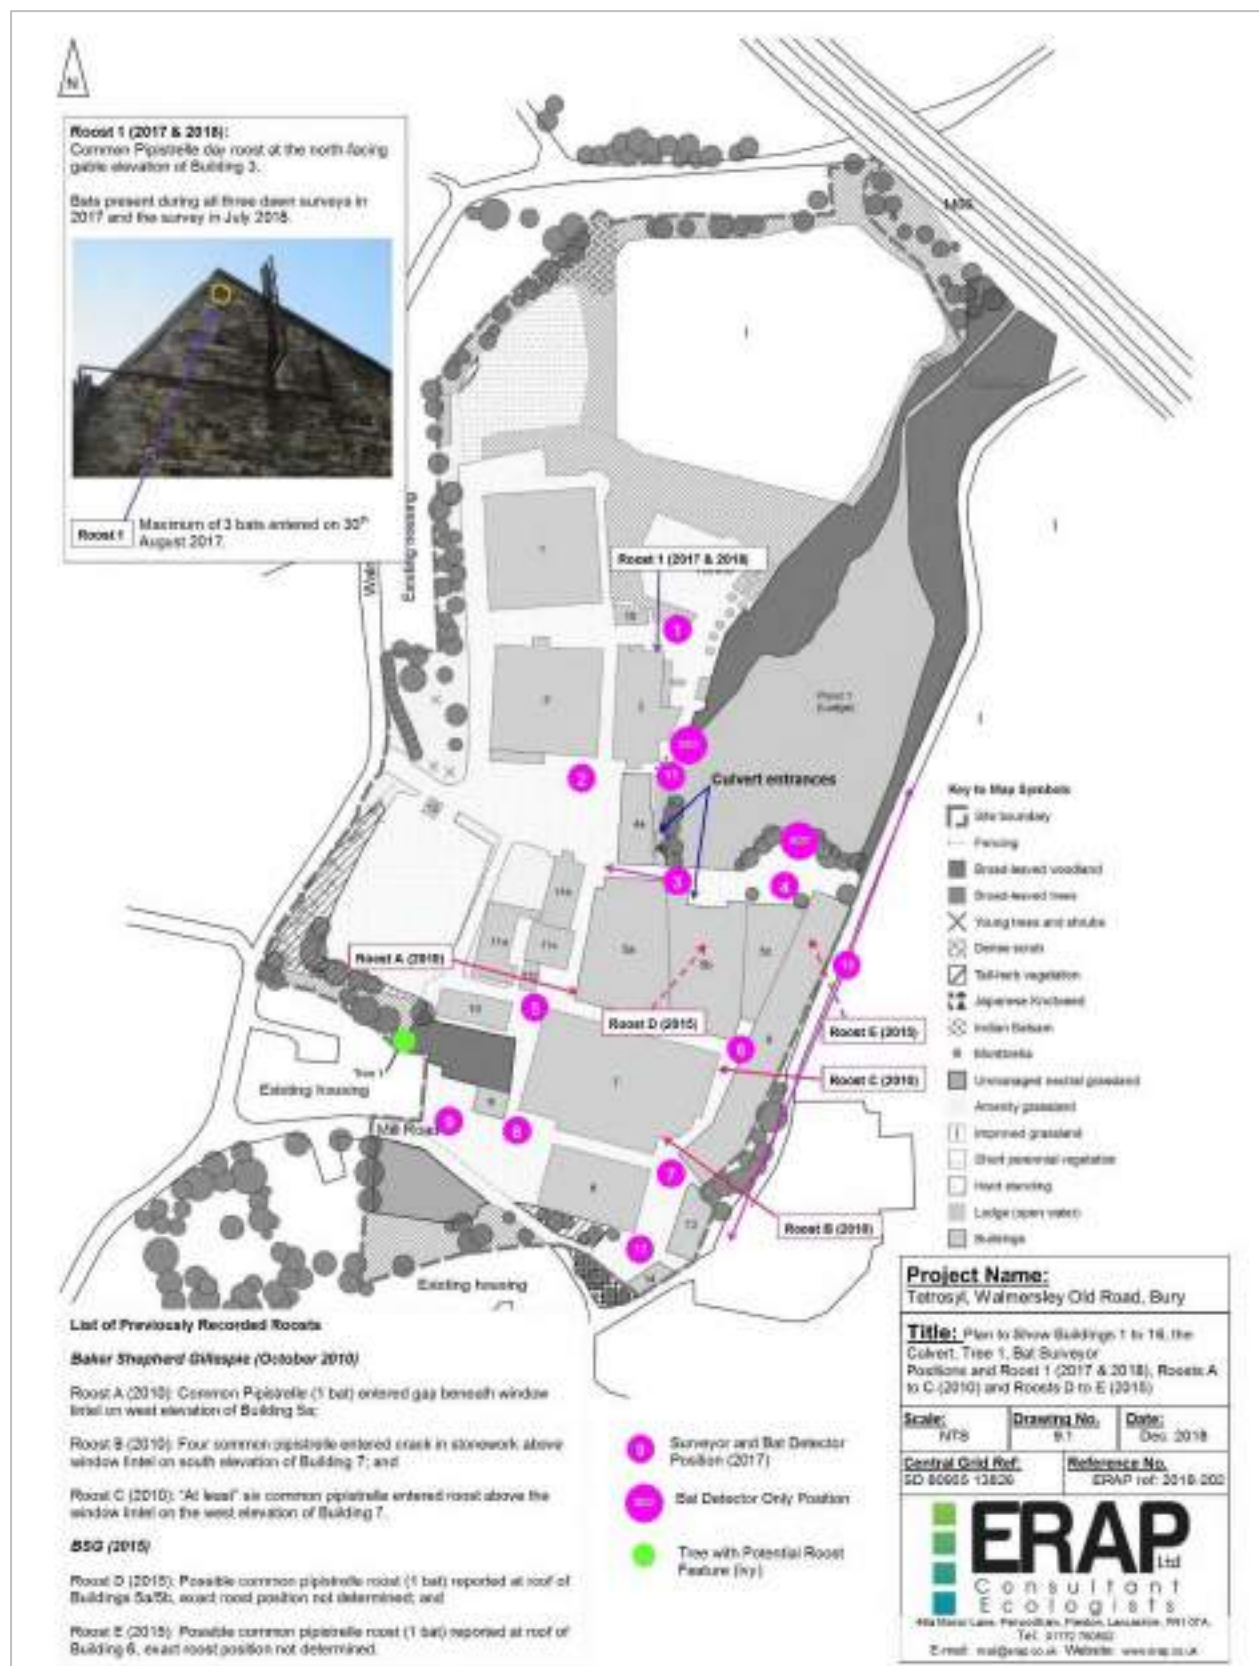
**Figure 9.1:** Plan to Show All Buildings, Surveyor Locations and Position of Roost 1 (2017 & 2018), Roosts A to C (2010) and Roosts D to E (2015)

- 9.3.47 Three common pipistrelle bats were observed entering a hole in the stone wall (Roost 1) at the northern elevation of Building 3 between 05:23 and 05:31 (25 to 17 minutes before sunrise). The roost is annotated on **Figure 9.1**.

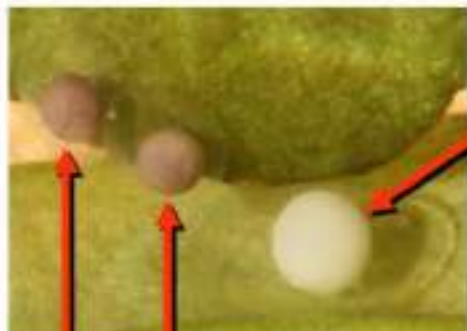
Newt eggs are usually wrapped, singly, in vegetation. Leaves folded around great crested newt eggs are particularly conspicuous. To identify, unfold the leaf. Identification of undeveloped eggs is easiest.

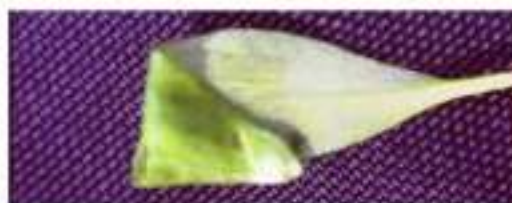
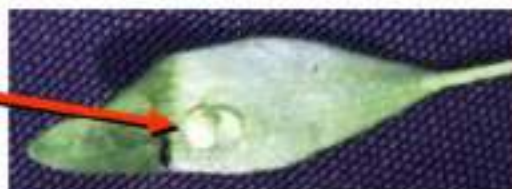
Great crested newt eggs are white, sometimes with a tint of green or orange (jelly capsule 5 mm).

Eggs of smooth and palmate newts cannot be distinguished by eye, but they are smaller (jelly capsule 3 mm) than great crested newt eggs and are grey or beige when newly laid.

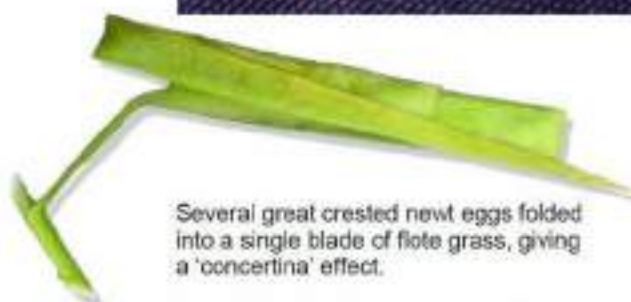
Several great crested newt eggs folded into a single blade of flote grass, giving a 'concertina' effect.

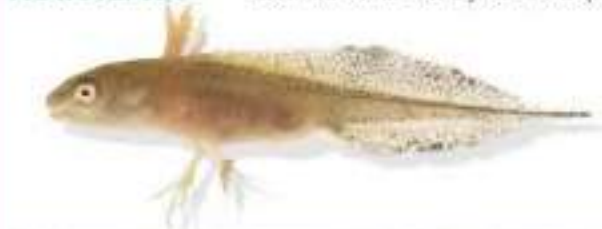
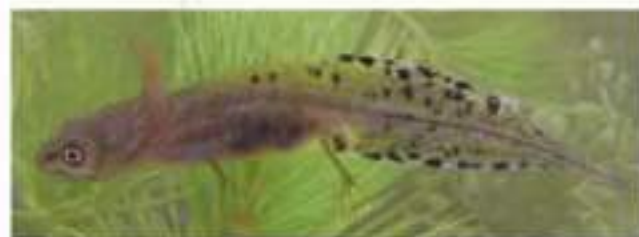
Great crested newt larvae (above) have long toes and blotches of dark pigmentation on tail fins. Grow to approximately 5 cm.

Palmate and smooth newt larvae (above) are indistinguishable in the field—but do not have the long toes or spotted tail fins of great crested newt larvae. Grow to approximately 3 cm.

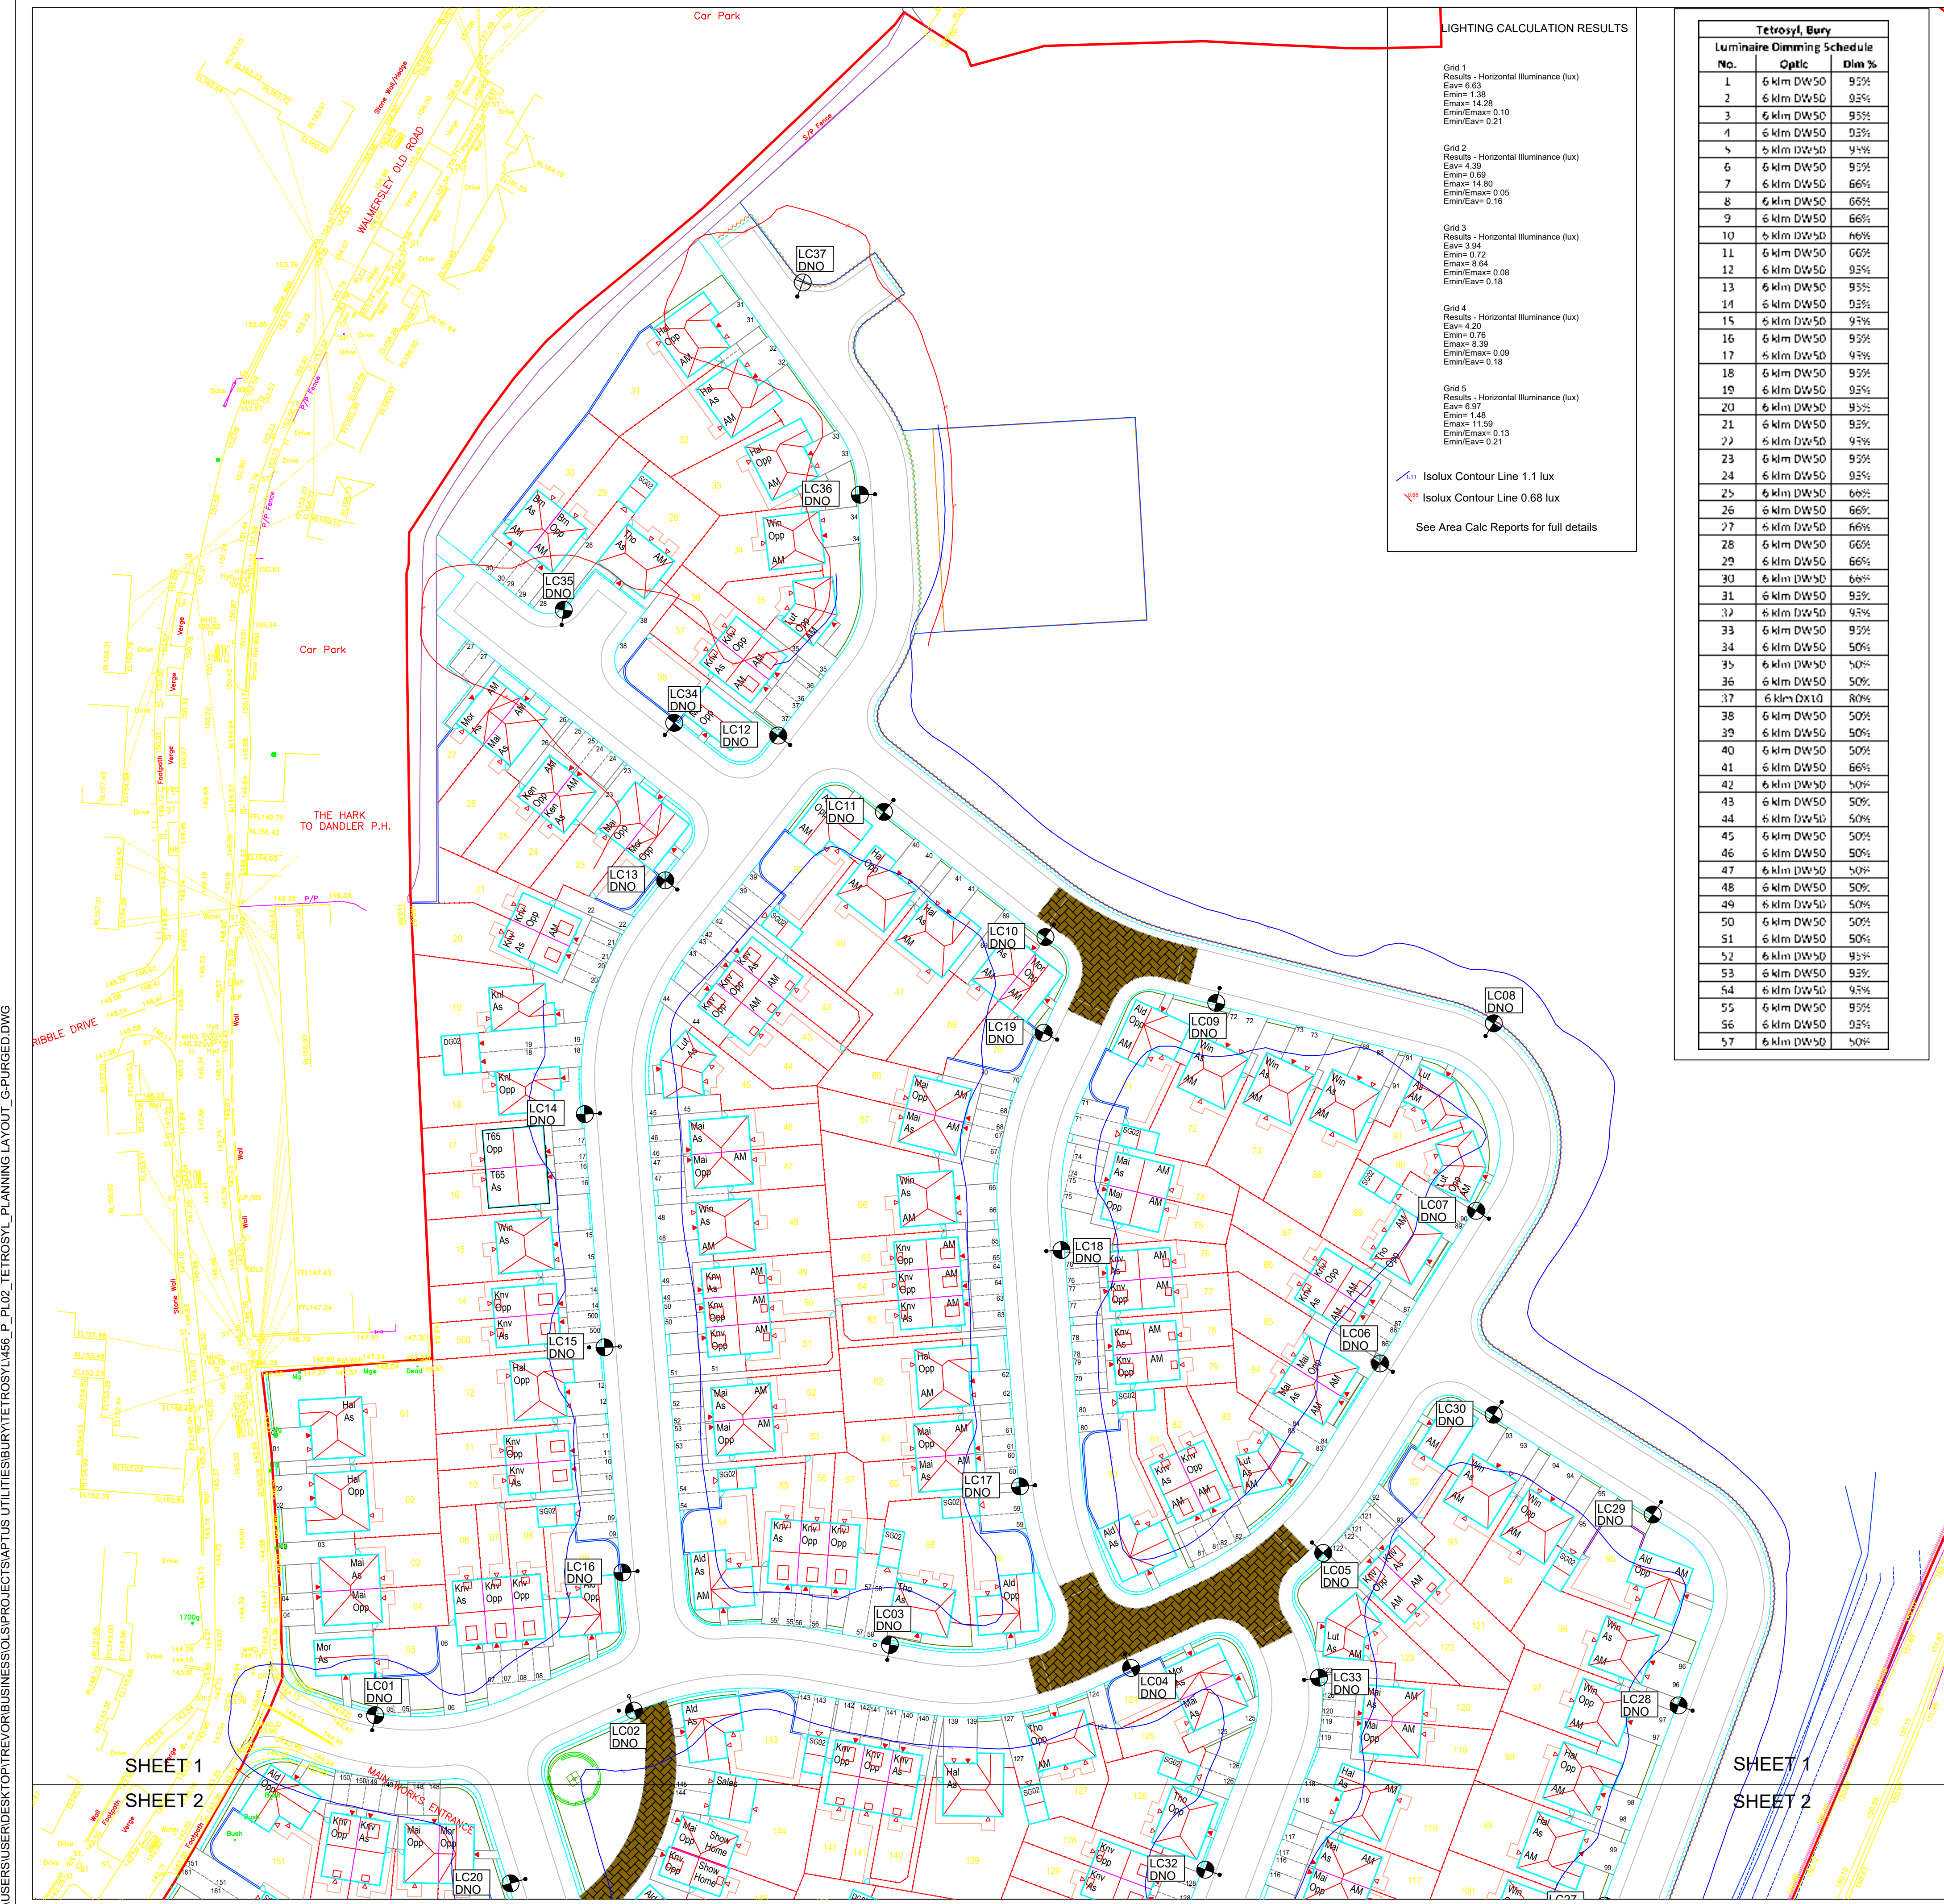
LIGHTING CALCULATION RESULTS

Grid 1  
Results - Horizontal Illuminance (lux)  
Eav= 6.63  
Emin= 1.38  
Emax= 14.28  
Emin/Emax= 0.10  
Emin/Eav= 0.21

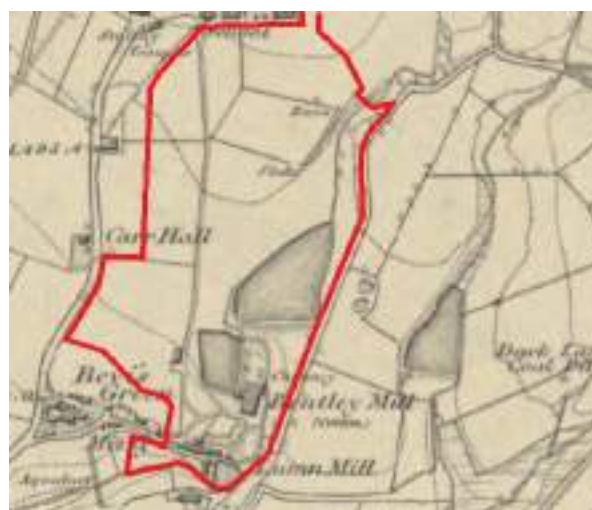
Figure 3.1: 1844 map

3.1.1. The site occupies the valley of a tributary to Pig Lee Brook which was dammed to form a mill lodge discharging to two further lodges and a culvert below the southeast part of the site. Bentley and Lumn Cotton Mills were the original development within the site. Part of the site extends south of Mill Road and is referred to as 'The Croft'. An abandonment survey for Lumn Mills Mine dated 1877 shows 2 adit entrances (one as an incline) located in the south east corner of the site connecting with workings in the Sand Rock coal seam off-site to the east. An extract from the 1844 Ordnance Survey 6"/mile scale map is provided below showing the mills at an early stage of development.

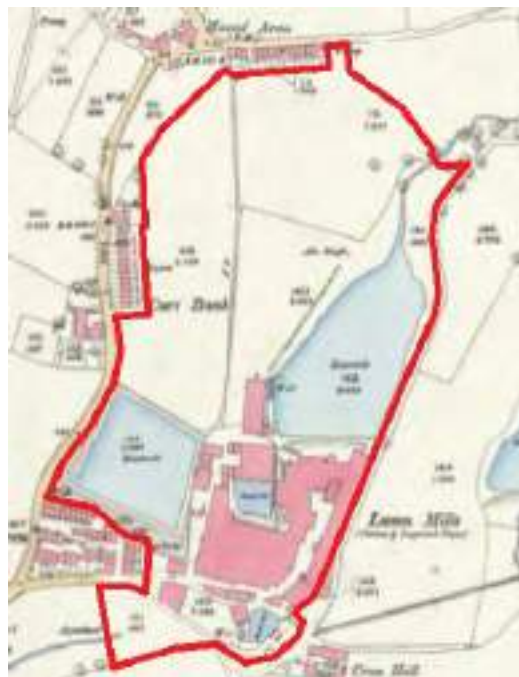
**Figure 3.2: 1890 Map**

3.1.2. The mills were redeveloped or expanded before the date of the 1877 mine abandonment plan, and the main mill lodge extended northwards, presumably by raising the height of the dam. The 1890 Ordnance Survey 25"/mile scale map (see figure 3.2) shows the current masonry-constructed mill buildings were largely in place, annotated 'Lumn Mills (Cotton and Logwood Dyes)', with two small lodges still present in the south, and a new earth-retained reservoir in the southwest; the central lodge enclosed by buildings was reduced in size compared to the 1844 plan. An air shaft is shown on the northwest side of the main lodge, and a well in the southwest corner of the site. Two round structures (marked as chimneys on the 1908 revision) were shown alongside the mill buildings.

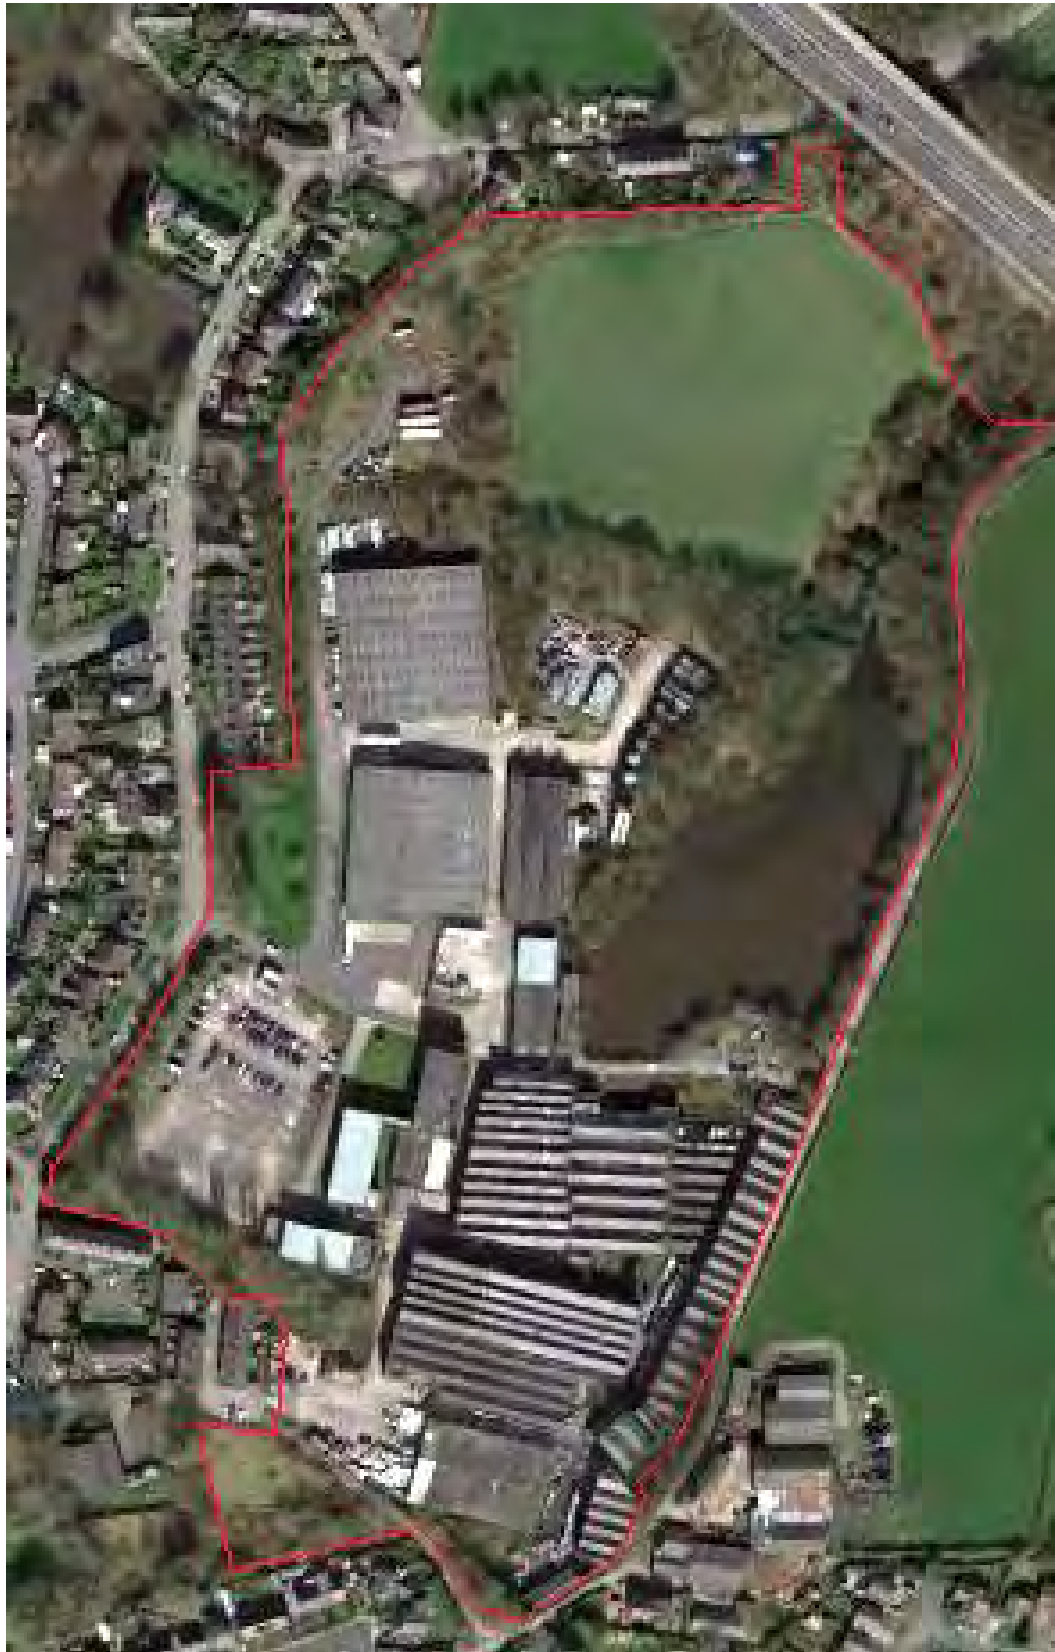
**Figure 3.4. Recent Aerial Photograph**

3.4.1. The aerial photograph below shows the recent land condition.
