## 6155 Bevis Green, Bury - EA Bespoke Permit - Risk Assessment (Issue 1 - February 2021)

Environmental management system for the realignment/diversion of the un-named tributary of Pigs Lee Brook and the treatment of associated silts.

**Former Tetrosyl Works,  
Walmersley Old Road,  
Bury.  
BL9 6RG**

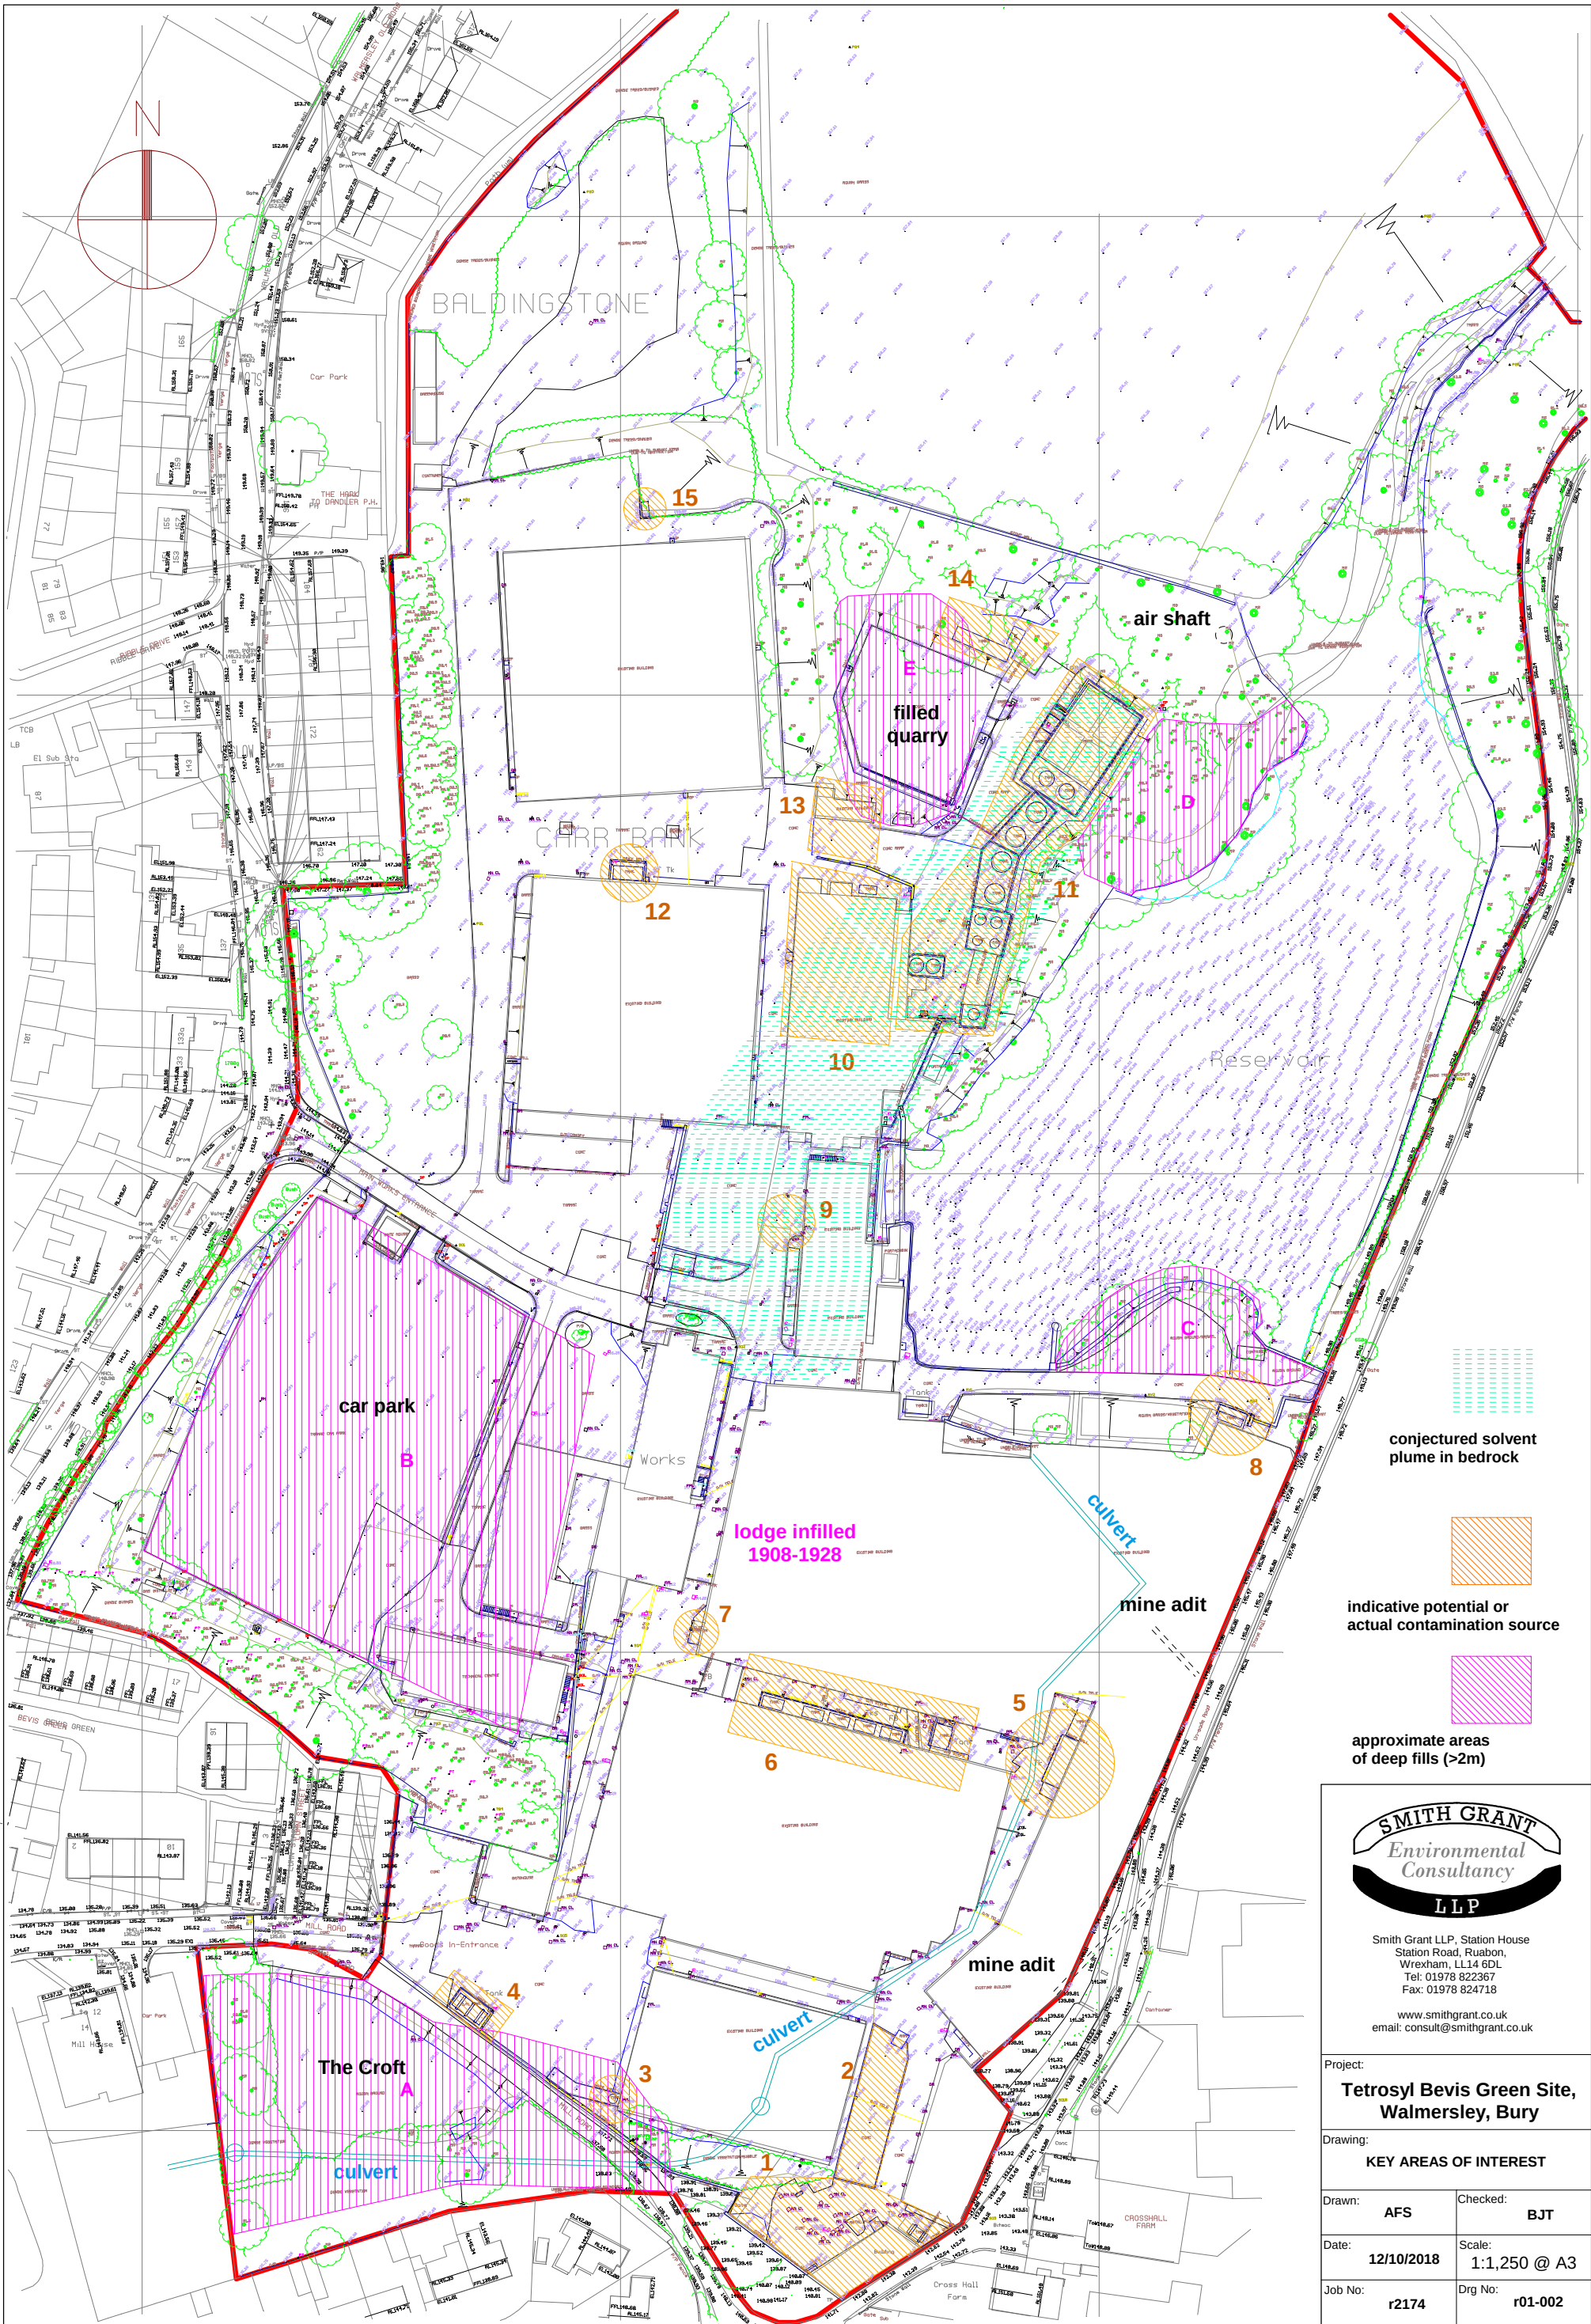
| Job No: | r2174 | Drg No: | r01-002 |

conjectured solvent  
plume in bedrock

indicative potential or  
actual contamination source

3.5.1. 15 potential or known hydrocarbon contamination source areas have been identified in table 3.3 below, at the approximate positions shown on drawing D02; this information is cross-referenced with the areas of potential concern (APCs) listed by ENSR (2003).

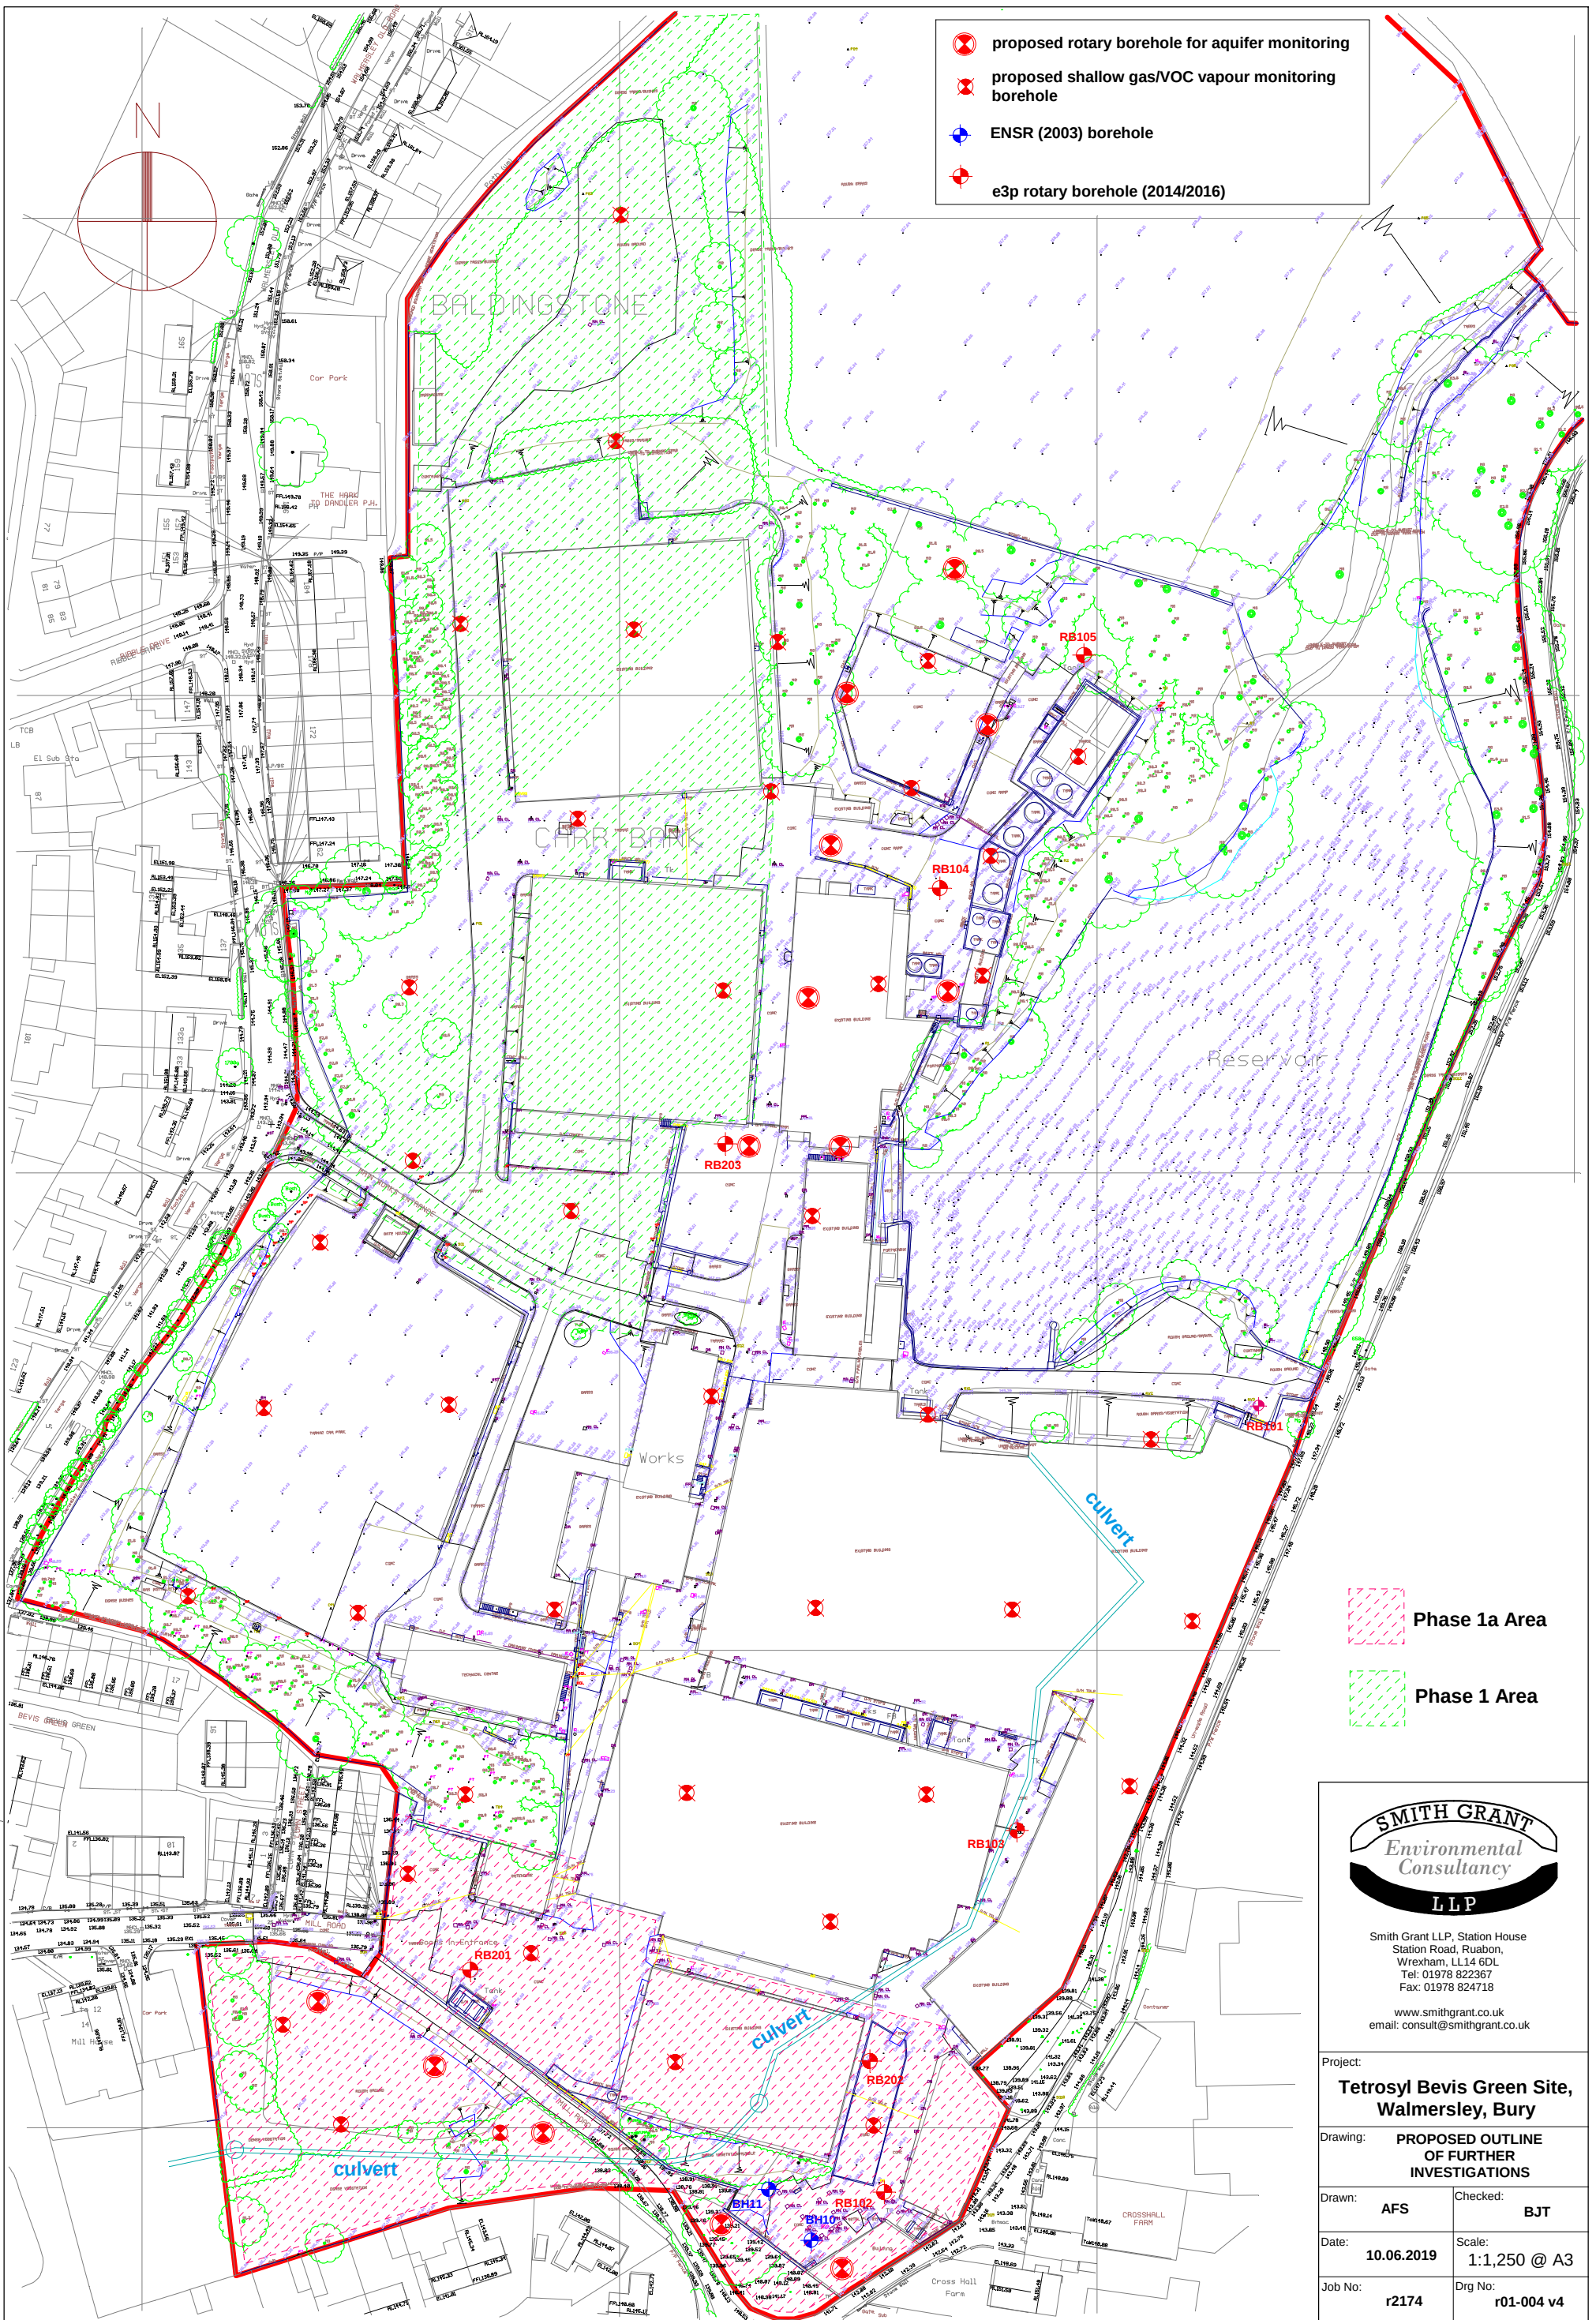
| r2174 | r01-004 v4 |

Phase 1a Area

Phase 1 Area

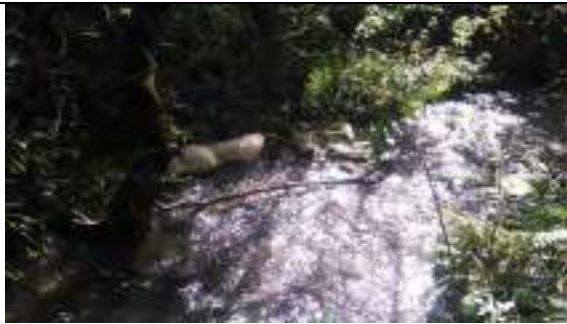
**Off-site outfall to culvert (Sample Analysis 17-65246; sample ref: SW-DS)**

- 3.5.11. Anionic surfactants were detected in all samples: RB201 0.7 mg/l; RB203 1.4 mg/l; upstream culvert 1.3 mg/l; downstream culvert 1.2 mg/l. Moderate foaming was noted at the culvert exit downstream.

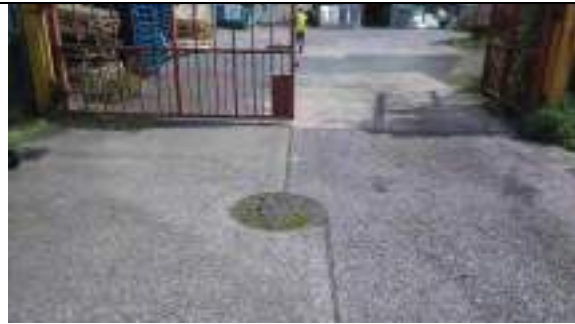
**Off-site drain cover on Mill Road associated with elevated PID readings in chamber**

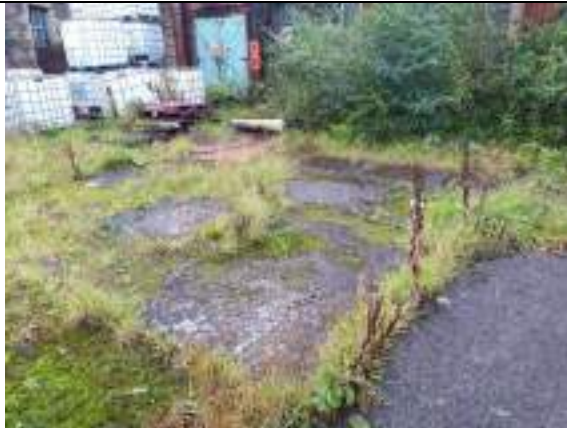
**Assumed covers for USTs in Area 1**

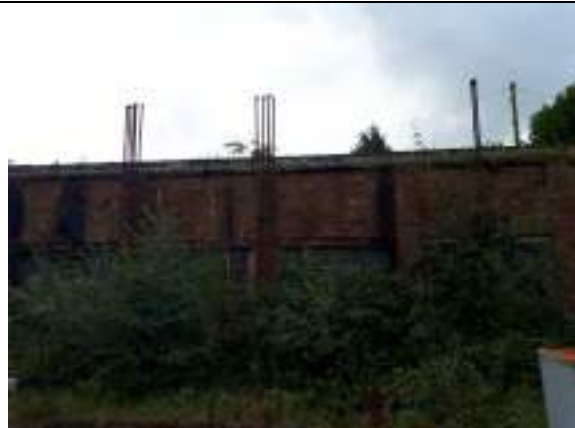
**Assumed vents for USTs in Area 1**

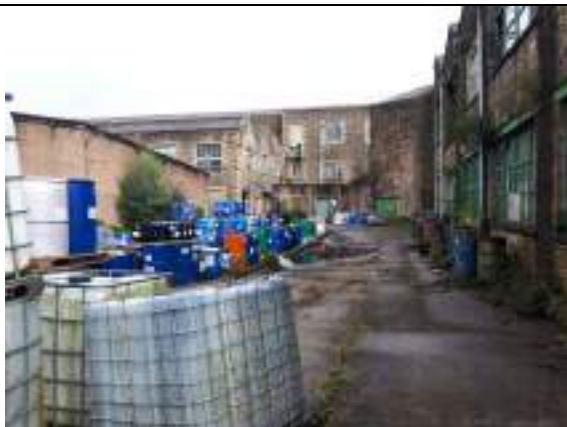
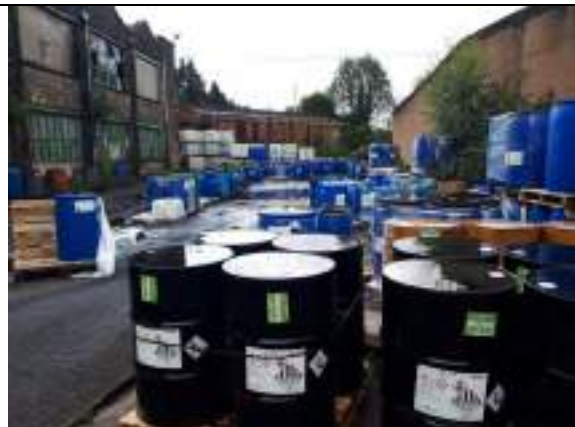
**Drum Store in Area 2**

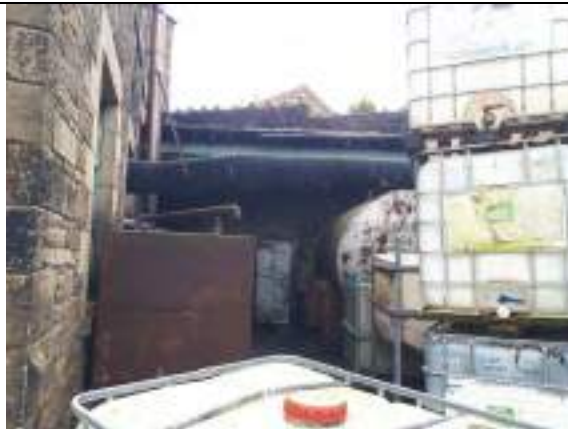
**Oil AST in Area 3**

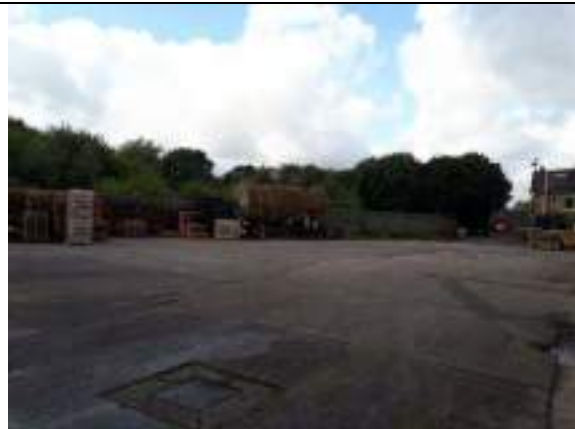
**Diesel AST in Area 4**

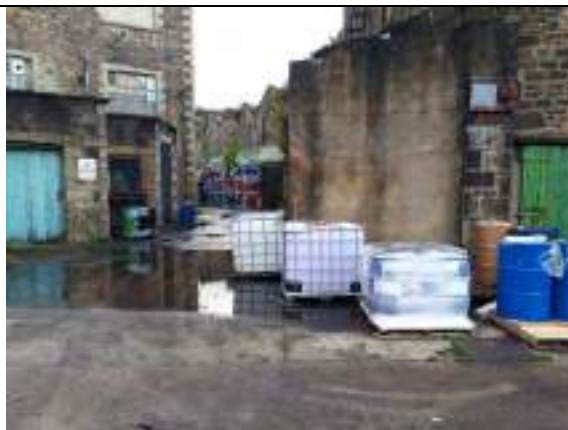
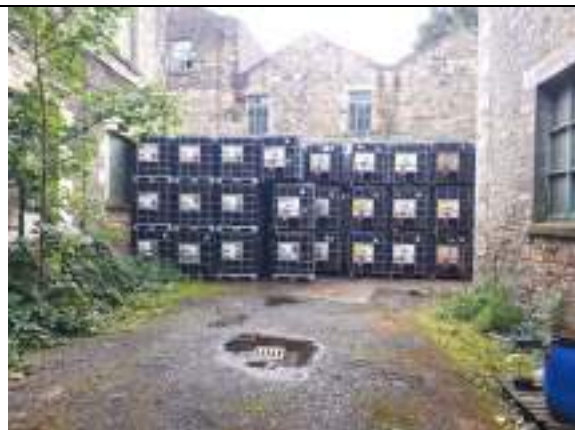
**View towards area 5 numerous unbanded drum  
/ IBC stores restrict access**

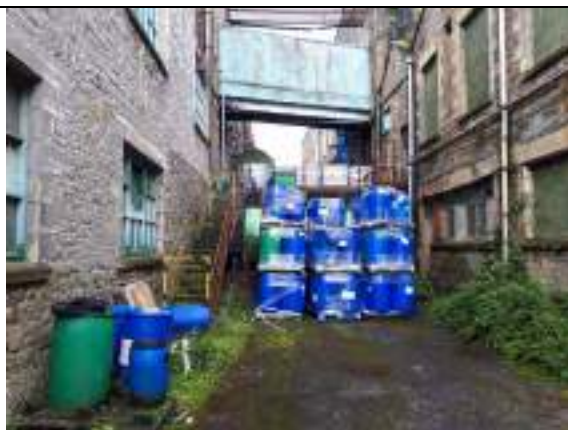
**View towards area 6 numerous unbanded drum  
/ IBC stores restrict access**

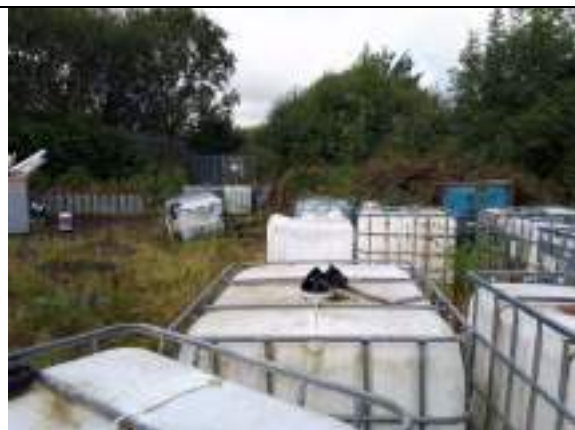
**Various other containers in all parts of central  
and western areas**

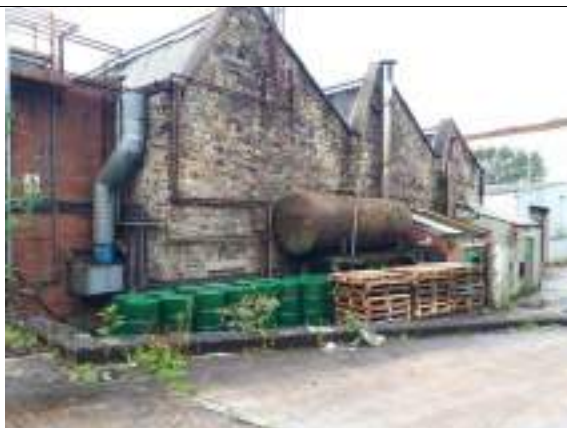
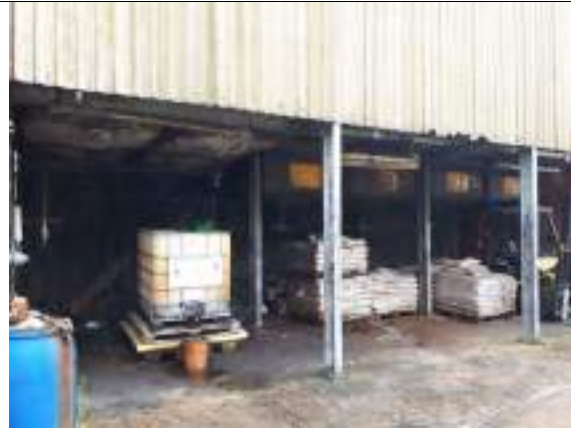
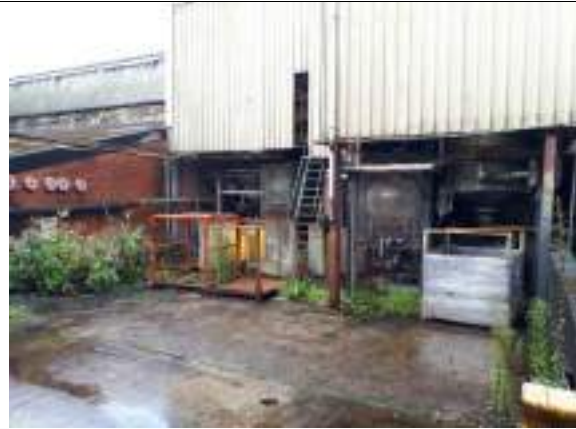
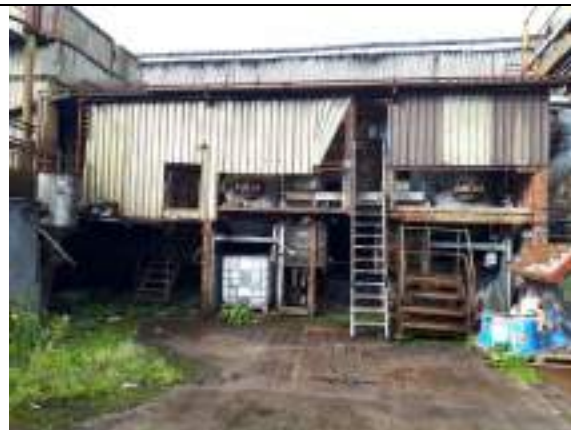
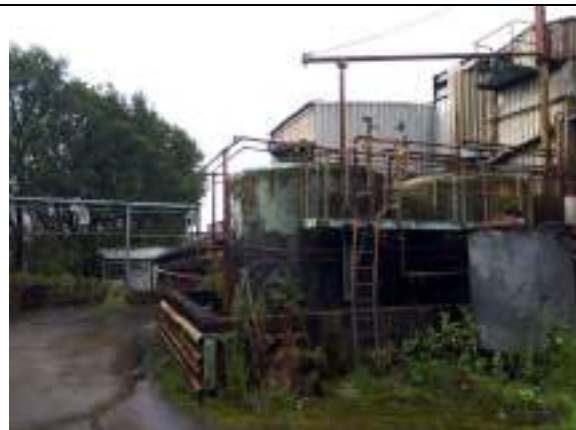
**Solvent Filling room at Area 10**

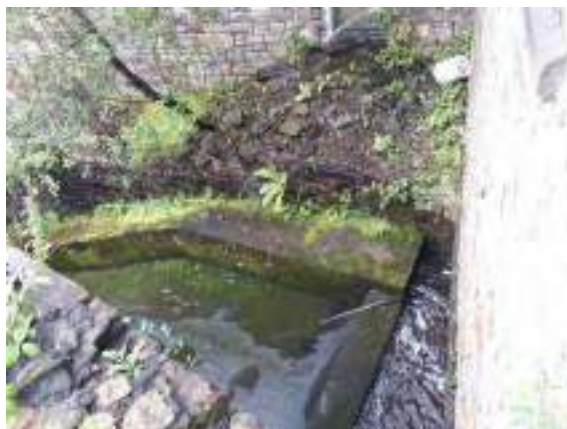
**Inlet to culvert (Sample Analysis 17-65246;  
sample ref: SW-DU)**

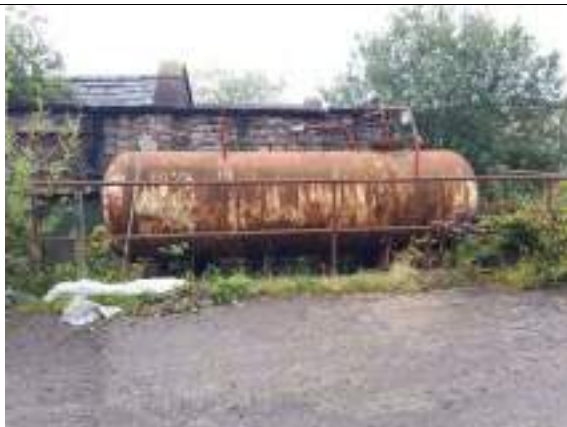
**Unknown AST in Area 8**

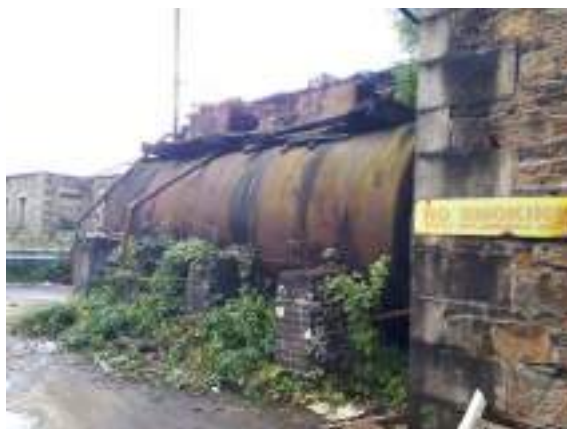
**Additional 'hot' bitumen product tank near top  
of dam (west of Area 8)**

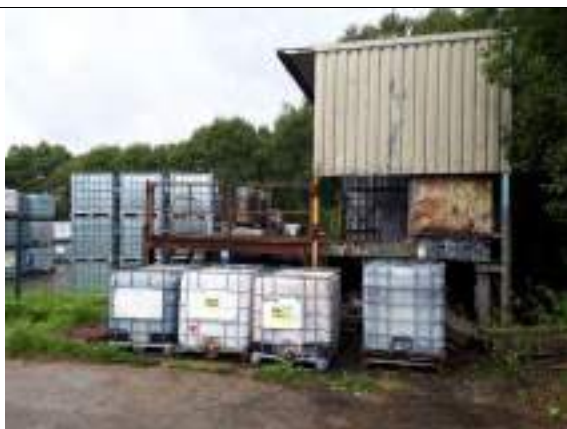
**Area 13 Waste sludge reclamation plant at**

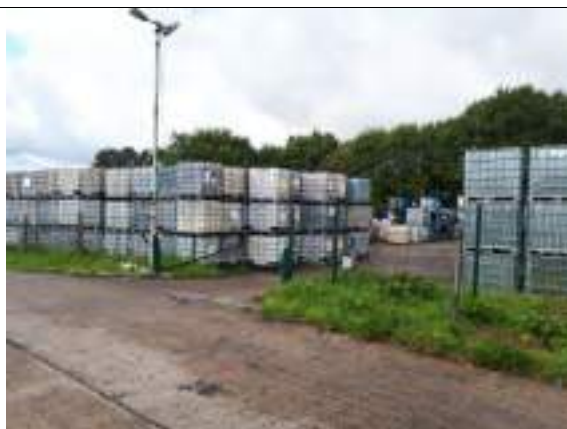
**Large IBC/Drum store on Area E**

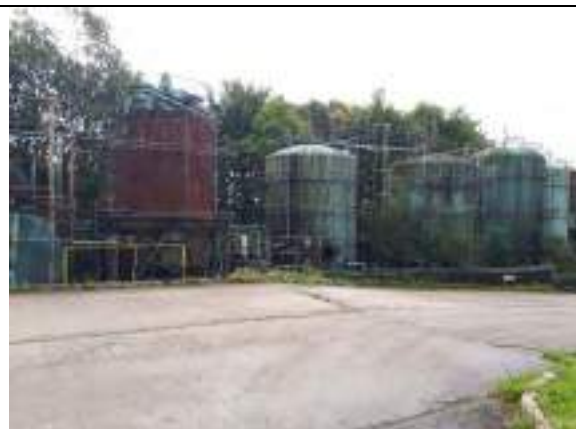
**Tank Farm at area 11**

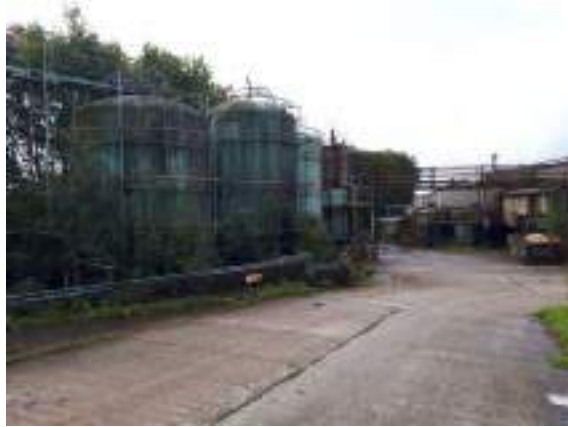
**Tank Farm at area 11**

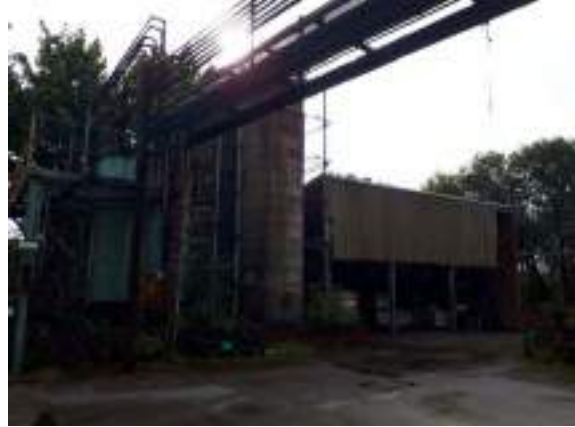
**Tank Farm at area 11**

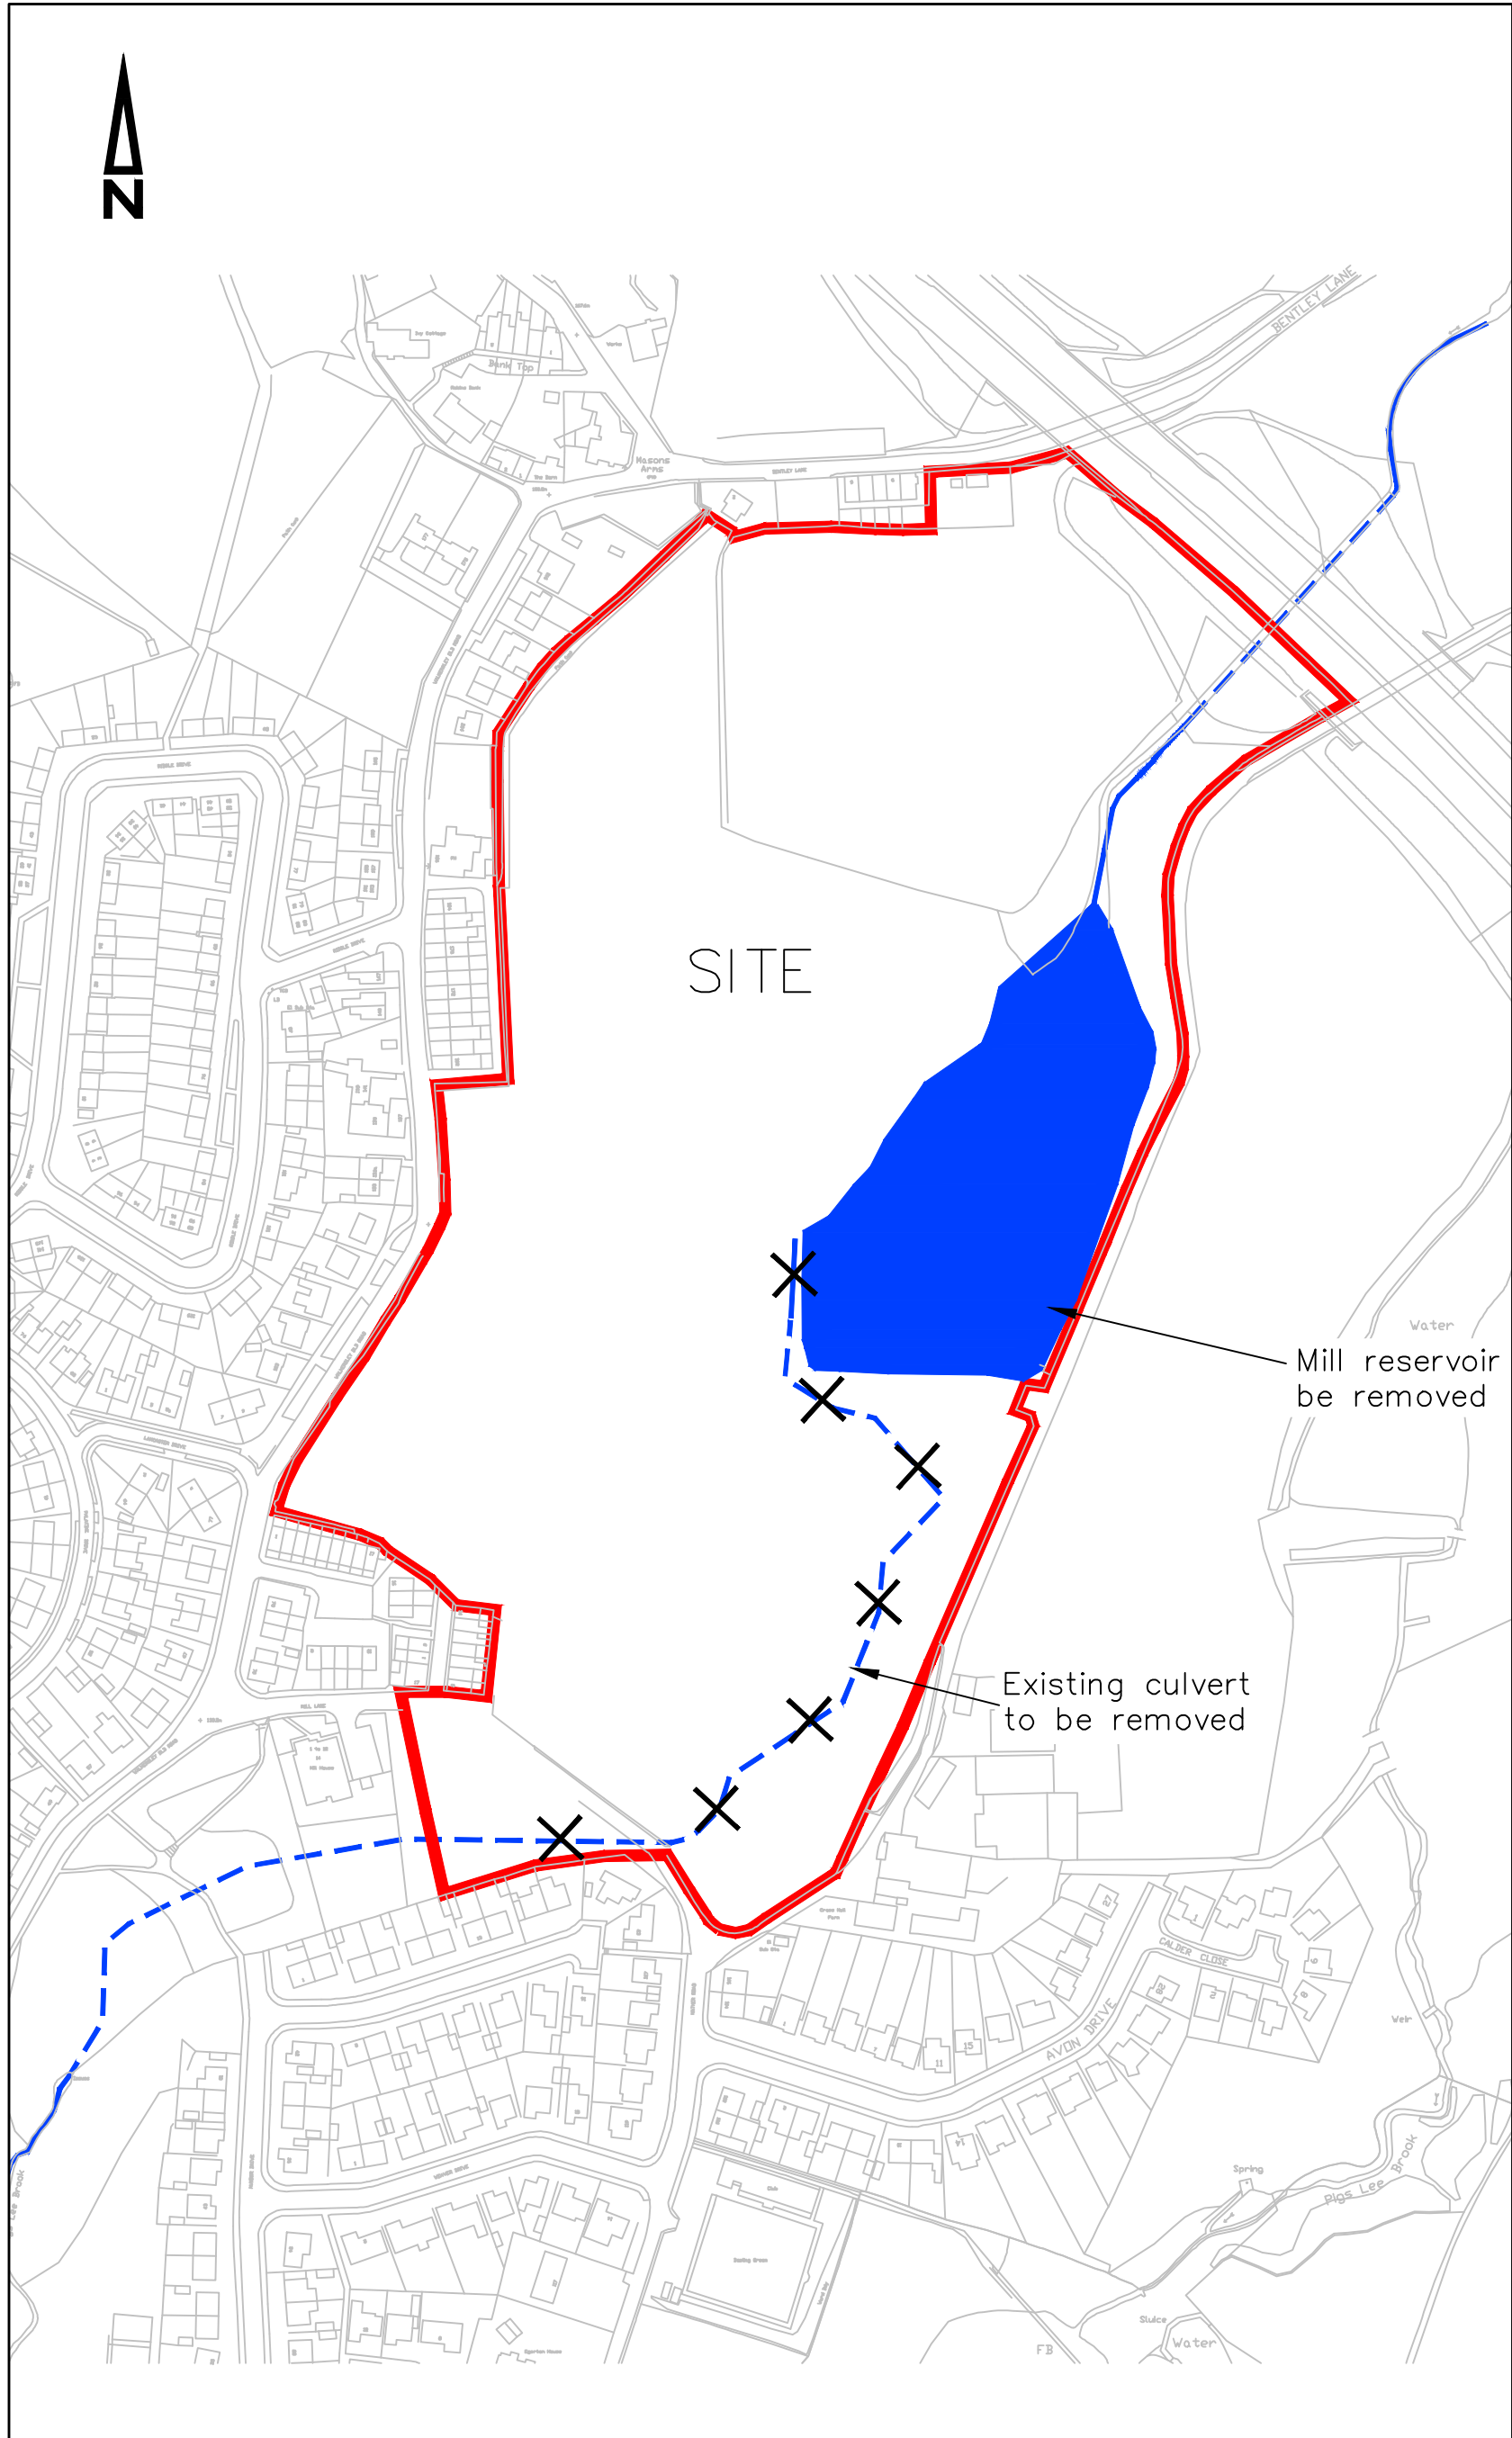
EXISTING SITE

| Hazard<br>(Refer to CEC Plan 6155/520 for construction activity locations - Appendix 9) | Receptor<br>(Refer to CEC Plan 6155/521 for Receptor locations - Appendix 9) | Pathway | Probability of exposure | Consequence | Severity | Risk Management Techniques | Overall Risk<br>(after implementation of management techniques) |
