## Proposed Artificial Grass Pitch Philips High School Higher Lane, Whitefield Manchester M45 7PH

## Site Investigation Report

Revision 00: January 2026  
R-SI-30447-01-00

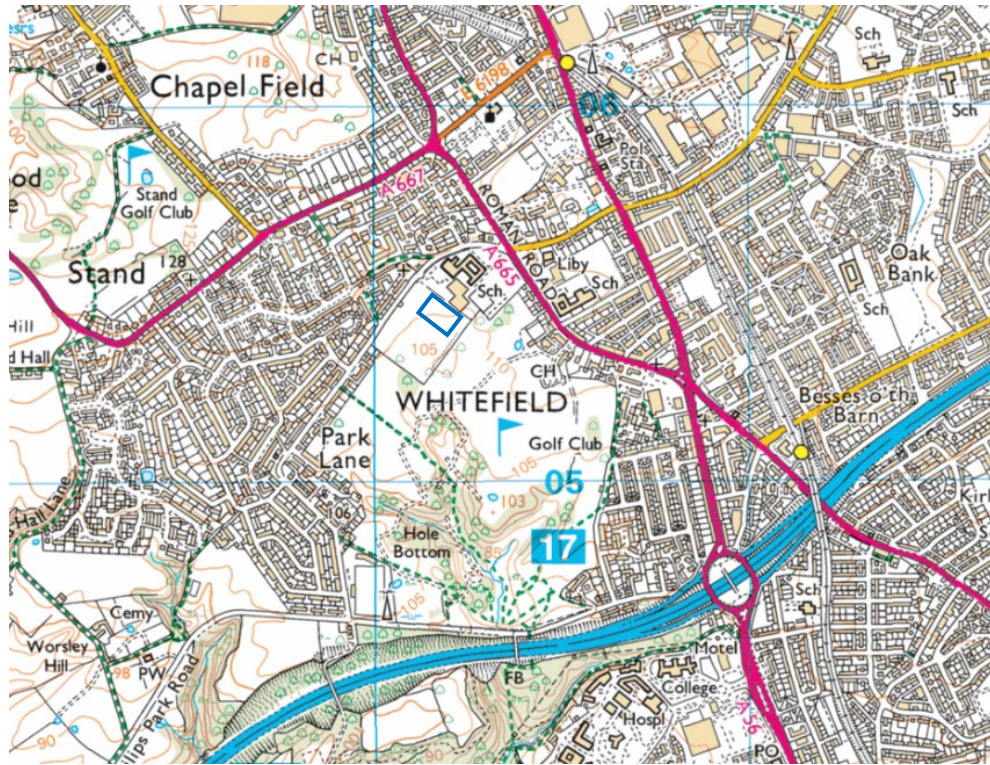
Figure 3.1: OS mapping showing the approximate pitch location in blue.

- 3.1.4 Ordnance Survey map contours suggest there to be a fall to the south east, with an 110m AOD contour crossing through the proposed pitch from the north east to south west and a 115m AOD contour to the north west of the school site. There is a small localised low point of an 105m AOD contour circle adjacent to the south west of the proposed pitch, however there is indicated to be a slope down to this or possible bund along the south west boundary. The playing fields and proposed pitch location appear to be relatively flat at around 112m AOD and there is a slope down into the area of school buildings from the north west. It is possible therefore that the playing fields have been subject to some past levelling earthworks.

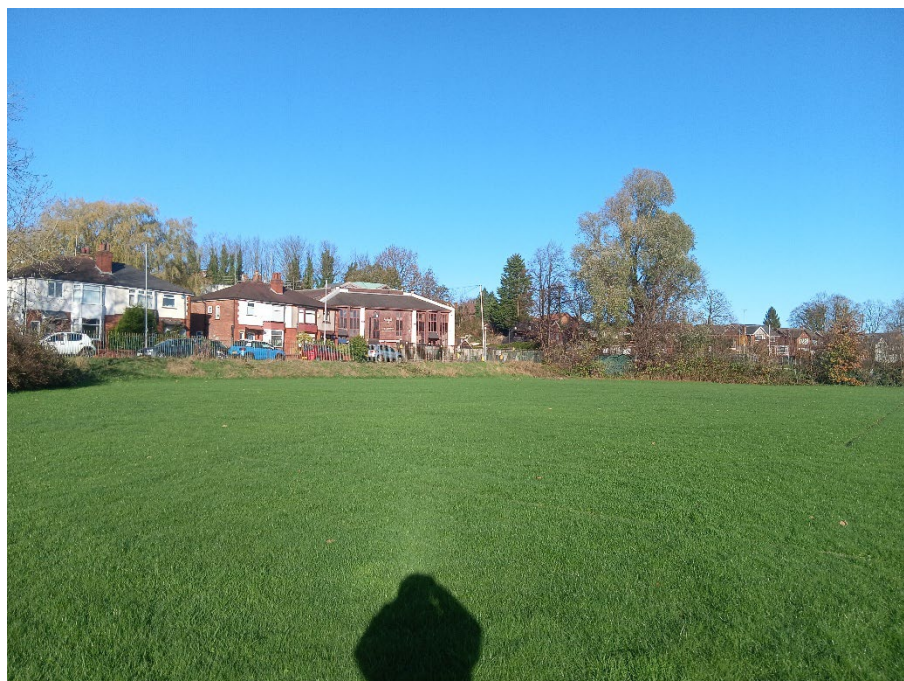
**Photograph 3.2.4** View from the north west corner of the proposed pitch position, looking roughly north towards the pumping station and field entrance.
