## HERITAGE STATEMENT

### UNION BUILDINGS, BURY

### ARCHITECTURE + HERITAGE

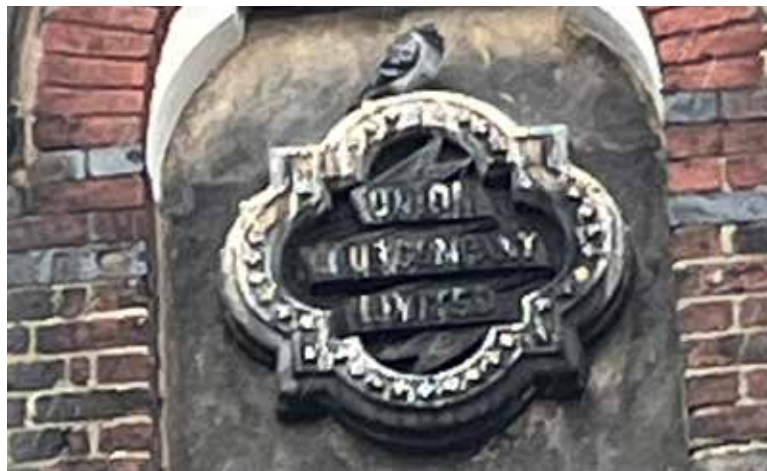
Image: Stone to external face, 'Union Club Company Limited.'  
Image: Roof timbers, visible at top floor level.

Above the entrance is a date stone from 1874 (external face in stonework). The construction is brick with regular timber framed windows and decorative elements to the faces, and a pitched tiled roof.

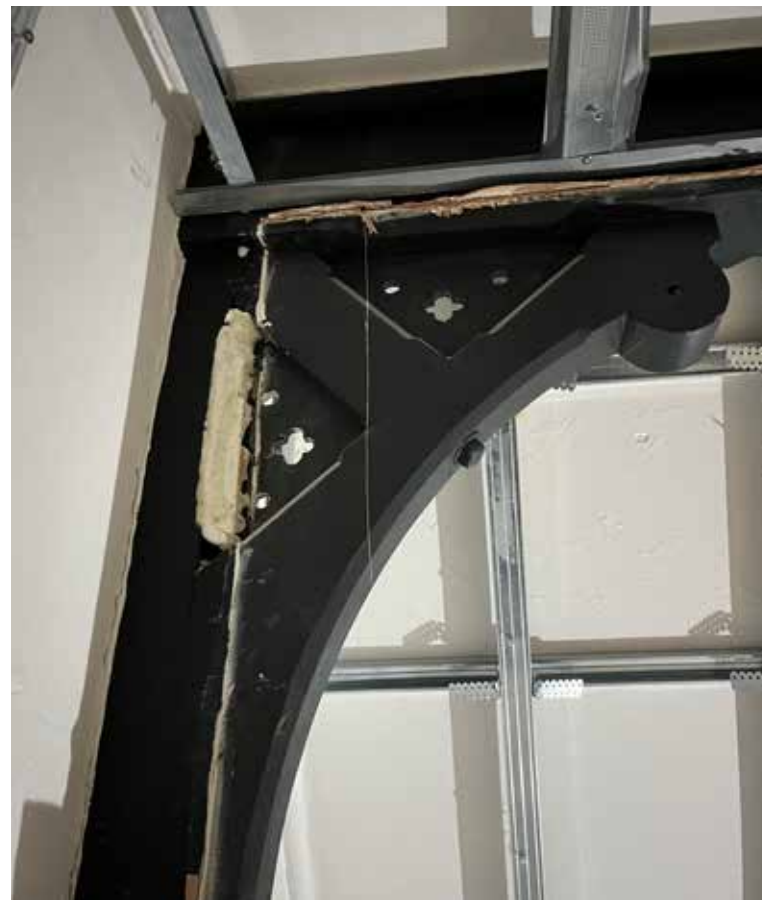
Image: Timber roof framing example, to upper floor.  
Image: Typical interior.

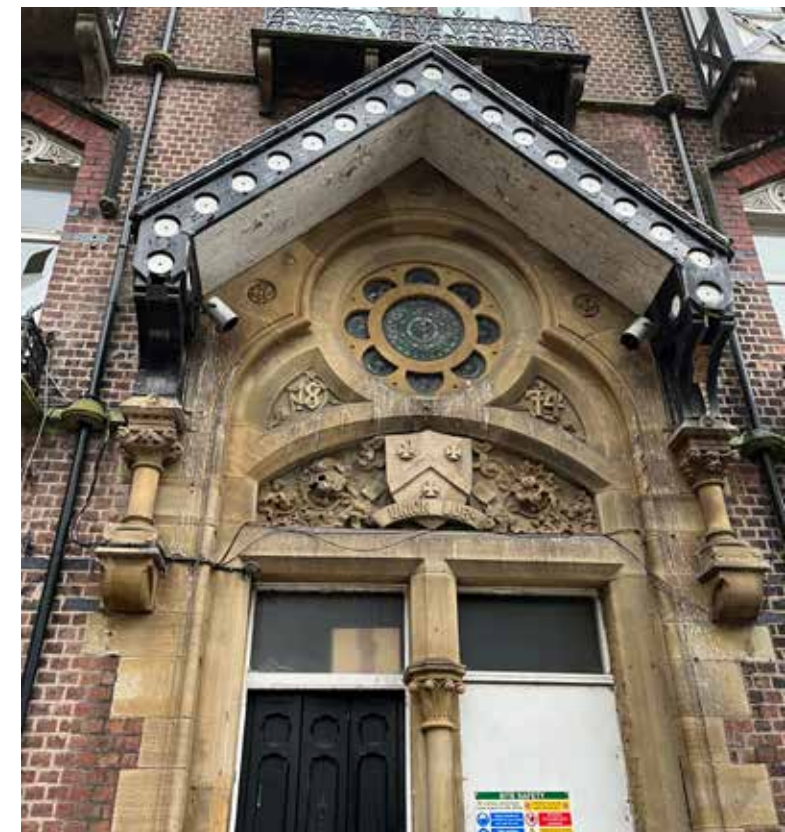
Image: Side elevation of Union Buildings.  
Image: Detail of entrance with date stone, Union Club 1874.

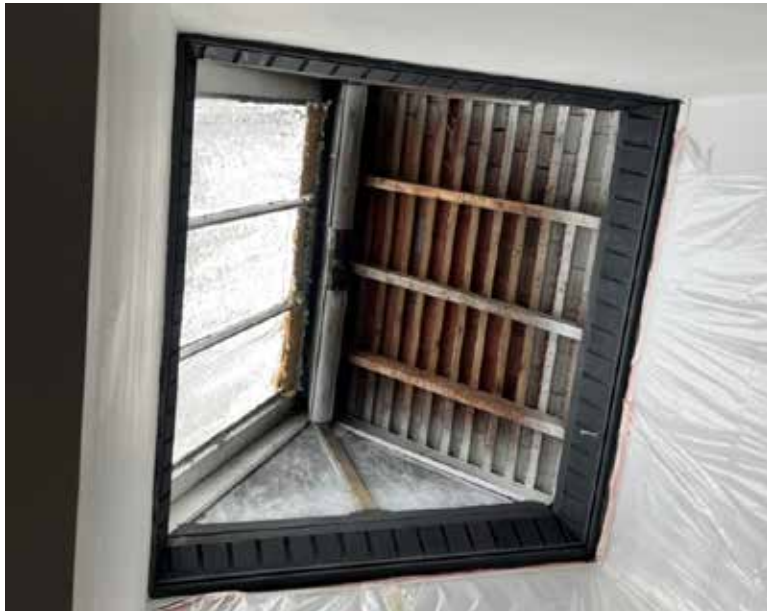
Image: Evidence of former roof light location- with one pane remaining glazed.  
Image: Deteriorating front elevation with timber and plaster.

Historic images and altered roof tiles show that there were previously 4 no. roof lights in groups of two either side of the main ridge. These remain though are partially covered. This feature, originally in glass, has heritage significance as part of the original design.

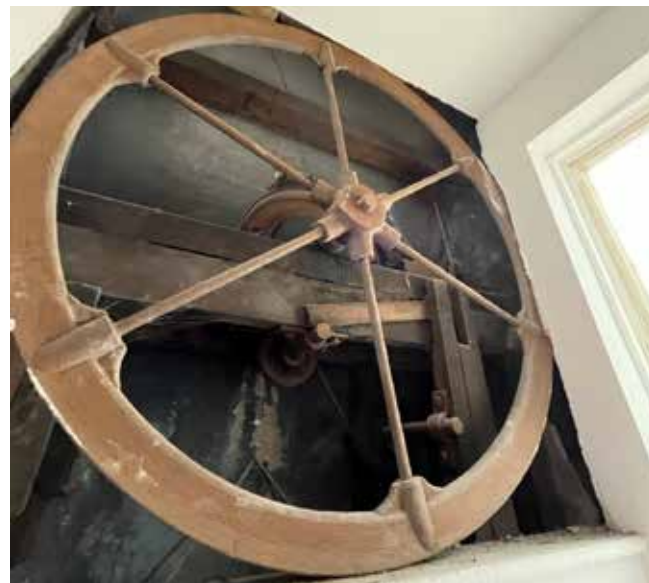
Image: Wheel from dumb waiter at third floor.

To the third floor there is an exposed dumb waiter mechanism, with wheel, pulley and tray. The shaft serving the feature remains . This element is of high evidential value.

Dumb waiter: This is a feature with strong evidential value, revealing former use. It is of high heritage significance.

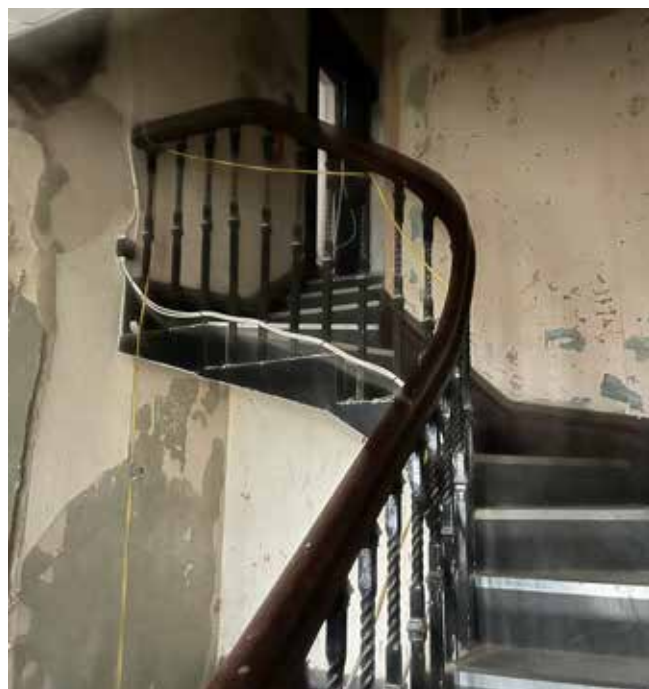
Image: Original staircase at top level.

The main stone cantilevered staircase is of high heritage significance and has a curved timber handrail with iron balusters. It is considered to be original and appears to have had little alteration, other than its modern tread covering. A second stair, presumed to be less ornate and described as being in poor condition in the Design and Access Statement from 2015 has been removed as per permissions/consent and the floor in this area infilled (towards the rear of the building).

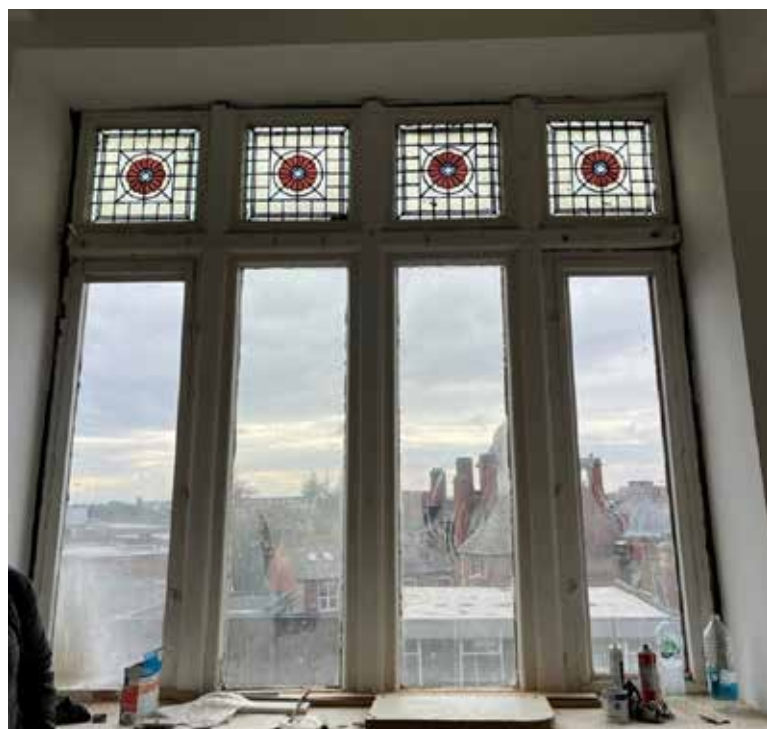
Image: Original bay window, top floor, with cut frames to edges.

The large bay windows over-looking Bury Parish Church feature deep cills.

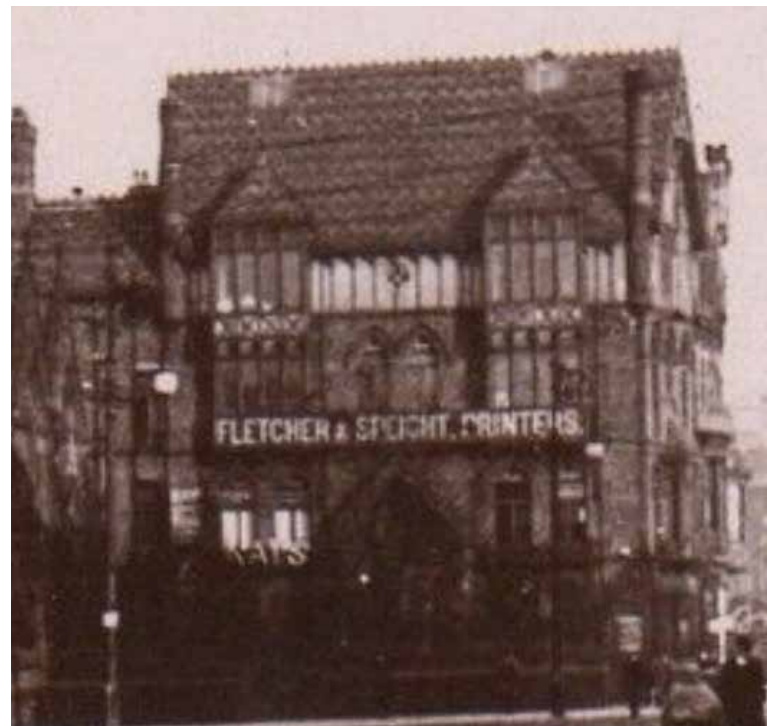
Image: External elevation of Union buildings, with Fletcher & Speight signage clearly identifiable, along with the zip zag pattern to roof.

Historic photographs show that the roof has been altered. The original tiling appears to be in a zigzag pattern, no longer present. Sarking is evident to the underside of the roof covering. Chimneys remain.

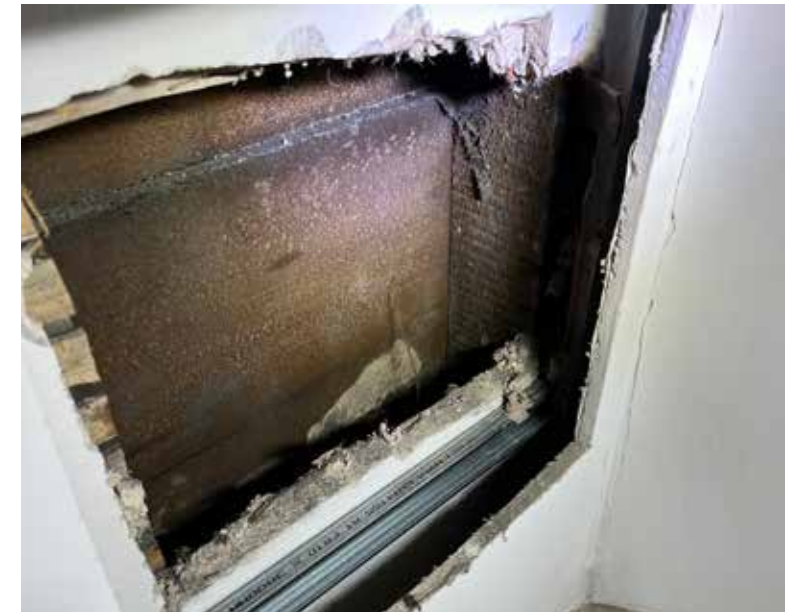
Image: Sarking to the underside of the tiled roof.

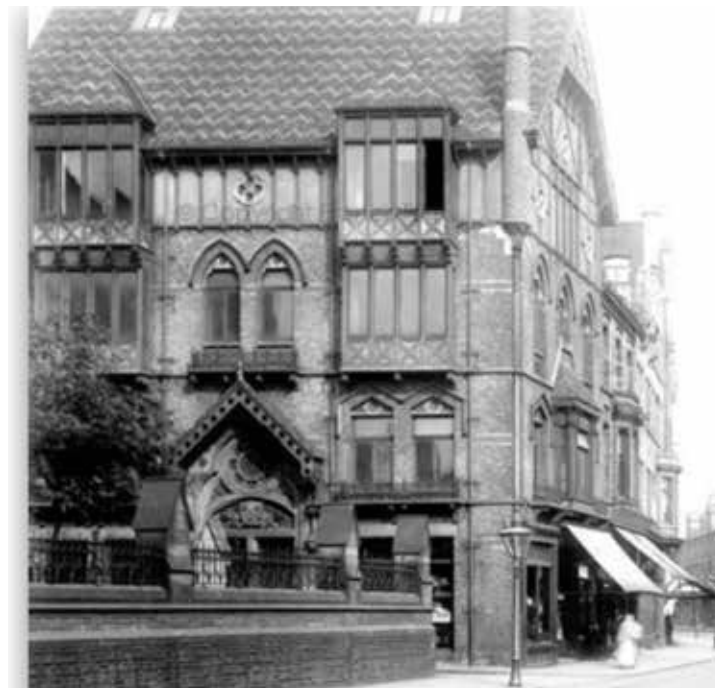
Image: Late 19th century– note roof lights zig zag tiling pattern and colour scheme of facade and window frames.

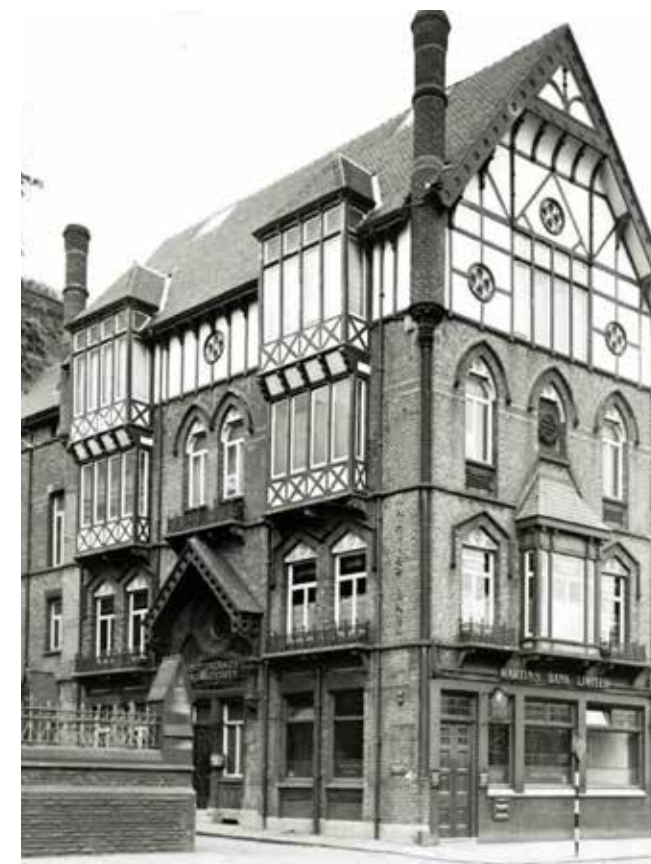
Image: Later half of 20th century. Outside plaster and window frames have been painted and roof re-tiled. Rooflight still visible.

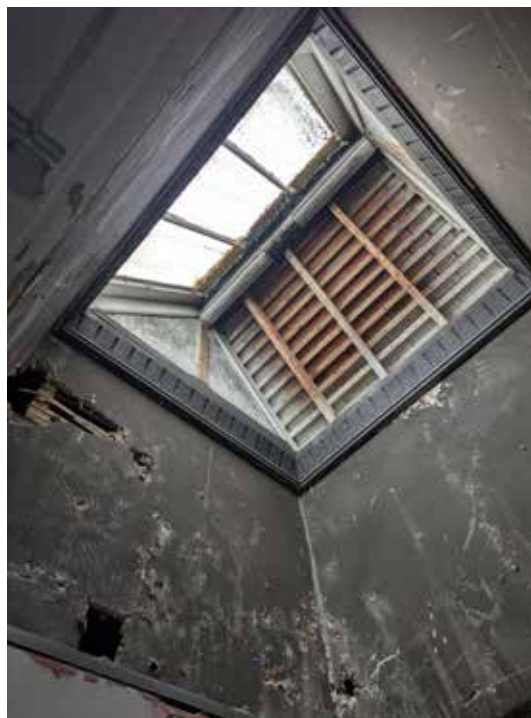
Image: Existing roof light, partially infilled.

Roof: Internally, the roof lights which were originally present remain to one side. This is a significant form and part of the historic design. This feature has moderate heritage significance.

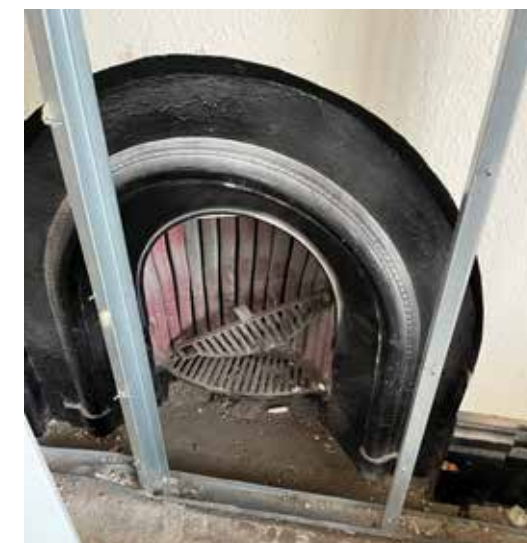
Image: Example of remaining fireplace to upper floor.

Fireplaces remain in two locations on the upper floors and are of moderate heritage significance.

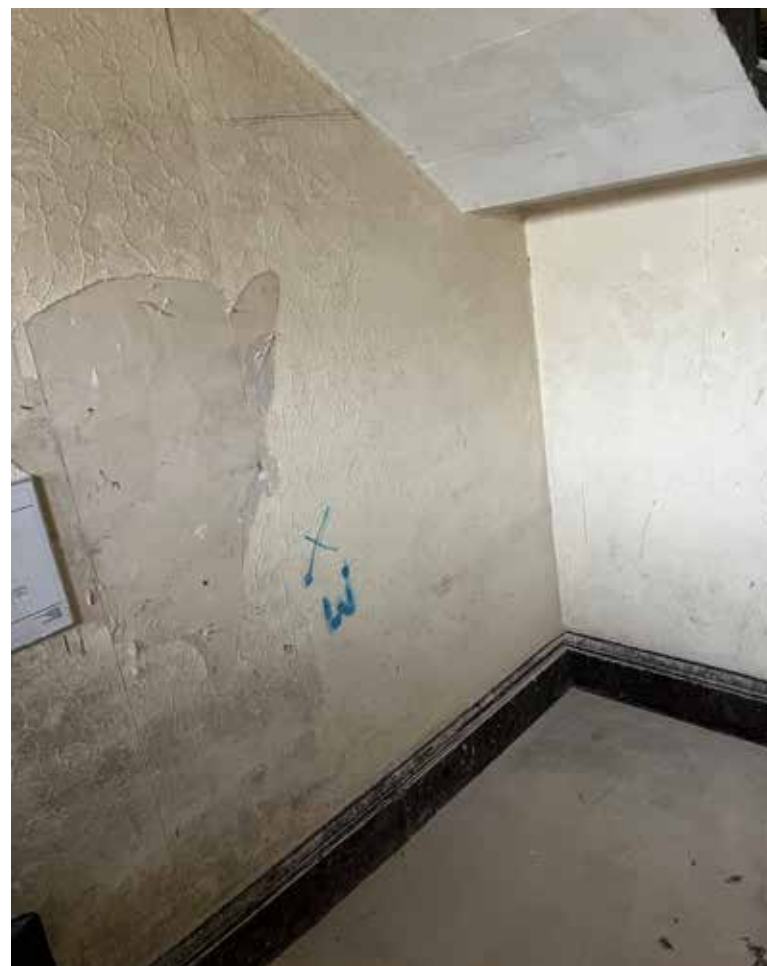
Image: Entrance hall at ground floor showing wall, proposed location of new opening.

In order to access the ground floor flat, a section of wall is to be removed to form a doorway. This is limited in size to the minimum required and the historic fabric which is affected has no features of special significance.

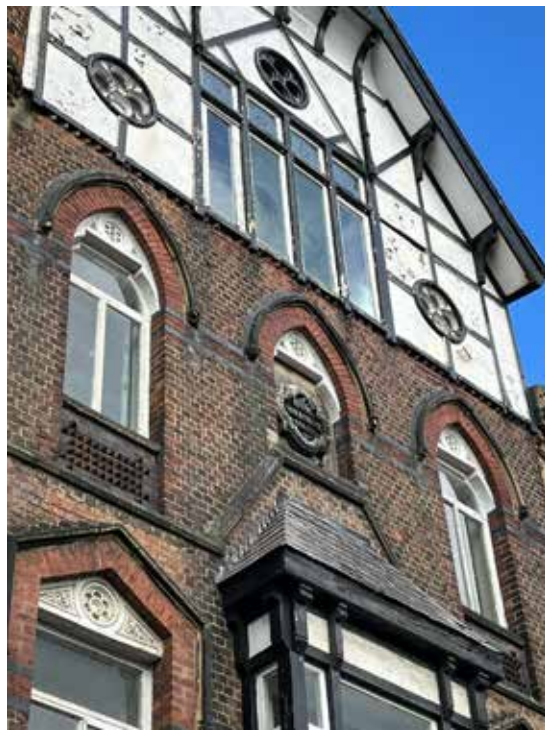
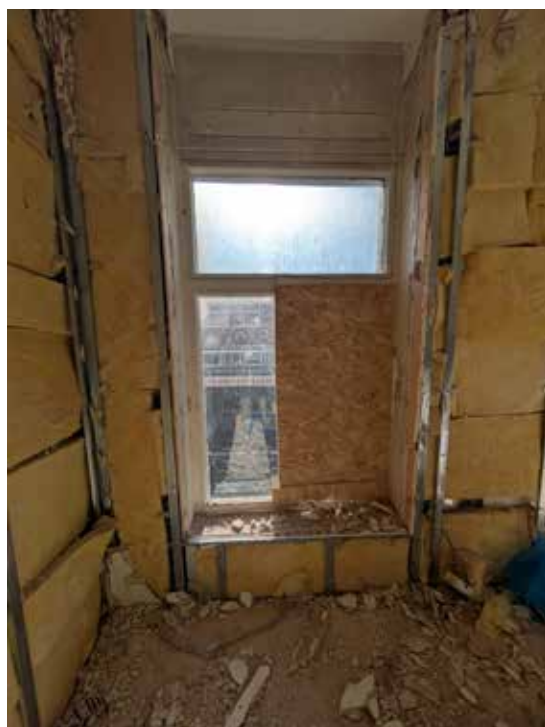
Images, Above: Example of windows to The Rock elevation.  
Below: Non-original example of window to The Rock elevation.

Full refurbishment: removal of frame, stripping to original wood, minor timber splice repairs, primed and top coated. Putty applied to single glazed glass type: Histoglass Mono

Full refurbishment: removal of frame, stripping to original wood, minor timber splice repairs, primed and top coated. Putty applied to single glazed glass type: Histoglass narrow double glazed HD10

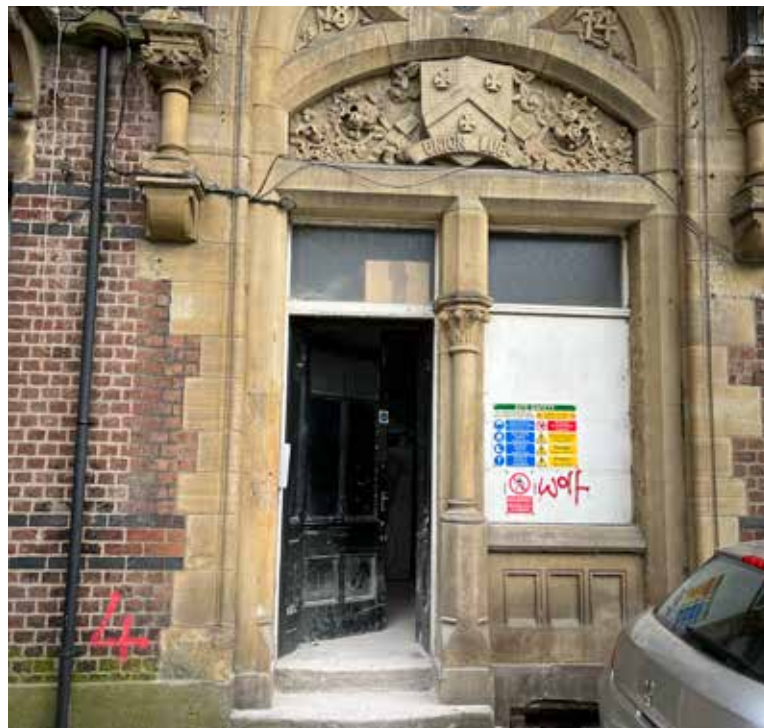
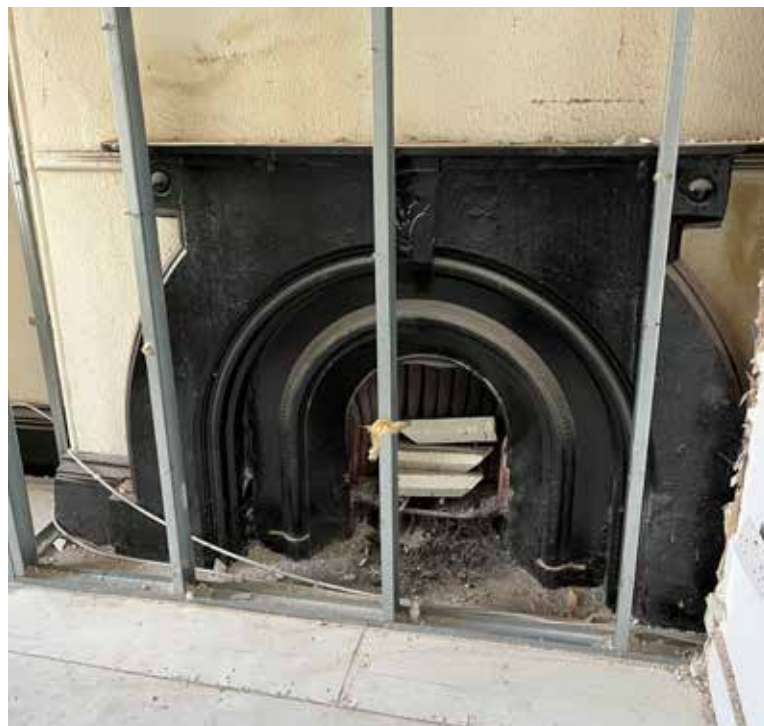
Images, Above: Entrance with timber door, to be retained.  
Below: Historic fireplace, to be retained.

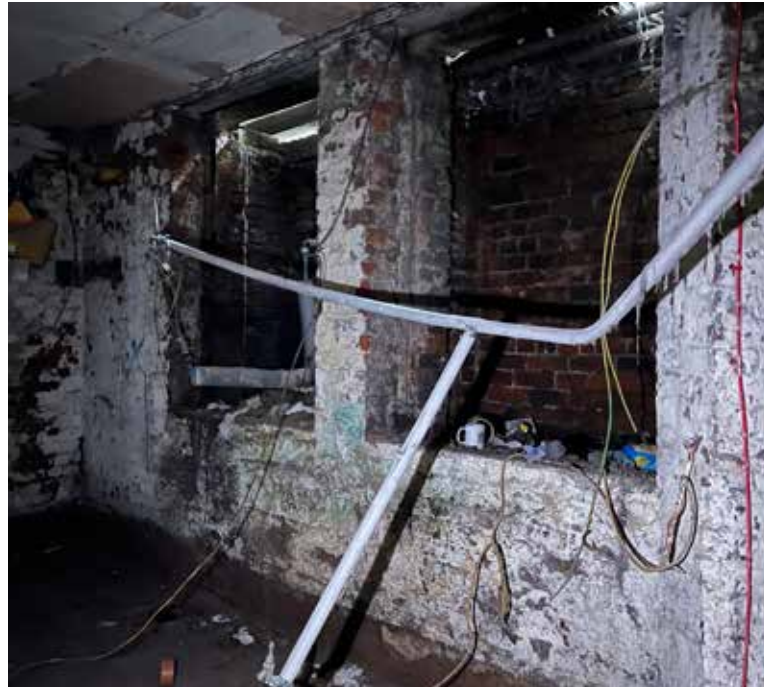
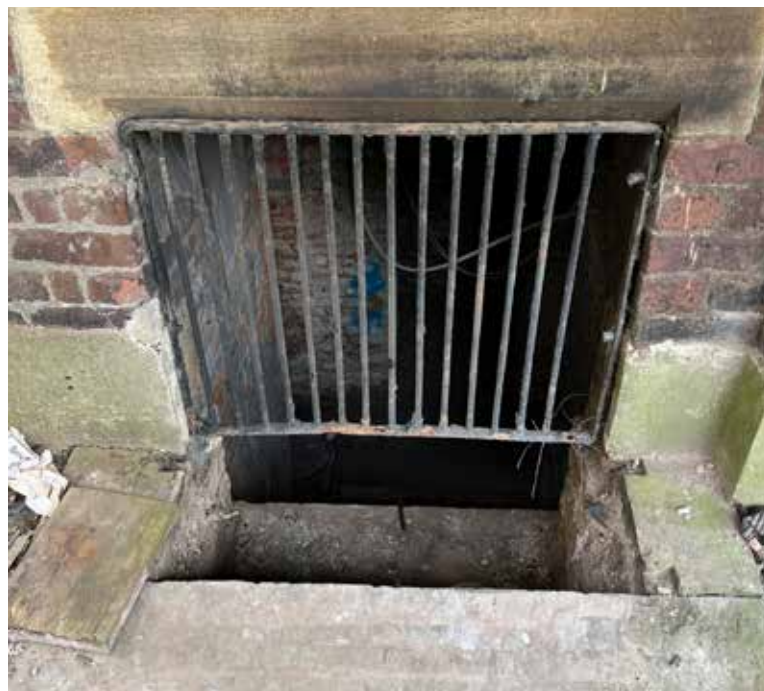
Images, Above: Basement showing existing openings.  
Below: Existing basement openings and pavement lightwell.

There is non-original infill to the opening on the right hand side of the front door. The timber boarding will be removed and the opening used to fit post boxes for the development, accessible from either side.  
IMPACT: NEUTRAL This is considered to be the most appropriate and least harmful location for post boxes. There is no degree of harm to historic fabric as a result of this change.
