## Stand United Reformed Church

Stand lane , Radcliffe, Manchester

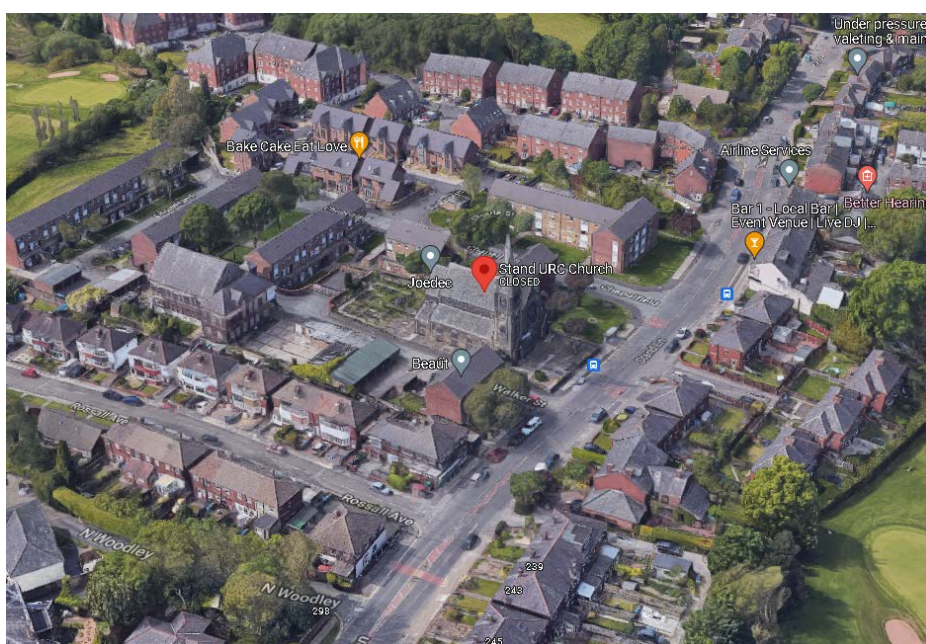
Image 01: the existing church building and its site setting.

- c. The Church Building is sited on a rectilinear 'island site', bounded by Chapelfield Road (to the north), Stand Lane (to the east), Walker Street (to the south), and a parking area (to the west).
- d. The properties within the immediate vicinity are mainly terraced and semi-detached residential properties (C3 dwellinghouses) not exceeding 2-3 storeys in height, typically built in the late 19th and 20th centuries in various architectural styles and forms, with a variety of extensions and modifications.

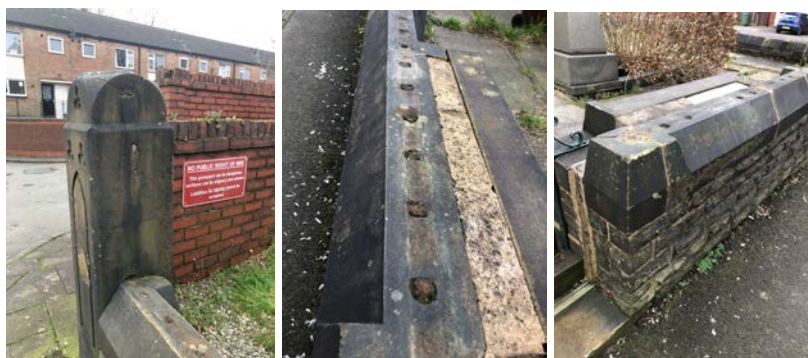
Image 02: Remnants of previously installed perimeter railings

- i. Sited on a raised rectilinear platform delineated by a rusticated dwarf sandstone wall with stone coping stones on three sides and a red brick wall on one side (western edge).
- ii. The original cast iron railings that would have surrounded the site, fixed to the top of the stone coping stones on the dwarf sandstone

wall are no longer present (evidenced by the presence of fixing holes to the top and sides of the perimeter wall).

- i. The grounds and area surrounding the church building.
  - 1. The removal of the perimeter railing (previously fixed to the top of the dwarf walls along the perimeter of the site), exposed the church to vandalism and neglect. The burial grounds to the rear have been used as a fly tipping site and the area to the front has been left unkempt with broken glass, refuse, being littered amongst overgrown vegetation in between the laid headstones.
  - 2. The proposal comprises clearing all 'fly-tipped' items/refuse dumped and built up within the burial grounds. All existing pebbles (pea gravel) and vegetation growing in between the headstones will be carefully removed.
  - 3. The following steps will be taken to restore the headstones, maintain the burial grounds, and minimise future sprouting or growth of weeds and vegetation:

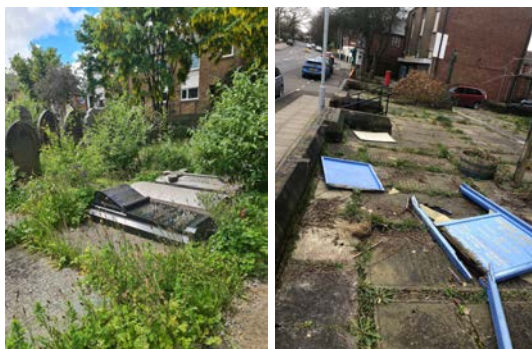
Image 03: The existing

burial grounds (photo taken on 8.6.22)

- iii. The Church building is inset from the edges of the raised platform, with the spaces to the eastern and southern side containing a large number of exposed headstones laid flat to the ground (with heavy vegetation growing in between the headstones), and a graveyard with vertical/upright gravestones located to the western side of the church, with heavily grown vegetation and a flytipping build up.
- iv. There is a set of external stairs (consisting of four steps with metal handrails and railings on either side) up the raised platform on the eastern side of the site (facing Stand lane). There are two additional gated entrances on the northern edge (facing walker street) with a

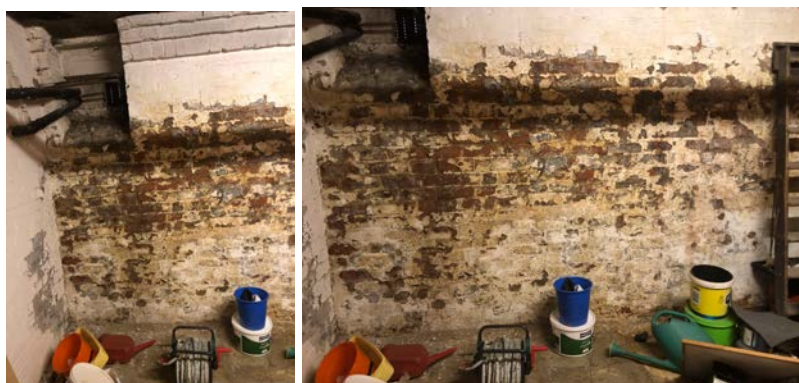
Image 04: existing water egress damage (in basement area)

- i. The existing wall surfaces to the walls beyond the crypt in the basement areas have been badly affected by the egress of water. These walls will be cleaned carefully and cleared of all debris and dust before the application of one coat Classidur Tradition paint (Classidur AF Mat) to a ral 9010.
