## Stand United Reformed Church

Stand lane , Radcliffe, Manchester

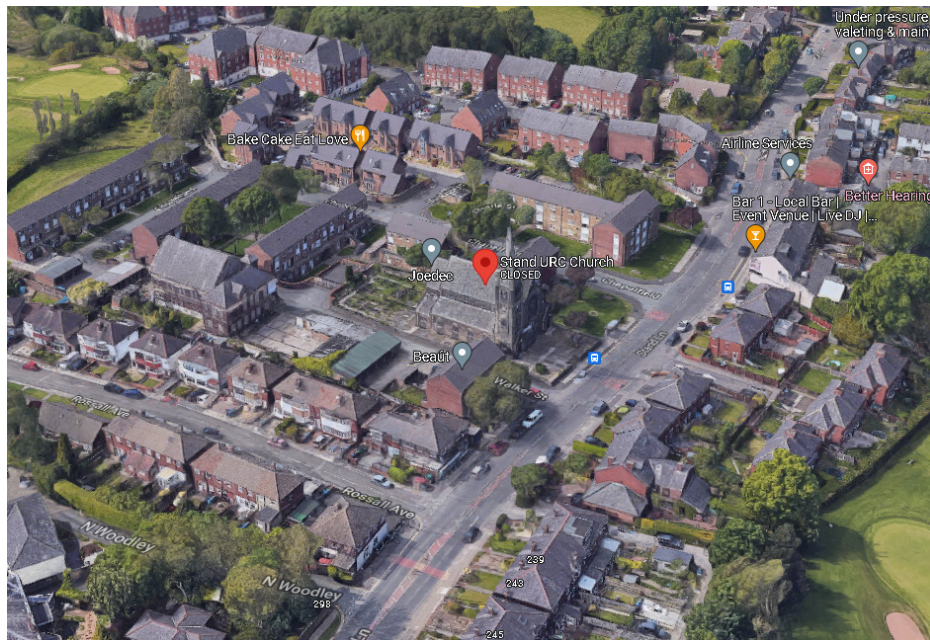
Image 01: the existing church building and its site setting.

- b. The church building is located within the Radcliffe West Ward, constituency of Bury South, in the Northwest region of England.
- c. The Church Building is sited on a rectilinear 'island site', bounded by Chapelfield Road (to the north), Stand Lane (to the east), Walker Street (to the south), and a parking area (to the west).
- d. The properties within the immediate vicinity are mainly terraced and semi-detached residential properties (C3 dwellinghouses) not exceeding 2-3 storeys in height, typically built in the late 19th and 20th centuries in various architectural styles and forms, with a variety of extensions and modifications.

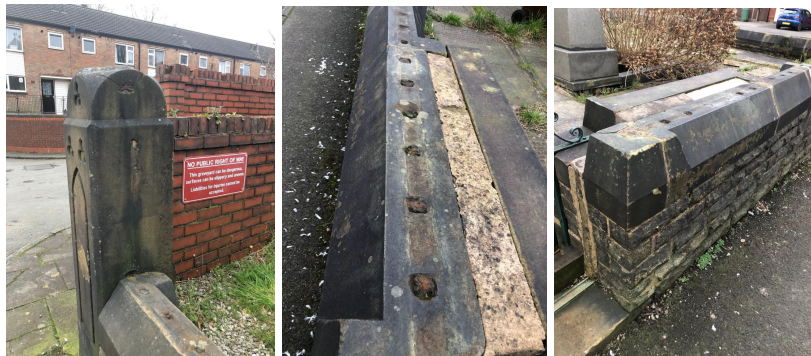
Image 02: Remnants of previously installed perimeter railings

- i. Sited on a raised rectilinear platform delineated by a rusticated dwarf sandstone wall with stone coping stones on three sides and a red brick wall on one side (western edge).
- ii. The original cast iron railings that would have surrounded the site, fixed to the top of the stone coping stones on the dwarf sandstone wall are no longer present (evidenced by the presence of fixing holes to the top and sides of the perimeter wall).

- 1. The removal of the perimeter railing (previously fixed to the top of the dwarf walls along the perimeter of the site), exposed the church to vandalism and neglect. The burial grounds to the rear have been used as a fly tipping site and the area to the front has been left unkempt with broken glass, refuse, being littered amongst overgrown vegetation in between the laid headstones.

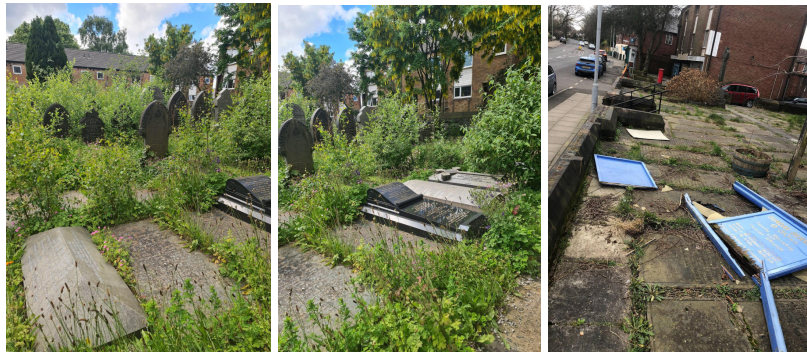
Image 03: The existing burial grounds (photo taken on 8.6.22)

- iii. The Church building is inset from the edges of the raised platform, with the spaces to the eastern and southern side containing a large number of exposed headstones laid flat to the ground (with heavy vegetation growing in between the headstones), and a graveyard with vertical/upright gravestones located to the western side of the church, with heavily grown vegetation and a flytipping build up.
- iv. There is a set of external stairs (consisting of four steps with metal handrails and railings on either side) up the raised platform on the eastern side of the site (facing Stand lane). There are two additional gated entrances on the northern edge (facing walker street) with a single step up to the raiders platform.

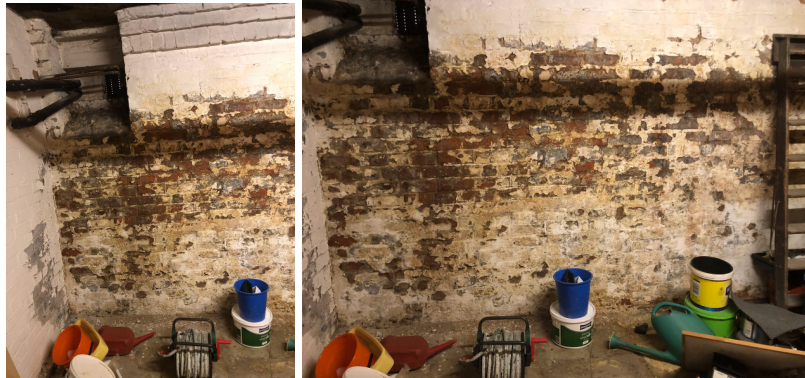
Image 04: existing water egress damage (in basement area)

- i. The existing wall surfaces to the walls beyond the crypt in the basement areas have been badly affected by the egress of water. These walls will be cleaned carefully and cleared of all debris and

dust before the application of one coat Classidur Tradition paint (Classidur AF Mat) to a ral 9010.
