**PITCH DEVELOPMENT  
RADCLIFFE MOOR ROAD, BURY**

**HYDROLOGICAL ASSESSMENT**

**PITCH DEVELOPMENT  
RADCLIFFE MOOR ROAD, BURY  
HYDROLOGICAL ASSESSMENT**

**Document Reference:** HYD633 Hydrological Assessment  
**Revision:** 1.2  
**Date of Issue:** 11<sup>th</sup> May 2022  
**Report Status:** DRAFT

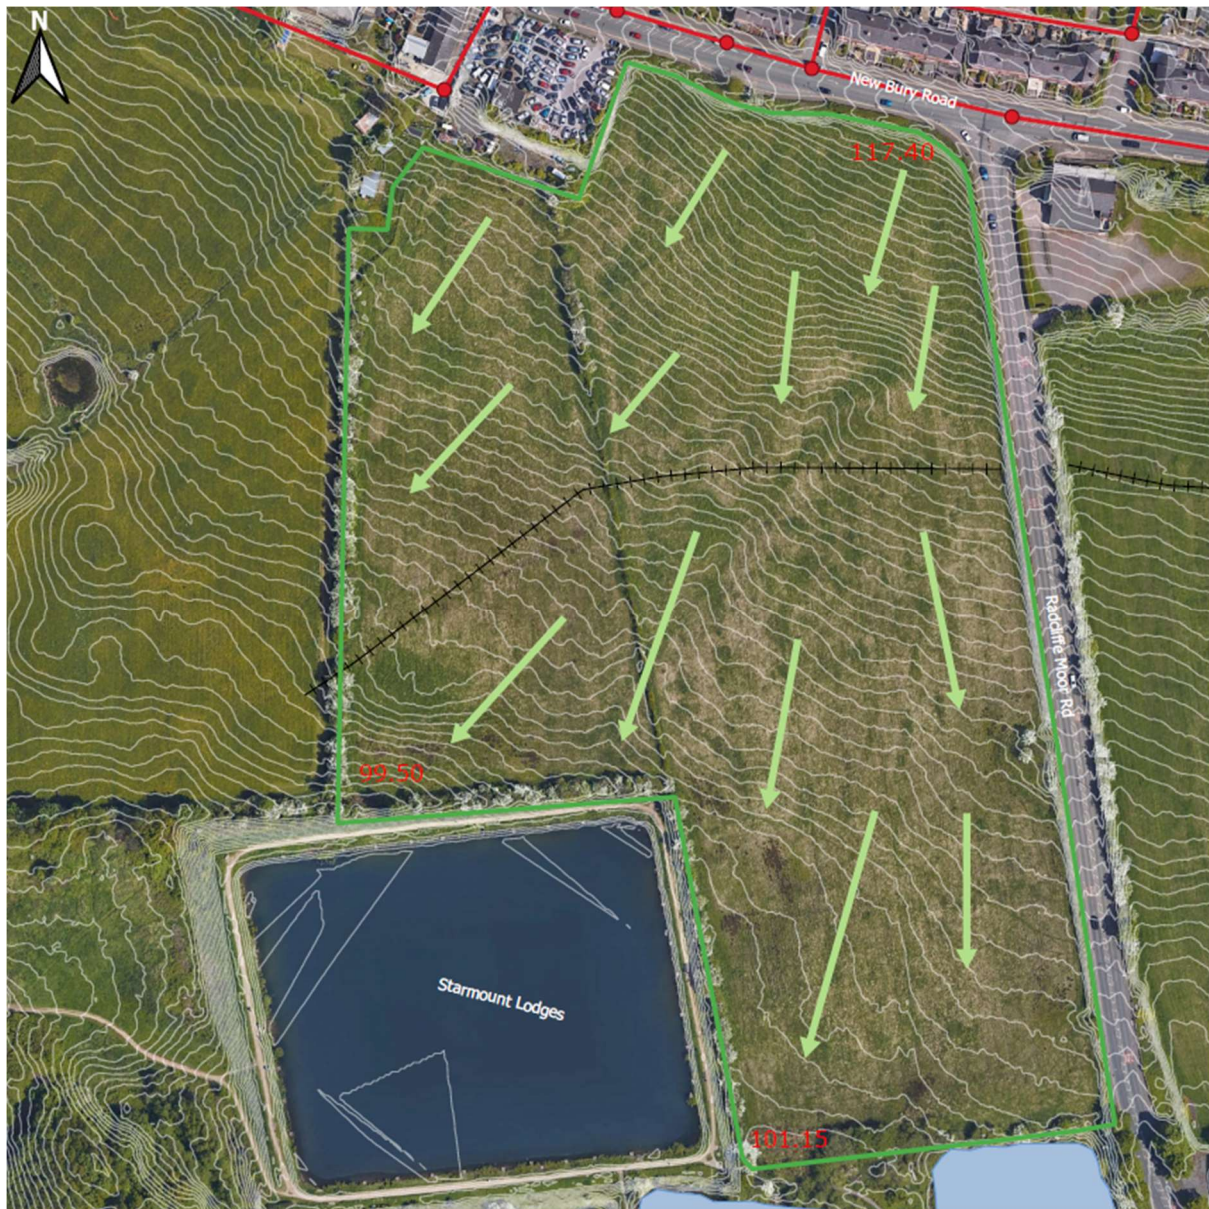
Figure 2 – existing ground level contours (from LiDAR) overlaid on an aerial image

- 2.3.1 A topographic survey has been undertaken and included within **Appendix C**. Existing ground levels fall from at high point ~117.40mAOD in the northeast corner (adjacent to Bury New Road) to ~99.50mAOD in the southwest (adjacent to the reservoir's northern embankment) and to ~101.15mAOD to the south (fishing ponds), as shown in Figure 2 overleaf.

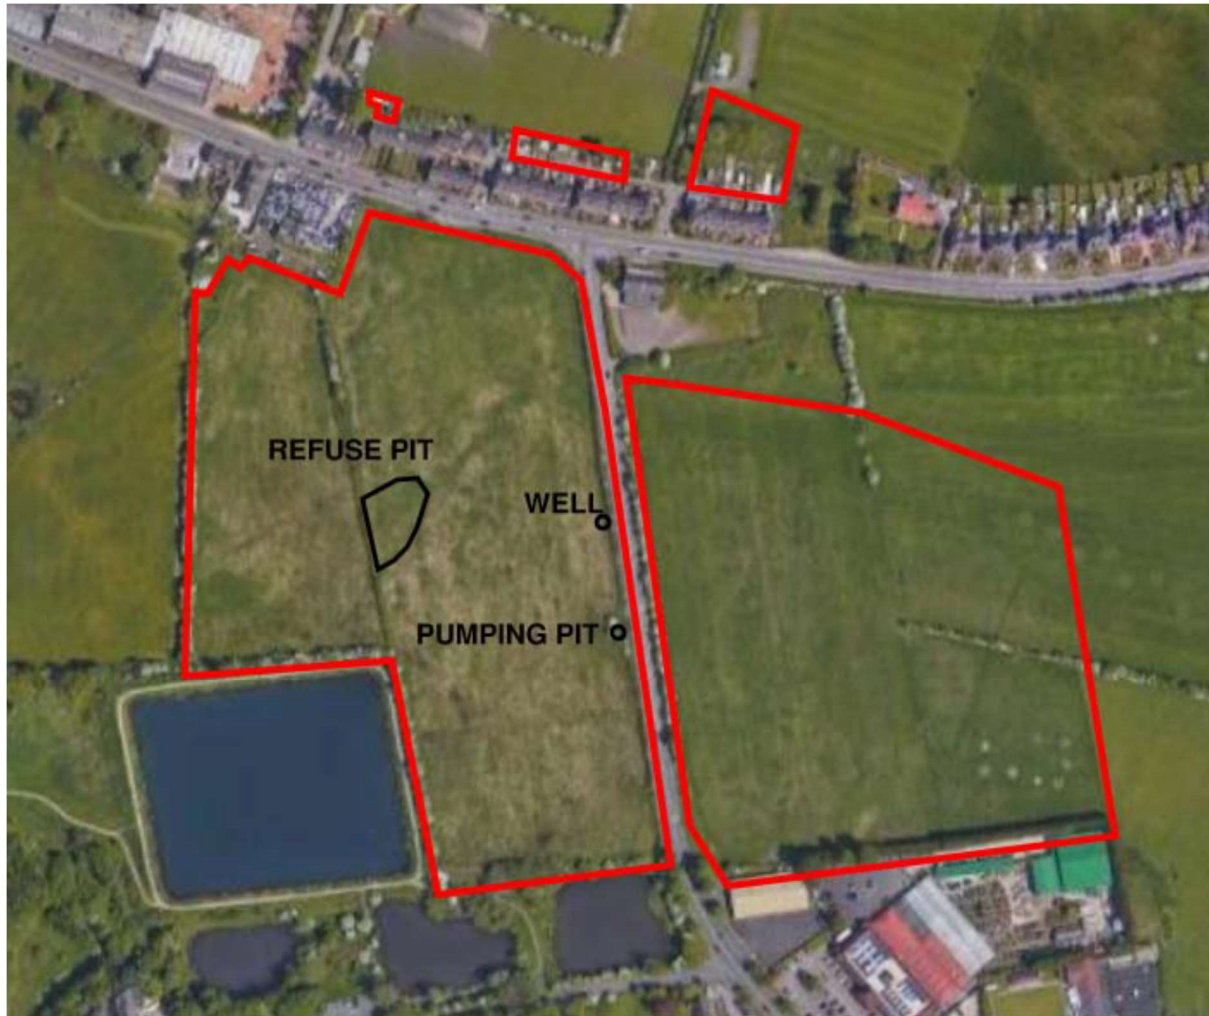
Figure 3 – suspected approximate locations of historical features (Note the red-edge is shown beyond application site as part of a wider study area)

2.2.1 The site is currently undeveloped and comprises of low-density vegetation, with trees and shrubs along the field boundaries. Historically the site was utilised for agricultural purposes and no other historical uses have been identified during this assessment, however the Ground Investigation has identified a number of historic uses including a former well, a pumping pit (for drainage of coal mines), possible mound of made / reworked ground (eastern parcel) and former houses along the boundary edge. The suspected approximate locations are shown in figure 3 which is an extract from the Betts Geo-Environmental Ground Investigation Report, 2021.

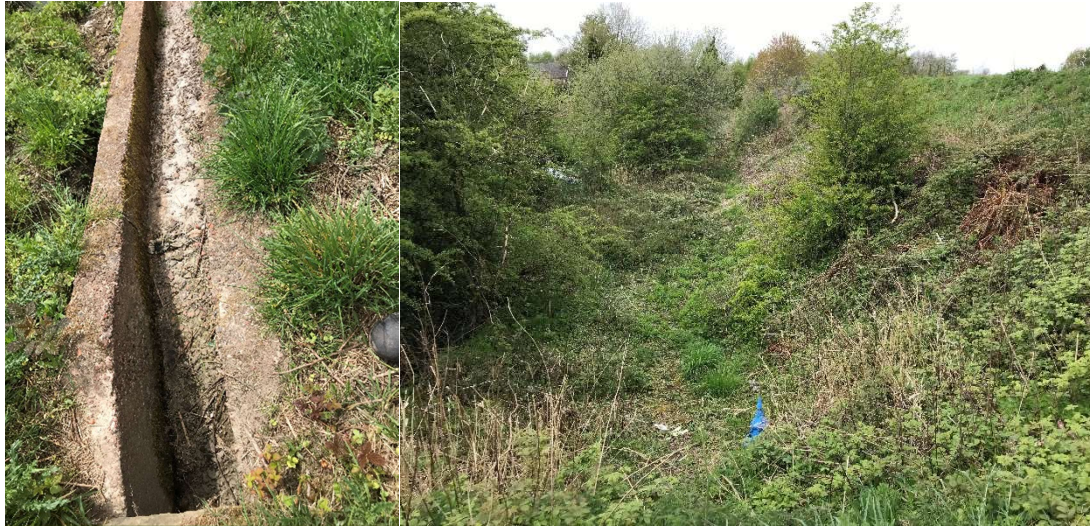
- 2.2.2 It is understood that the reservoir to the south of site was constructed for the Bradley Fold Print Works to be used as processing water.
- 2.2.3 It was confirmed during the site walk-over that the reservoir is not used for abstraction and is linked to the middle lodge by a high-level overflow channel shown in photograph 1 overleaf.
- 2.2.4 There is also a drain-down valve from the reservoir to the lower lodge which was installed relatively recently, shown in photograph 2 overleaf, however it is understood that following installation this would not function, most likely due to corrosion in the upstream pipework.

*Photographs 1 and 2 – showing the high-level overflow and low-level drain-down valve*

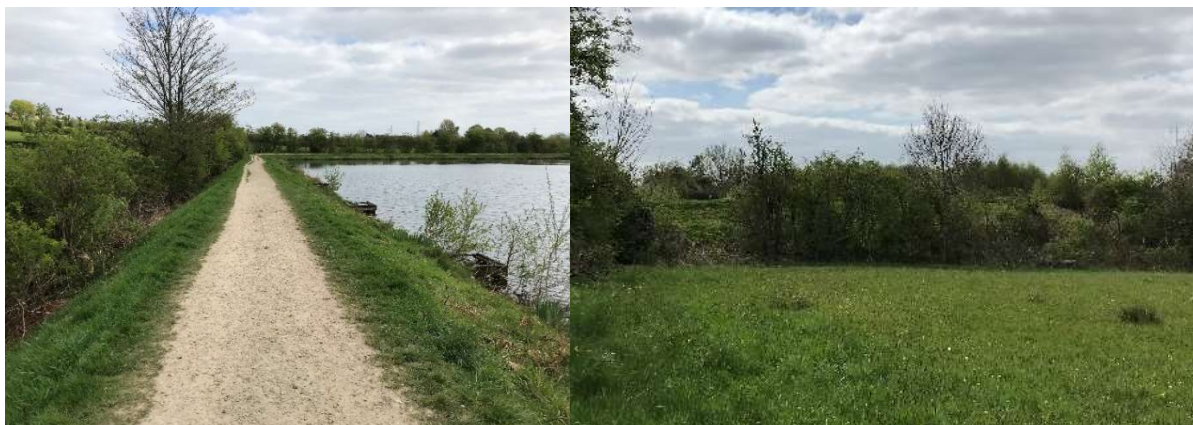
6.4.2 Photographs 3 and 4 below show the relative elevation of the reservoir compared to the significantly lower level on the northern side of the reservoir. Photograph 3 is looking east standing on footpath that runs along the top of the northern embankment. Photograph 4 is looking south at the northern embankment.

*Photographs 3 and 4 – showing the relative elevation of the reservoir's northern embankment compared to site.*

6.4.1 The reservoir is elevated relative to the surrounding ground and is understood to be fed by artesian water from the aquifer beneath (the Secondary A Aquifer with High Permeability within the bedrock deposits of the Sandstone and Pennine Coal Measure).

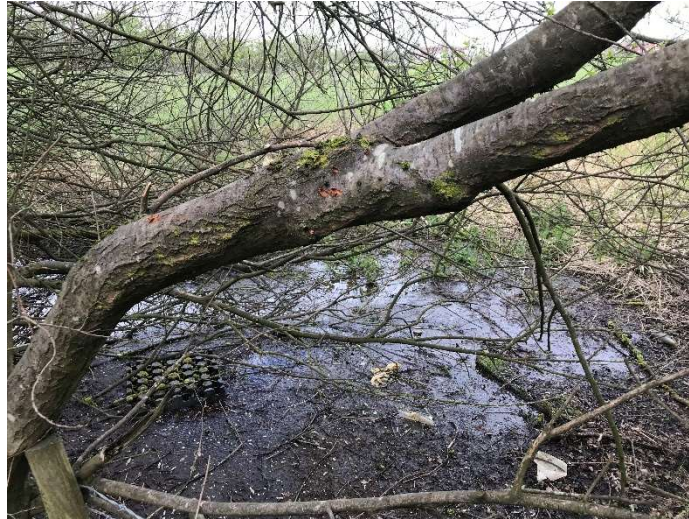
- 6.5.1 There is a spring observable near the southern boundary with flow leaving the site discharging into the upper and middle lodges. This is understood to be from the Secondary Aquifer within the Glacial Till layer (superficial deposits).
- 6.5.2 This spring water provides a baseflow through the fishing lakes and must be maintained.

*Photograph 5 – Spring location on the southern boundary feeding the lodges*

- 6.5.3 It was a dry day when the most recent site walk-over was undertaken and there was an observable flow from the spring at the location in photograph 5 above.

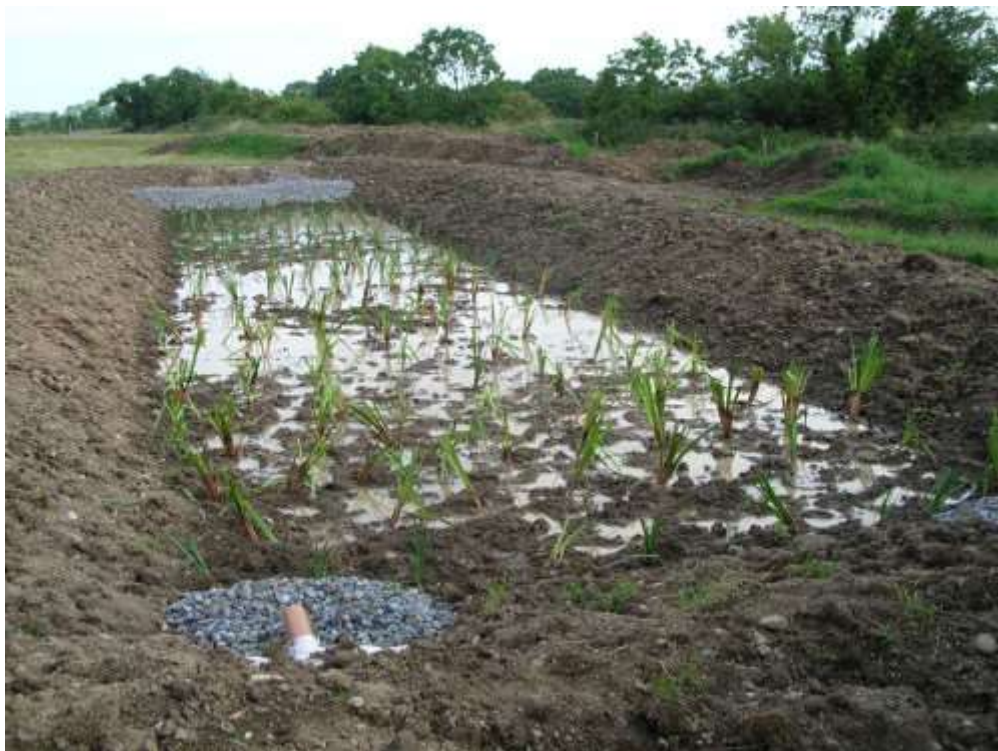
- 7.9.4 The wet swale will connect into a reed bed. A reed bed is a wastewater treatment system that use growing wetland plants as the active component in getting effluent clean enough to discharge back into the receiving environment. Alternately called treatment wetlands, constructed wetlands or reed bed treatment systems, they have the potential to be low-cost, zero energy input, low-tech, high-efficiency systems that can be used to help protect streams and rivers from almost any source of effluent or dirty water. A typical example of the type of system proposed is shown below in Photograph 6.

Photograph 6 – Reed beds (lowimpact.org, 2022)

- 7.9.5 The runoff going through the reed bed is surface water only as foul water will be discharged to the public sewer network the reed beds provide an additional means of improving water quality beyond that typically provided for such a land use. They are being proposed following discussion with the BMBC to provide further resilience to the downstream receiving network.
- 7.9.6 Aeration is provided by the plants, which draw oxygen down to the roots via the leaves, where it becomes available for aerobic bacteria; tertiary polishing is carried out if the reed bed is built large enough, providing further removal of nitrogen and phosphorus.
