**JAMES STREET, BURY**

**STAGE 1 PRELIMINARY CONTAMINATION  
RISK ASSESSMENT**

**For: Bethell Group PLC on behalf of United  
Utilities**

**R3191A-R01-v1**

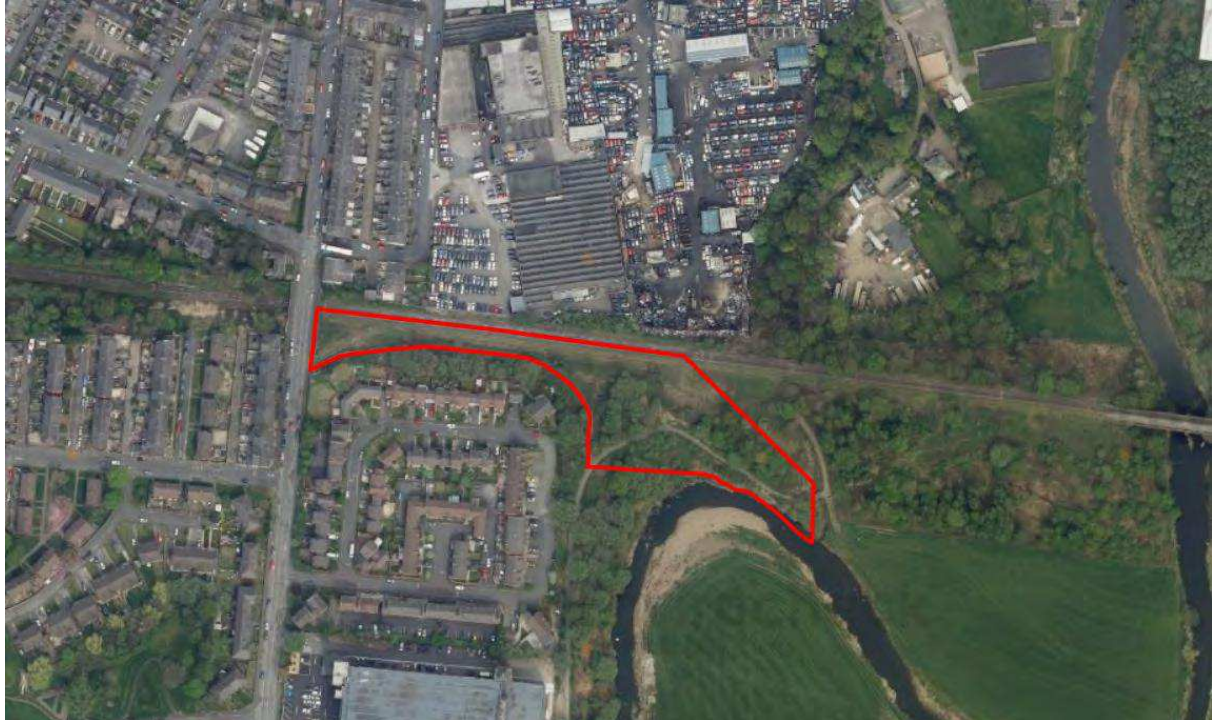
**Figure 6.1. Satellite Imagery of site**

*Aerial Imagery from 2023 obtained from Envirocheck Report 310769692*

*Red line shows approximate site boundary: for accurate boundary refer to plans in Appendix A*

6.3.1. A main historical change noted is the presence of railway sidings on site between 1910 -1959. The East Lancashire railway siding remains off site, lying adjacent to the site's northern boundary, with associated embankments and cuttings inside the site boundary. The site lies on the fringes of developments both residential and industrial. From 2016 onwards, the site is an informal public green space, with a public footpath leading towards to the river Roch. A small stream encroaches the site from the north which flows west to east.

6.3.3. Contemporary mapping (2016-2023) shows the surrounding area to be largely residential. There is a recycling site mapping north of the site, further northeast Waterford Business Park is annotated. Barn Brook is annotated to the east of the site boundary, forming a tributary off the River Roch.
