**PITCH DEVELOPMENT  
RADCLIFFE MOOR ROAD, BURY**

**HYDROLOGICAL ASSESSMENT**

**PITCH DEVELOPMENT  
RADCLIFFE MOOR ROAD, BURY  
HYDROLOGICAL ASSESSMENT**

**Document Reference:** HYD633 Hydrological Assessment  
**Revision:** 2.0  
**Date of Issue:** 28<sup>th</sup> July 2022  
**Report Status:** FINAL

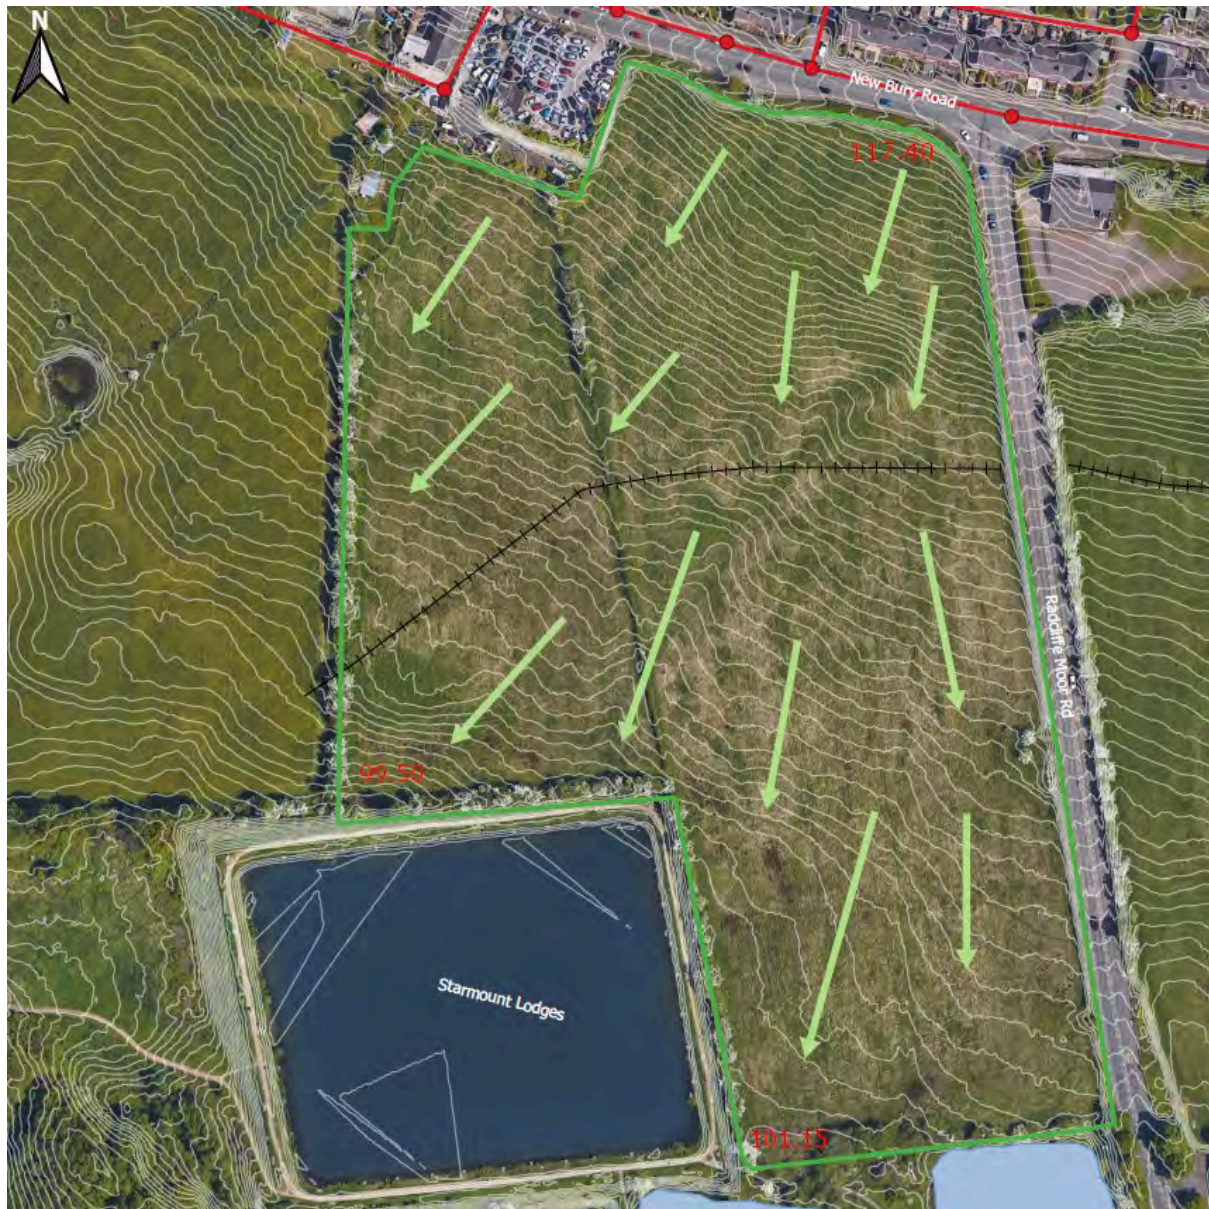
Figure 2 – existing ground level contours (from LiDAR) overlaid on an aerial image

- 2.3.1 A topographic survey has been undertaken and included within **Appendix C**. Existing ground levels fall from at high point ~117.40mAOD in the northeast corner (adjacent to Bury New Road) to ~99.50mAOD in the southwest (adjacent to the reservoir's northern embankment) and to ~101.15mAOD to the south (fishing ponds), as shown in Figure 2 overleaf.

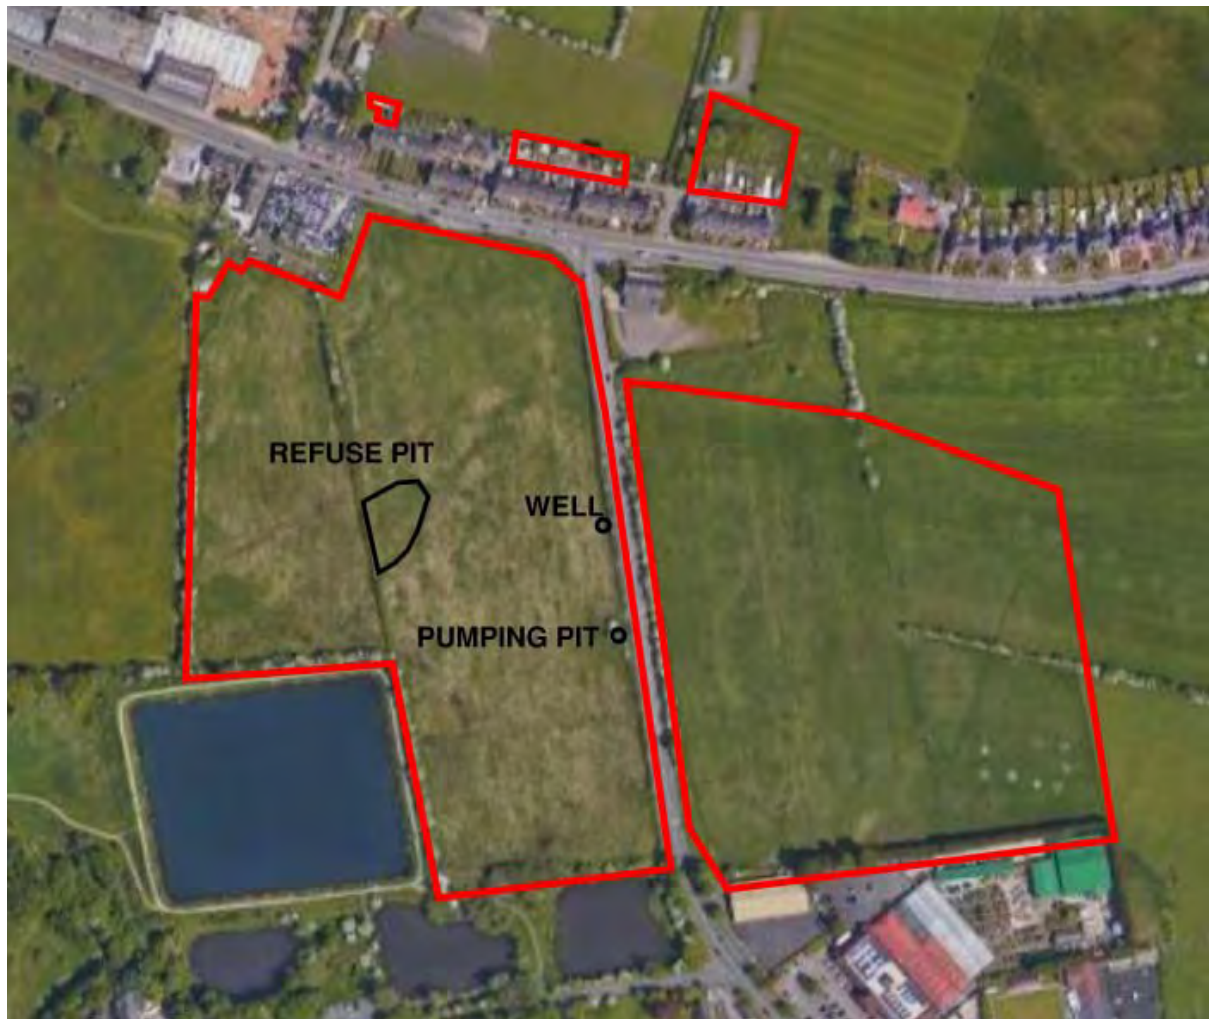
*Figure 3 – suspected approximate locations of historical features (Note the red-edge is shown beyond application site as part of a wider study area)*

2.2.1 The site is currently undeveloped and comprises of low-density vegetation, with trees and shrubs along the field boundaries. Historically the site was utilised for agricultural purposes and no other historical uses have been identified during this assessment, however the Ground Investigation has identified a number of historic uses including a former well, a pumping pit (for drainage of coal mines), possible mound of made / reworked ground (eastern parcel) and former houses along the boundary edge. The suspected approximate locations are shown in figure 3 which is an extract from the Betts Geo-Environmental Ground Investigation Report, 2021.

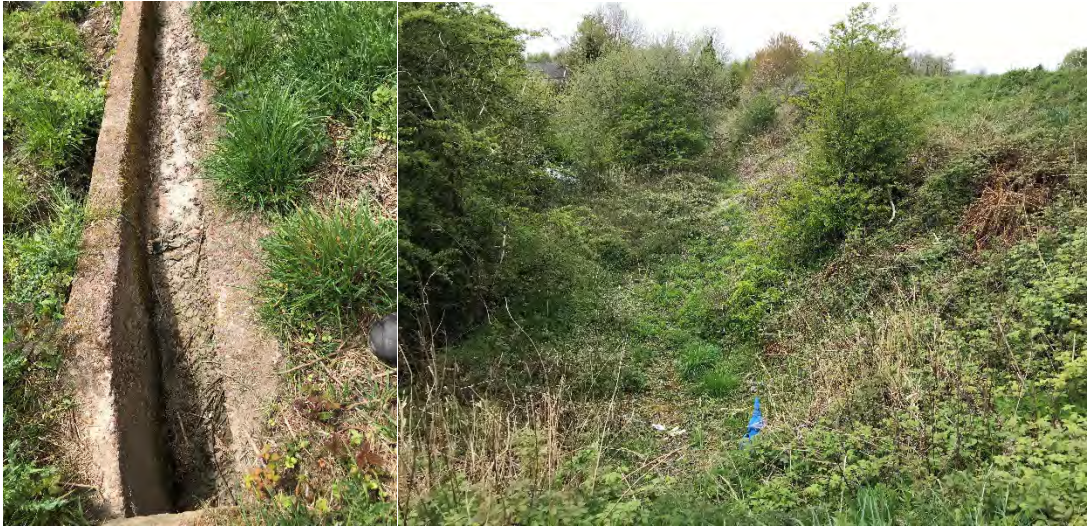
*Photographs 1 and 2 – showing the high-level overflow and low-level drain-down valve*

- 2.2.2 It is understood that the reservoir to the south of site was constructed for the Bradley Fold Print Works to be used as processing water.
- 2.2.3 It was confirmed during the site walk-over that the reservoir is not used for abstraction and is linked to the middle lodge by a high-level overflow channel shown in photograph 1 overleaf.
- 2.2.4 There is also a drain-down valve from the reservoir to the lower lodge which was installed relatively recently, shown in photograph 2 overleaf, however it is understood that following installation this would not function, most likely due to corrosion in the upstream pipework.

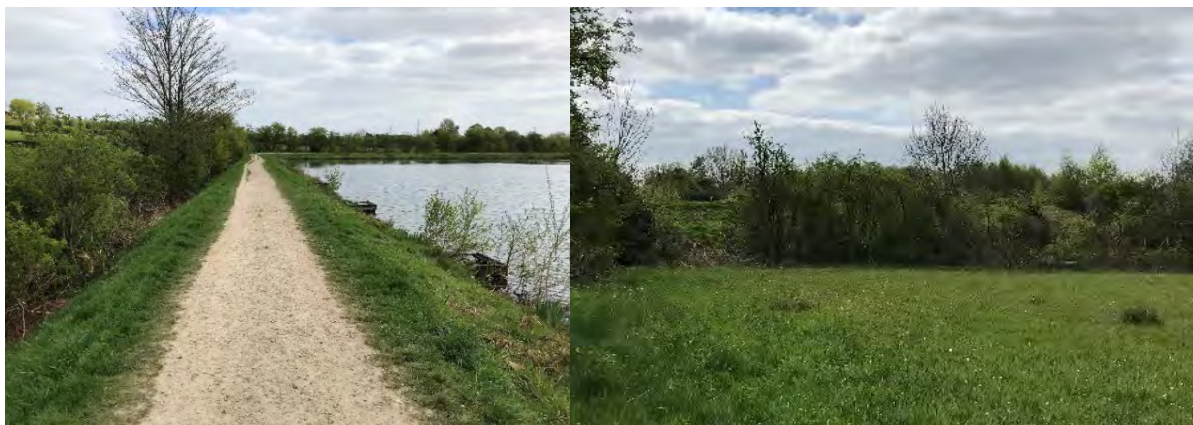
*Photographs 3 and 4 – showing the relative elevation of the reservoir's northern embankment compared to site.*

6.4.1 The reservoir is elevated relative to the surrounding ground and is understood to be fed by artesian water from the aquifer beneath (the Secondary A Aquifer with High Permeability within the bedrock deposits of the Sandstone and Pennine Coal Measure).

6.4.2 Photographs 3 and 4 below show the relative elevation of the reservoir compared to the significantly lower level on the northern side of the reservoir. Photograph 3 is looking east standing on footpath that runs along the top of the northern embankment. Photograph 4 is looking south at the northern embankment.

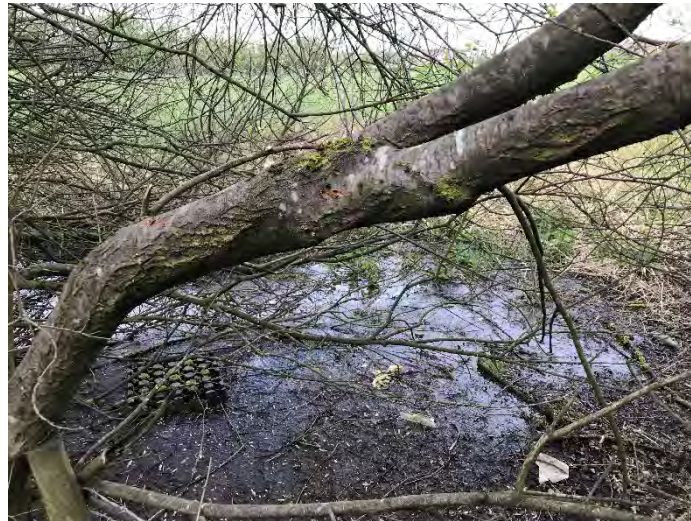
*Photograph 5 – Spring location on the southern boundary feeding the lodges*

- 6.5.1 There is a spring observable near the southern boundary with flow leaving the site discharging into the upper and middle lodges. This is understood to be from the Secondary Aquifer within the Glacial Till layer (superficial deposits).
- 6.5.2 This spring water provides a baseflow through the fishing lakes and must be maintained.

- 6.5.3 It was a dry day when the most recent site walk-over was undertaken and there was an observable flow from the spring at the location in photograph 5 above.

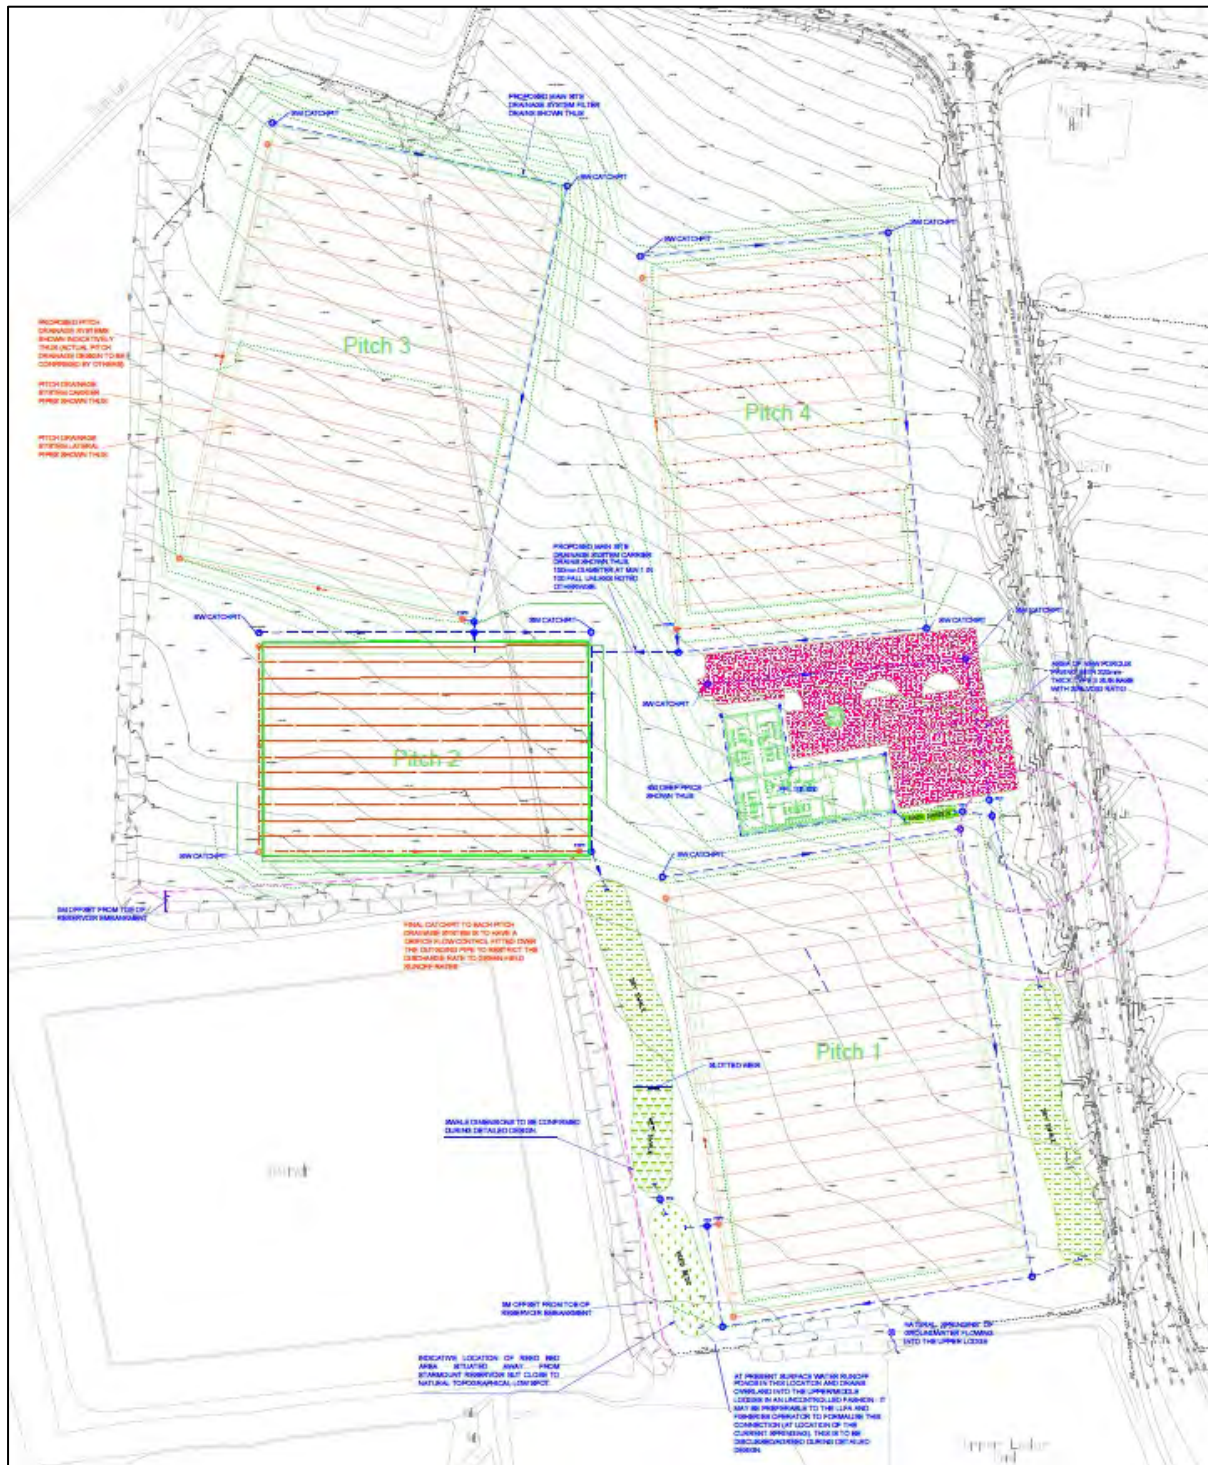
Figure 9 – Preliminary Drainage Strategy (Extract from HYD633-001-ABetts Hydro, 2022)

7.7.1 The runoff will be intercepted by the pitch drainage systems before flowing through a swale system and in turn a reed bed system. This is shown on the appended drainage drawing (ref. ENG001B, Westchurch Homes, 2022), an extract of this drawing is shown overleaf in Figure 9.

The flow control system will not work as drawn in Figure 9. Constraining the flow at the point indicated without the water having elsewhere to go will cause the manhole to discharge due to the head of water from Pitch 3 and Pitch 4 which are both higher than Pitch 2.

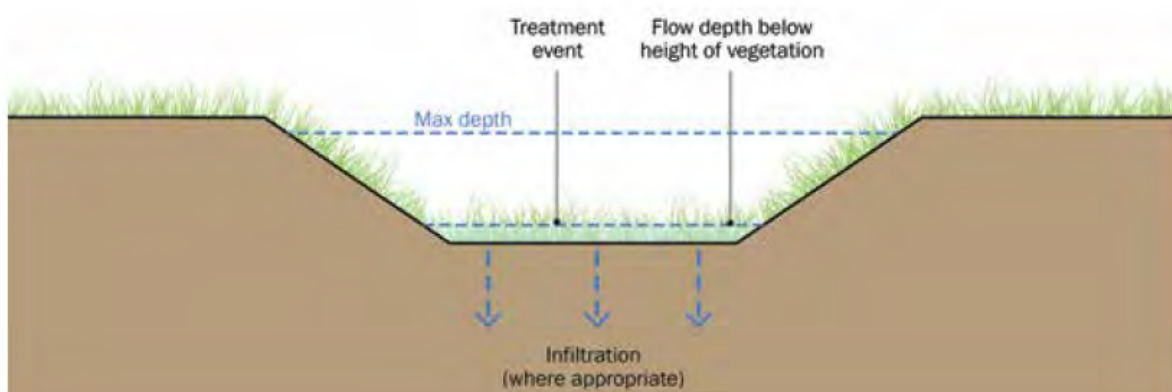
Figure 12 – Typical conveyance/attenuation swale (CIRIA, 2015)

- 7.9.2 The conveyance swale is a shallow vegetated channel, these are particularly effective at collecting and conveying surface water runoff from the drained area to another stage of the SUDS management 'train'. They provide both treatment and attenuation.

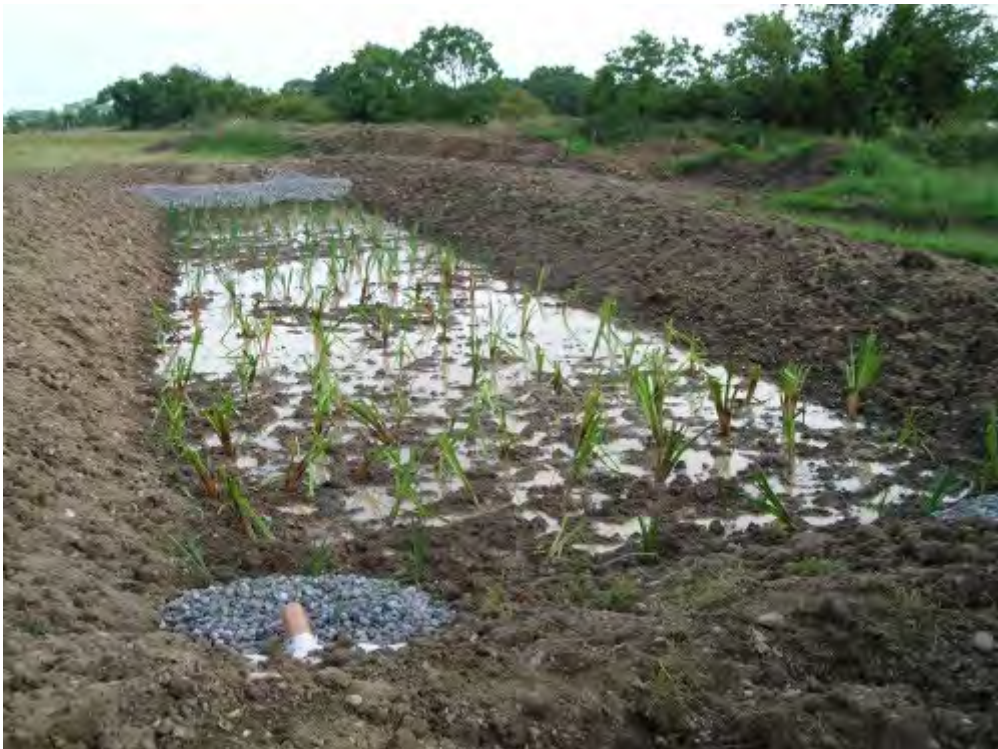
Photograph 6 – Reed beds (lowimpact.org, 2022)

- 7.9.4 The wet swale will connect into a reed bed. A reed bed is a wastewater treatment system that use growing wetland plants as the active component in getting effluent clean enough to discharge back into the receiving environment. Alternately called treatment wetlands, constructed wetlands or reed bed treatment systems, they have the potential to be low-cost, zero energy input, low-tech, high-efficiency systems that can be used to help protect streams and rivers from almost any source of effluent or dirty water. A typical example of the type of system proposed is shown below in Photograph 6.

- 7.9.5 The runoff going through the reed bed is surface water only as foul water will be discharged to the public sewer network the reed beds provide an additional means of improving water quality beyond that typically provided for such a land use. They are being proposed following discussion with the BMBC to provide further resilience to the downstream receiving network.
- 7.9.6 Aeration is provided by the plants, which draw oxygen down to the roots via the leaves, where it becomes available for aerobic bacteria; tertiary polishing is carried out if the reed bed is built large enough, providing further removal of nitrogen and phosphorus.

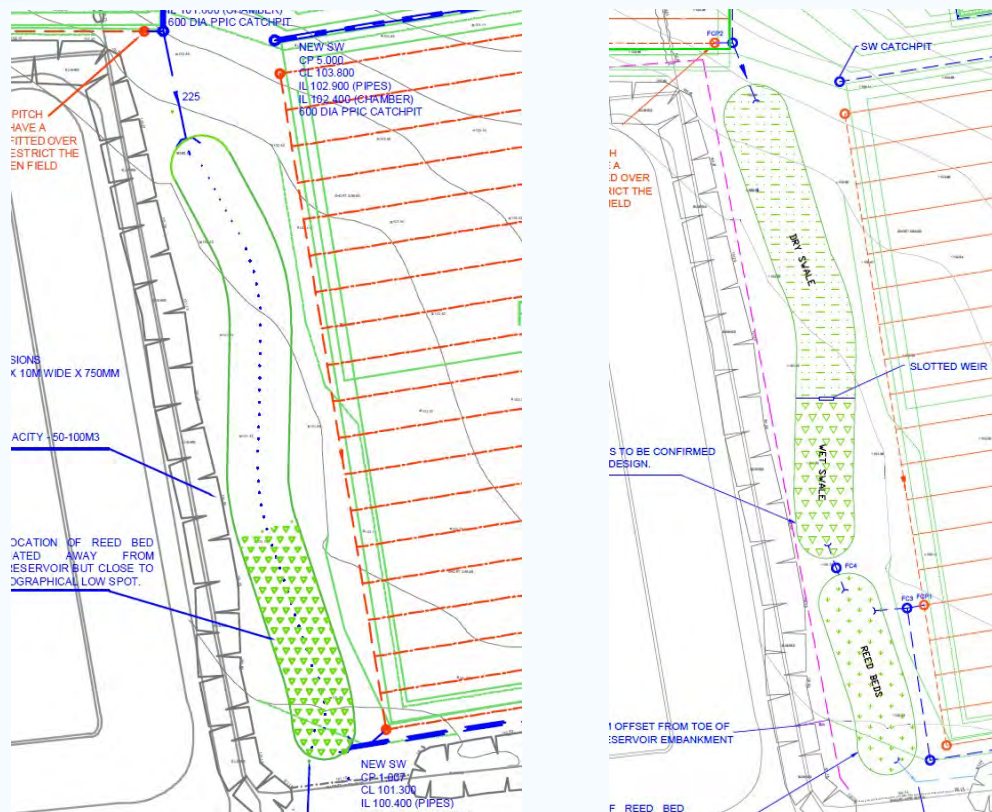
4.2 The report explains that the swale and reedbed are in two parts. This is shown in the extract below from the Hydrological Assessment drainage strategy plan – both the previous version on the left and the updated plan on the right which shows more detail.

4.3 In fact there are three distinctly different parts as the swale is a 'dry swale' in the upper portion, then becomes a 'wet swale' and then this swale discharges into the reedbed. The detail of the interface between the dry swale, wet swale and reedbed are a matter of detailed design but I would envisage a slotted weir between the dry and wet swale to make landscape maintenance easier and then a spill weir from the wet swale to maintain a permanent water level in the base with a piped connection into the reedbed.

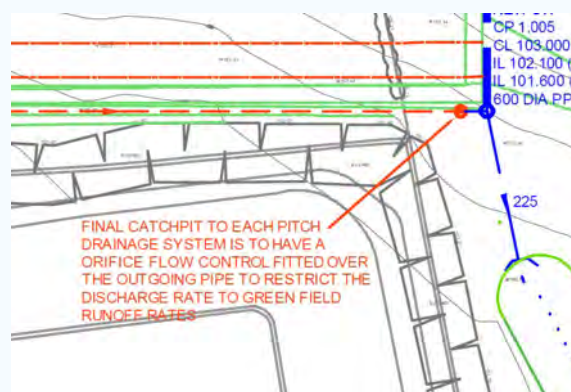
6.1 What is being described in the comment is not what is being proposed. What is being proposed is an orifice flow control to 'each pitch' on the final catchpit. This creates a cascading effect specifically so that one pitch does not hydraulically impact on the subsequent lower pitches. The note encircled specifically states this – see the note below which I have increased in size for clarity.
