Star Academy, Radcliffe (Temporary Accommodation)

Remediation Validation Report – Temporary Accommodation

TM/C5394/13333

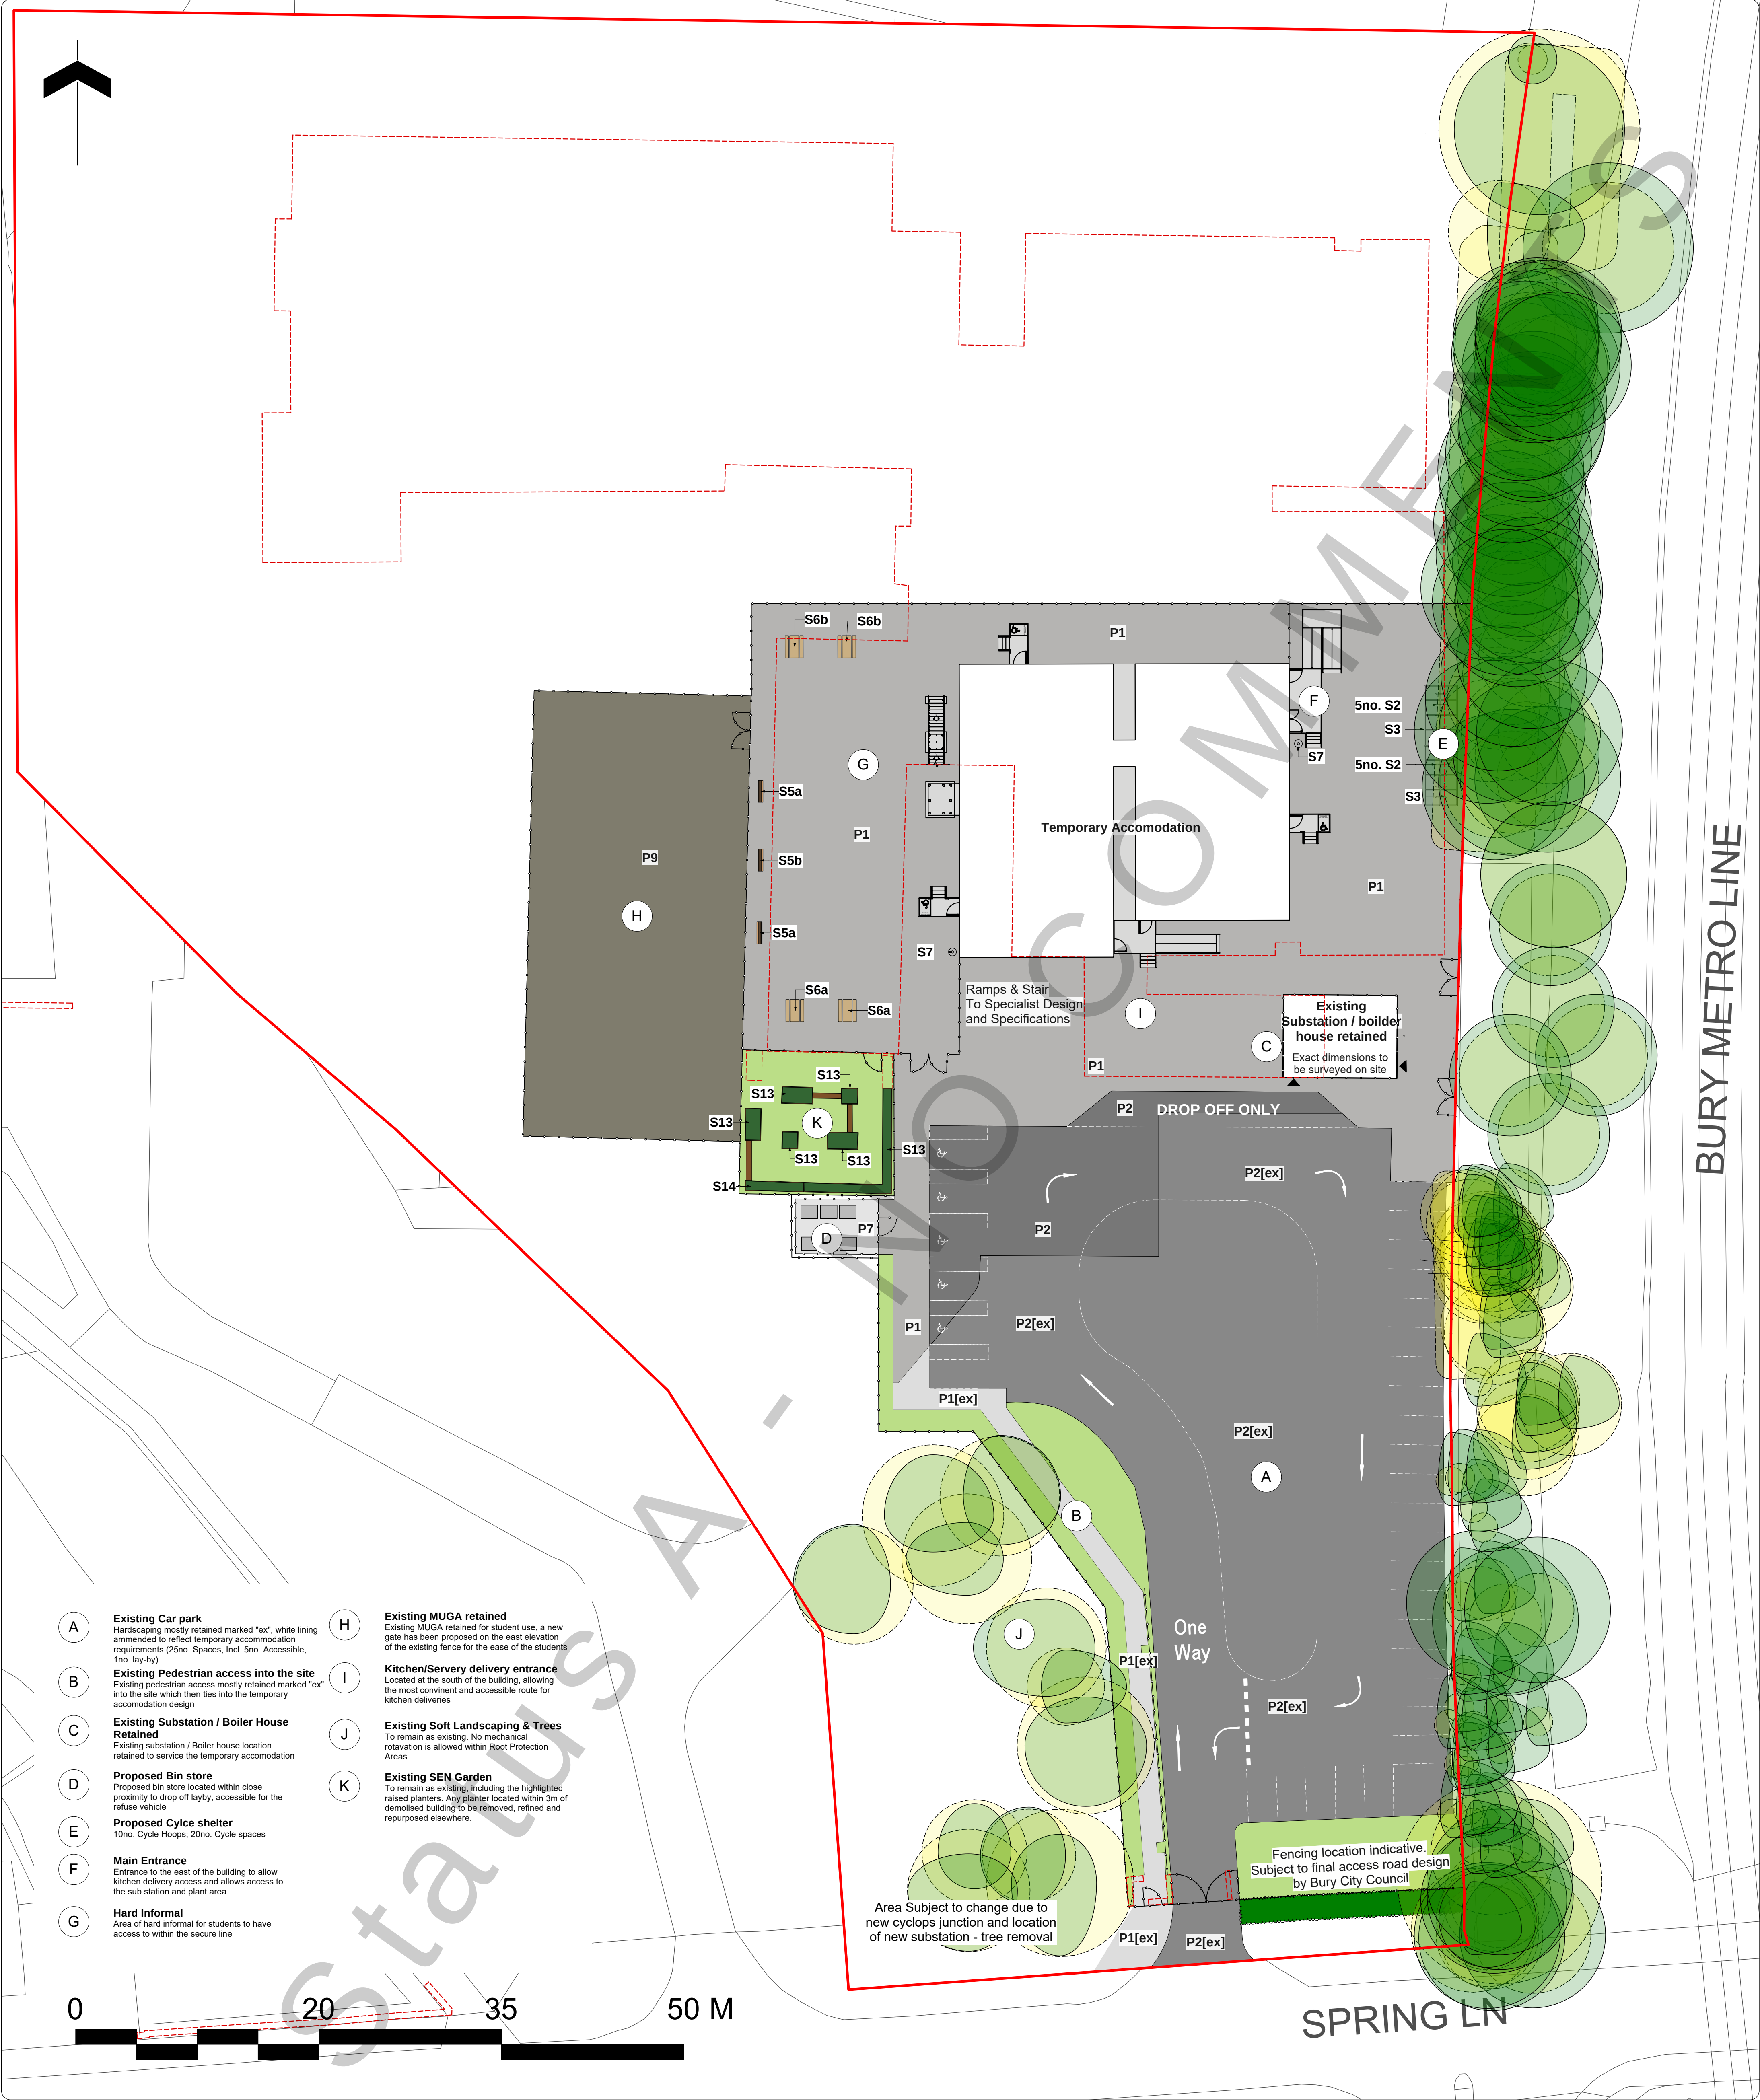
| STATUS : | |
|---|---|
| DRAWING NUMBER :<br>FS1013-ALA-EX-ZZ-D-L-0101 | STATUS :<br>S2 |

- A** Existing Car park  
Handscaping mostly retained marked "ex", while lining amended to reflect temporary accommodation requirements (25no. Spaces, Ind. 5no. Accessible, 1no. lay-by)

- B** Existing Pedestrian access into the site  
Existing pedestrian access mostly retained marked "ex" into the site which then ties into the temporary accommodation design
