# **The Lee, Walmersley Road, Bury, BL9 5JA**

## **Statement of Heritage Significance**

(For refurbishment / repair of the existing roof covering, including leadwork)

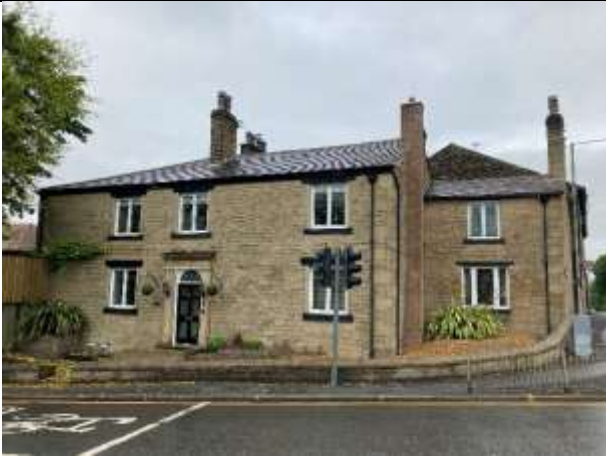
East elevation to Walmersley Road, including traditional slated roof surfaces and painted timber fascia boards to eaves.

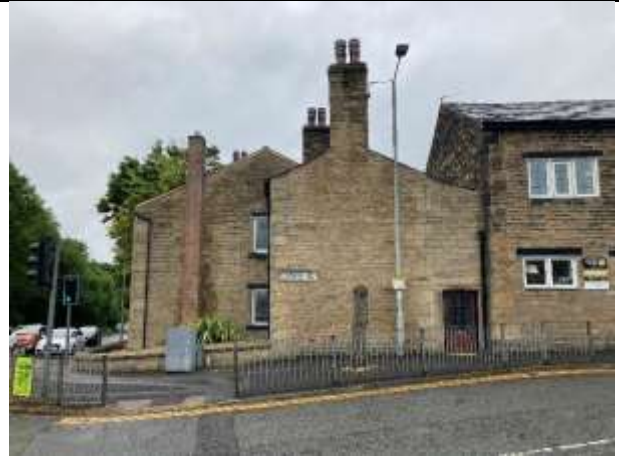
North elevation to Springside Road, with mortar bedded verges and chimney stacks.

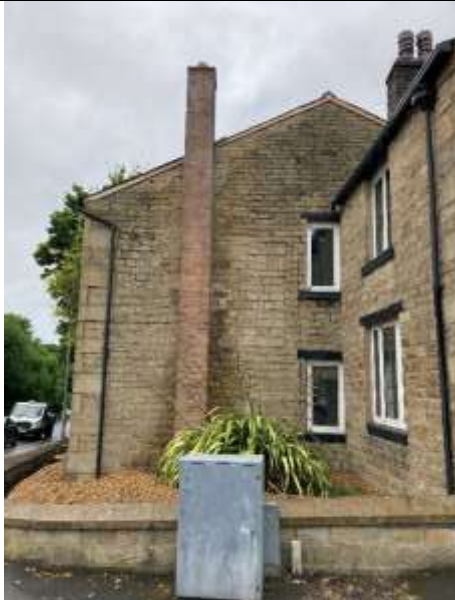
North gable with central brick chimney stack.

The north gable is more modest and has been altered and adapted over the years and is blighted by a contemporary brick chimney circa 500mm square which rises circa 2m above the verge.

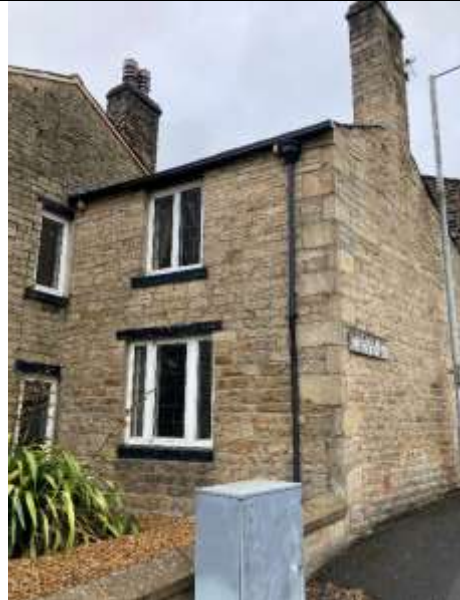
East elevation to north extension.

To the north of the aforementioned gable is a 2 storey extension which abuts the adjacent terraces on Springside Road. Formed in similar construction.

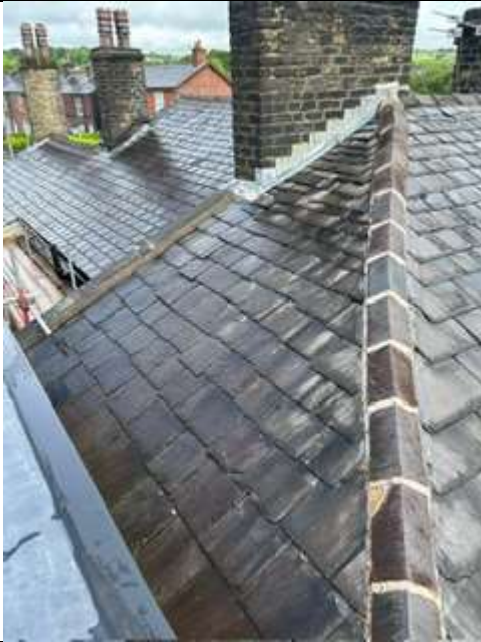
View across roof slopes E, C and A indicating Welsh slates, clay ridge and hip tiles, stone coping to verge and leadwork to stone chimney stacks.

1. Roof Slopes A, B, C, D, E & F. Careful removal of the existing mortar bedded, clay ridge and hip tiles, Welsh slates (note the existing spacing and gauge), existing stone coping / verge stones and set aside for re-use, replacing any broken / defective slates with matching Welsh slates of the same thickness and size. Remove existing timber slating battens and repair any rotten timber tongue and groove sarking boards with new treated timbers to match existing. Existing painted timber fascia boards to be retained / repaired as necessary. Remove / replace any defective lead soakers and flashings and replace with new lead sheet to codes 3 and 4 respectively and as Lead Sheet Association guidance.

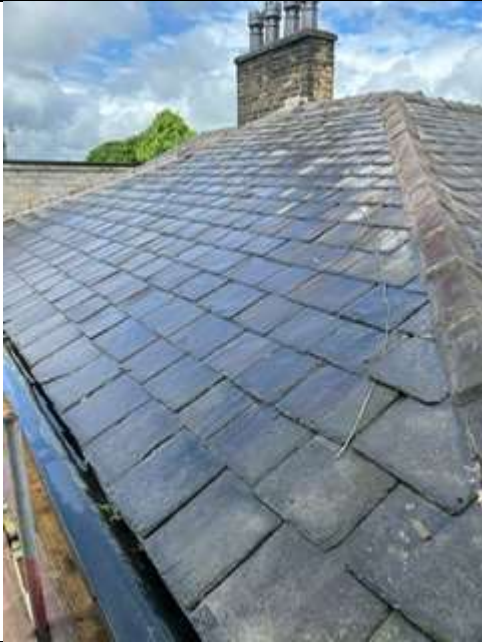
| <p>West facing view along roof slope F with parapet upstand to flat roofed area.</p> | <p>West facing view towards roof slope B.</p> |
