# Eccleston Homes

## REMEDIATION STRATEGY

Mondi Site, Ramsbottom

REPORT No: 19ECH016/RS

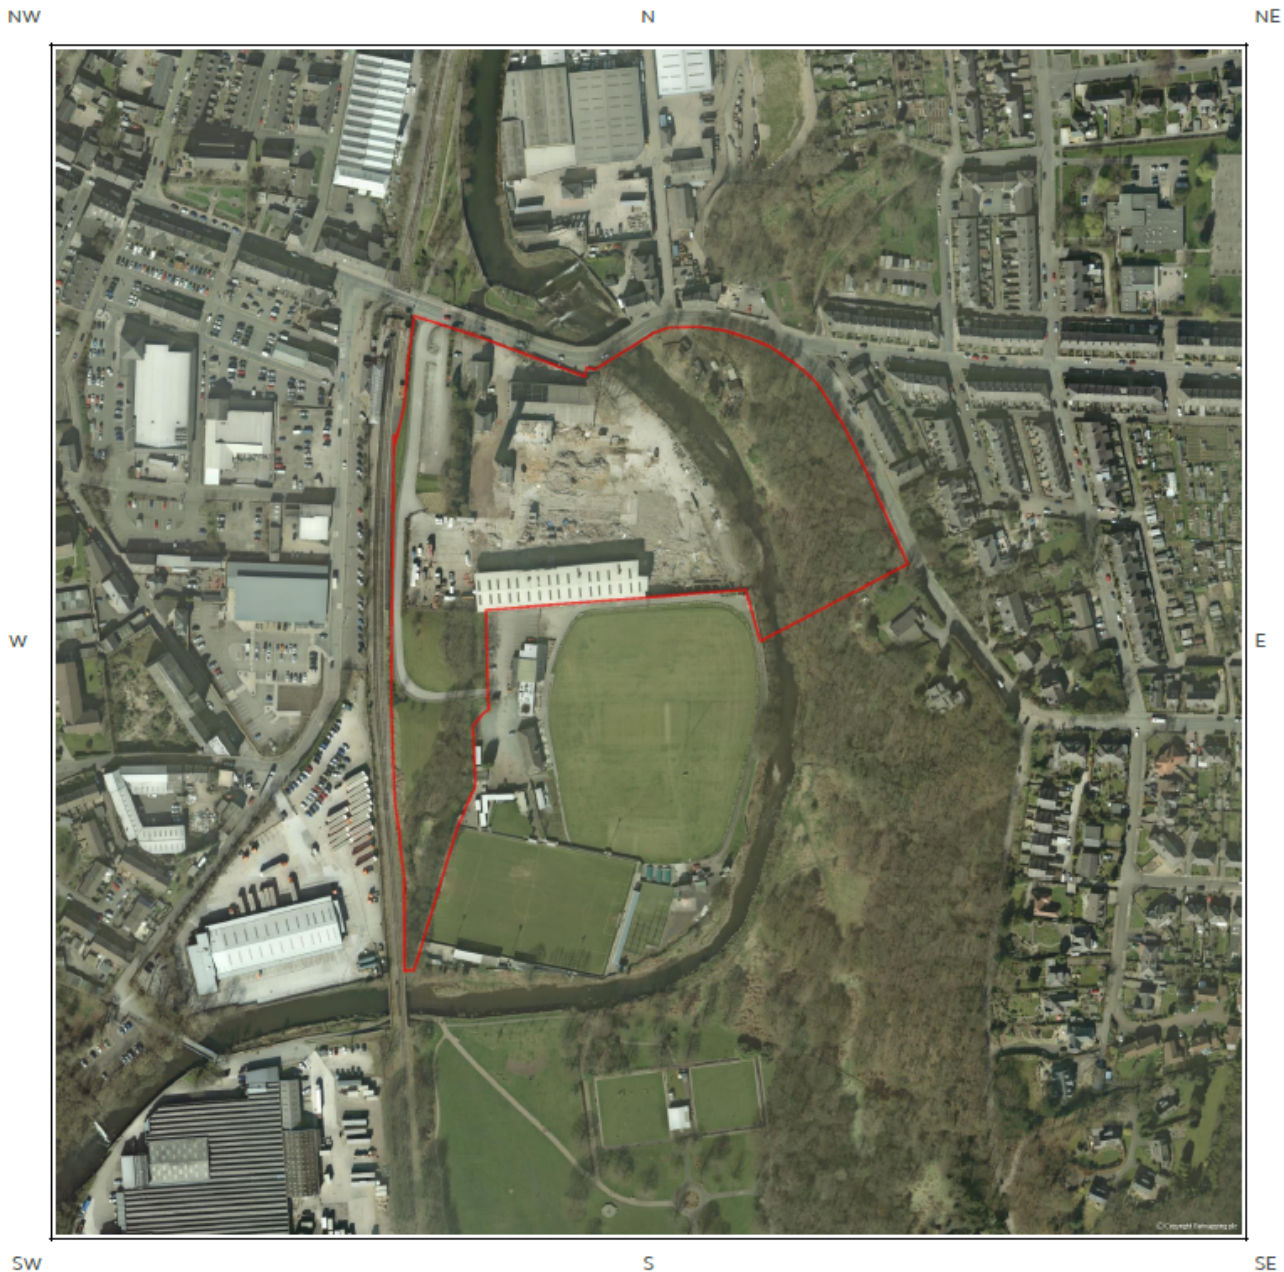
Site Boundary – March 2012

Betts Geo Environmental (Betts) has been commissioned by Eccleston Homes to prepare a Remediation Strategy for the remediation and preparatory works for former Mondi Mill site, Ramsbottom. The plan below shows the site boundary;

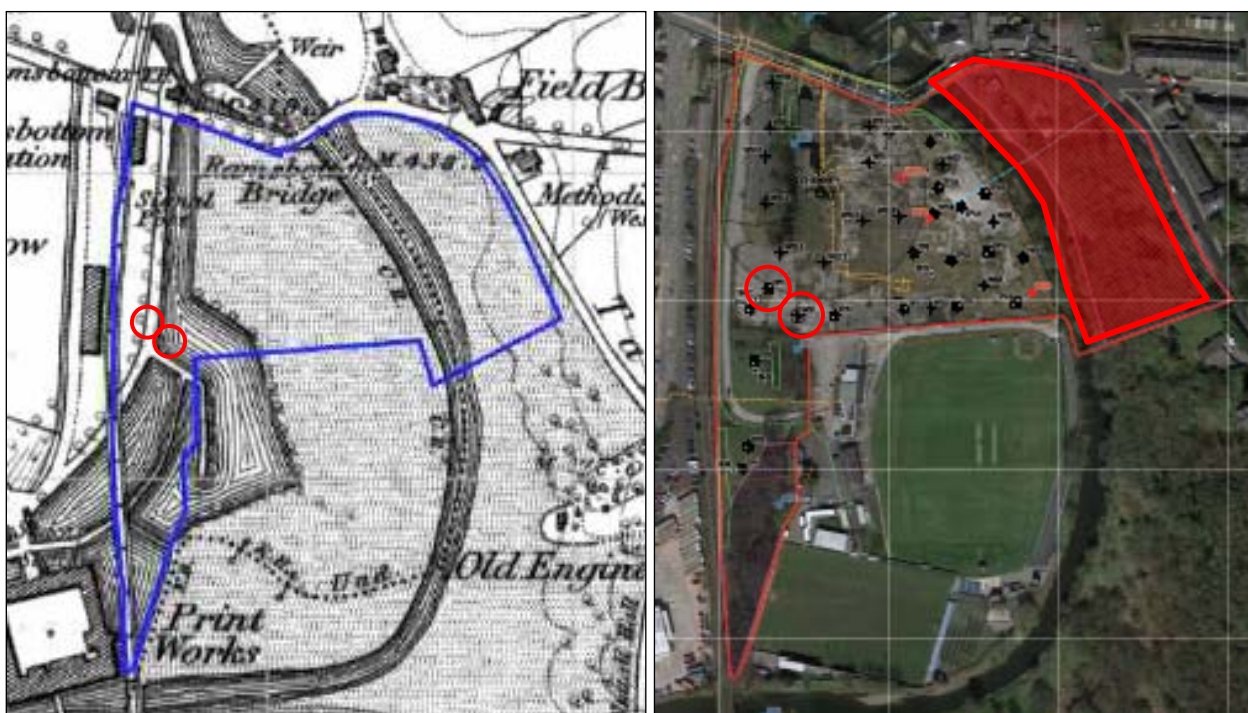
The Made Ground exceedances have been recorded at varying depths between 0.10mbgl and 2.00mbgl. With deeper exceedances at 2.25mbgl (TP5) and 2.75mbgl (WS1), within potential Made Ground strata.

Based on the locations of TP5 and WS1, in relation to the formerly existing reservoirs, it is now considered likely that these are Made Ground samples from backfill / basal reservoir materials. As shown in the sketch below;
