**GROUNDTECH**  
CONSULTING

**Job title:** New Office Block, Bury

**Report type:** Coal Mining Risk Assessment

**Prepared for:** JD Sports

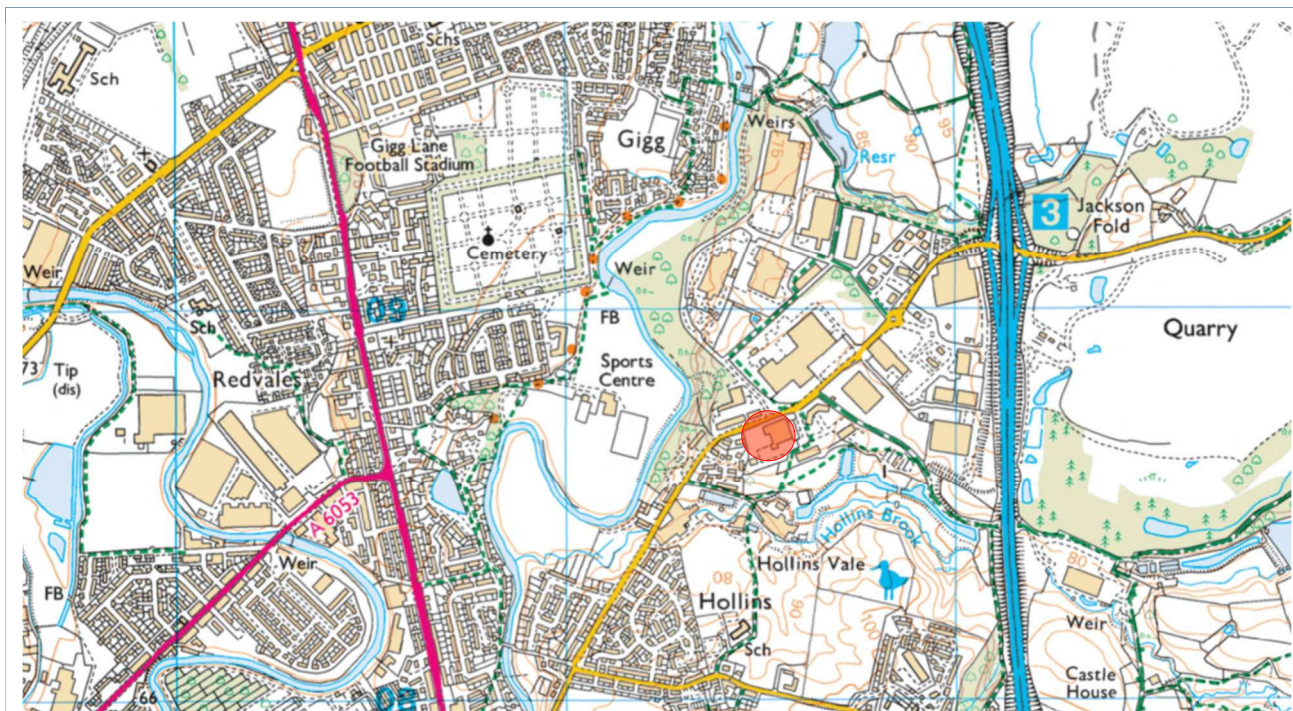
Site Location

The site is located circa 2.4km southeast of Bury Town Centre, as shown on the Project Location Plan GRO-21438-P01. The site is approximately centred on National Grid Reference 381527, 408662.
