# 1:50 EXISTING "GROUND FLOOR PLAN"

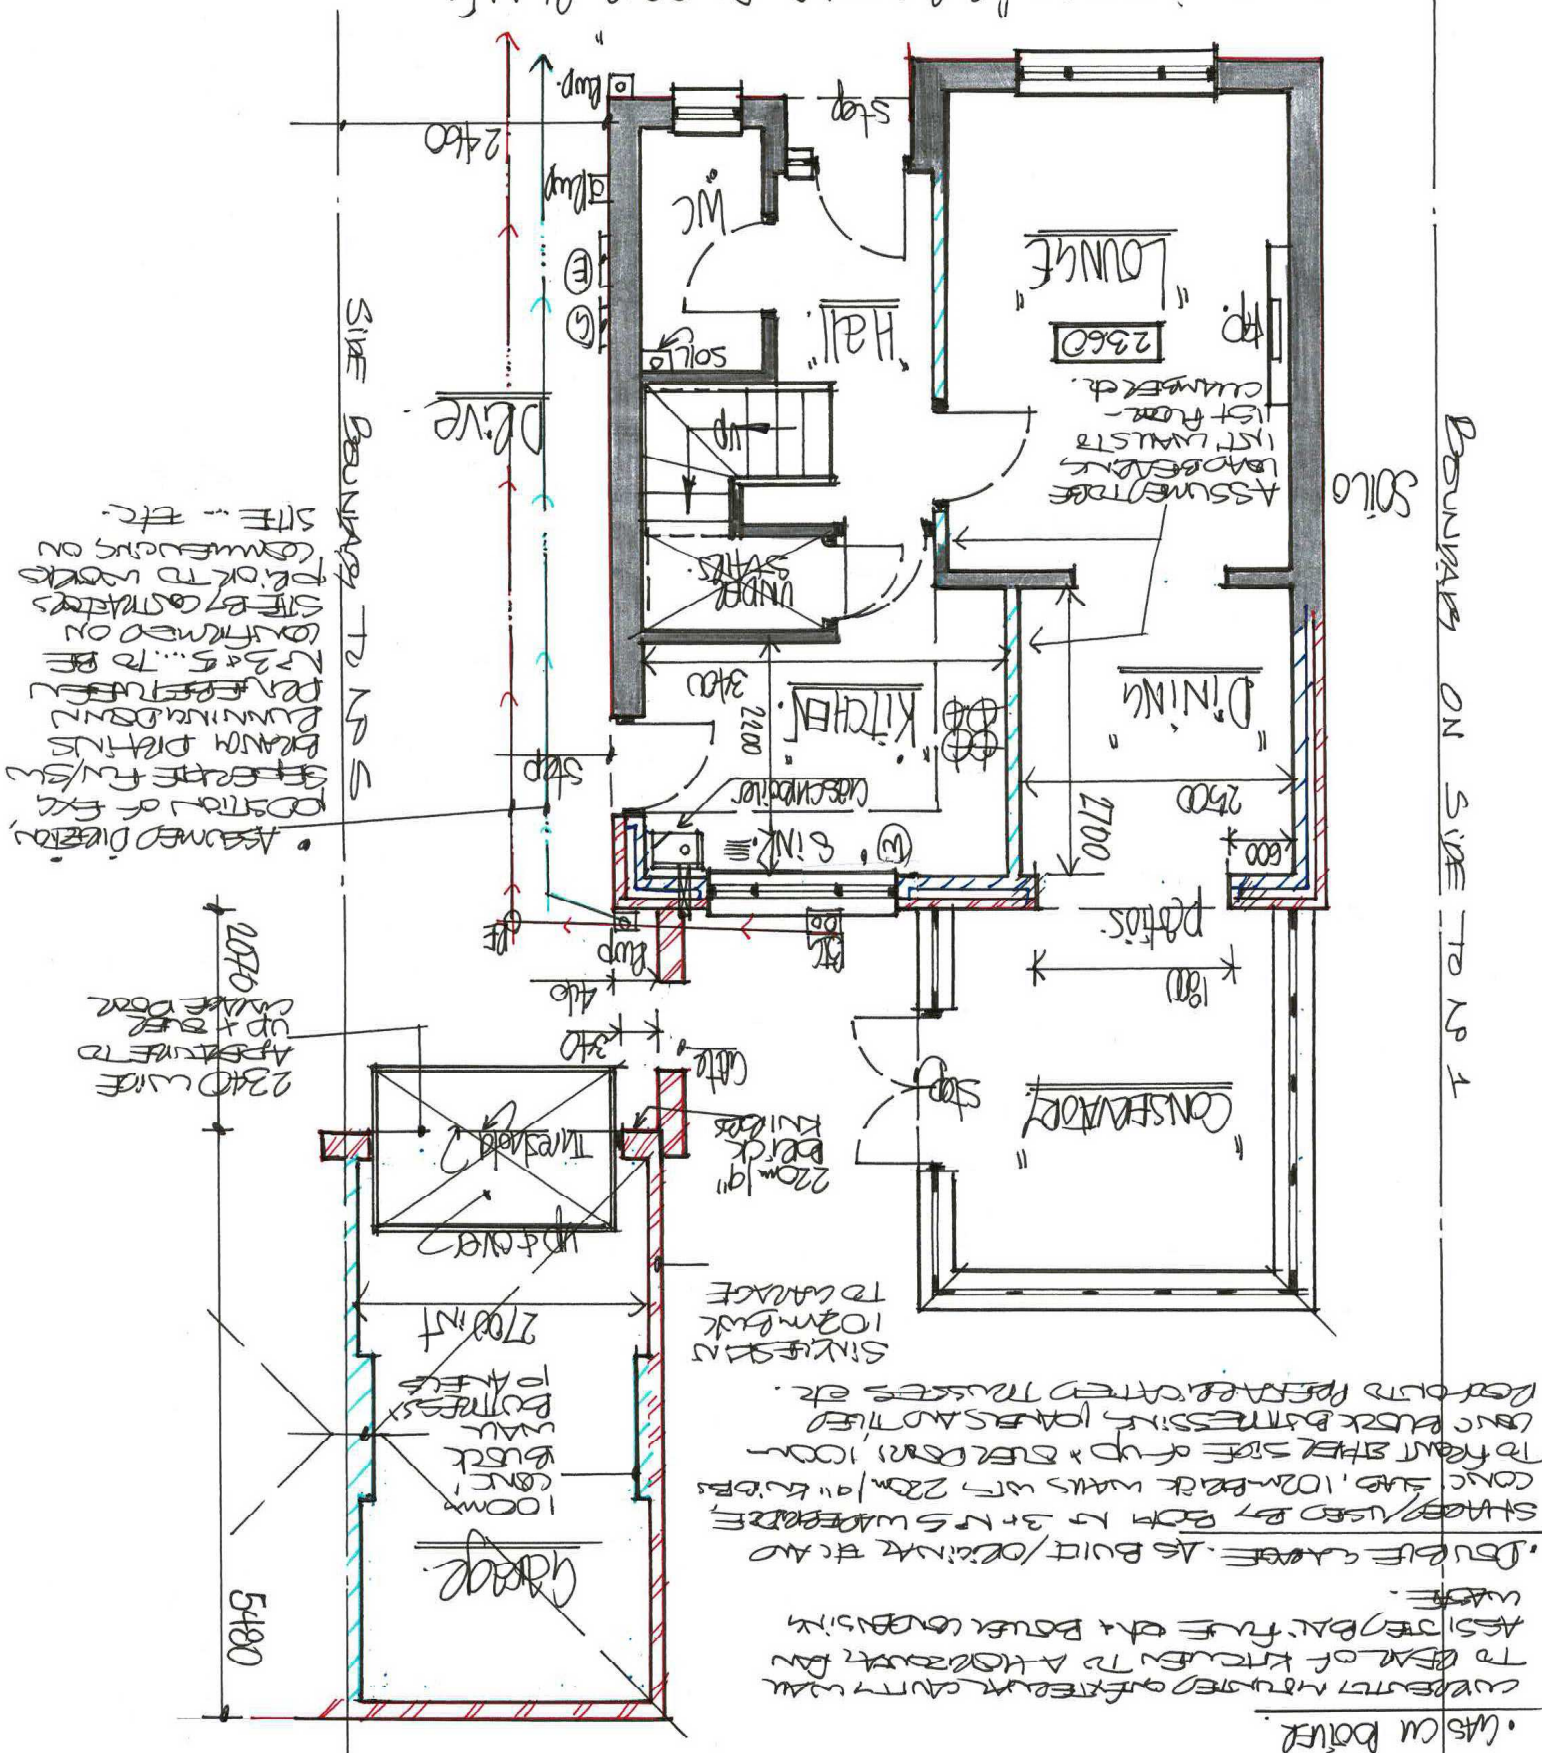
• SITE DRAINAGE :- Aft of plan and observations made & time of surface water suggest a separate system of F/SW site drains exists in duct. Inspection chambers located at right in corner of site, connected to main drains in order to ascertain and establish the exact location, direction, depth and invert levels of site drains and also sewerage pipe, storm and modify to suit proposed works and sewerage carried out to full satisfaction and approval of WAO on site. Details of 1975.

• WAS CU DRAIN. CURRENTLY MIXED GREASEY DRAINAGE TO REAR OF KITCHEN TO A HORIZONTAL DRAIN. ASSUMED BALANCE OF 4" BOUNDED DRAINAGE.

• DOUBLE GARAGE. AS BUILT/ORIGINAL AT AND STAIRS USED BY BOTH 3 & 4 F/S WAREHOUSE, CONC. SLAB, 100mm BRICK WALLS W/ 220mm/4" KIRBS TO REAR OTHER SIDE OF UP & OVER DRAIN, 100mm CONC. SLAB, 100mm BRICK WALLS W/ 220mm/4" KIRBS. REAR DRAIN REINFORCED TRUSSES ETC.

SINKS IN 100mm BRICK TO GARAGE

• ASSUMED DIRECTION, POSITION OF EX. EXISTING F/SW BRANCH DRAINS RUNNING DOWN DOWN DRAINAGE TO BE 3" x 5" TO BE CONFIRMED ON SITE BY CONTRACTOR PRIOR TO WORKS COMMENCING ON SITE - ETC.
