# **Arboricultural Impact Assessment with Arboricultural Method Statement**

**- Whitefield Fire Station, Bury New Road, Manchester -**

**Greater Manchester Combined Authorities**  
Greater Manchester Fire and Rescue Service

November 2022

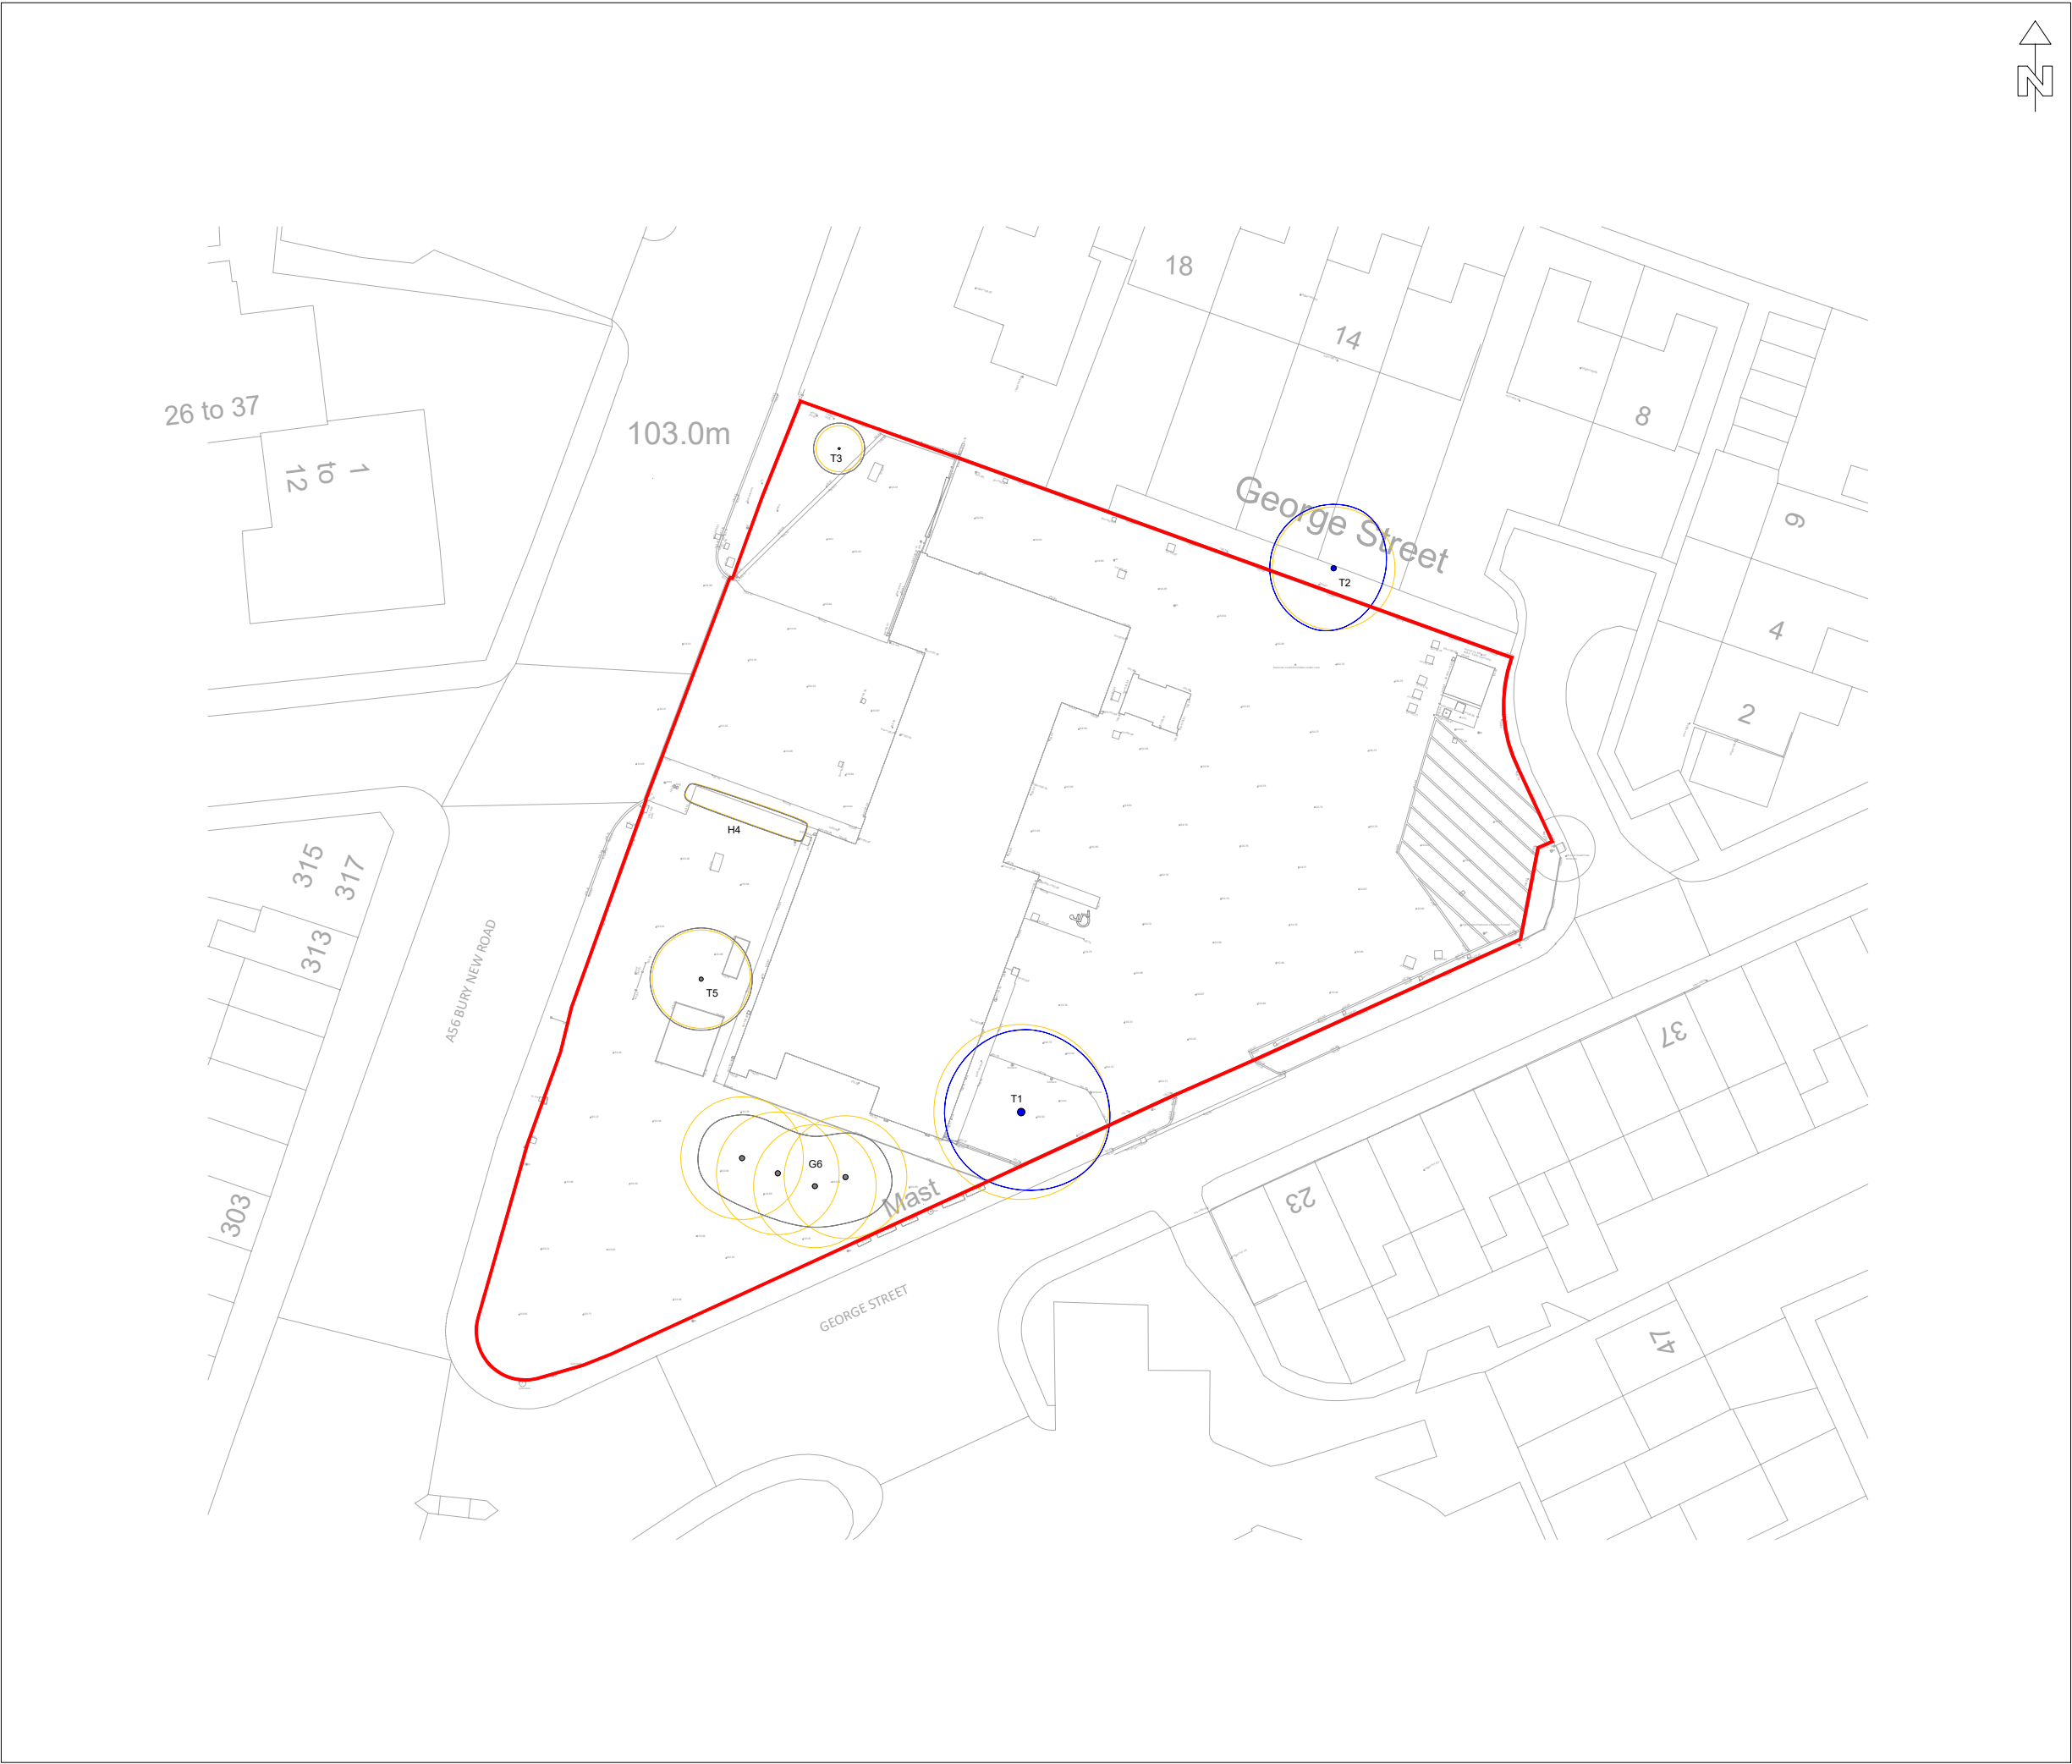
## Drawing 1. Tree Constraints Plan

The Root Protection Area (RPA) is a layout design tool highlighting the underground tree constraints.  
Along with the tree stem and branches the RPA must be considered prior to and during development.

2.2.1. Please see *Appendix 1* for the detailed list on existing species, age class, dimensions and condition of trees within the site, and *Appendix 2* for an explanation of retention category criteria. Tree locations can be seen on the *Tree Constraints Plan* at the rear of this report (*Drawing 1*).

- 2.3.1. The tree Root Protection Area (RPA) is a layout design tool indicating the area around a tree that, along with the tree stem and branches, must be considered during development. The protection of the roots and soil structure within the RPA should be treated as a priority. The RPA of each tree or group is marked on the *Tree Constraints Plan* at the rear of this report.

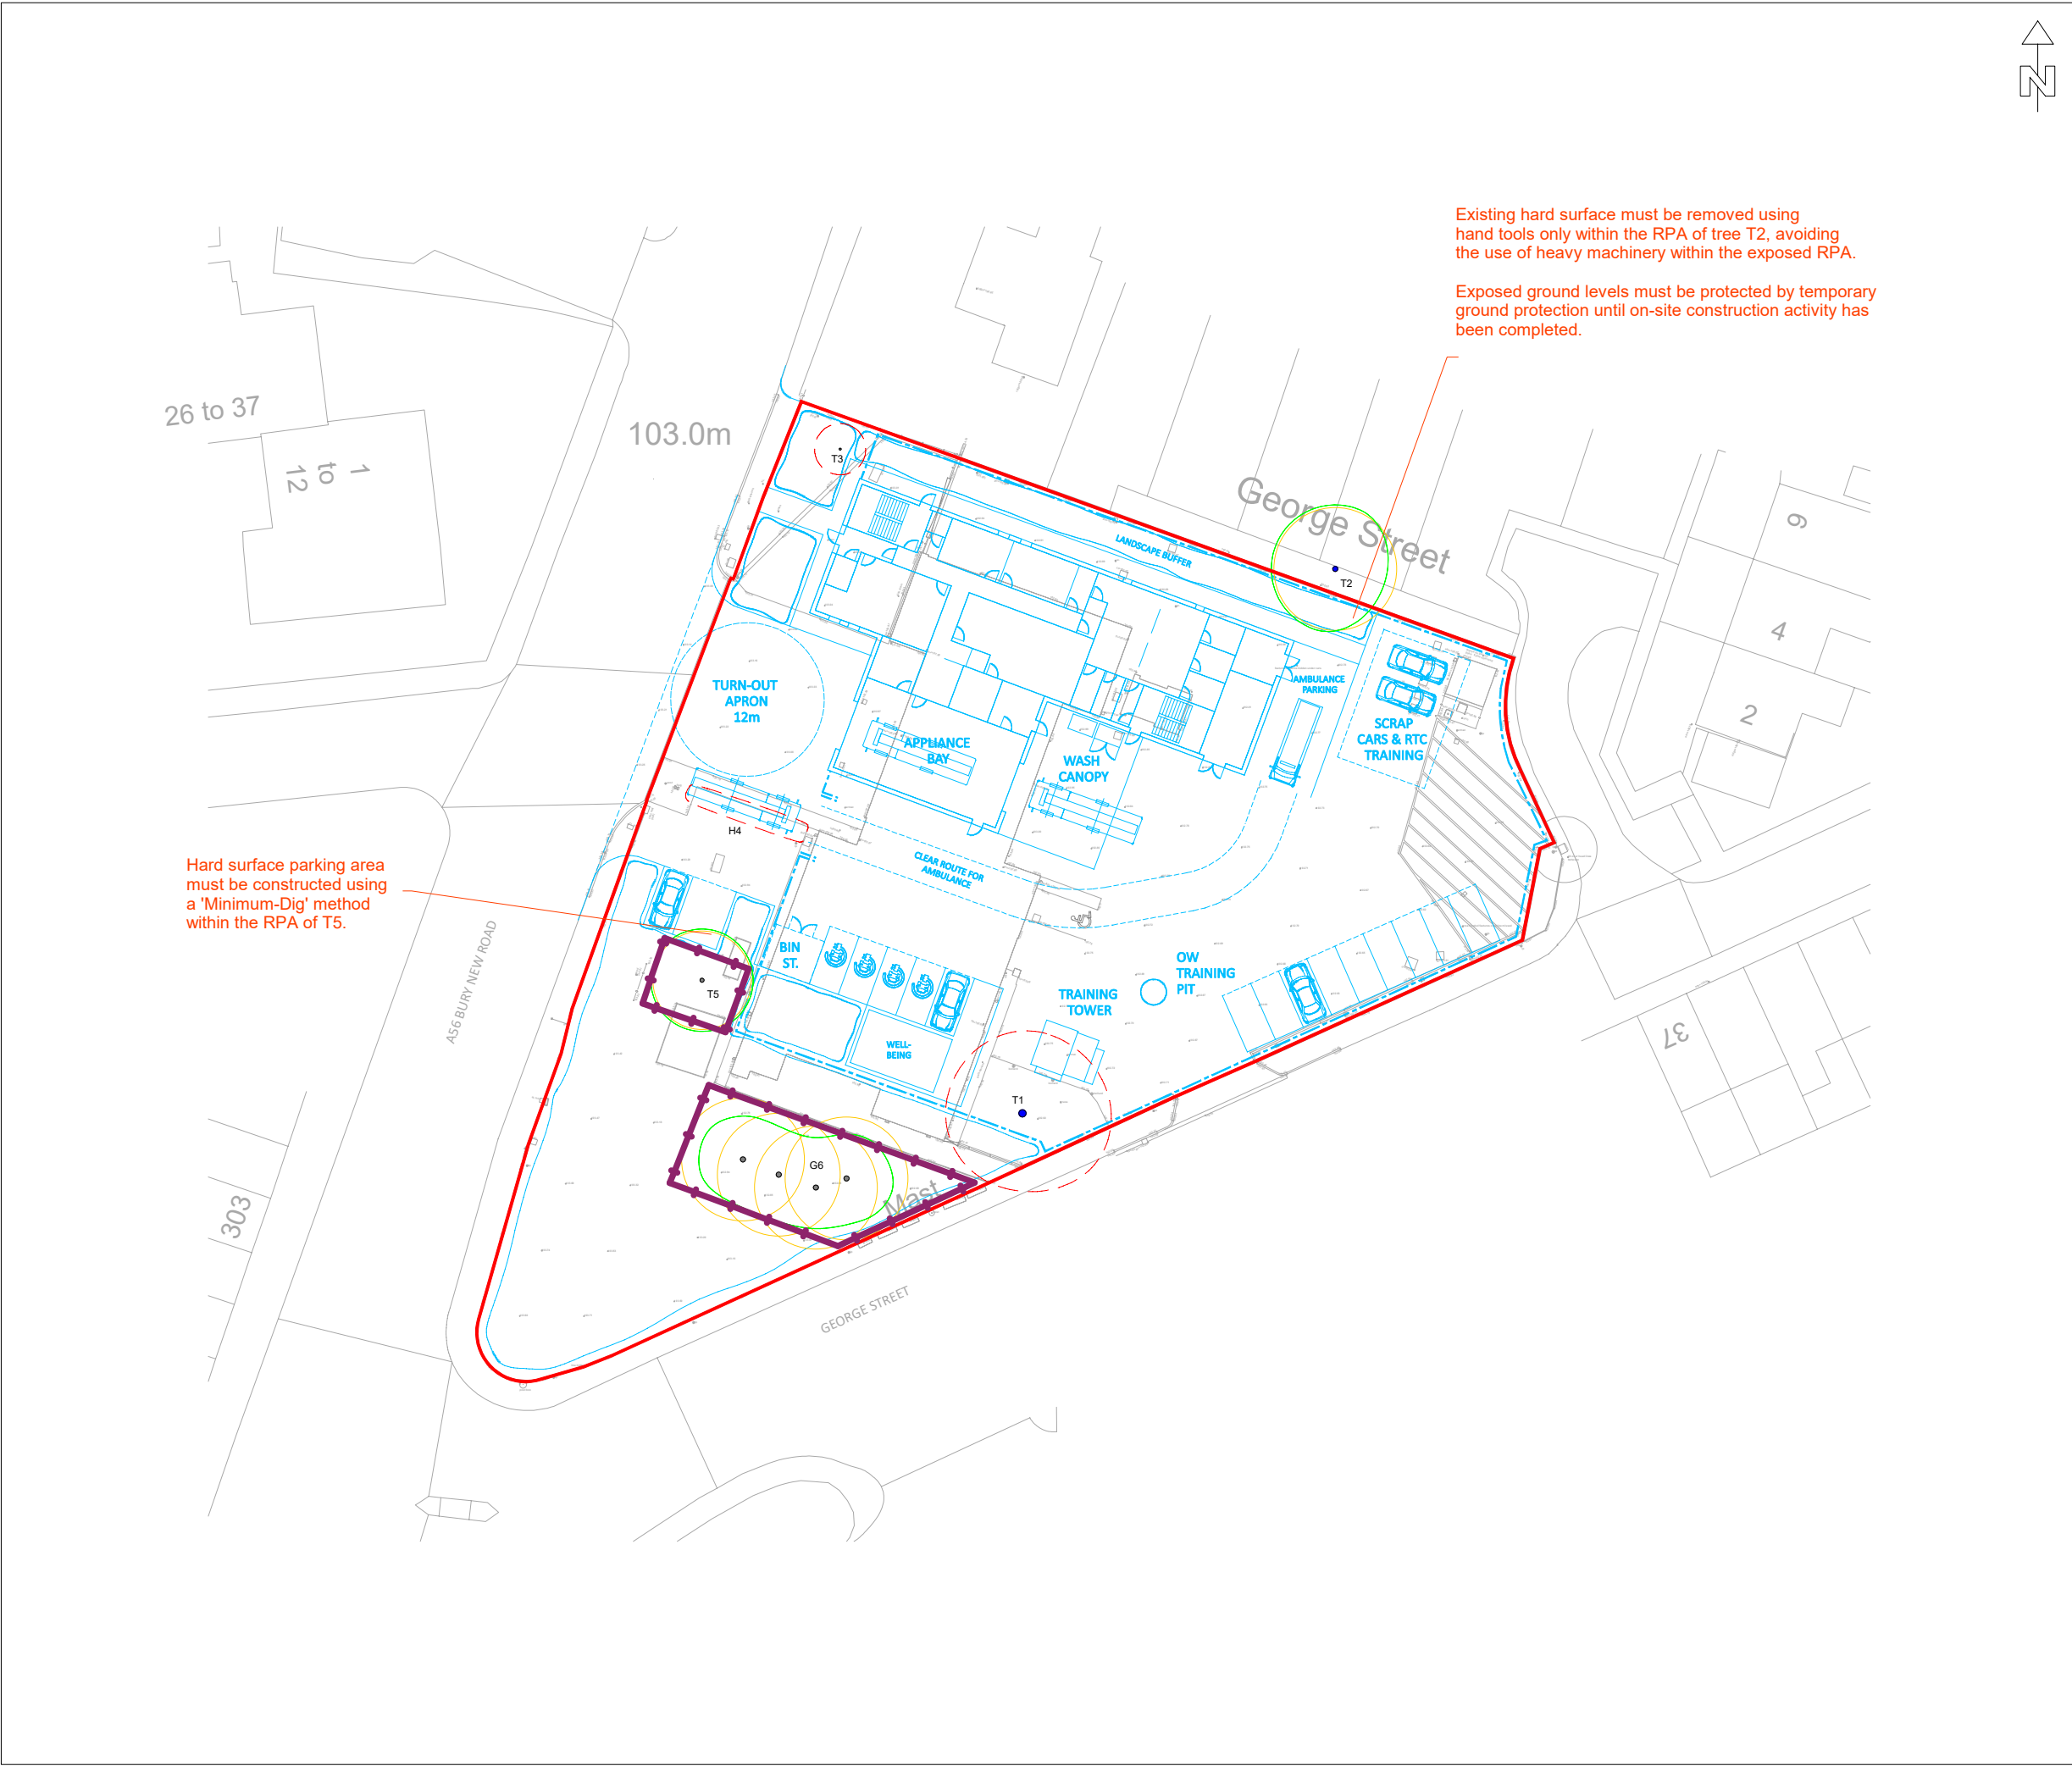
## Drawing 2. Tree Protection Plan

| | T1, T3 & H4 |

The Root Protection Area (RPA) is a layout design tool highlighting the underground tree constraints. Along with the tree stem and branches the RPA must be considered prior to and during development.

- 4.2.3. Please see *Appendix 4* for suggested barrier construction detail. It is recommended that in this instance the protective barrier shown in *Figure 2* would be appropriate. The suggested location for protective fencing is shown on the *Tree Protection Plan (Drawing 2)*.
