PROJECT TITLE :  
**Star Radcliffe Academy, Bury**

DRAWING TITLE :  
**Tree retention and removal plan**

DRAWING NUMBER : FS1013-ALA-EX-ZD-L-0031  
STATUS : S2  
REVISION : P08

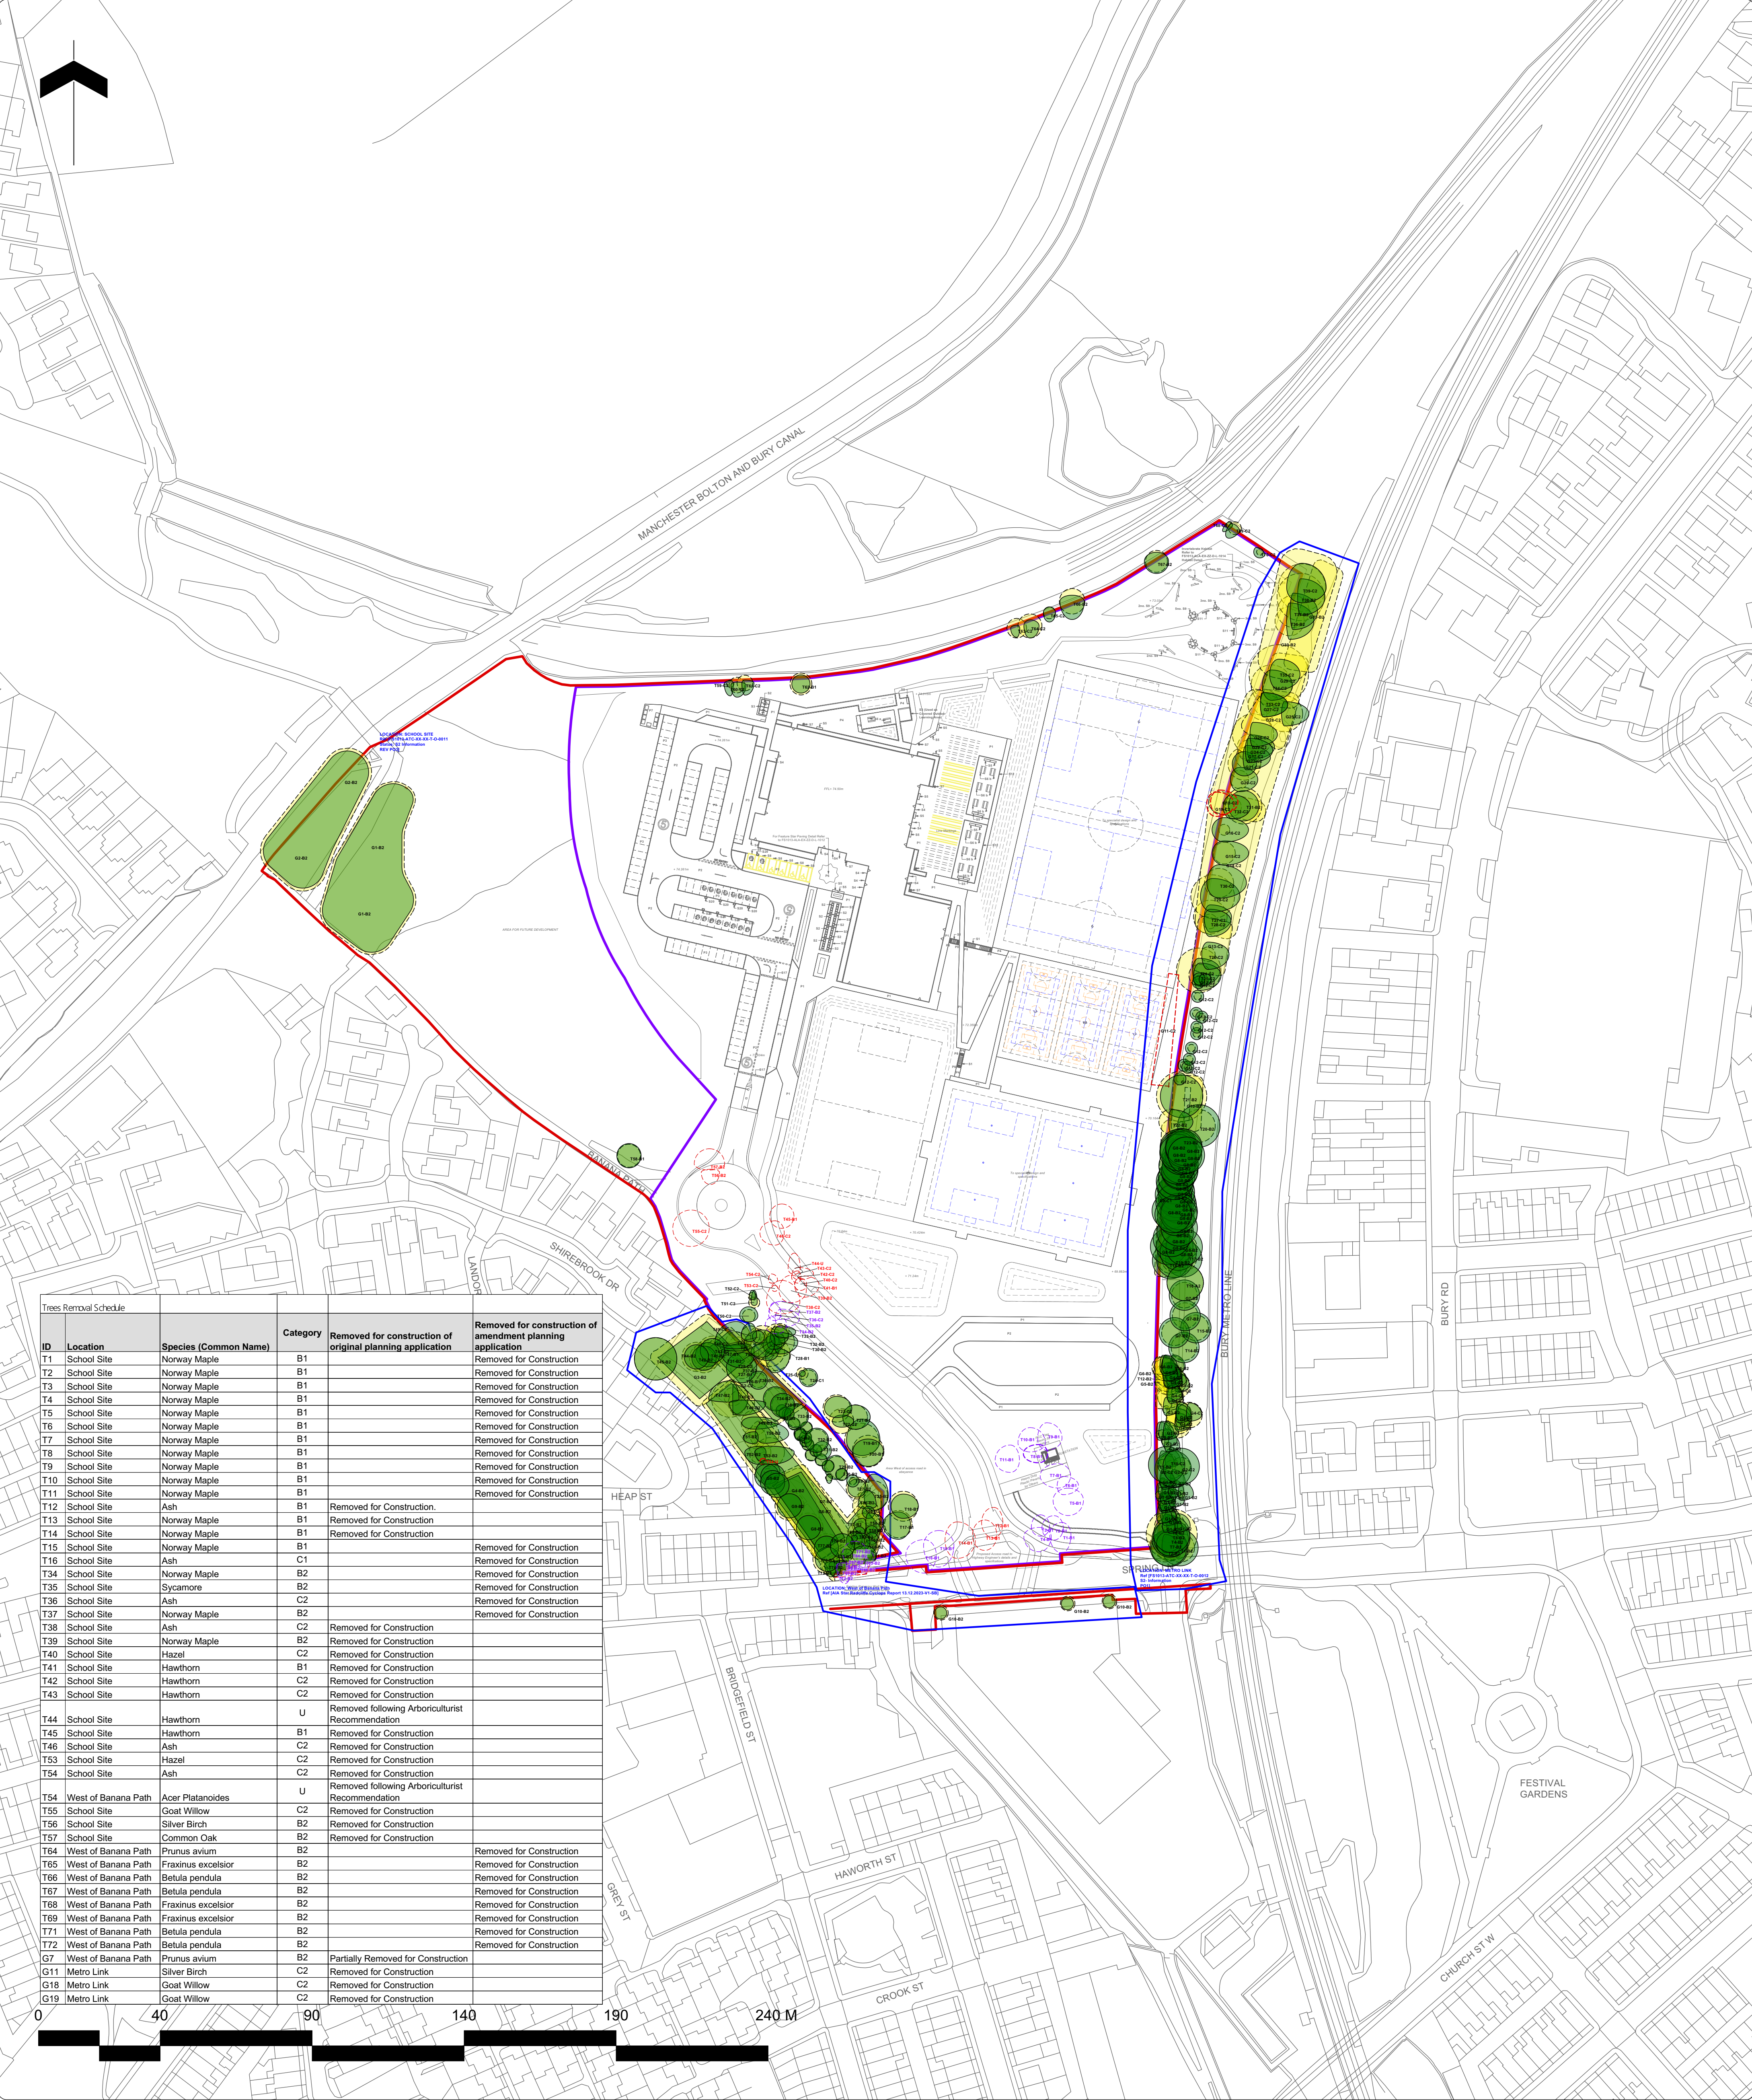
As shown in Preliminary Arboricultural Impact Assessment. (Please refer to BS 5837: 2012 Preliminary Tree Survey Report prepared by Amenity Trees Arboricultural Consultants REF FS1013-ATC-XX-XX-T-F-0001)

Vegetation removal is recommended outside of the main breeding season (October – February) It is recommended that supervised checks are carried out prior to tree removal by a suitably qualified ecologist.

- Planning Application Boundary
- Extent of Works
- T1 Tree to be retained
- T1 Tree to be removed as a result of original planning application
- T1 Tree to be removed as a result of amendment planning application
- Tree Root Protection Area (RPA)
