Order Details: 296205844\_1\_1  
Customer Ref: 22-1127.01  
National Grid Reference: 380180, 408500  
Slice: A  
Site Area (Ha): 1.52  
Search Buffer (m): 1000

Tesco Mobile Customer Care, Cellnet Building, Dumers Lane, BURY, BL9 9QL

## Envirocheck<sup>®</sup> Report:

### Mining and Ground Stability Datasheet

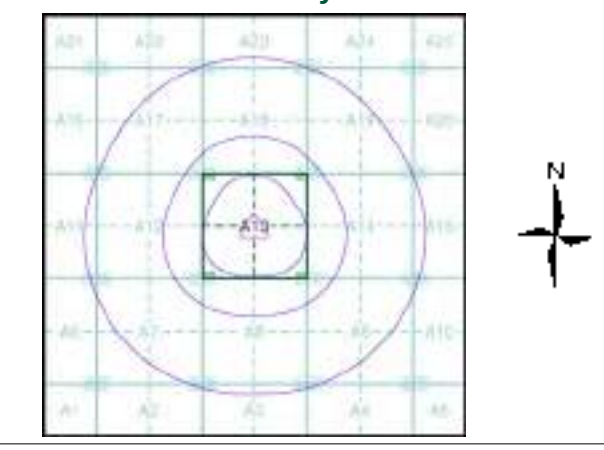
**Estimated Soil Chemistry Arsenic - Slice A**

Arsenic Concentrations mg/kg

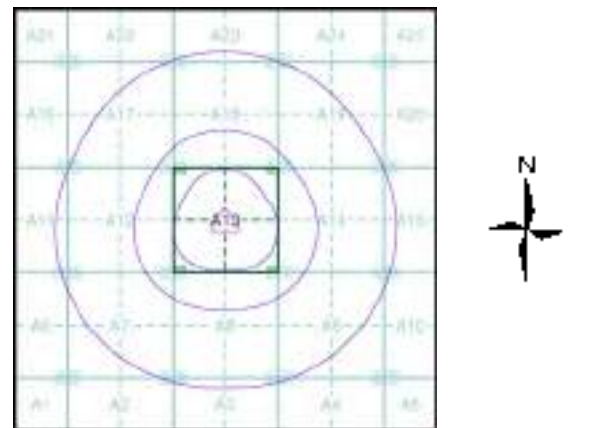
## Estimated Soil Chemistry Cadmium - Slice A

Cadmium Concentrations mg/kg

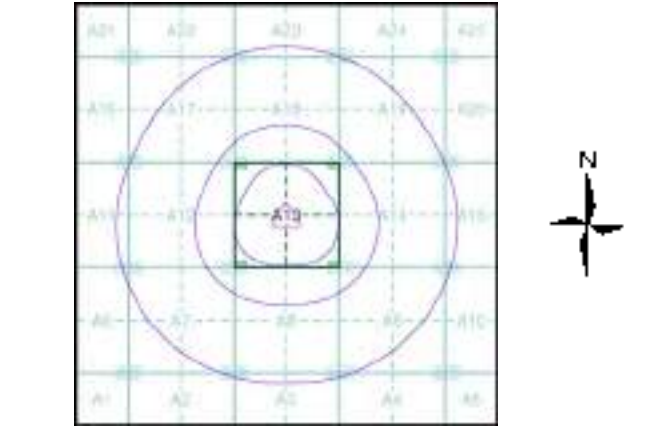
**Estimated Soil Chemistry Chromium - Slice A**

Chromium Concentrations mg/kg

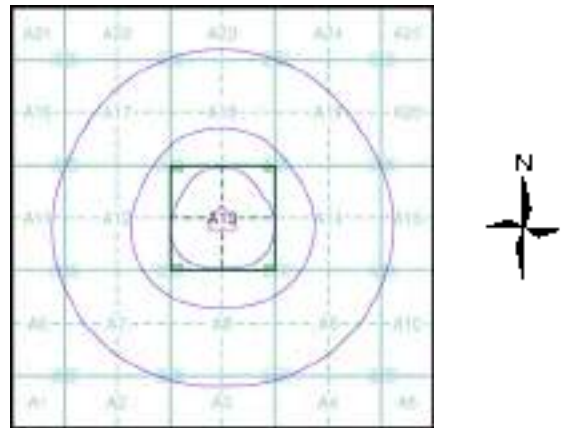
**Estimated Soil Chemistry Lead - Slice A**

Lead Concentrations mg/kg

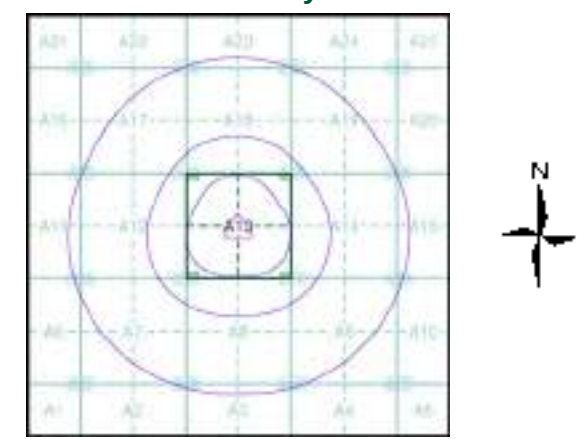
**Estimated Soil Chemistry Nickel - Slice A**

Nickel Concentrations mg/kg

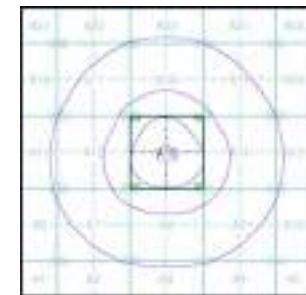
### Site Sensitivity Context Map - Slice A

- High Vulnerability, Principal Aquifer
- High Vulnerability, Secondary Aquifer
- Medium Vulnerability, Principal Aquifer
- Medium Vulnerability, Secondary Aquifer
- Low Vulnerability, Principal Aquifer
- Low Vulnerability, Secondary Aquifer

- Unproductive Aquifer
- Soluble Rock
