**Site plan**

Sports Pavilion

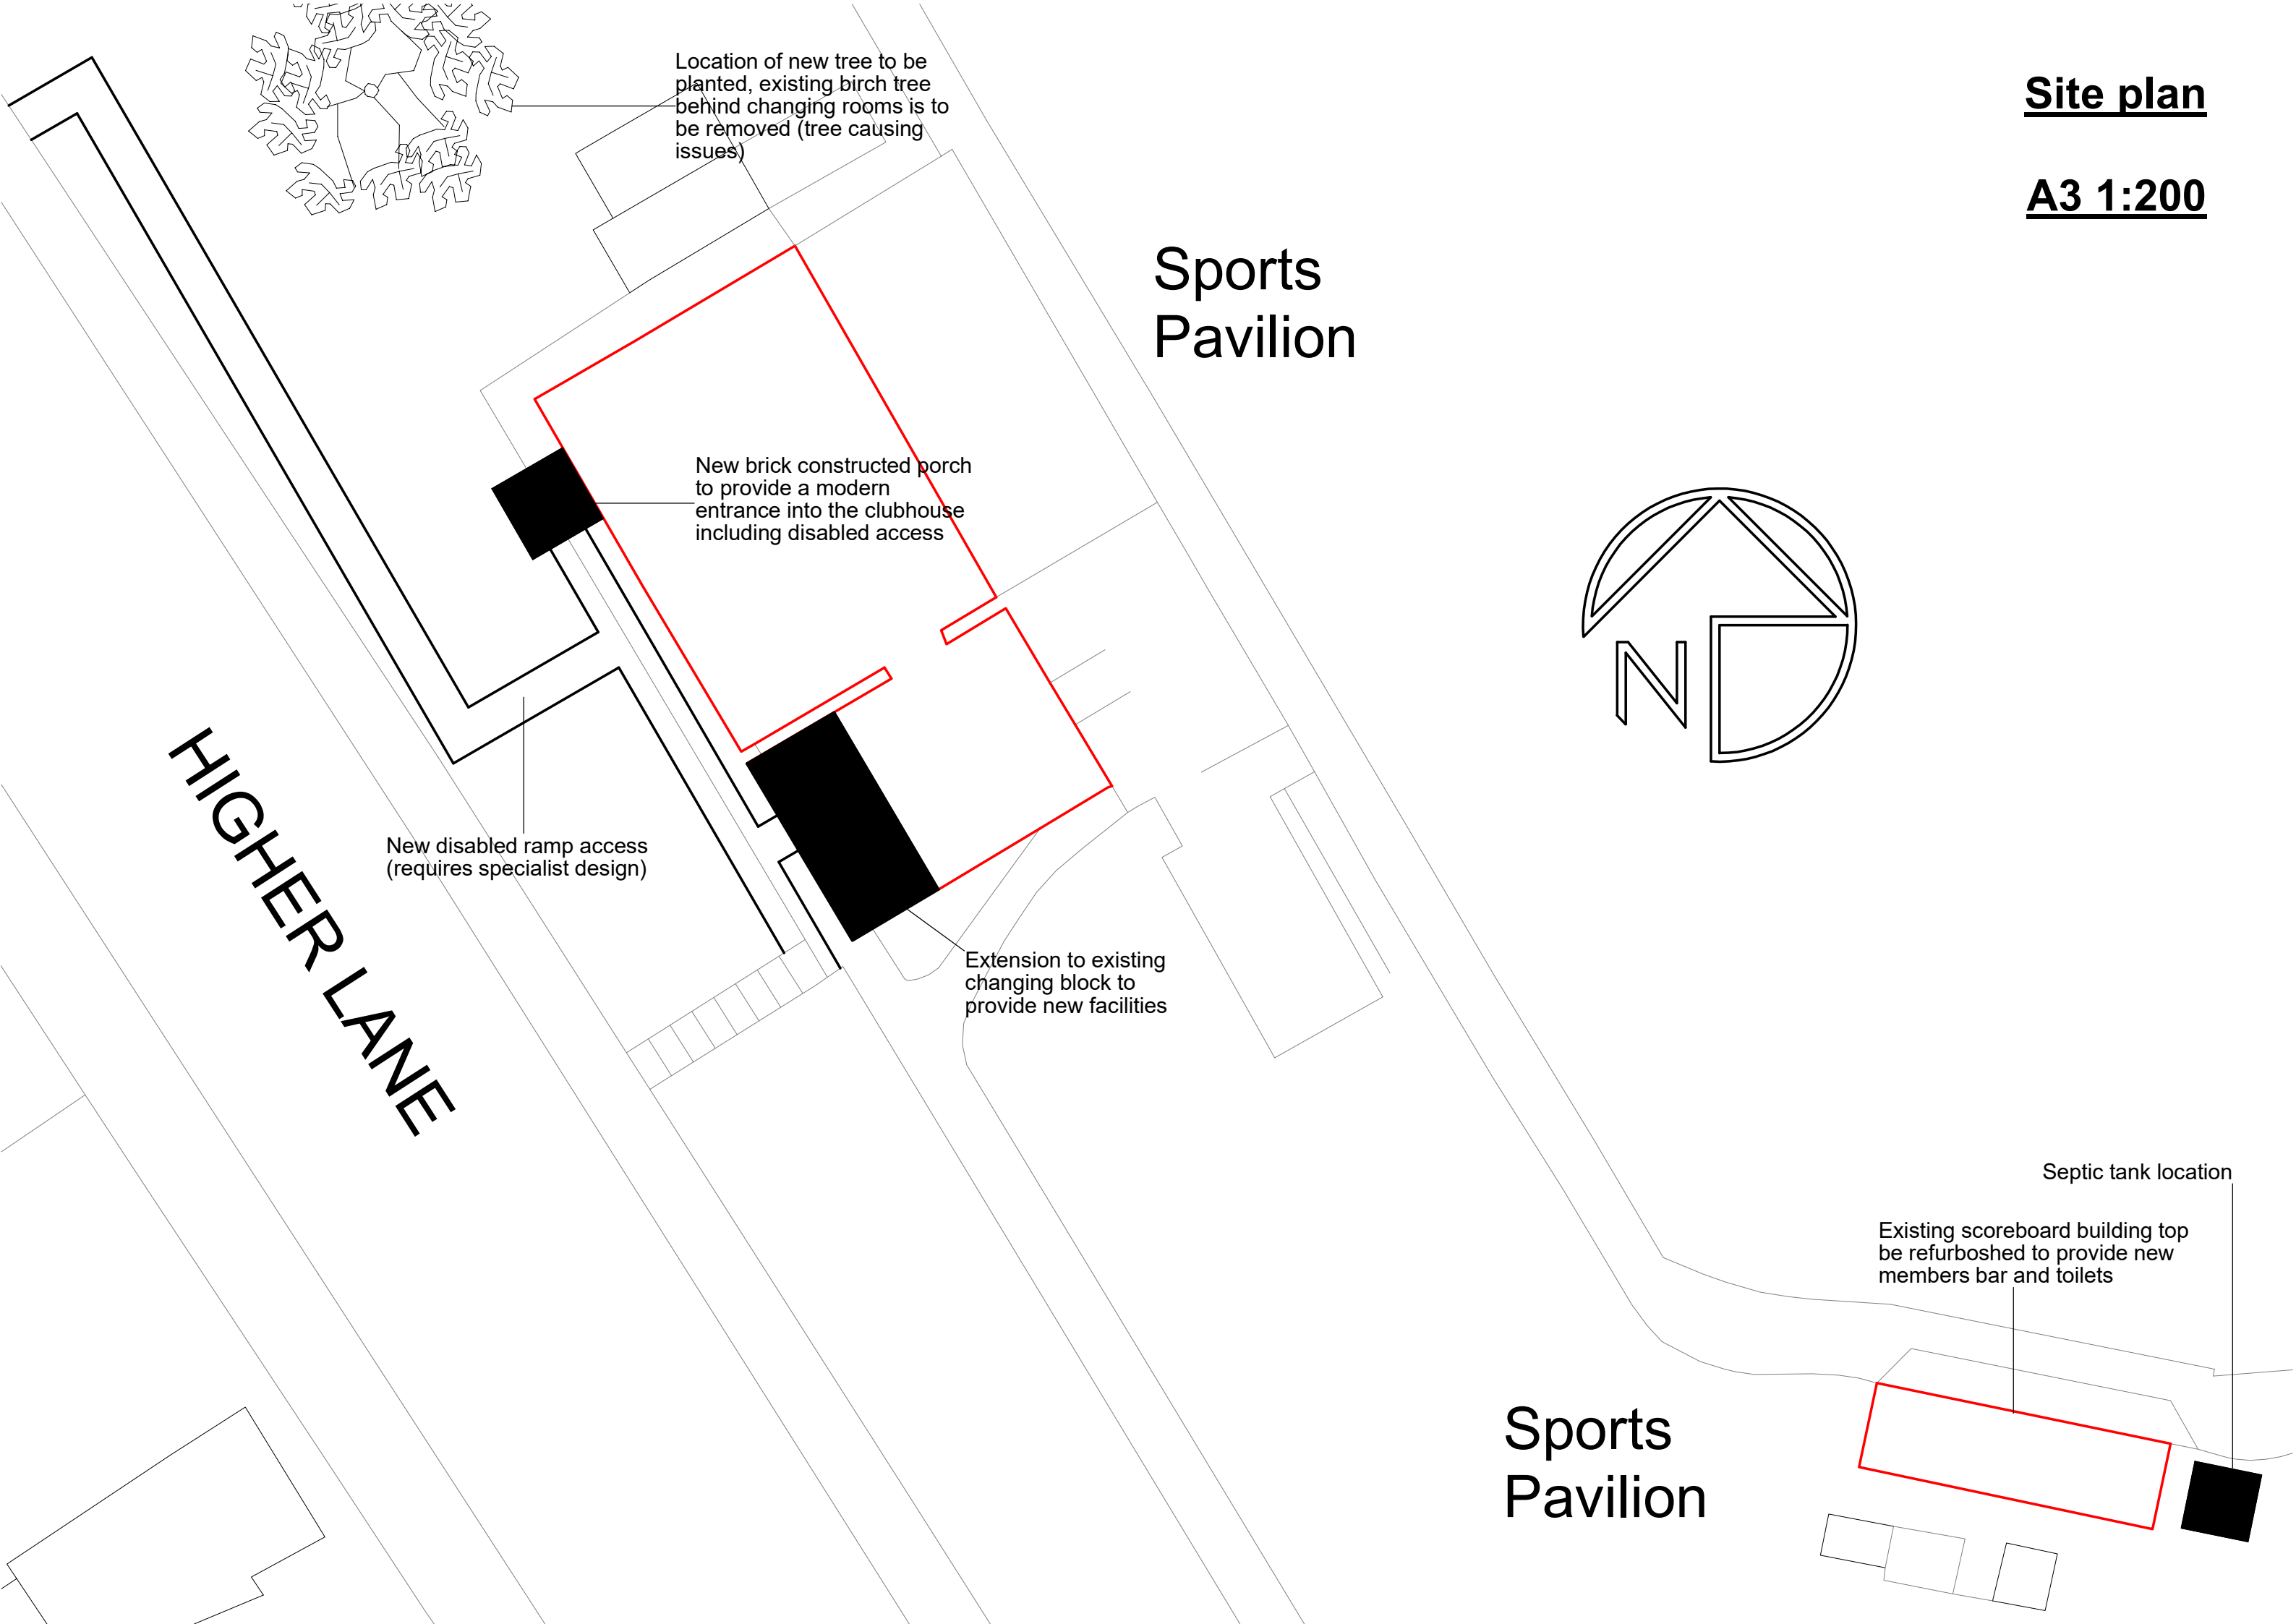
Location of new tree to be planted, existing birch tree behind changing rooms is to be removed (tree causing issues)

New brick constructed porch to provide a modern entrance into the clubhouse including disabled access

New disabled ramp access (requires specialist design)

Extension to existing changing block to provide new facilities

Septic tank location

Existing scoreboard building top be refurbished to provide new members bar and toilets
