# ARBORICULTURAL IMPLICATIONS ASSESSMENT

PROPOSED DEVELOPMENT

SHAUNINGS COTTAGE  
HAWKSHAW

Author: C. Salisbury  
Date: 30 October 2024  
Ref: TRE/SCH/Rev B

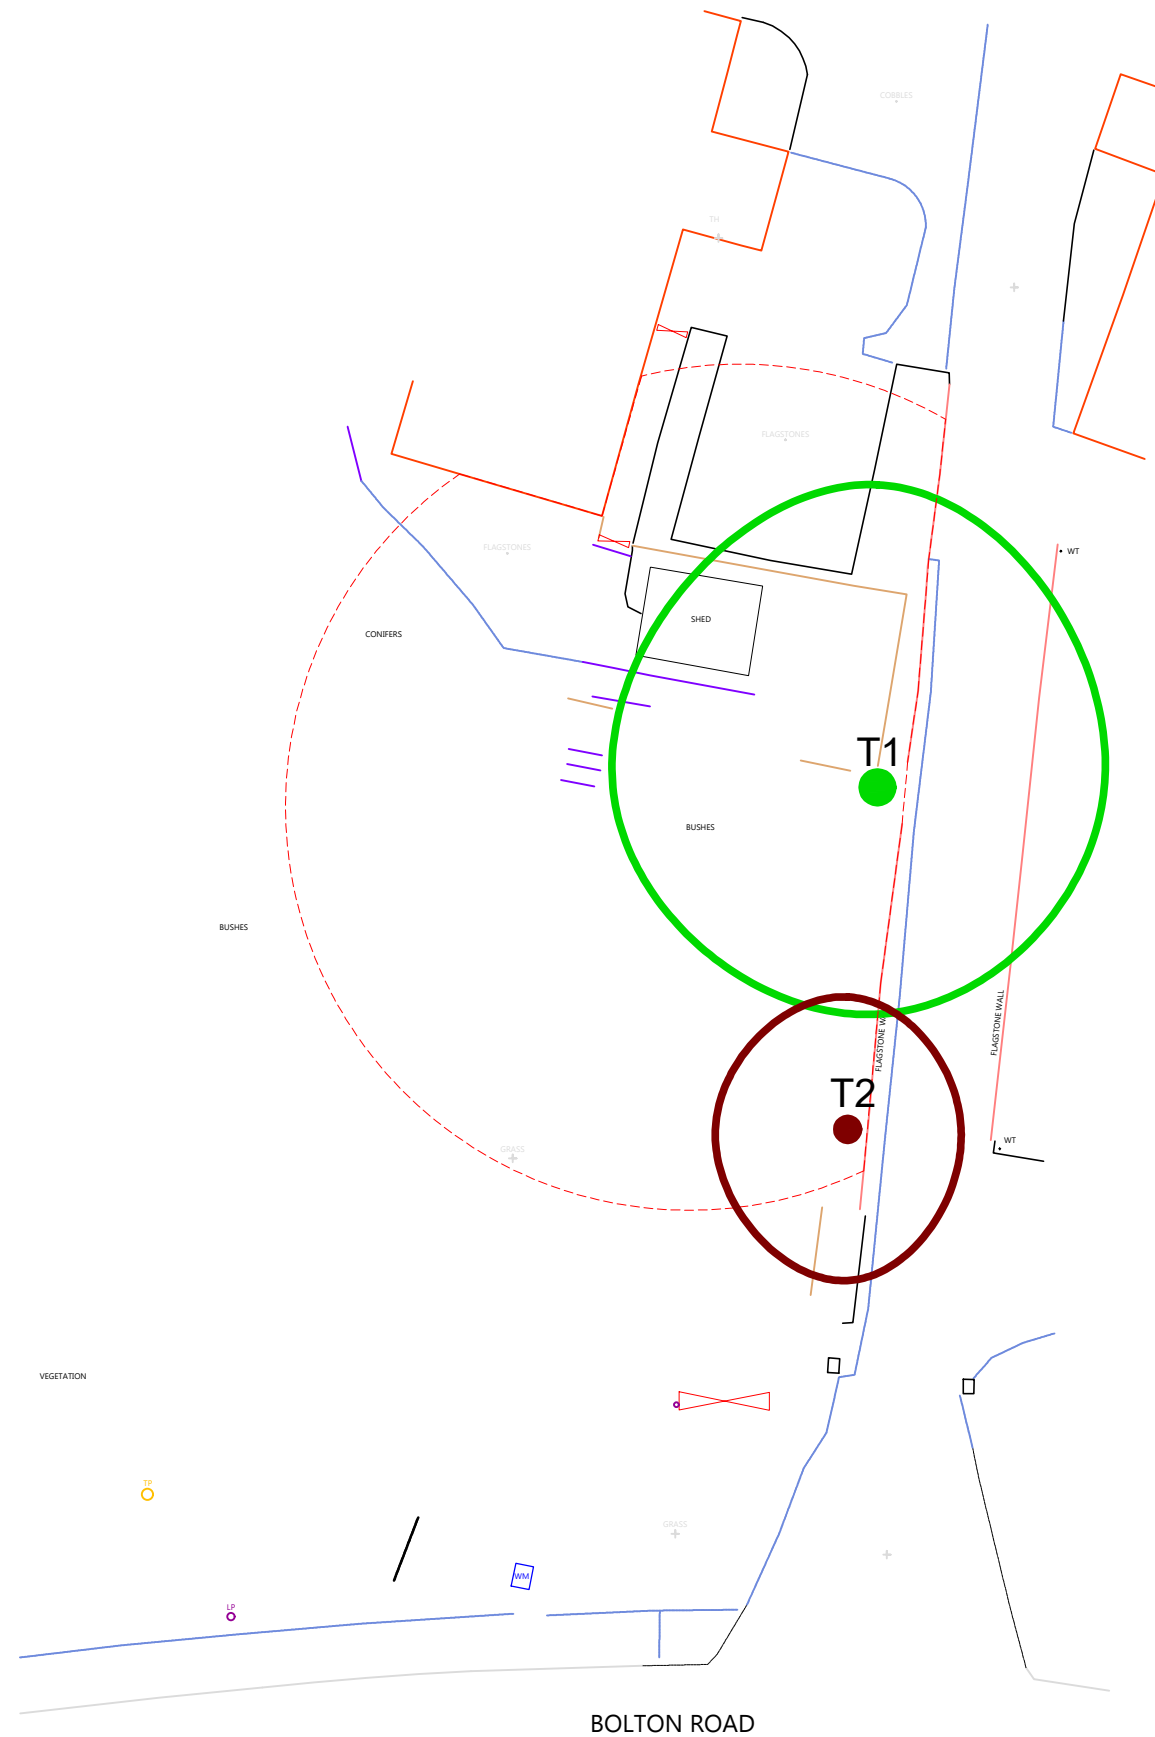
Drawing No:  
SCH/BS/01

Root protection area

Drawing Title:  
BS5837 Plan

- 2.1 The trees were surveyed (prefixed T, or G for group) and recorded in the tree schedule in appendix one. Where groups are recorded, average height and diameter at breast height (DBH) of the trees in the group are reported. Where access to the base of any trees was limited, stem size was estimated.
- 2.2 All the trees were assessed using: a grading A to C (retention) and U (removal); condition and age class as defined in appendix two.
- 2.3 Where appropriate, canopy spread for each tree was recorded at four cardinal points in order to reproduce an accurate representation of the crown shape of the tree on the tree plan in appendix three.
- 2.4 The survey included all trees within the proposal area and trees near to the proposal.

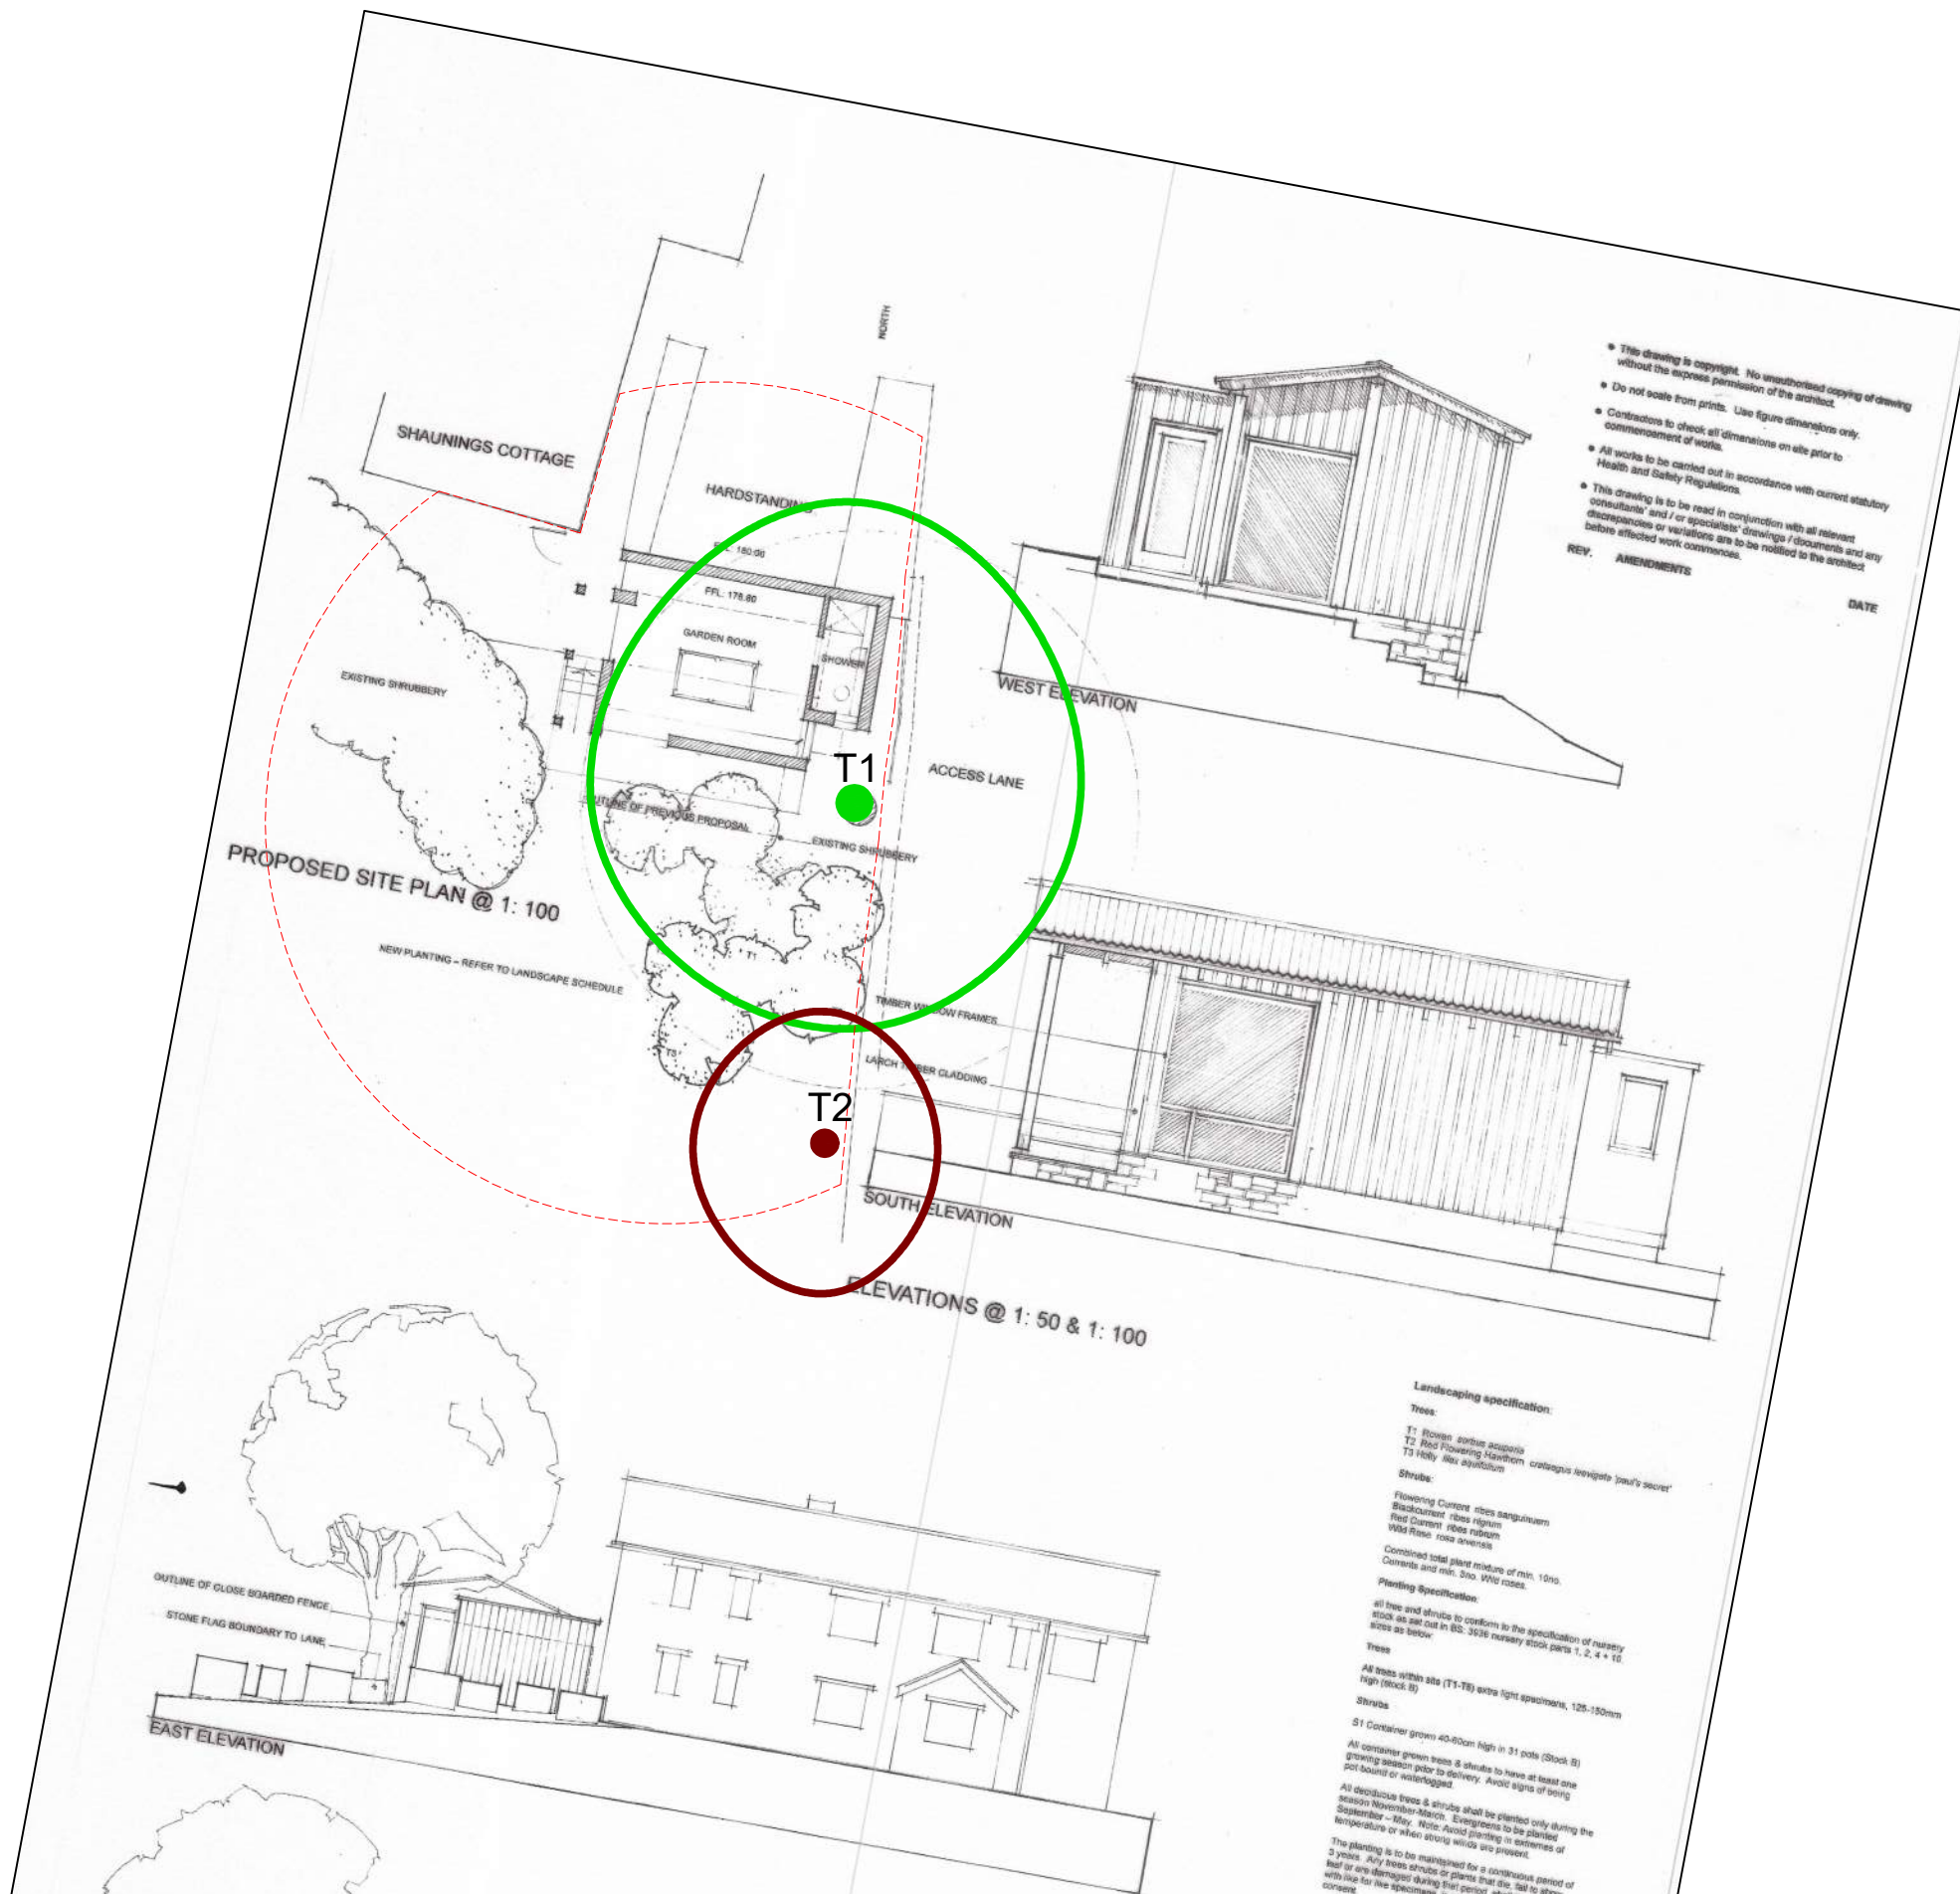
Drawing No:  
SCH/AIS/01 Rev B

Drawing Title:  
AIS Plan

- 3.1 Due to the proposed development and its associated infrastructure there are a number of locations where the proposals are in close proximity to the trees surveyed. The Site Layout Plan within appendix three identifies the trees in relation to the proposed development.
- 3.2 In order to fully assess the impact of the proposals an Impact Table has been created detailing each tree, which shows the proximity of the associated works to the tree.
- 3.3 This can then be assessed in accordance with BS 5837:2012 to determine whether the development will have a detrimental impact on the health of each tree. Once this has been determined remedial measures can be detailed to reduce the impact the proposals will have on the treescape.

5.1.1 The garden room is to be located on an area of made-up ground which had been created to provide a flat patio area. The subbase of the patio offers little in the way of structure to allow for suitable root encroachment.

5.1.2 It is therefore proposed that the patio and subbase will be removed by hand and tracked machinery only back to the original ground/soil levels. The garden room will then be located on the existing levels with only minimal excavation works in localised areas, if required, to provide a level surface.
