Arboricultural  
Impact Assessment  
with  
Arboricultural Method Statement

**Woodbank Primary School  
Brandlesholme Road  
Bury  
BL8 1AX**

Project No. AIA.13733.01

21<sup>st</sup> November 2023

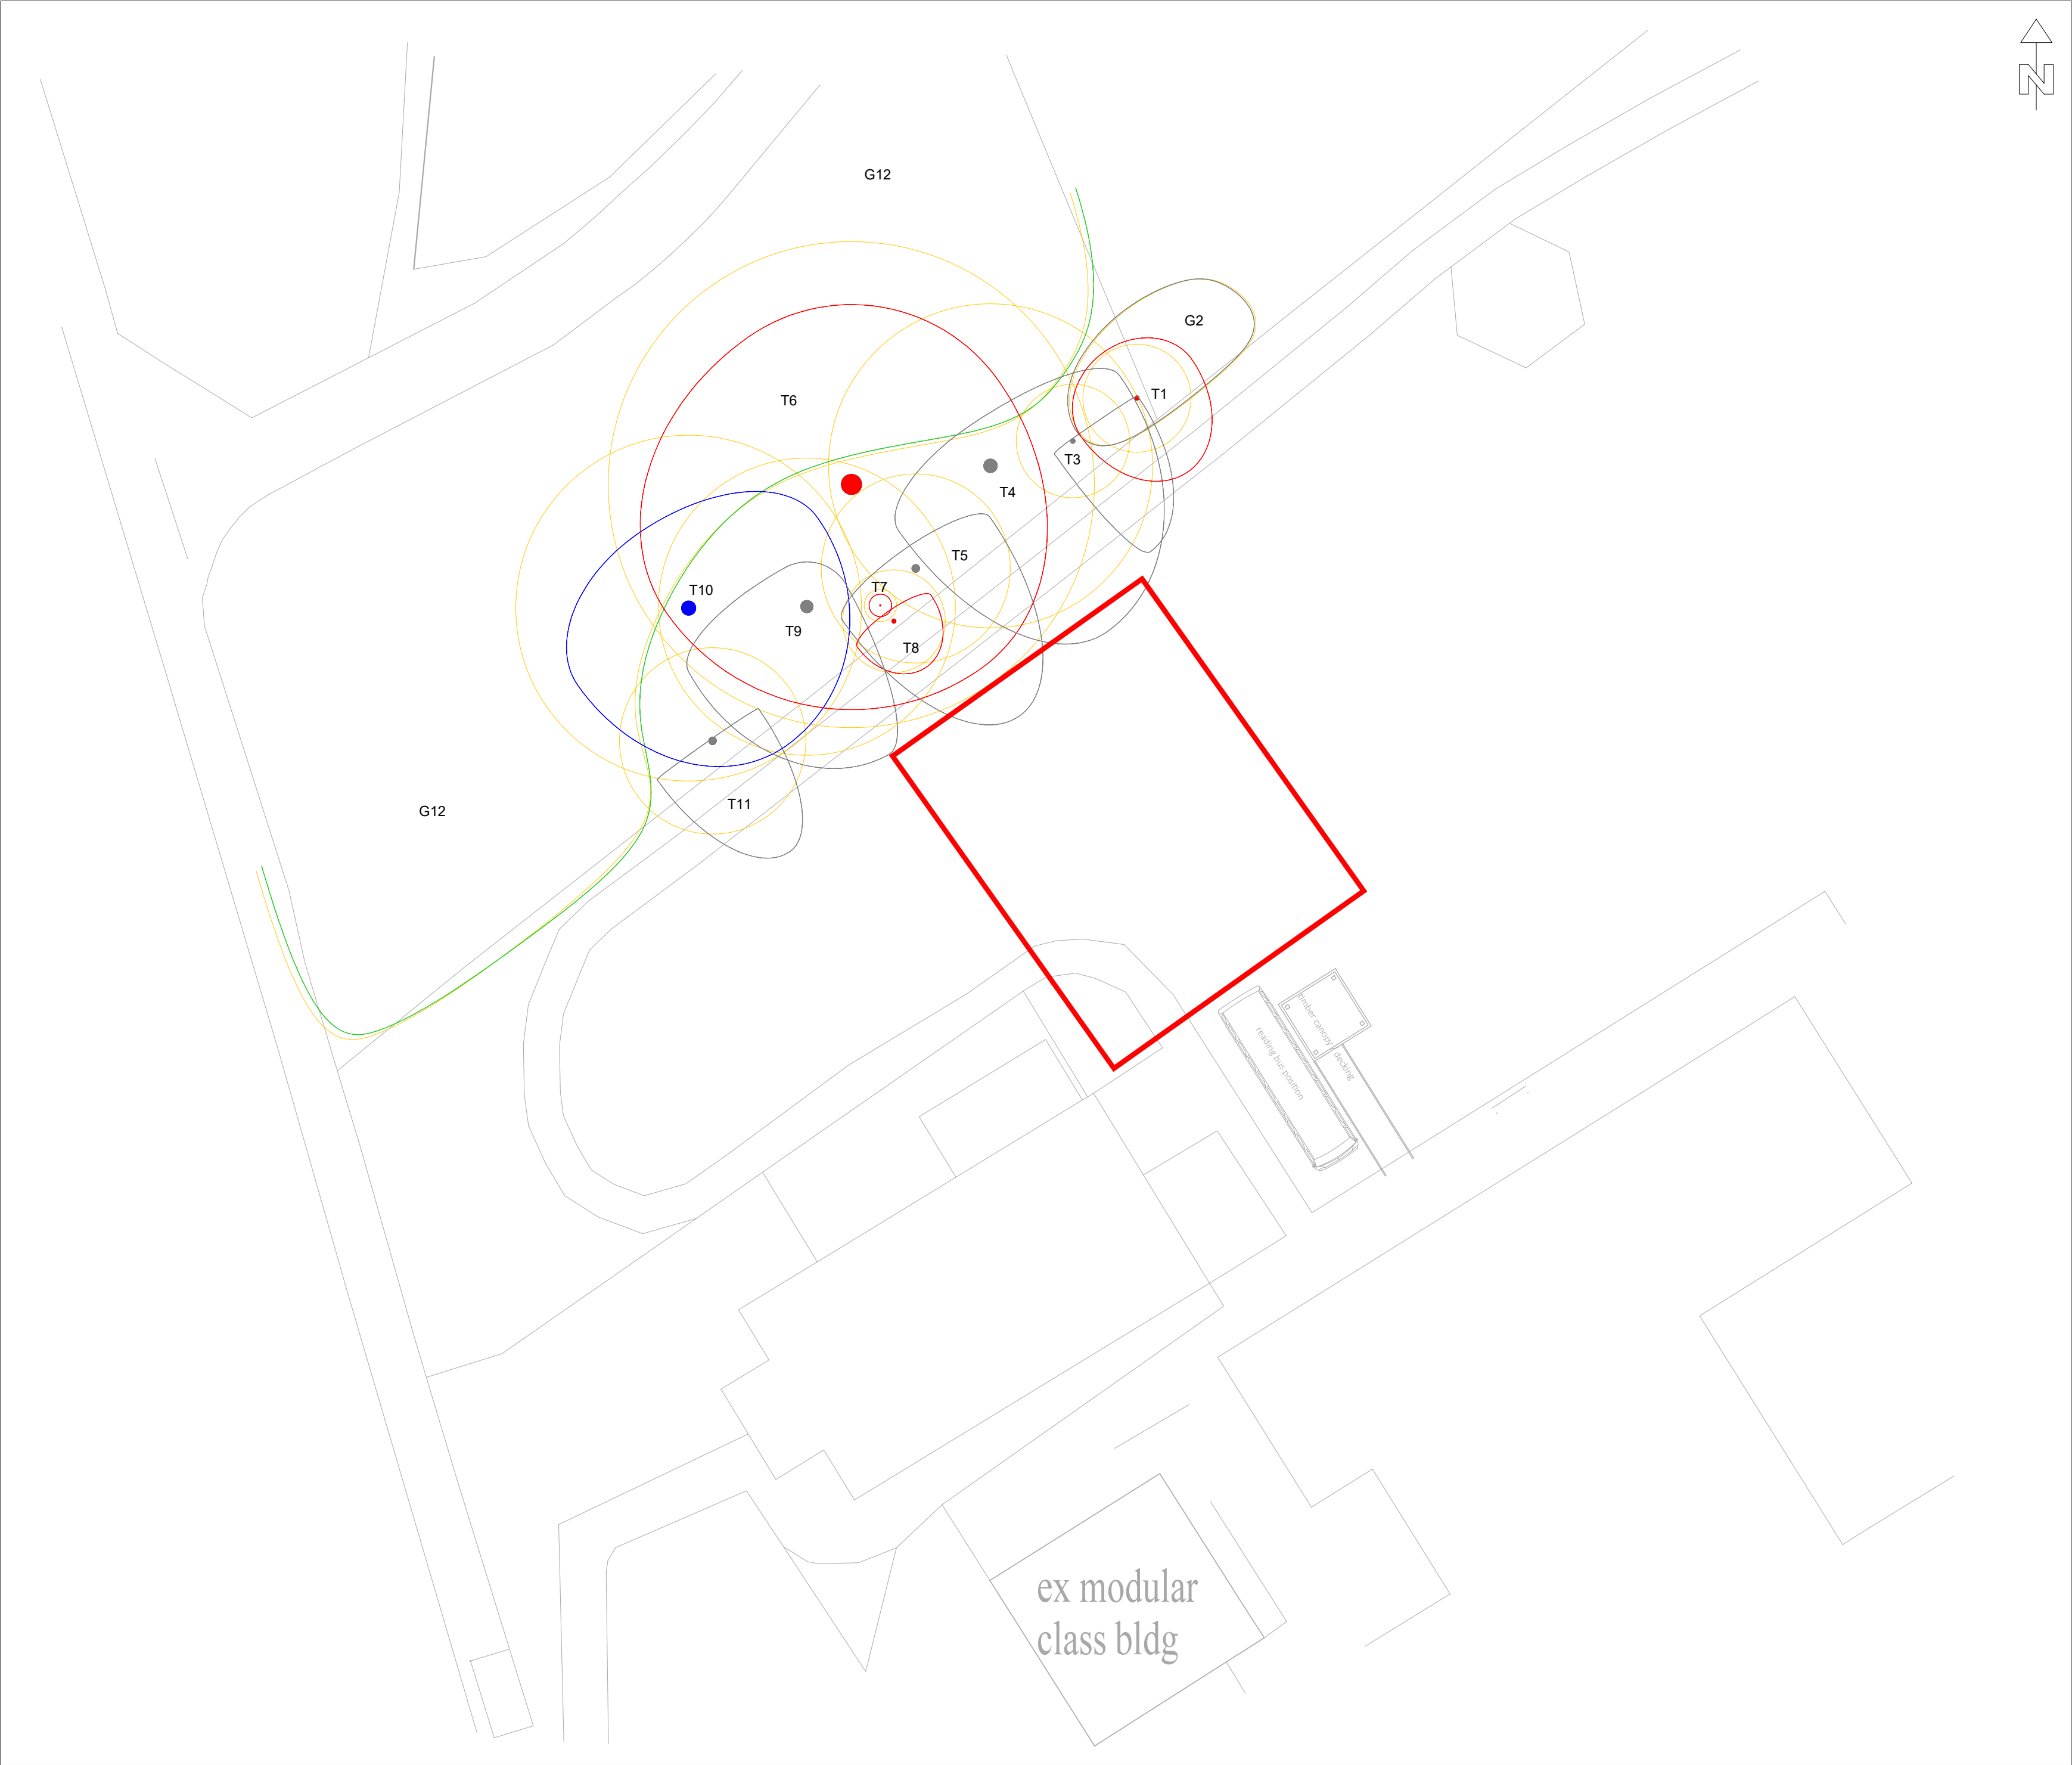
## Drawing 1. Tree Constraints Plan

2.2.1. Please see *Appendix 1* for the detailed list of existing species, age class, dimensions and condition of trees within the site, and *Appendix 2* for an explanation of retention category criteria. Tree locations can be seen on the *Tree Constraints Plan* at the rear of this report (*Drawing 1*).

- 2.3.1. The tree Root Protection Area (RPA) is a layout design tool indicating the area around a tree that, along with the tree stem and branches, must be considered during development. The protection of the roots and soil structure within the RPA should be treated as a priority. The RPA of each tree or group is marked on the *Tree Constraints Plan* at the rear of this report.

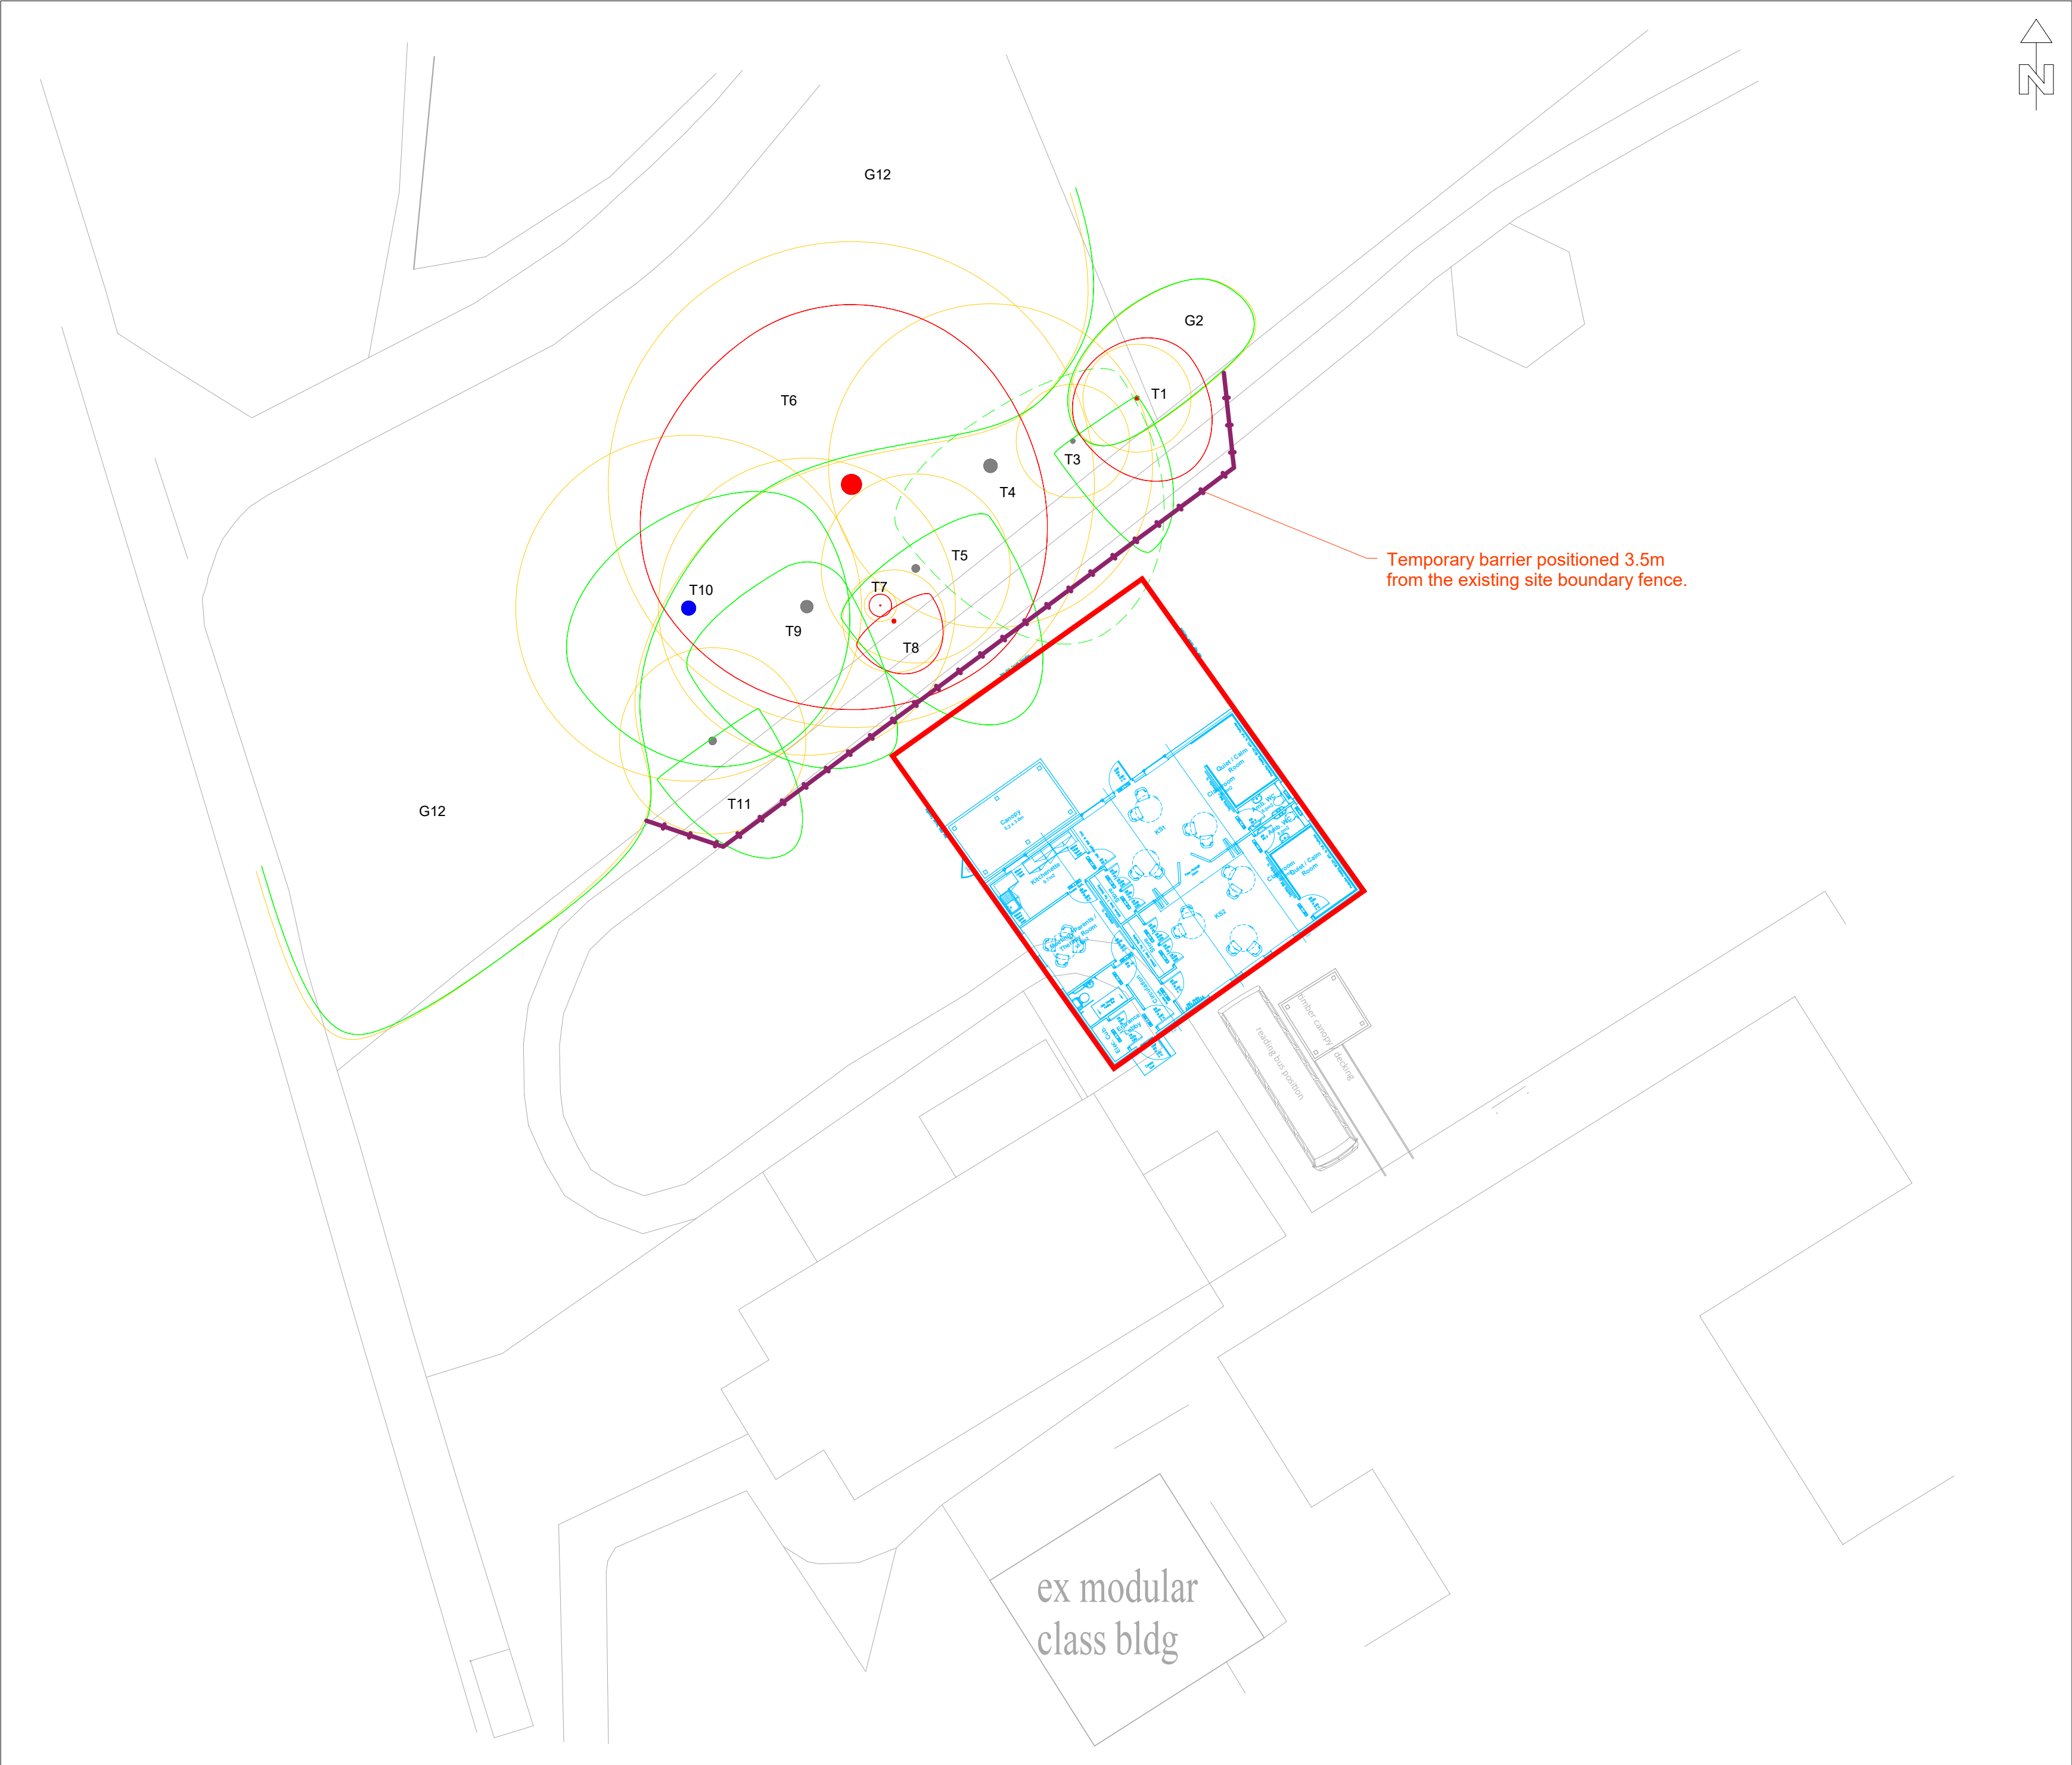
## Drawing 2. Tree Protection Plan

- 3.1.1. A new SEN modular building with an associated enclosed play area proposed. The proposed layout drawing can be seen within the *Tree Protection Plan* to the rear of this report. This drawing has been used to assess the potential direct and indirect arboricultural impacts.

T4

T1, T6, T7 & T8

None

- 4.2.3. Please see *Appendix 4* for suggested barrier construction detail. It is recommended that in this instance the protective barrier shown in *Figure 1* would be appropriate. The suggested location for protective fencing is shown on the *Tree Protection Plan (Drawing 2)*.
