# ARBORICULTURAL IMPLICATIONS ASSESSMENT

Stand Golf Club  
Ashbourne Grove  
Bury  
Sites A

Author: C. Salisbury  
Date: 05 November 2025  
Ref: TRE/SGCAGBSA/Rev C

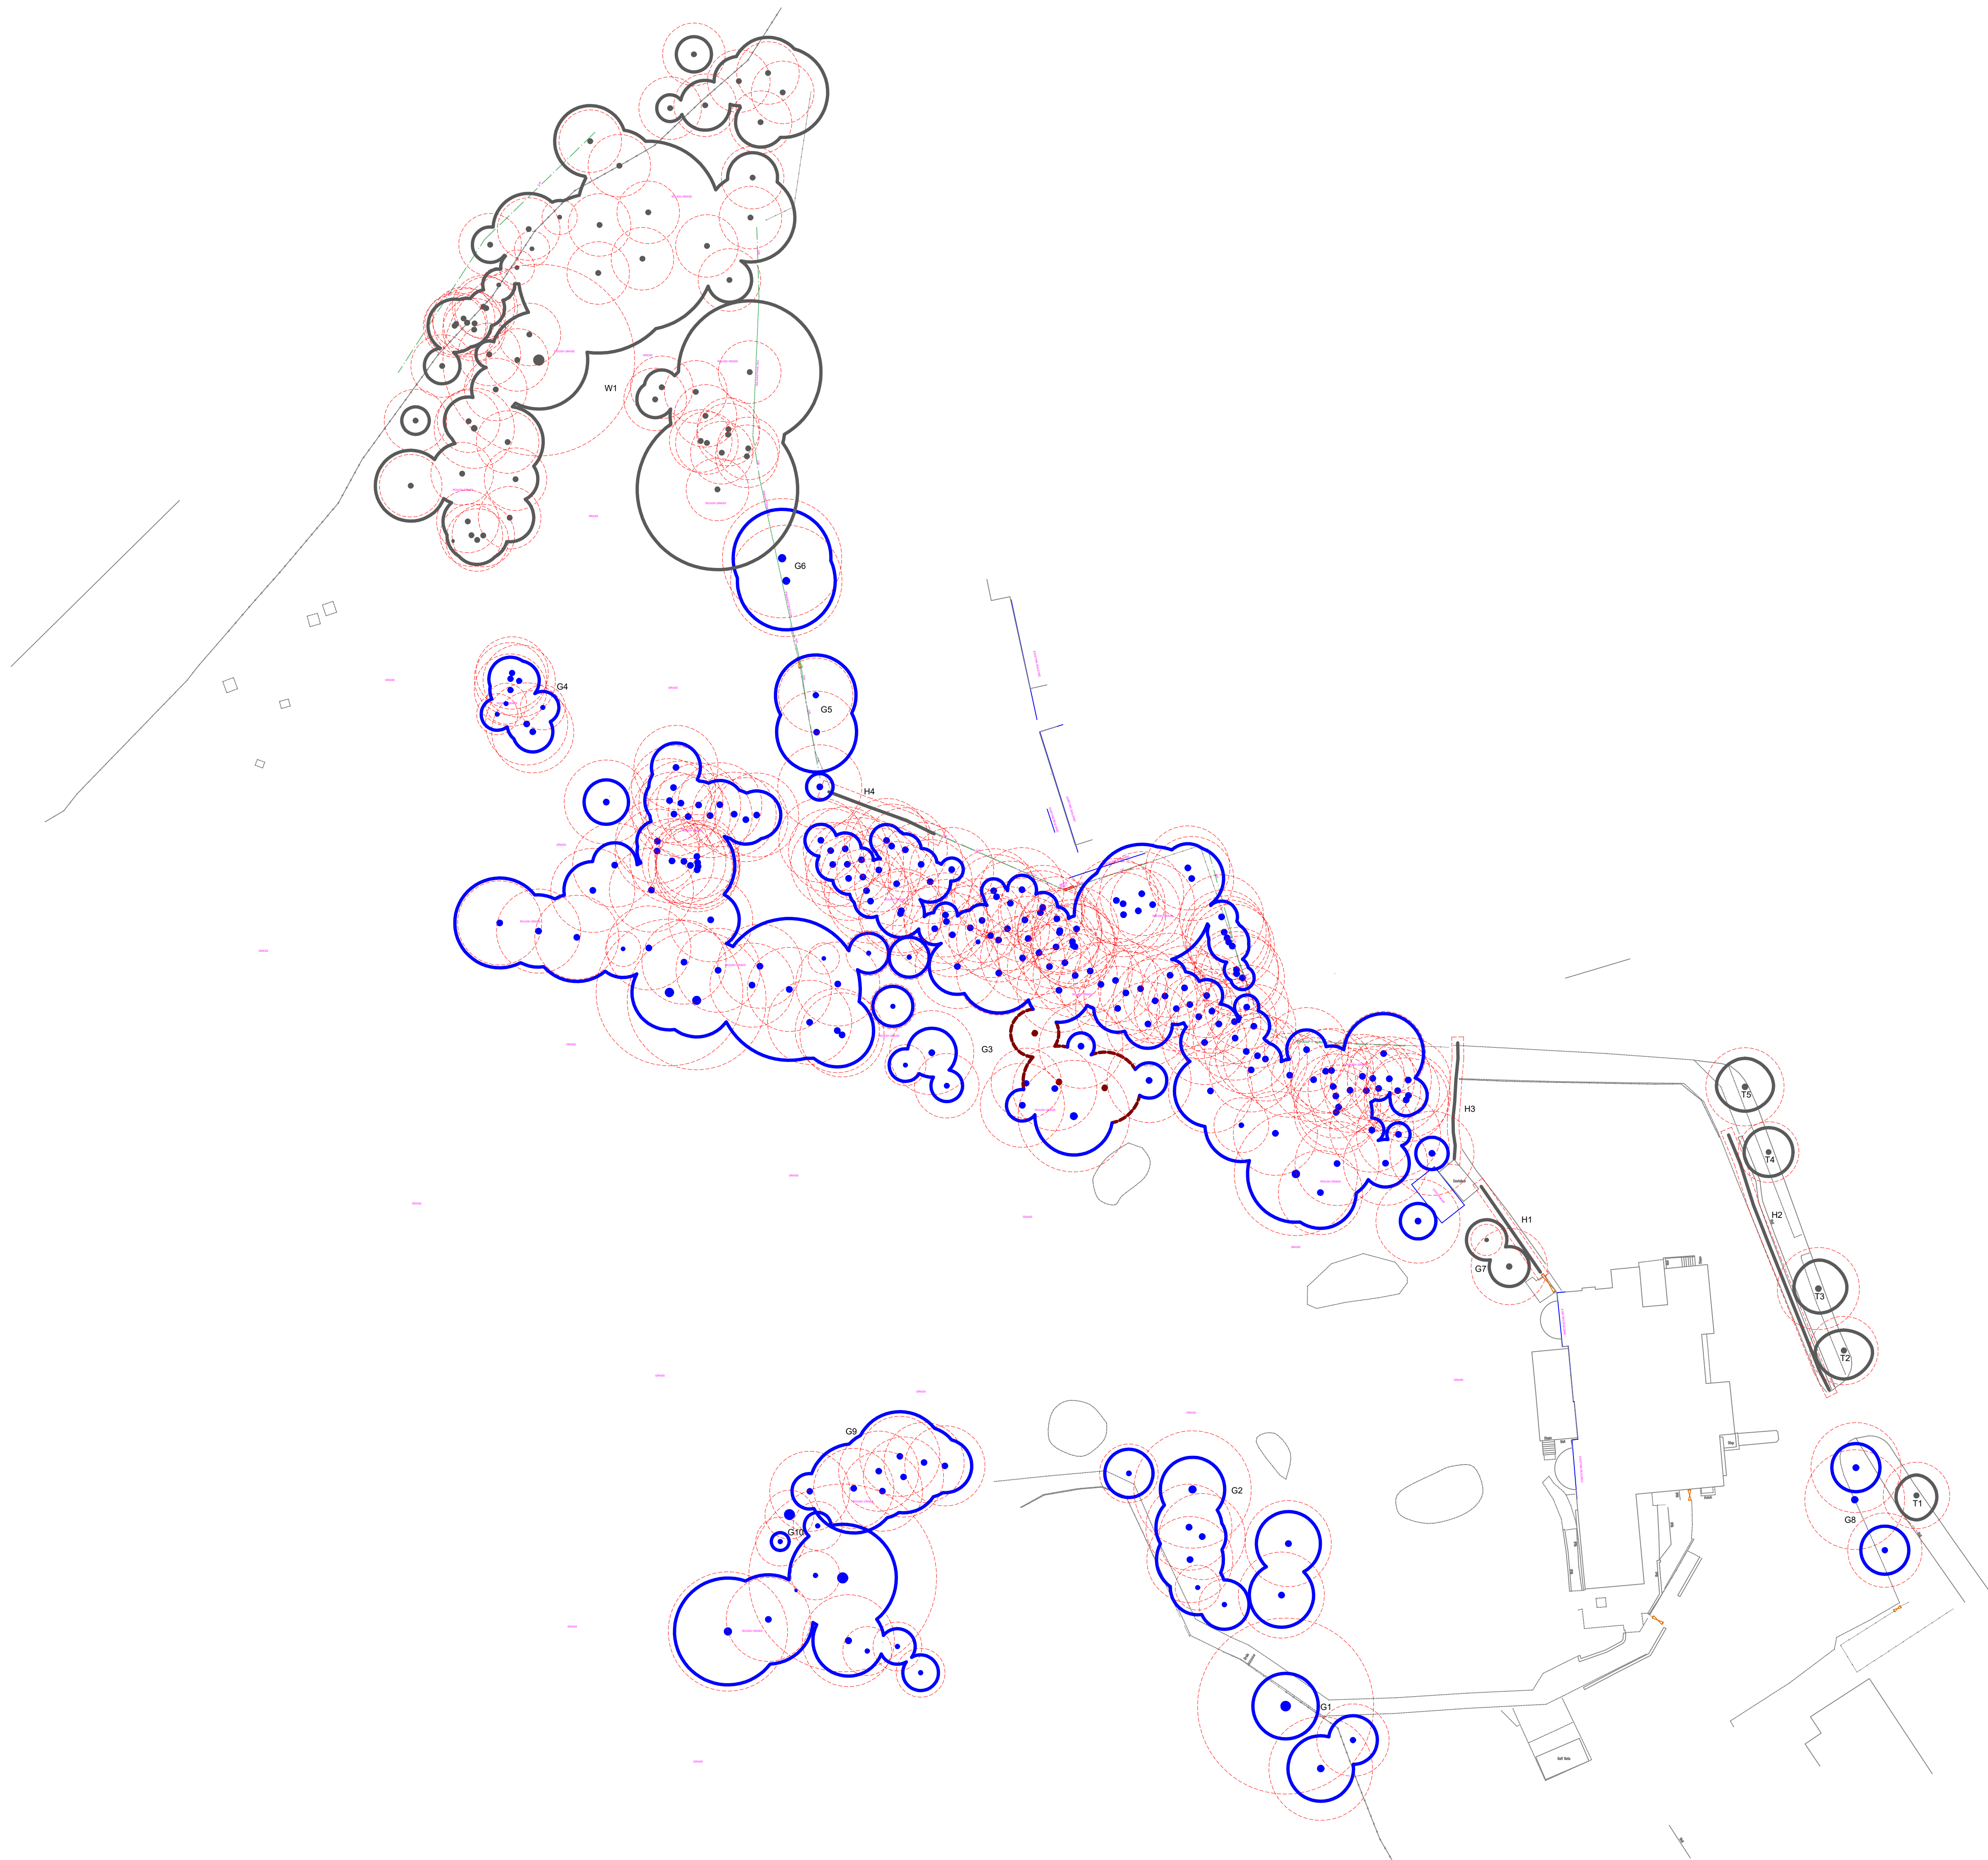
Drawing Title:  
BS5837 Plan

Root protection area

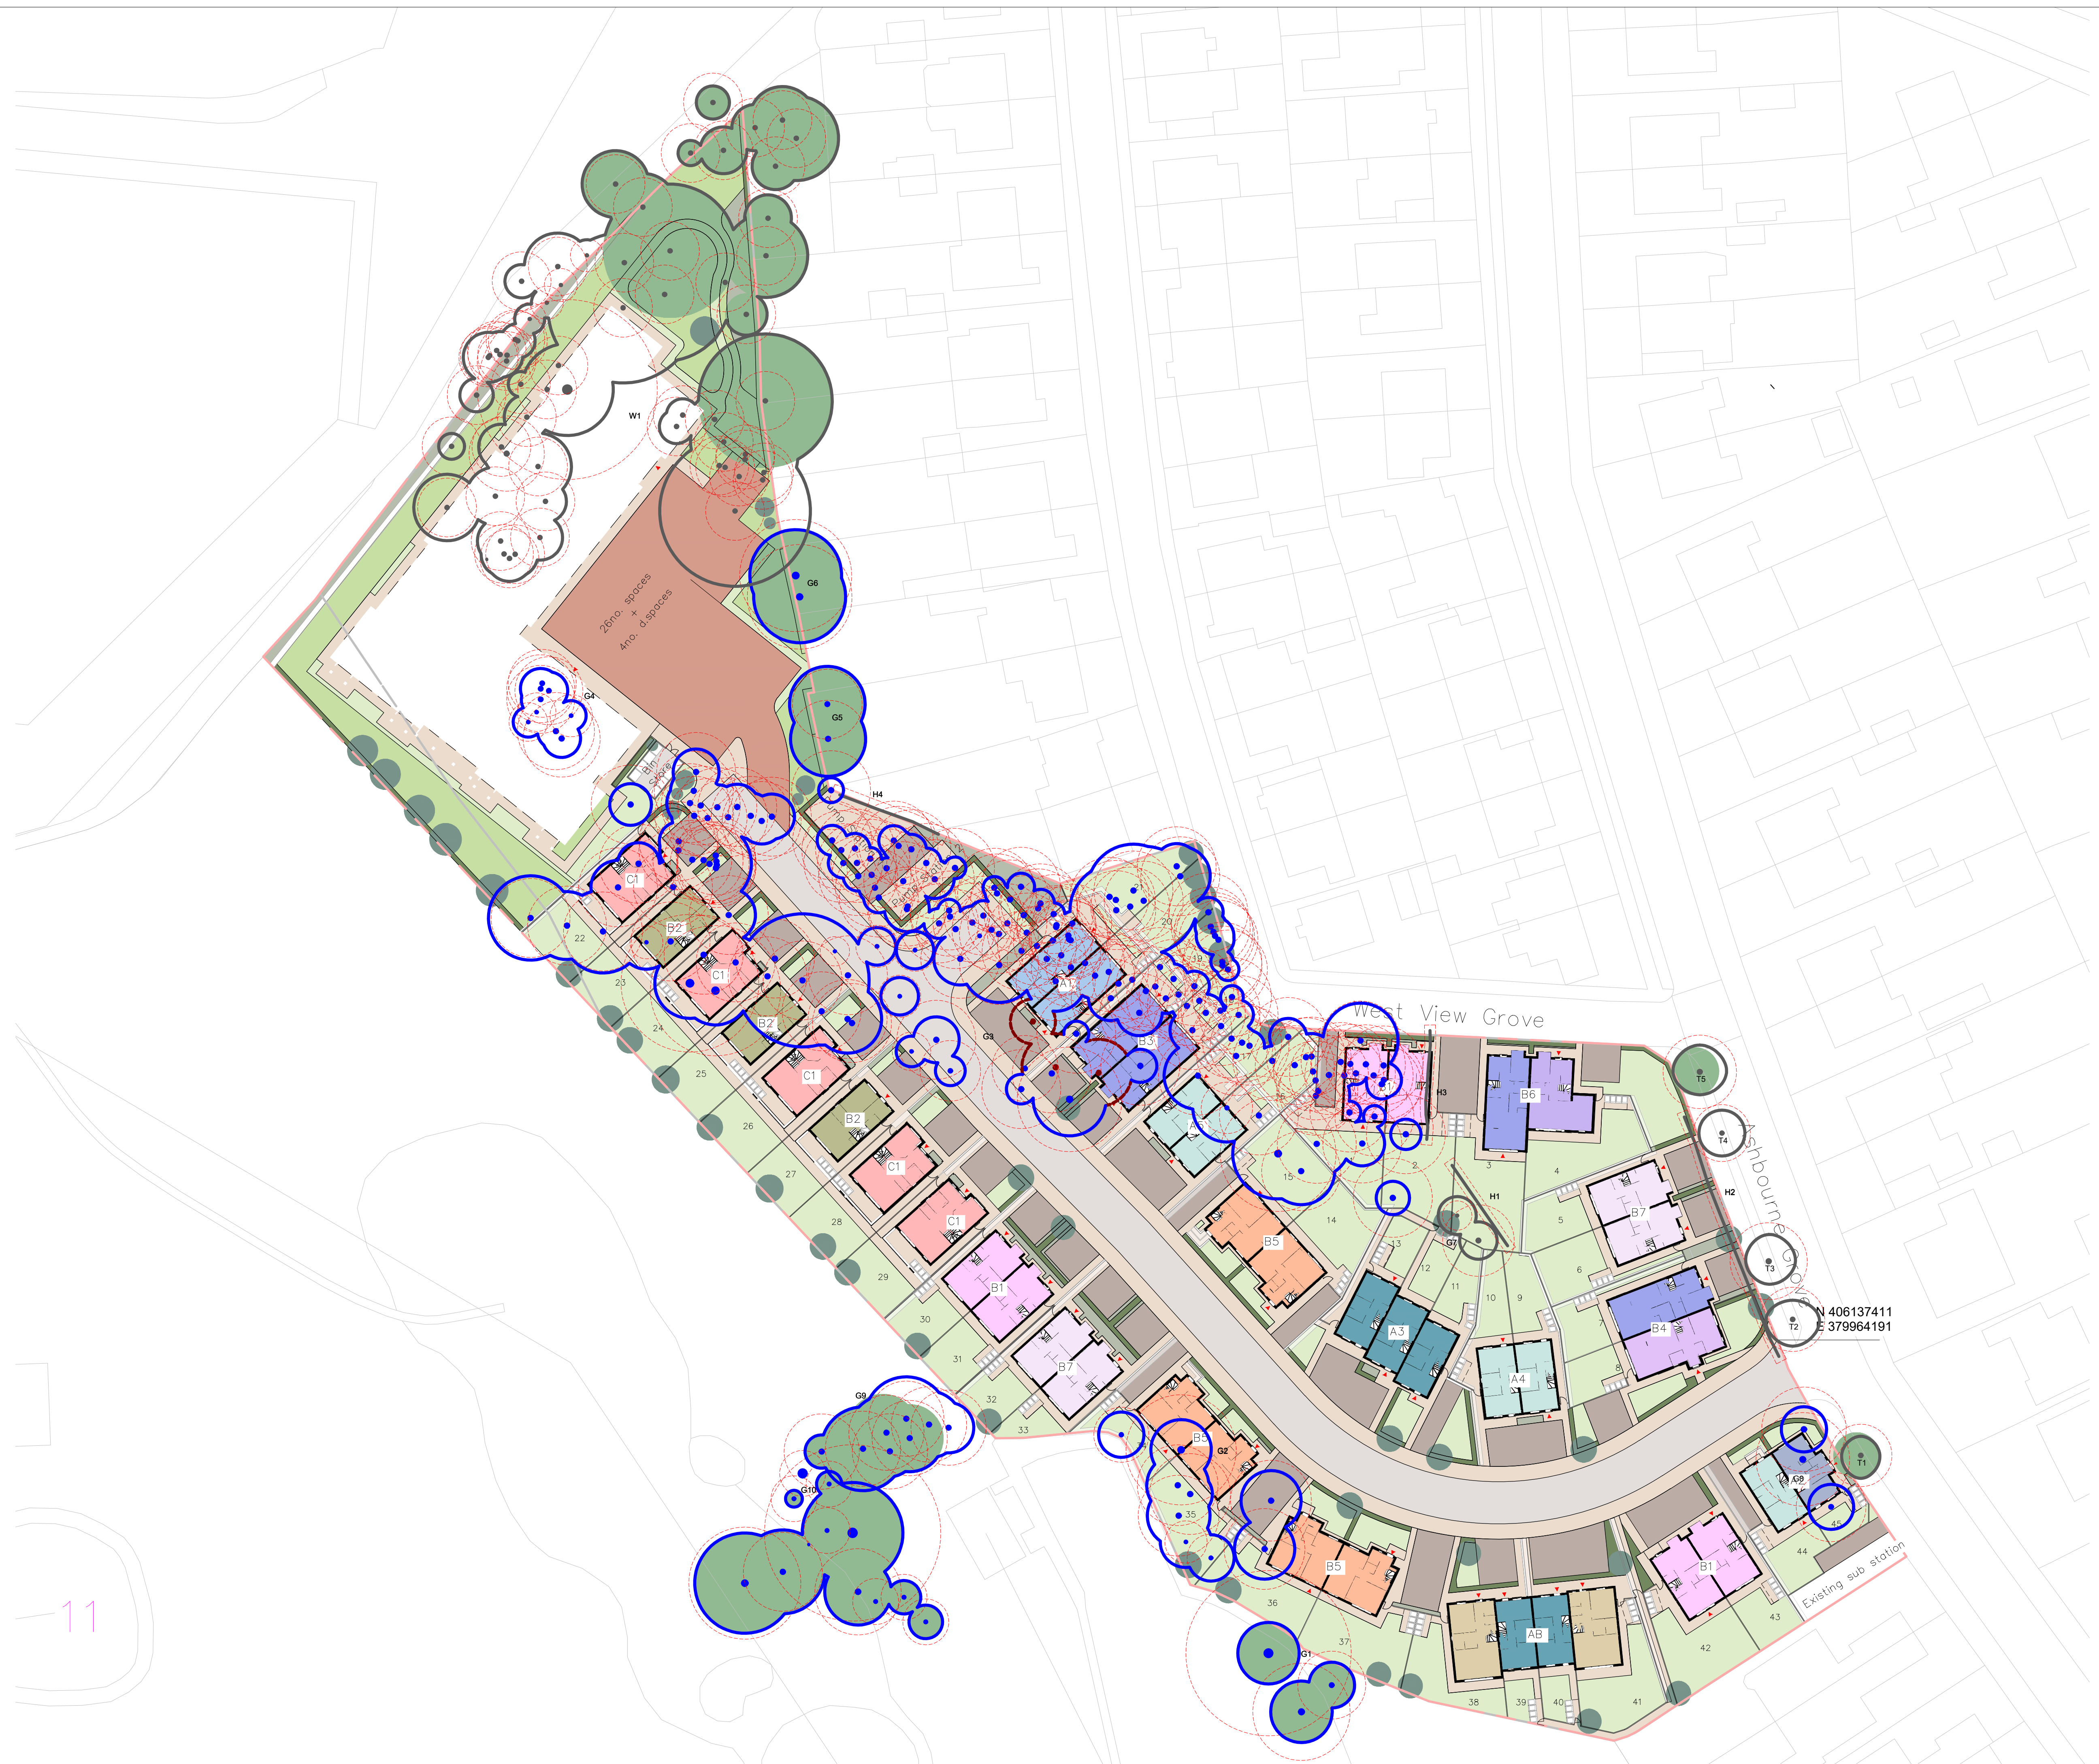
Drawing Title:  
AIS Plan

- 3.1 Due to the proposed development and its associated infrastructure there are a number of locations where the proposals are in close proximity to the trees surveyed. The Site Layout Plan within appendix three identifies the trees in relation to the proposed development.
- 3.2 In order to fully assess the impact of the proposals an Impact Table has been created detailing each tree, which shows the proximity of the associated works to the tree.
- 3.3 This can then be assessed in accordance with BS 5837:2012 to determine whether the development will have a detrimental impact on the health of each tree. Once this has been determined remedial measures can be detailed to reduce the impact the proposals will have on the treescape.

5.2.1 The impact table below shows the proposed development having a minor encroachment into the root protection area of G1. It is felt that due to the species, condition and limited extent of encroachment the proposal will not have a detrimental impact on the safe useful life expectancy of these trees.

5.3.1 The impact table below shows the proposed car parking having a minor encroachment into the root protection area of G5. It is felt that due to the species, condition and limited extent of encroachment the proposal will not have a detrimental impact on the safe useful life expectancy of these trees.
