# ARBORICULTURAL IMPLICATIONS ASSESSMENT

PROPOSED DEVELOPMENT

STAND GOLF CLUB  
ASHBOURNE GROVE  
BURY  
SITES B

Ref: TRE/SGVAGBSB/Rev C

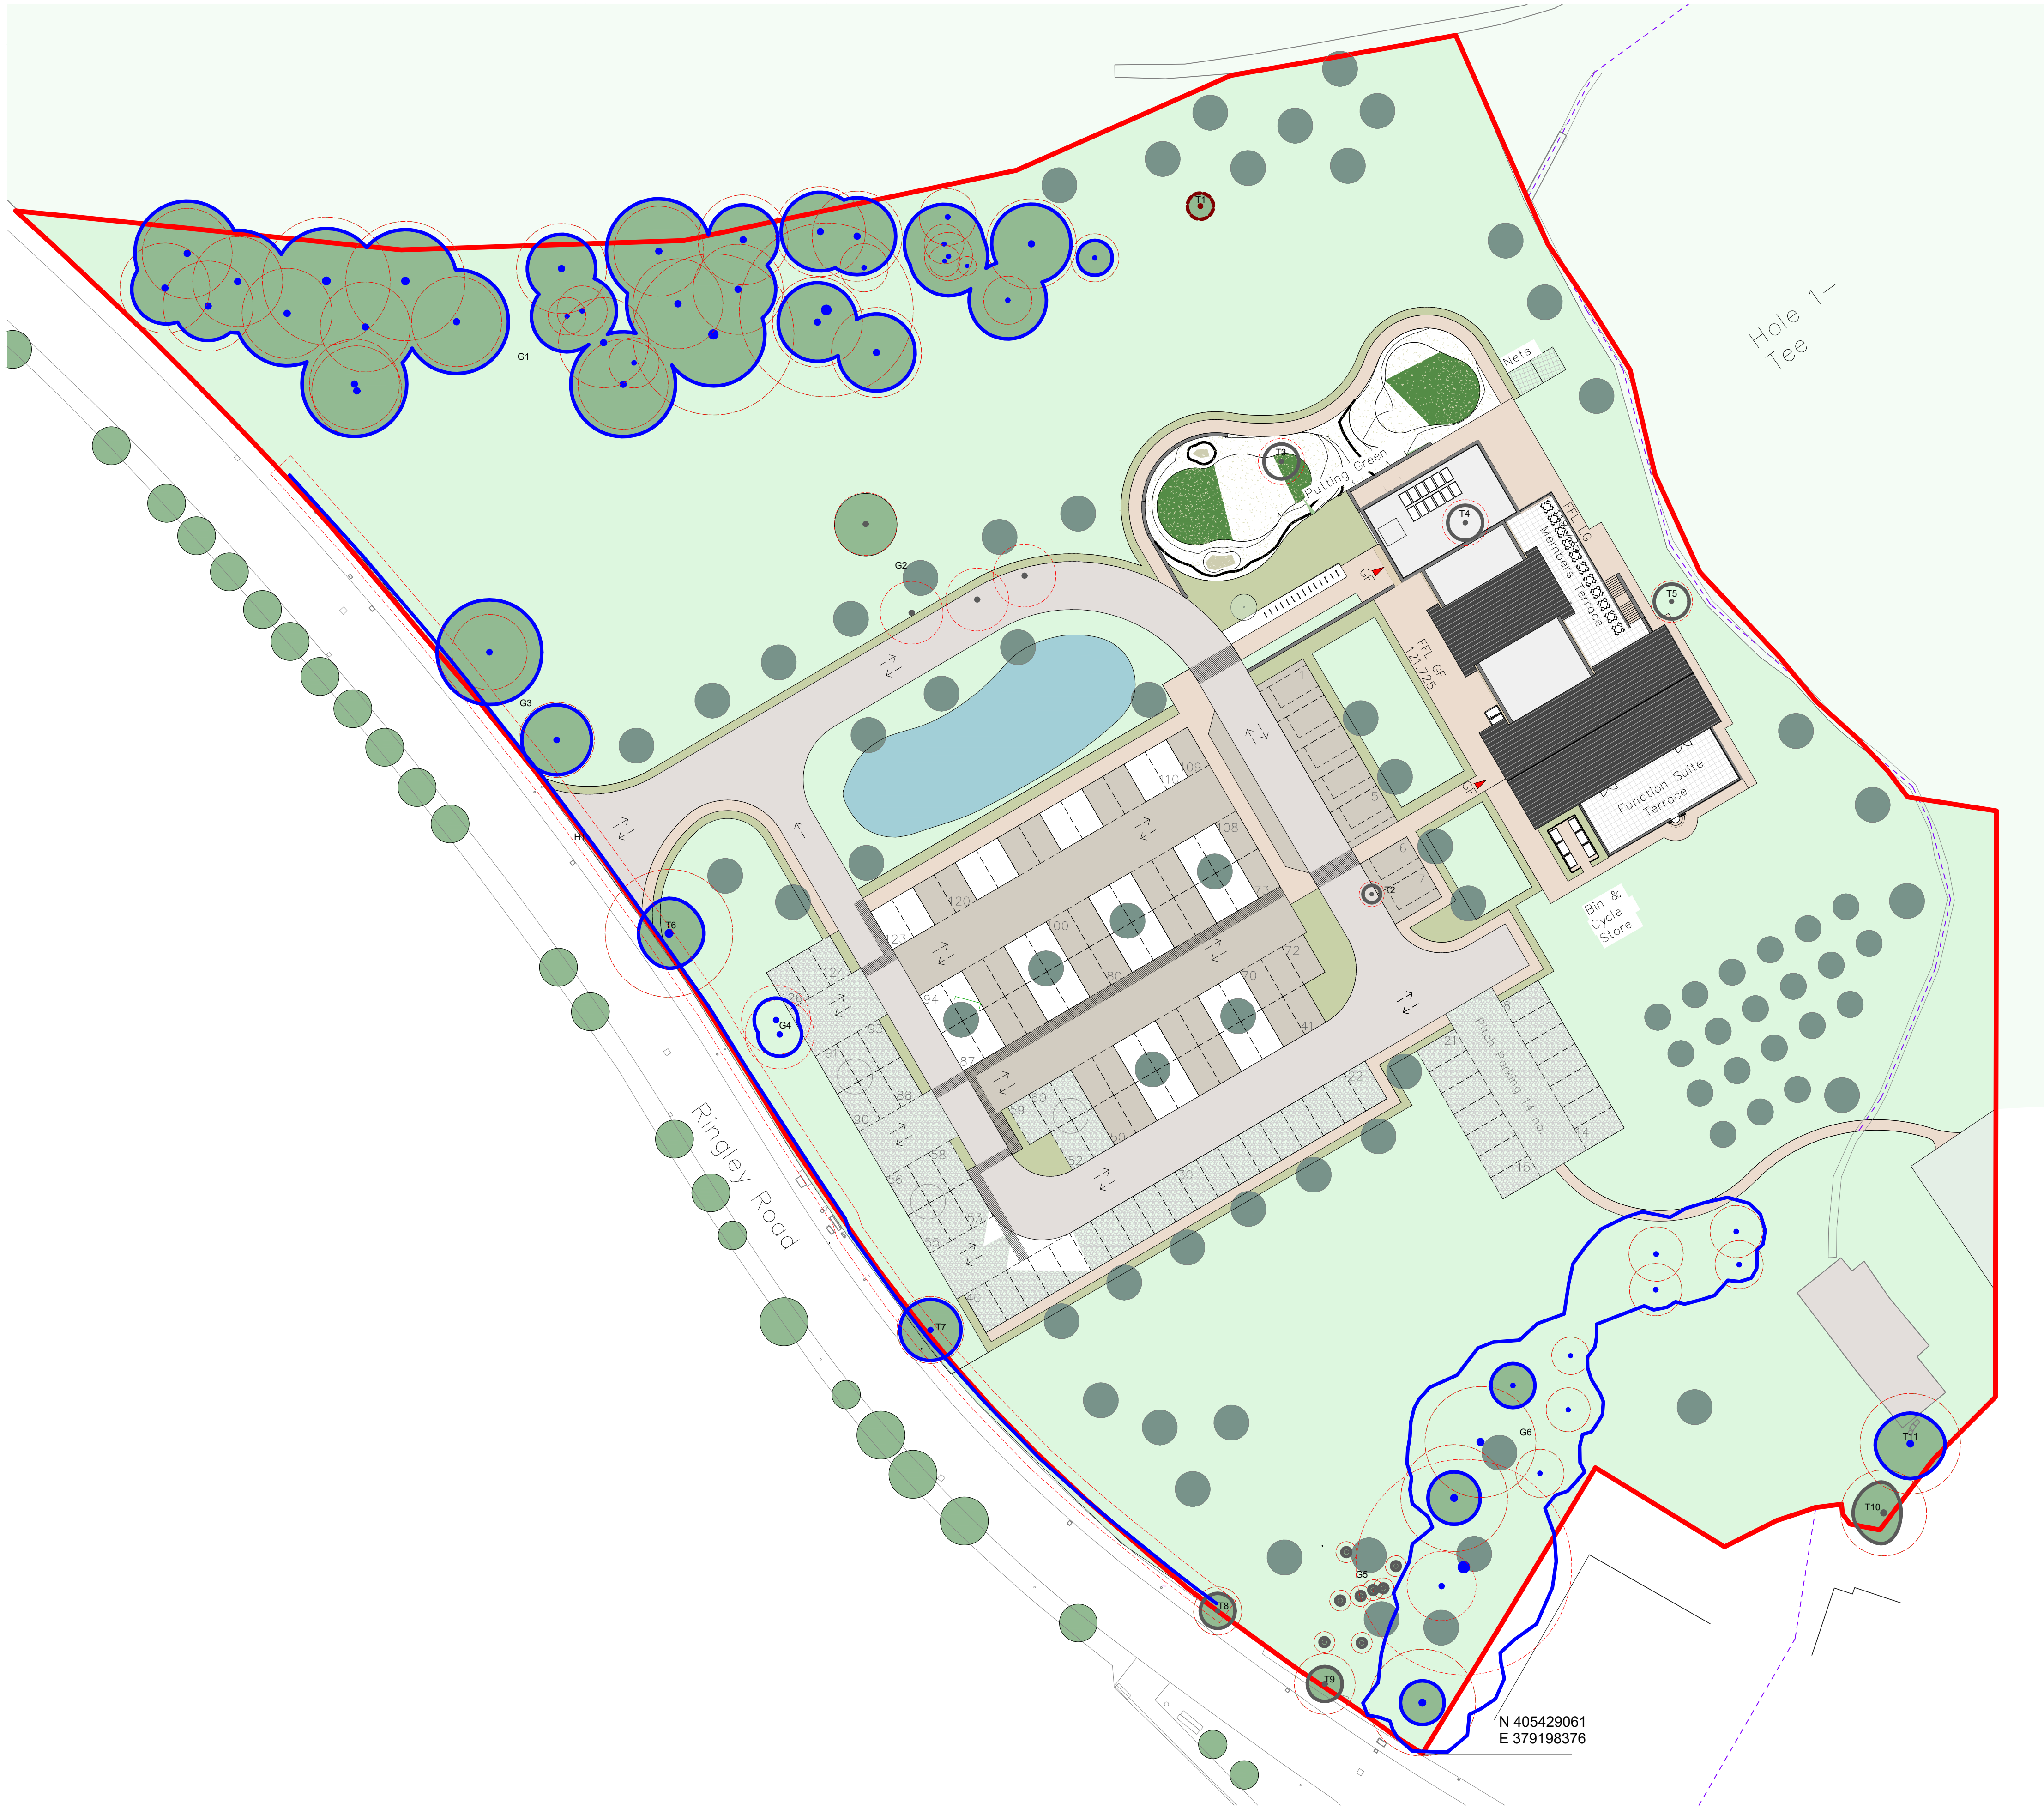
Drawing Title:  
AIS Plan

- 3.1 Due to the proposed development and its associated infrastructure there are a number of locations where the proposals are in close proximity to the trees surveyed. The Site Layout Plan within appendix three identifies the trees in relation to the proposed development.
- 3.2 In order to fully assess the impact of the proposals an Impact Table has been created detailing each tree, which shows the proximity of the associated works to the tree.
- 3.3 This can then be assessed in accordance with BS 5837:2012 to determine whether the development will have a detrimental impact on the health of each tree. Once this has been determined remedial measures can be detailed to reduce the impact the proposals will have on the treescape.

5.2.1 The impact table below shows the proposed car parking having a minor encroachment into the root protection area of T6. It is felt that due to the species, condition and limited extent of encroachment the proposal will not have a detrimental impact on the safe useful life expectancy of these trees.

5.2.3 As you can see from the table the proposed hard surfacing does not exceed 20% of the RPA. It is therefore felt that the proposed driveway will not have a detrimental impact upon the existing trees.
