**VERIFICATION REPORT**

**REMEDIATION AND  
PREPARATORY WORKS**

**RADCLIFFE HUB,  
RADCLIFFE**

**Report No. 5238-G-R003**

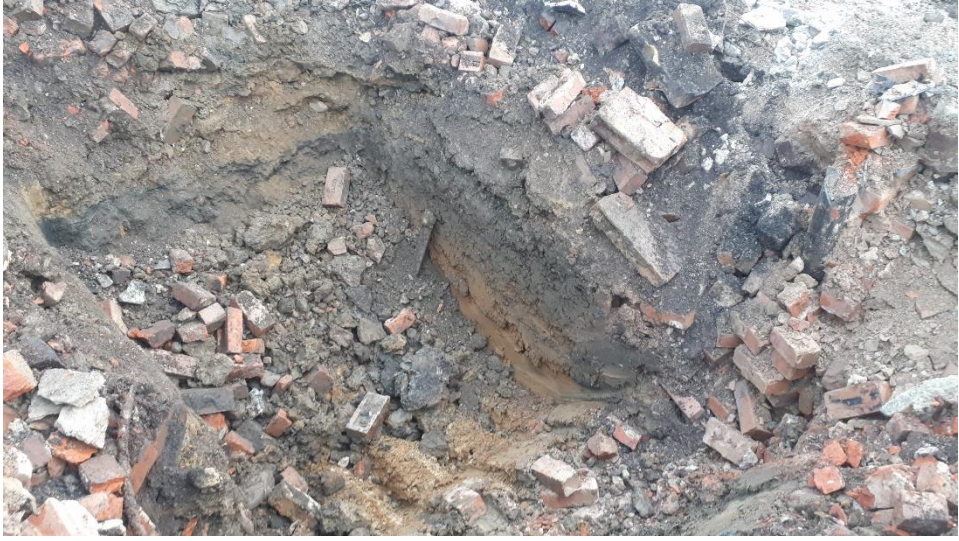
| <b>Photograph 1:</b><br><br>Post-Demolition Trial Pitting | | | |

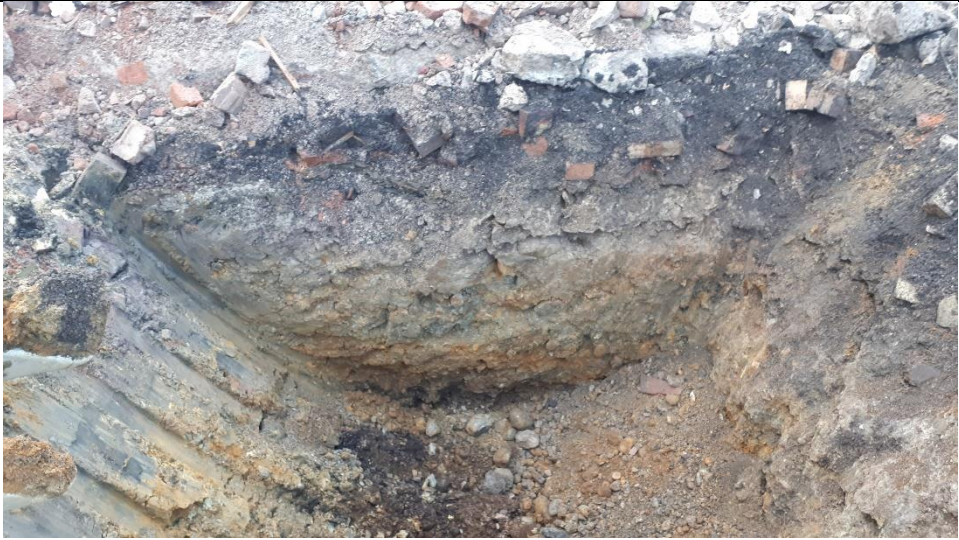
| <b>Photograph 2:</b><br><br>Post-Demolition Trial Pitting | | | |

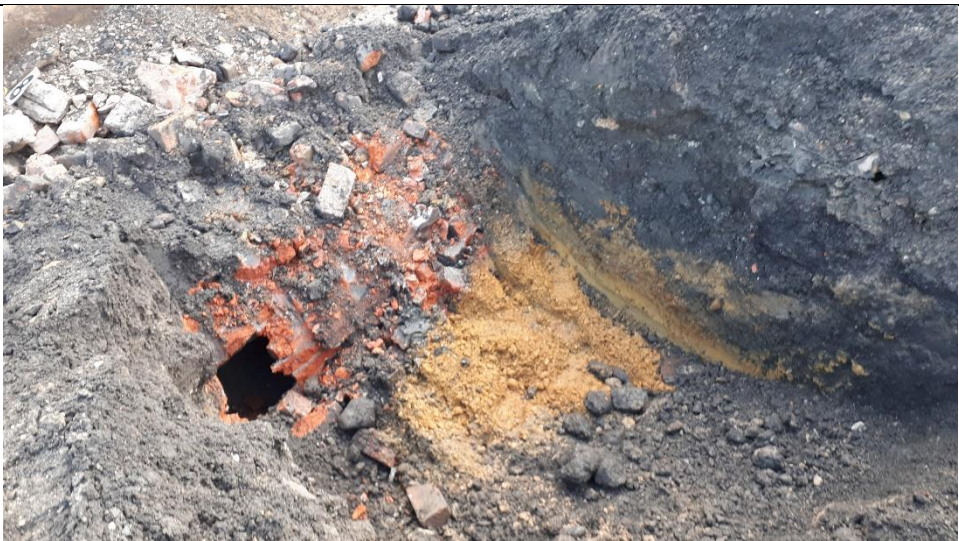
| <b>Photograph 3:</b><br><br>Post-Demolition Trial Pitting with old brick culvert exposed. | | | |

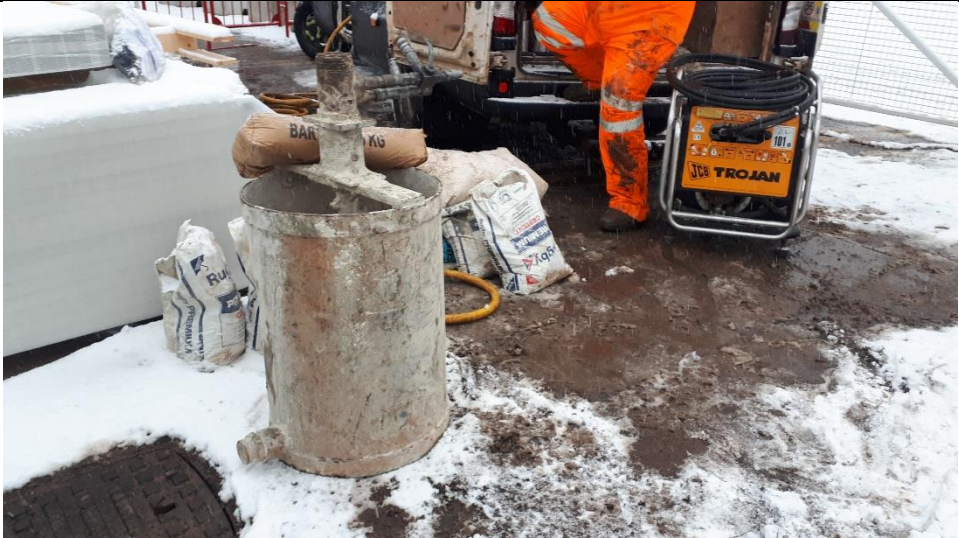
| <b>Photograph 4:</b><br><br>Mixing Grout to Decommission BH07 | | | |

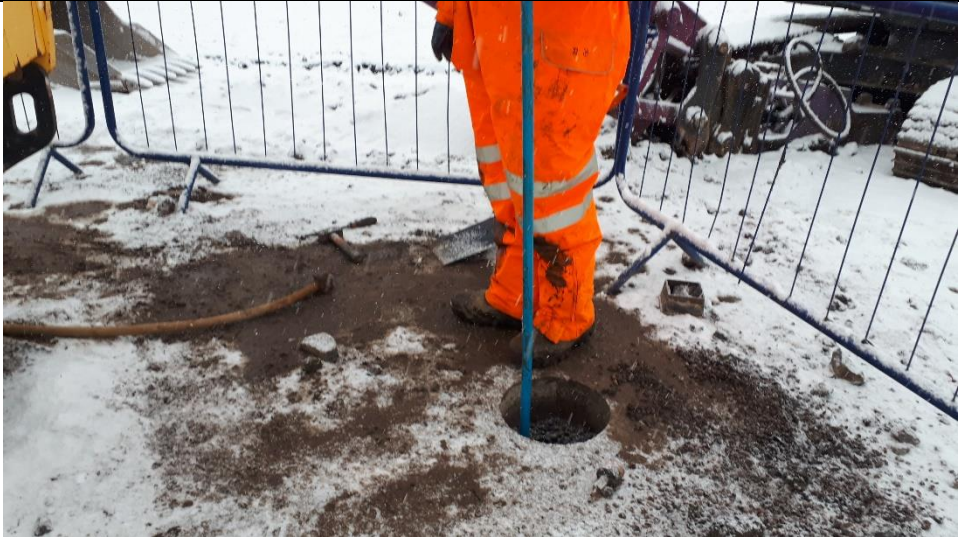
| <b>Photograph 5:</b><br><br>Injecting grout into BH07 via tremie pipe in 1m lifts. | | | |

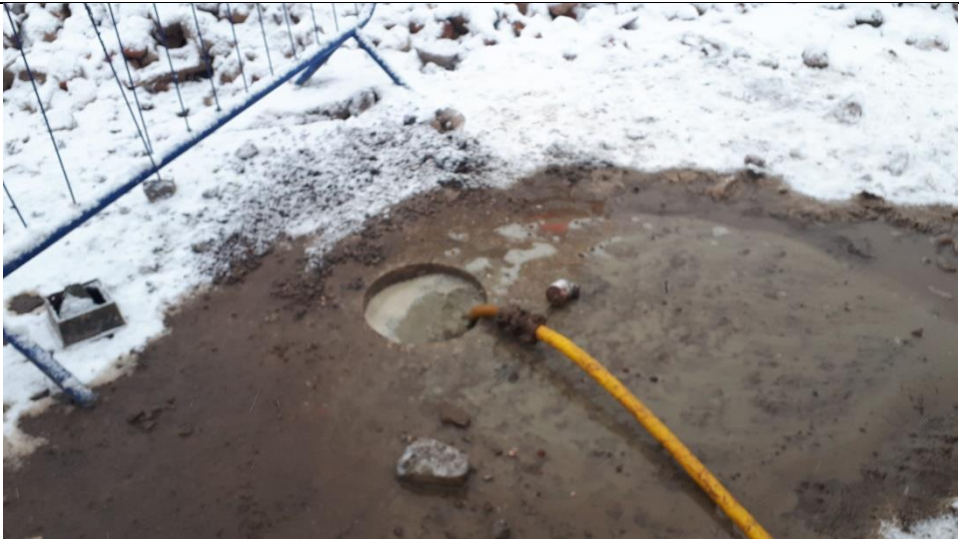
| <b>Photograph 6:</b><br><br>BH07 grouting completed to surface. | | | |

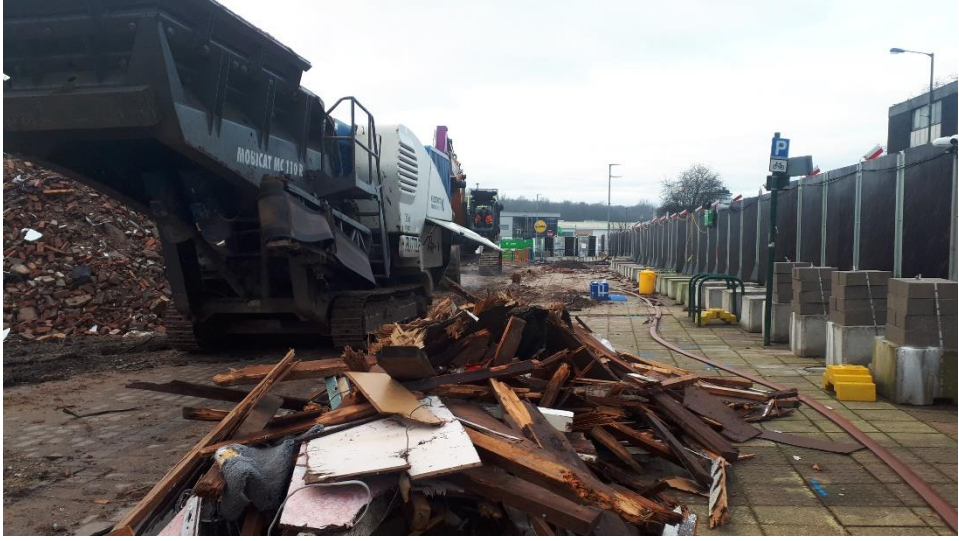
| <b>Photograph 7:</b><br><br>Crusher on-site to process excavated oversize materials and foundations. | | | |

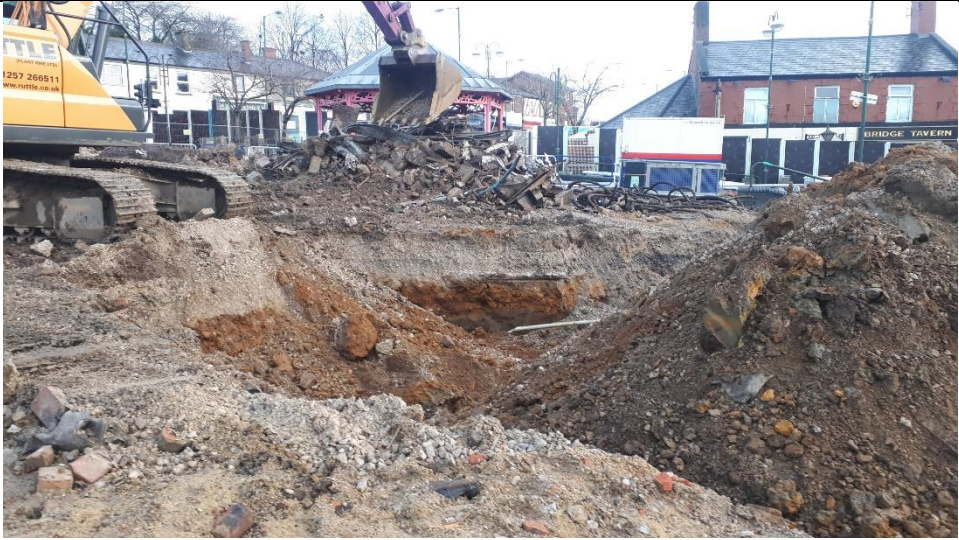
| <b>Photograph 8:</b><br><br>Turnover of Made Ground in progress to remove relict structures and foundations. | | | |

- 5.2.5 An IDG engineer attended site on a part-time basis to oversee the turnover of Made Ground and removal of relict structures and foundations which may present an obstruction to proposed new foundations and infrastructure. A selection of photographs obtained by the engineer are presented in Appendix C.

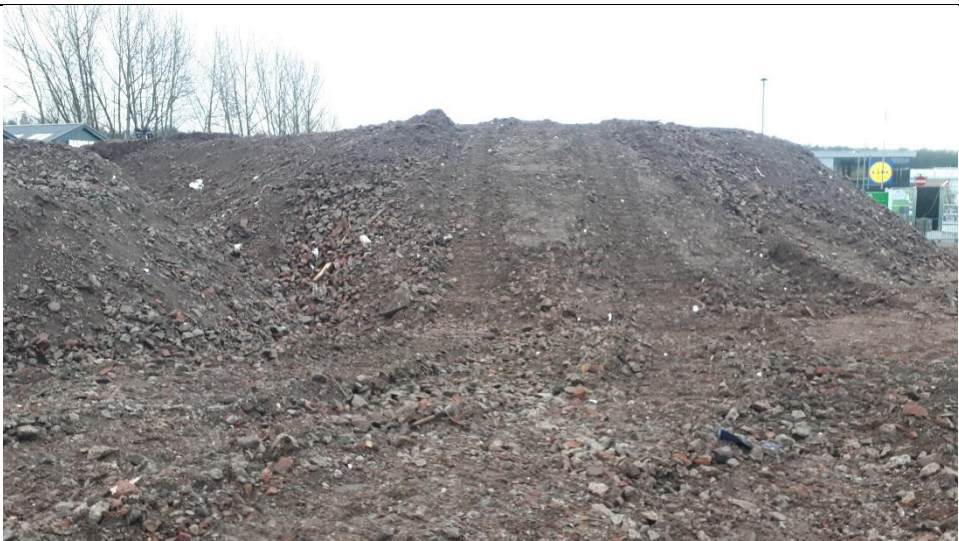
| <b>Photograph 9:</b><br><br>Site-won crushed aggregate stockpiled on site. | | | |

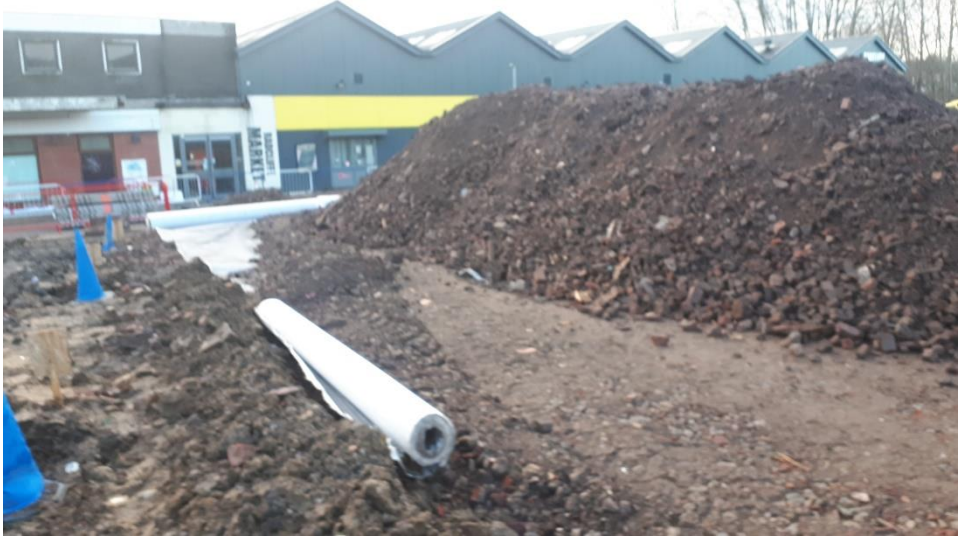
| <b>Photograph 10:</b><br><br>Geotextile being placed with site-won aggregate being placed for piling mat. | | | |

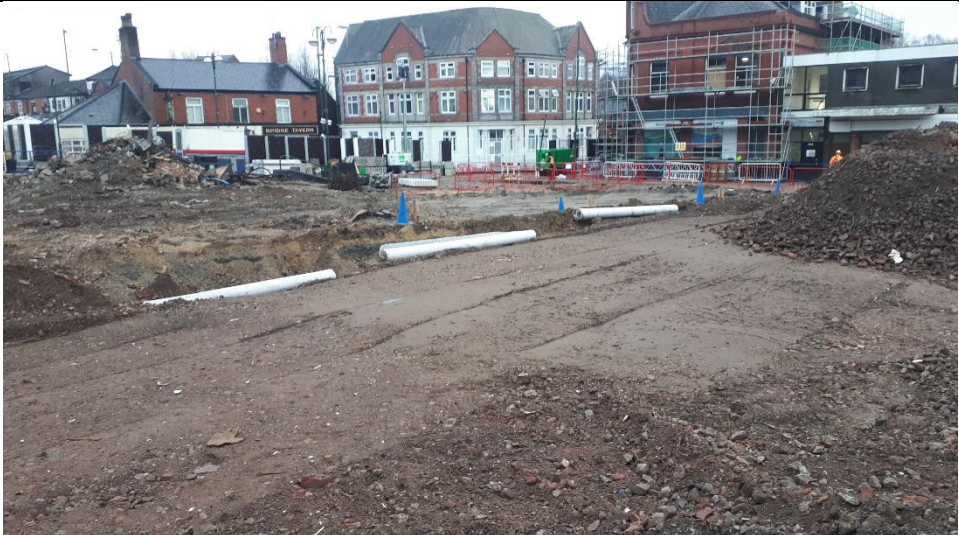
| <b>Photograph 11:</b><br><br>Turnover of western portion of site completed with piling mat in place. | | | |

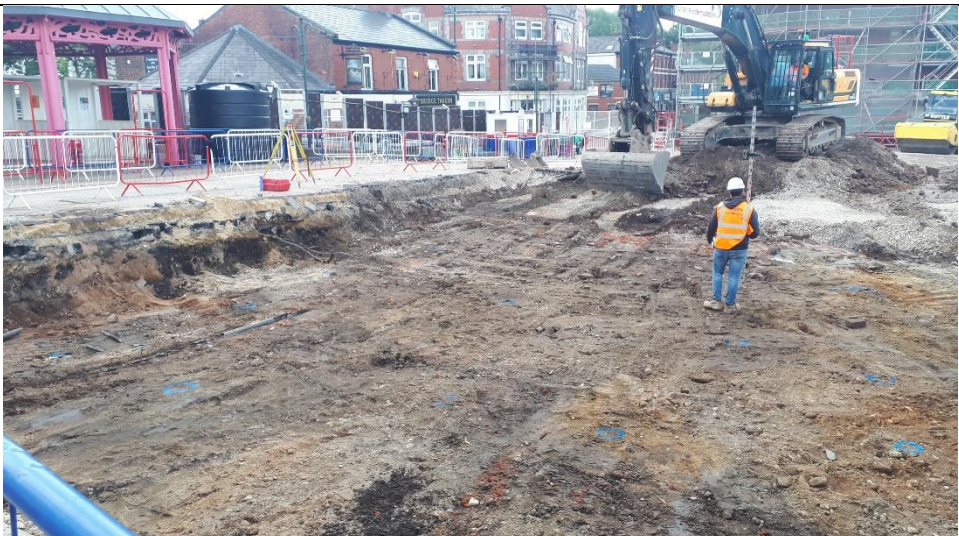
| <b>Photograph 12:</b><br><br>Turnover of Made Ground in eastern portion of site. | | | |

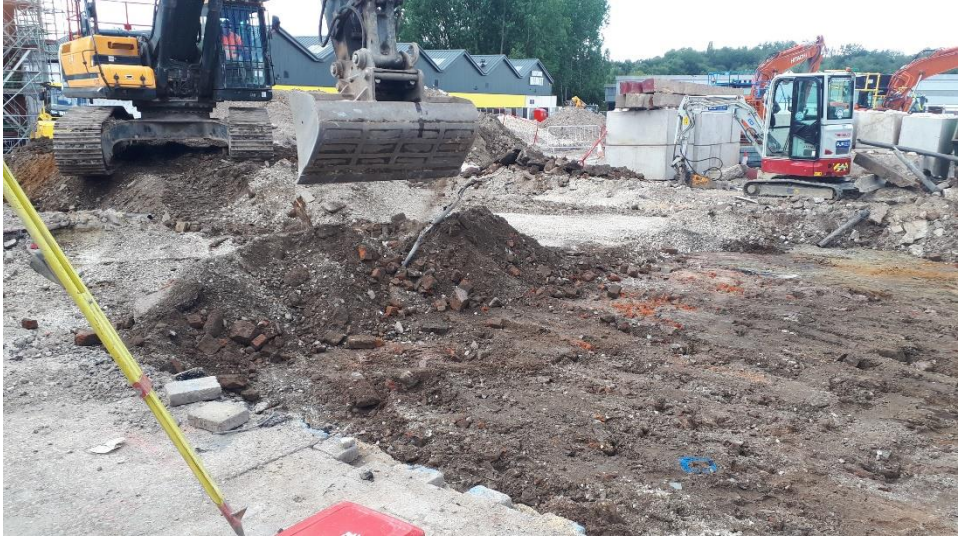
| <b>Photograph 13:</b><br><br>Turnover of Made Ground in eastern portion of site. | | | |

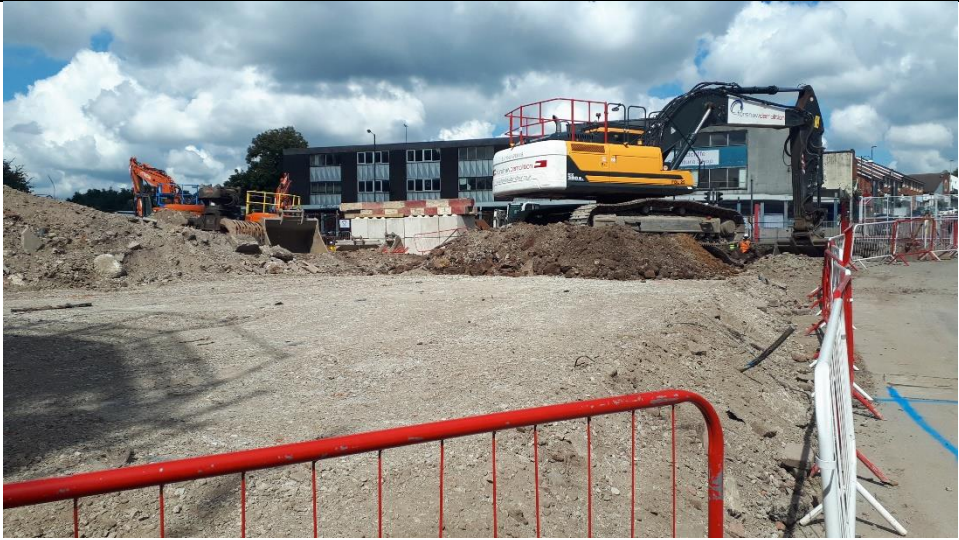
| <b>Photograph 14:</b><br><br>Turnover of Made Ground in eastern portion of site being followed by placement of piling mat. | | | |

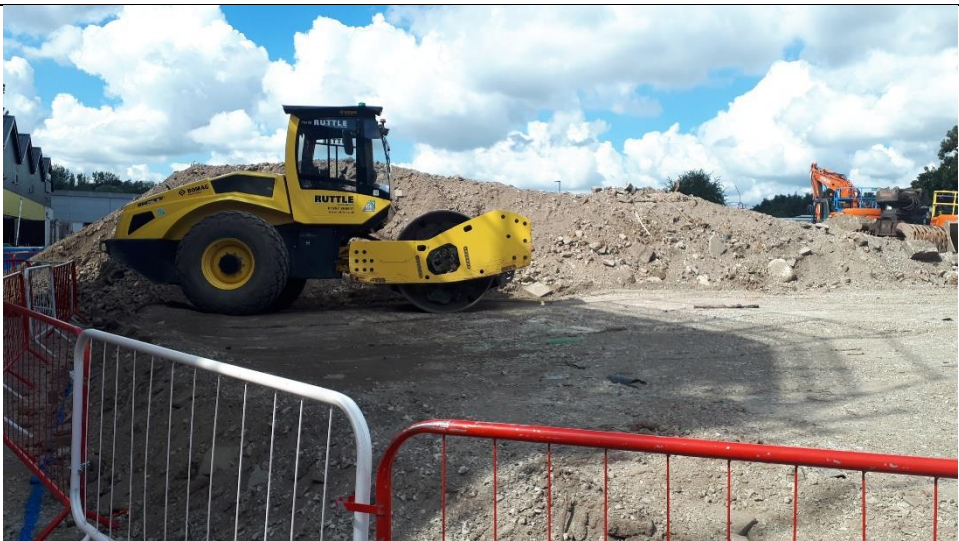
| <b>Photograph 15:</b><br><br>Compaction of piling mat in eastern portion of the site. | | | |

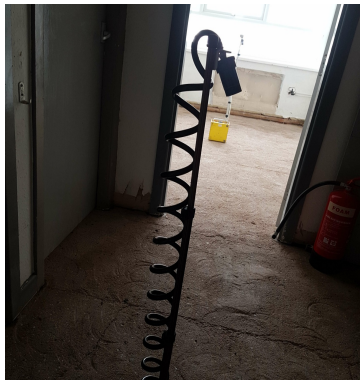
air monitoring taking place

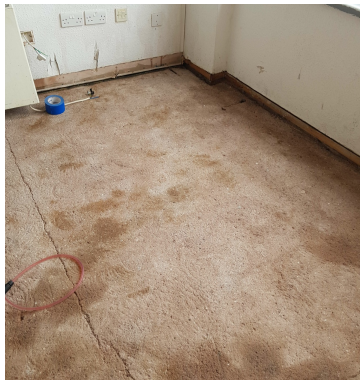
floor grinded and cleaned to dance room

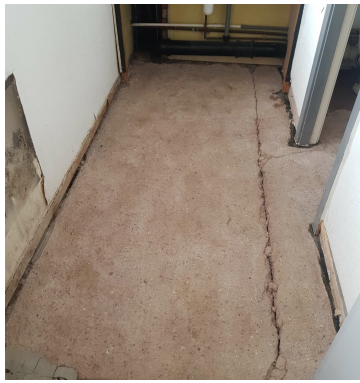
floors grinded and vacumed men's toilet 1st floor

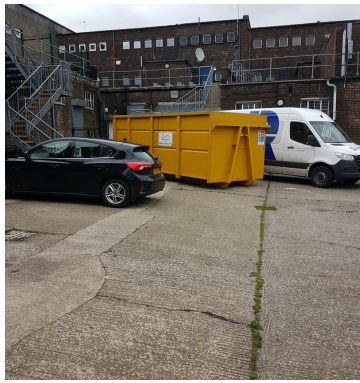
3 lads finish removal floor title location 1st floor 7 Dale street, transit waste bags to asbestos skip location outside building
