# Remediation Strategy and Verification Plan

## Millwood SEN School Development for ISG

August 2010

# Remediation Strategy and Verification Plan Millwood SEN School Development for ISG

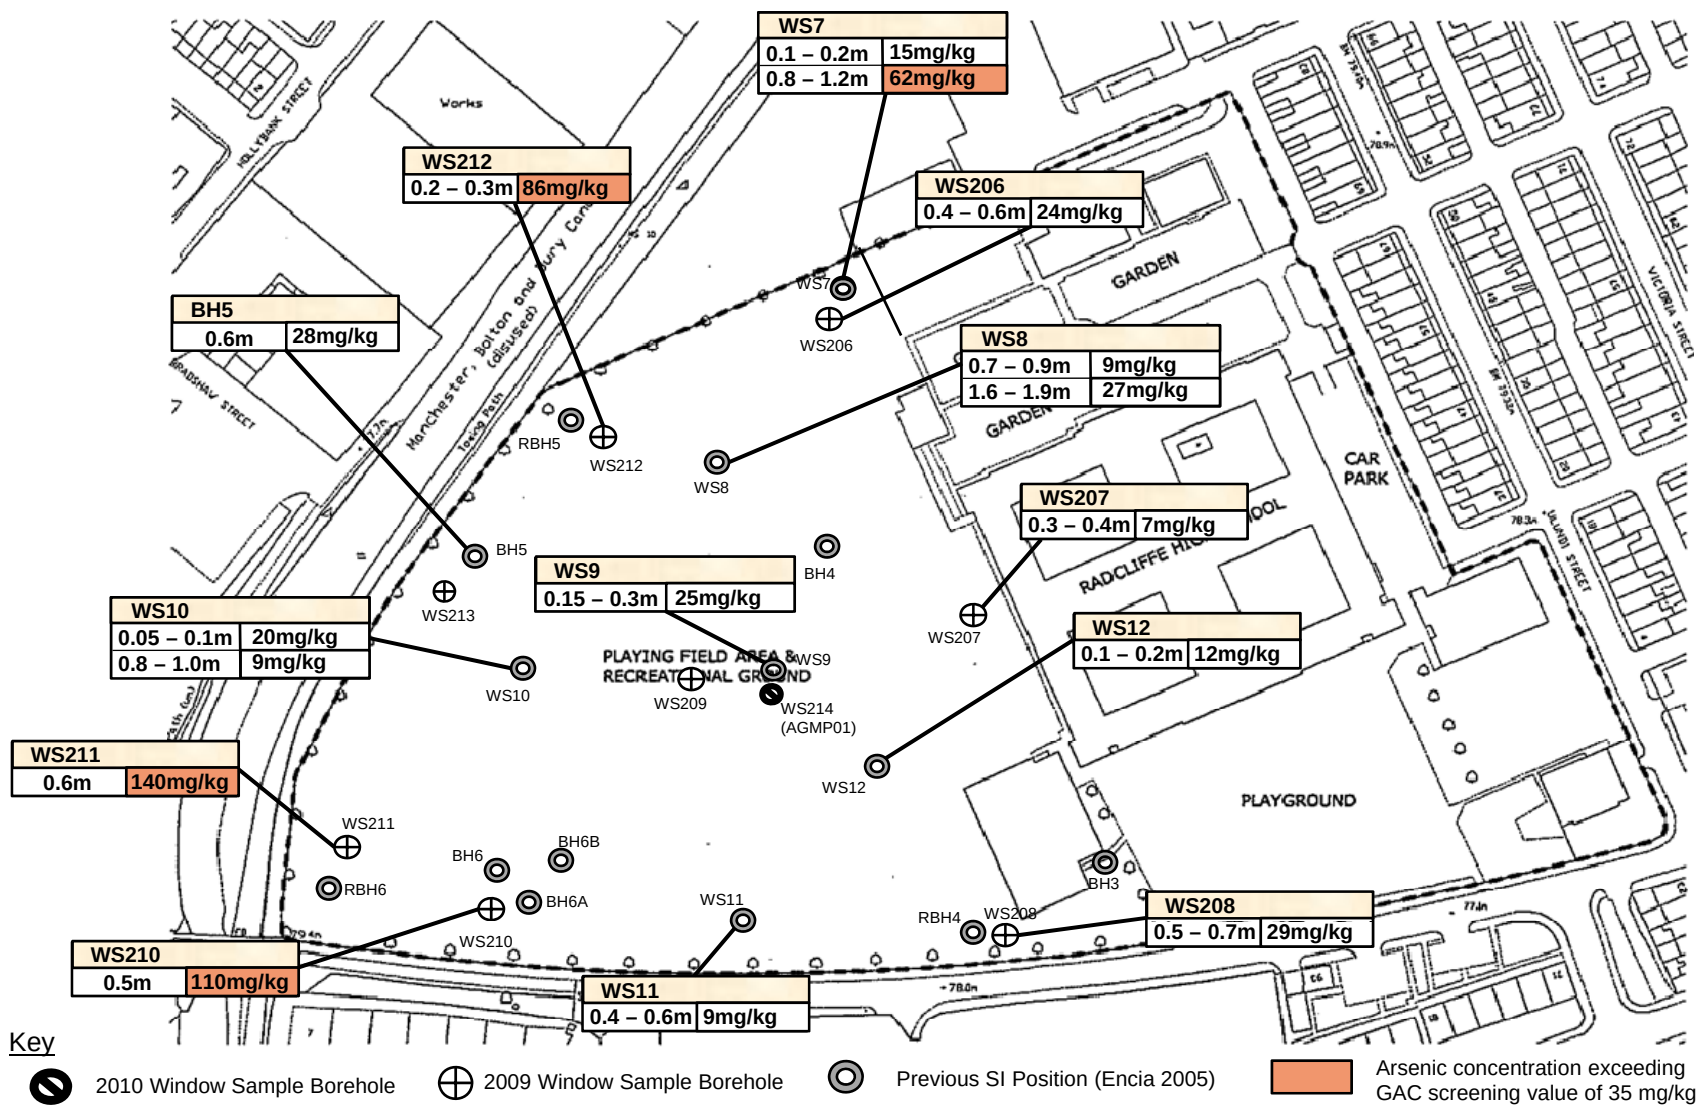
**Figure 2**      **Distribution of Arsenic in Shallow Soils (mg/kg)**

The findings of the GQRA indicated elevated concentrations of the arsenic, lead and benzo(a)pyrene in several samples exceeding their relevant GAC). The distribution of these contaminants of concern (CoCs) across the site are shown in Figures 2 to 4 and described as follows:

- Arsenic concentrations in soil exceed the GAC in four out of sixteen samples, three of which are likely to be located within soft landscaped areas. Of these three samples, two were taken at depths greater than 0.4m (WS210 and WS211) and no sample was taken at shallower depth, therefore it is not known whether contamination exists within the top 400mm.

The current layout of the site is presented in Figures 2 to 4.

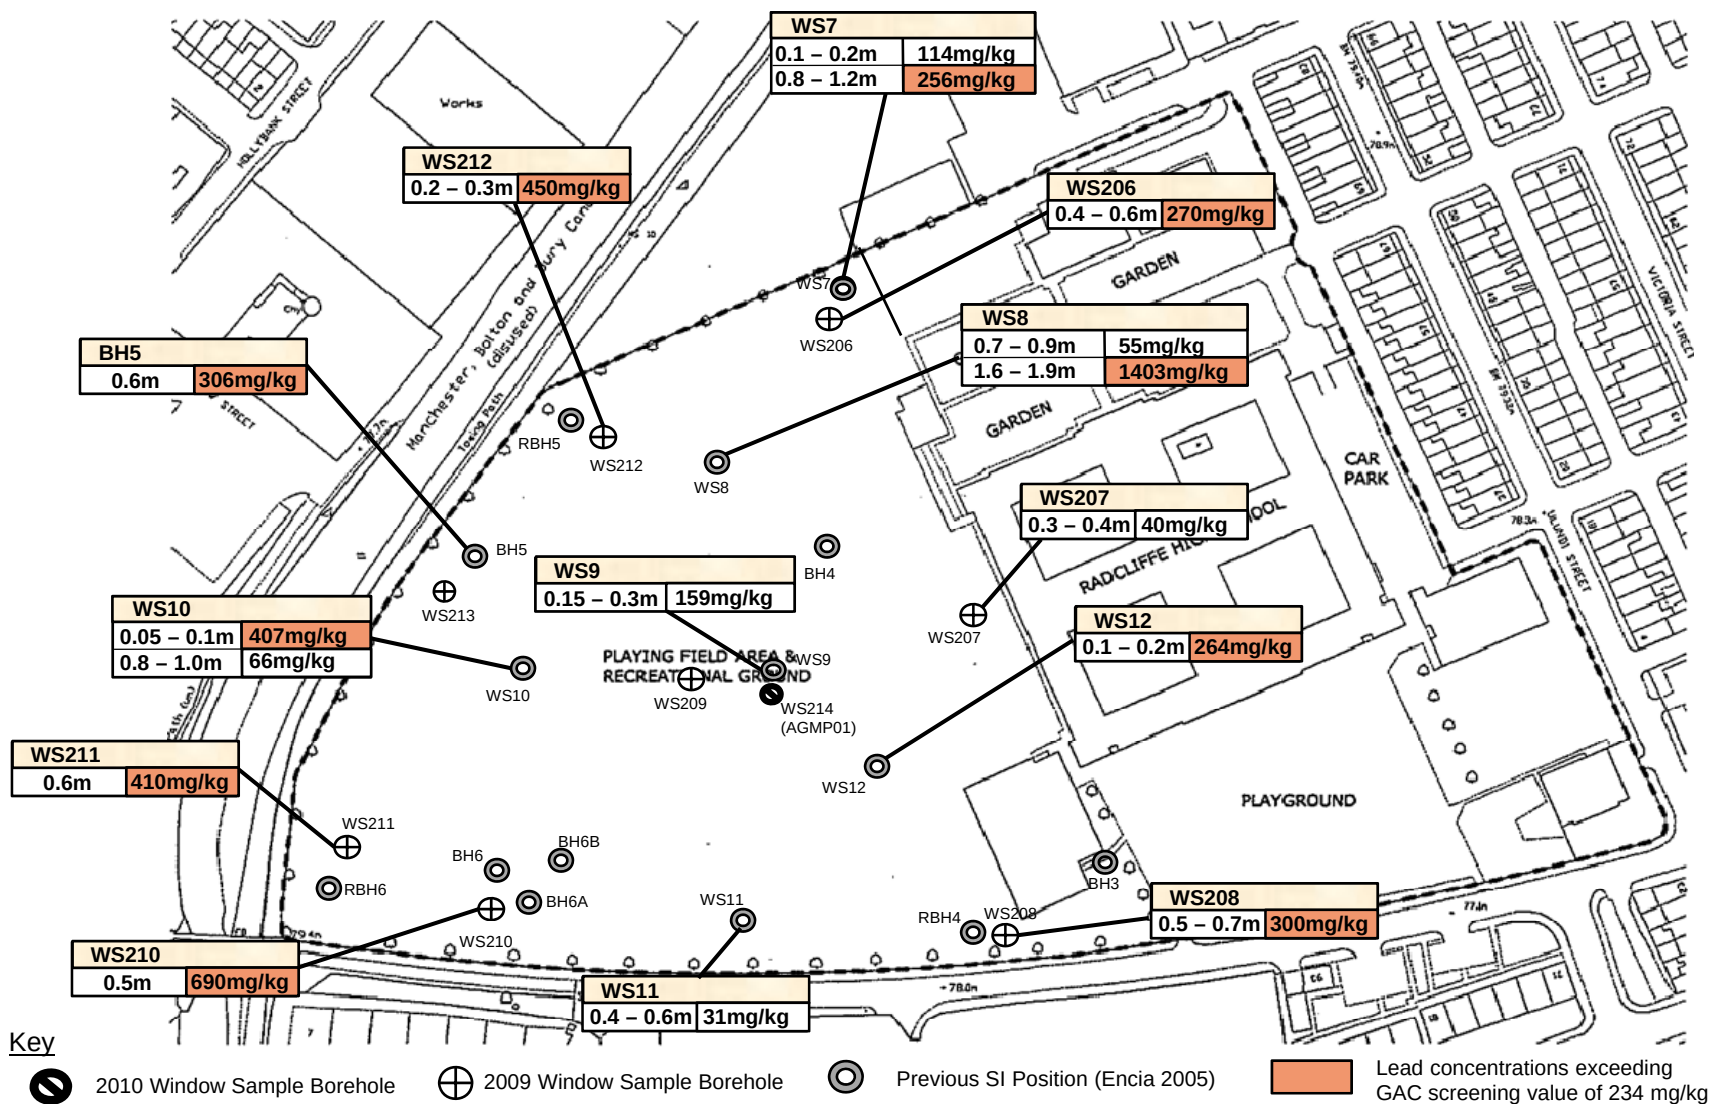
**Figure 3**      **Distribution of Lead in Shallow Soils (mg/kg)**

- Lead concentrations in soil exceed the GAC in ten out of sixteen samples, only four of which are likely to be located within soft landscaped areas. Of these four samples, two were taken at depths greater than 0.4m (WS210, WS211 and BH5) and no sample was taken at shallow depth, therefore it is not known whether contamination exists within the top 400mm;

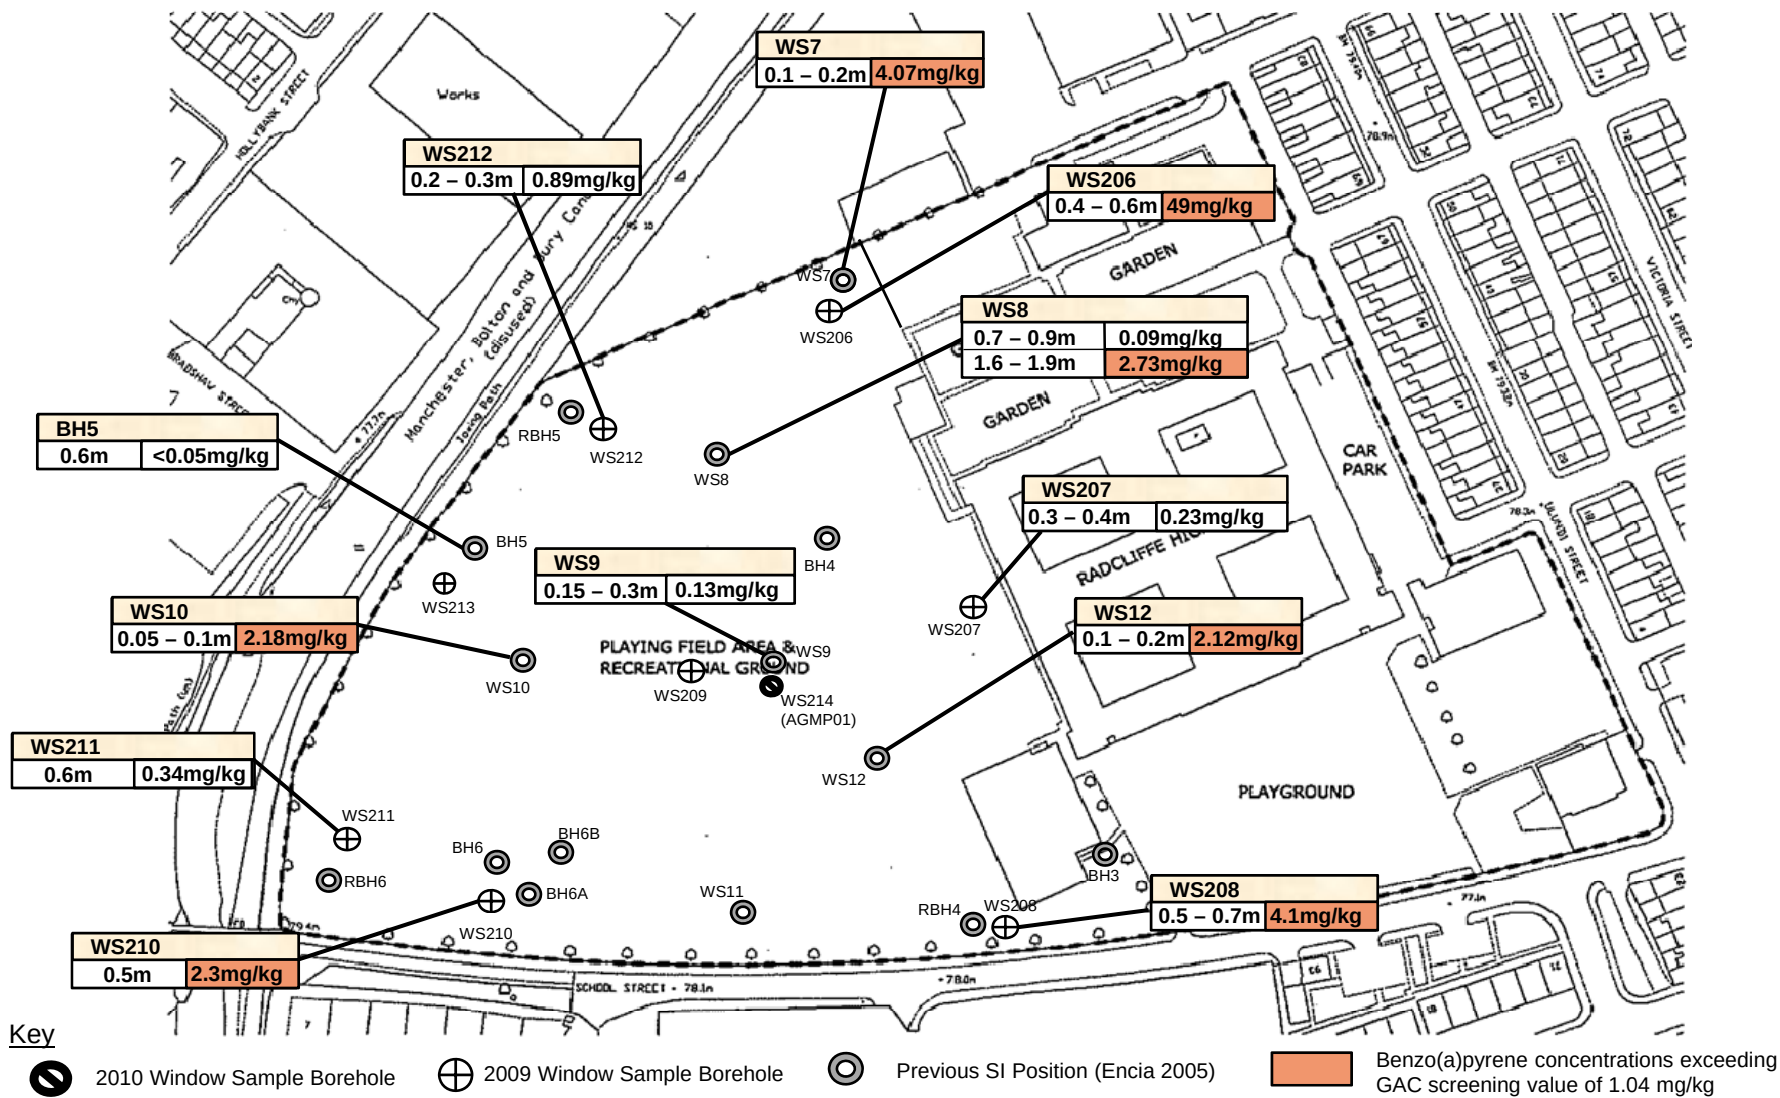
**Figure 4**      **Distribution of Benzo(a)pyrene in Shallow Soils (mg/kg)**

- Benzo(a)pyrene concentrations in soil exceed the GAC in seven of thirteen samples, only one of which is likely to be located within soft landscaped areas. This sample from WS210 was taken at 0.5m depth and sample was taken at shallow depth, therefore it is not known whether contamination exists within the top 400mm; and

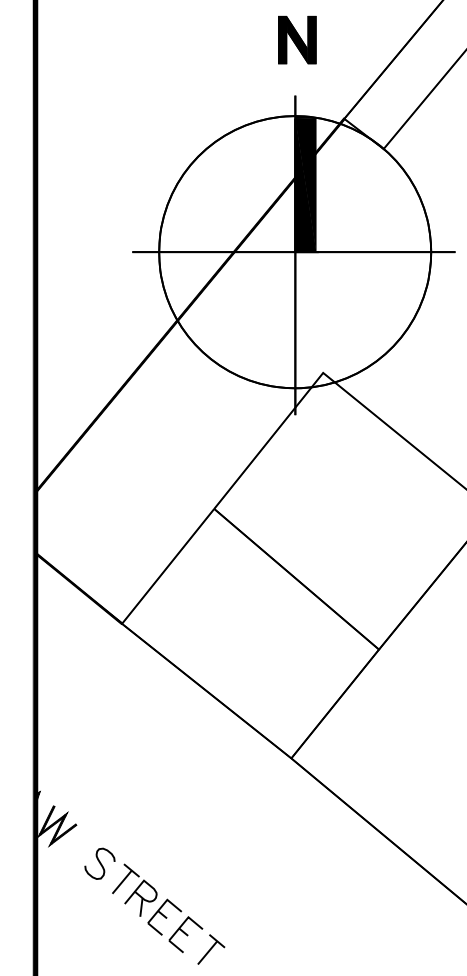
**Drawing 5086974/LA/P/00/4901/4**      **External Works General Arrangement**

The development proposal is for a special needs school with associated car parking, hard landscaped play areas and soft landscaped areas. The current design layout for the school development is presented in Drawing 5086974/LA/P/00/4901/4.
