# Health & Safety Safeguarding Hazard and Risk Assessment Report

| School Name | Peel Brow Primary School |
| Element Inspected | Perimeter Fencing |

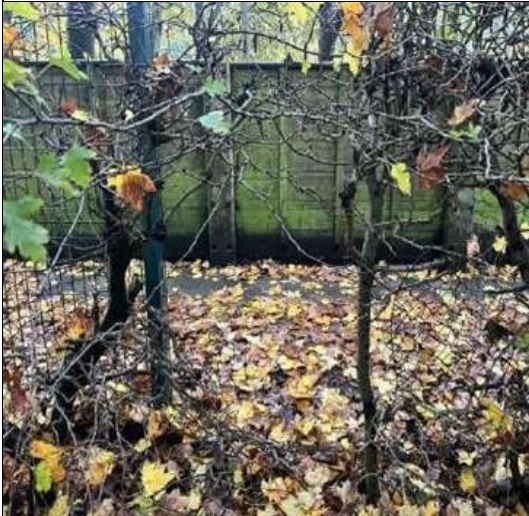
Photo 1

| Location | Hazard Description | Risk Type | Severity (L/M/H) | Occupants Affected | Photo Ref |
|---|---|---|---|---|---|
| East boundary fence (adjacent to public foot path) | Significant corrosion and deformation of fence panels; gaps large enough for pupil egress | Safeguarding / Absconding / Unauthorised Access | H | All pupils, particularly vulnerable pupils | 01 |

| Hazard / Location | Immediate Action | Interim Control Measures | Permanent Solution | Priority |
|---|---|---|---|---|
| Low fencing adjacent to public footpath | Stop pupil use of nearby external areas | Temporary height extension panels | Installation of full-height safeguarding-rated perimeter fencing | High |

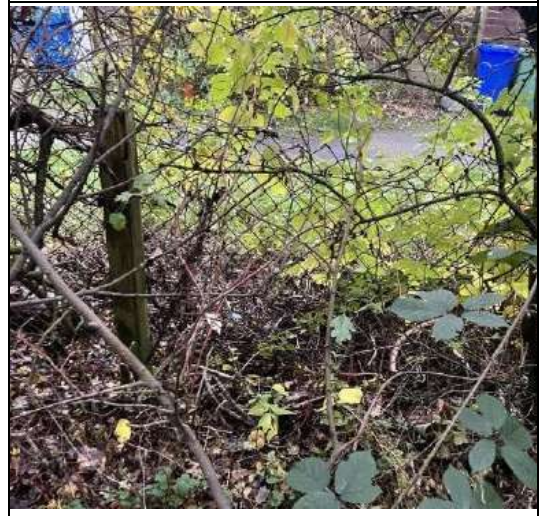
Photo 2

| Location | Hazard Description | Risk Type | Severity (L/M/H) | Occupants Affected | Photo Ref |
|---|---|---|---|---|---|
| South/ west perimeter adjacent to neighbouring properties | Fence leaning and unstable; posts loose in ground and movement under light pressure | Boundary breach / Physical injury | H | Pupils, staff, public | 02 |

| Hazard / Location | Immediate Action | Interim Control Measures | Permanent Solution | Priority |
|---|---|---|---|---|
| Breachable perimeter fencing (rear boundary) | Restrict pupil access to affected area; increase staff presence | Temporary fencing panels; monitored access routes | Temporary fencing panels; monitored access routes | High |

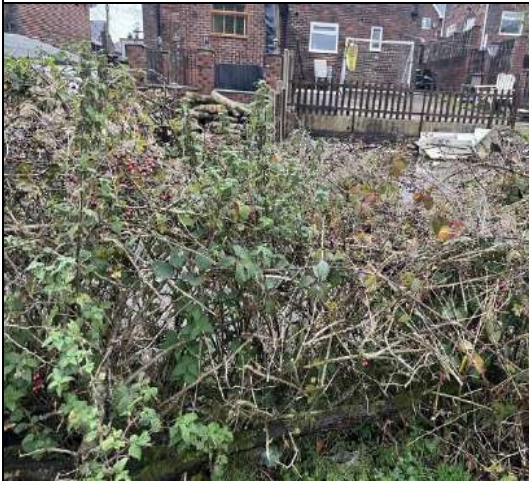
Photo 3

| Location | Hazard Description | Risk Type | Severity (L/M/H) | Occupants Affected | Photo Ref |
|---|---|---|---|---|---|
| North boundary | Overgrown vegetation creating blind spots; concealment risk and reduced natural surveillance | Safeguarding / Visibility / Anti-social behaviour | H | Pupils, staff | 03 |

| Hazard / Location | Immediate Action | Interim Control Measures | Permanent Solution | Priority |
|---|---|---|---|---|
| Blind spots and concealed | Restrict unsupervised | Increased supervision; | Installation of passive | High |

| areas around outbuildings | access | temporary CCTV deployment | surveillance measures | |
