Vinci Building Ltd

# Prestwich Multi-Storey Car Park Options Appraisal and Remediation Strategy

Rev A

September 2024

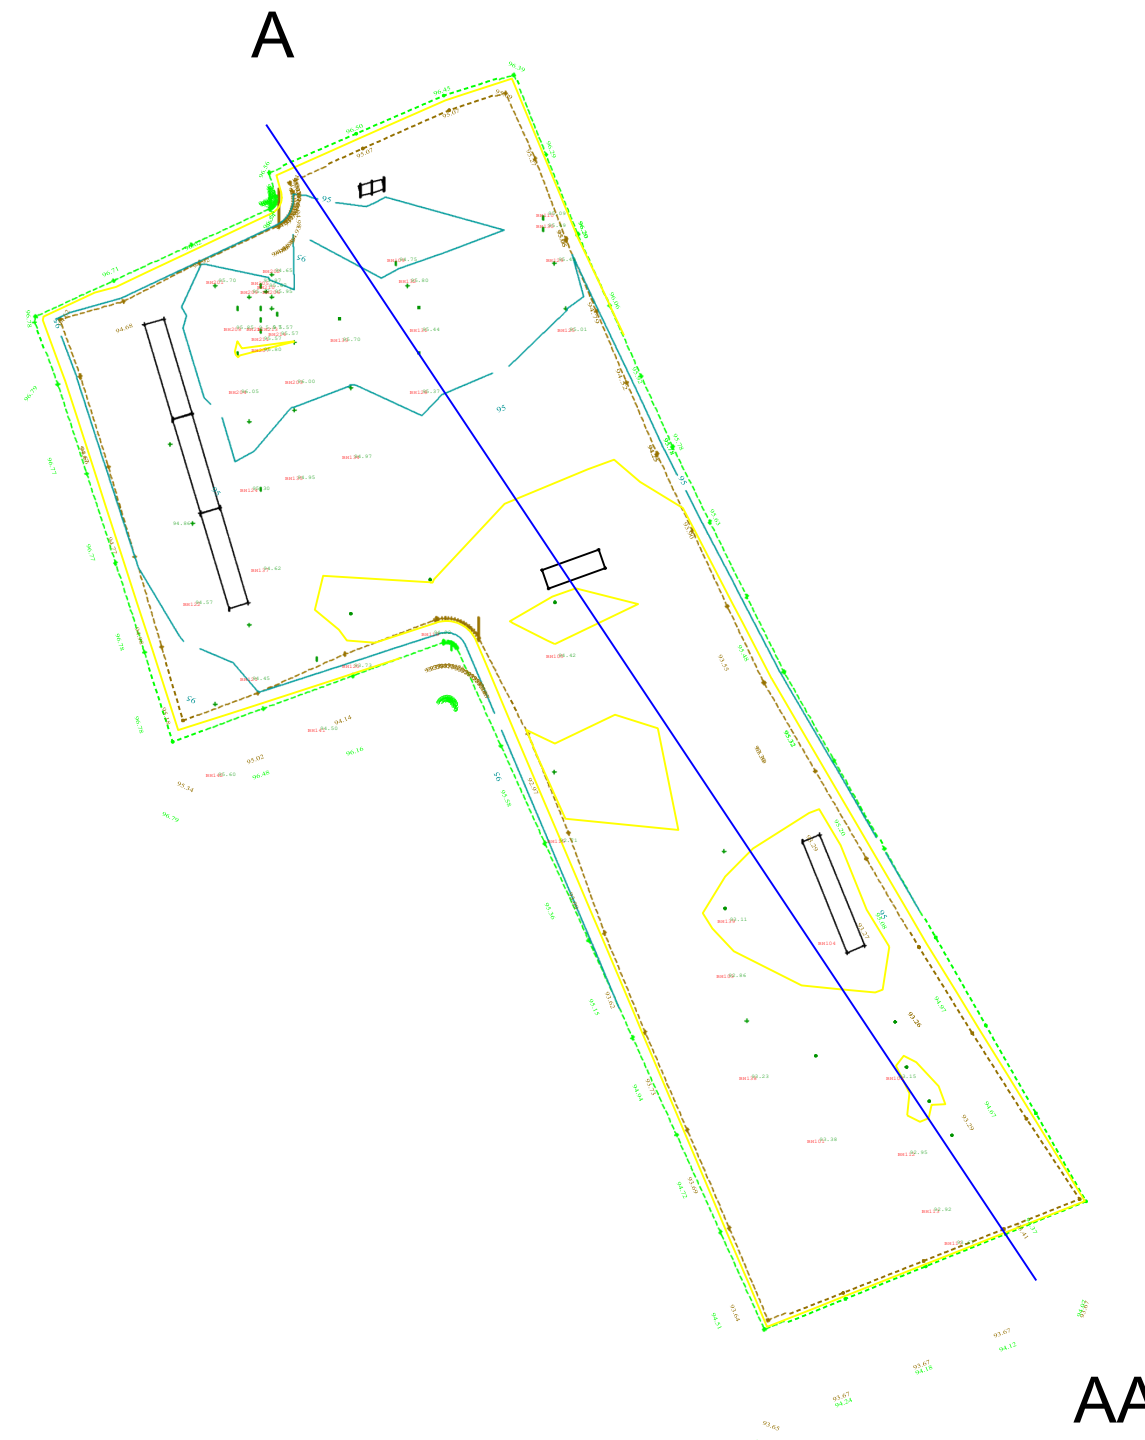
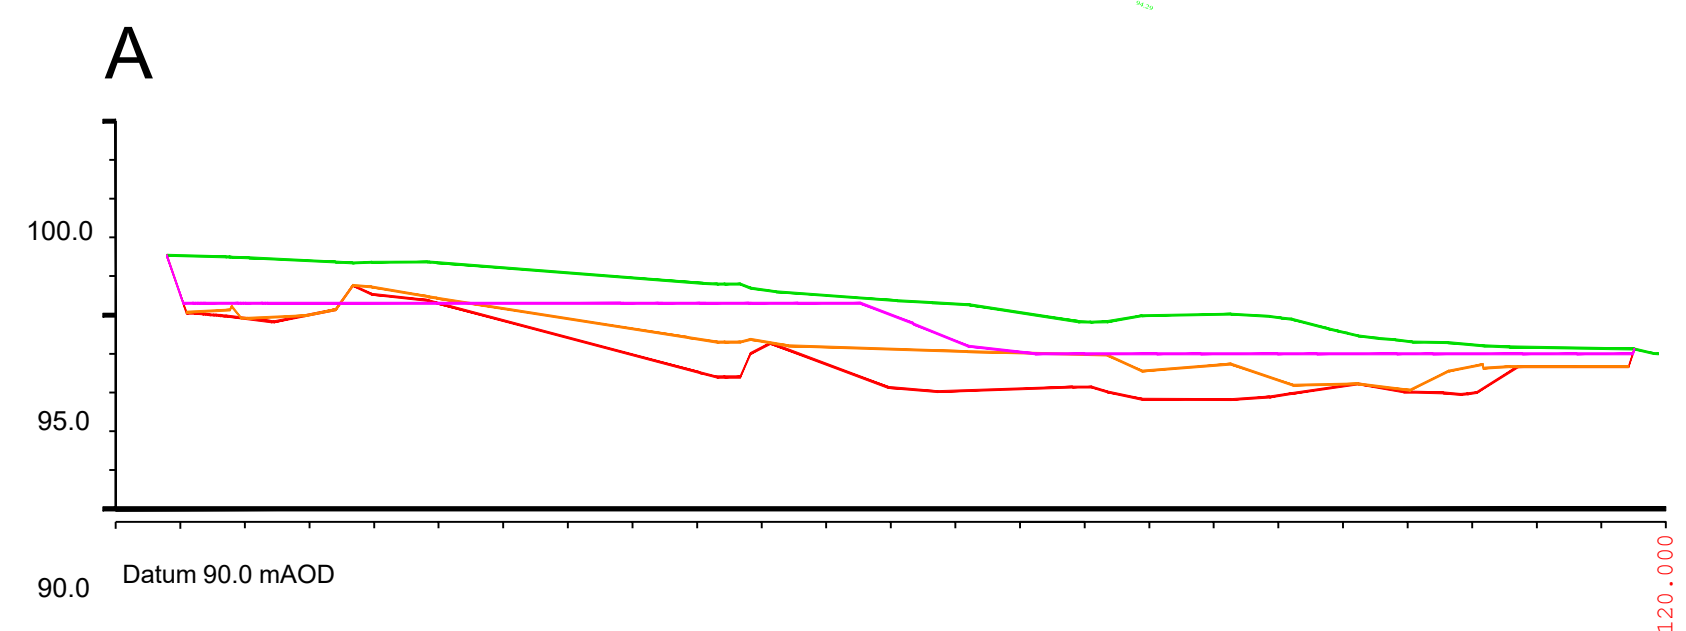
| Dwg: D4900_01 | Contract: 4900 | Scale: NTS |

| Title: Proposed Excavation with Section | | |

- 3.4.1 The final remediation strategy recommended for the Site comprises the following:
- Site-wide turnover of Made Ground to remove grossly contaminated materials and substructures for off-site disposal to an appropriate facility.
  - Excavation of geotechnically unsuitable materials for off-site disposal.
  - Placement and compaction of all materials that are suitable for re-use, all materials that are imported onto Site, to an engineered specification.
  - Import of recycled aggregate to replace removed quantities of materials and to construct a working platform / piling mat.
- 3.4.2 If localised areas of visible gross contamination is identified in natural material at the base of Made Ground, the impacted material may also be excavated for disposal.
