# Architectural Services

## Asbestos Management

### Park View Primary School – Asbestos Management Plan Review

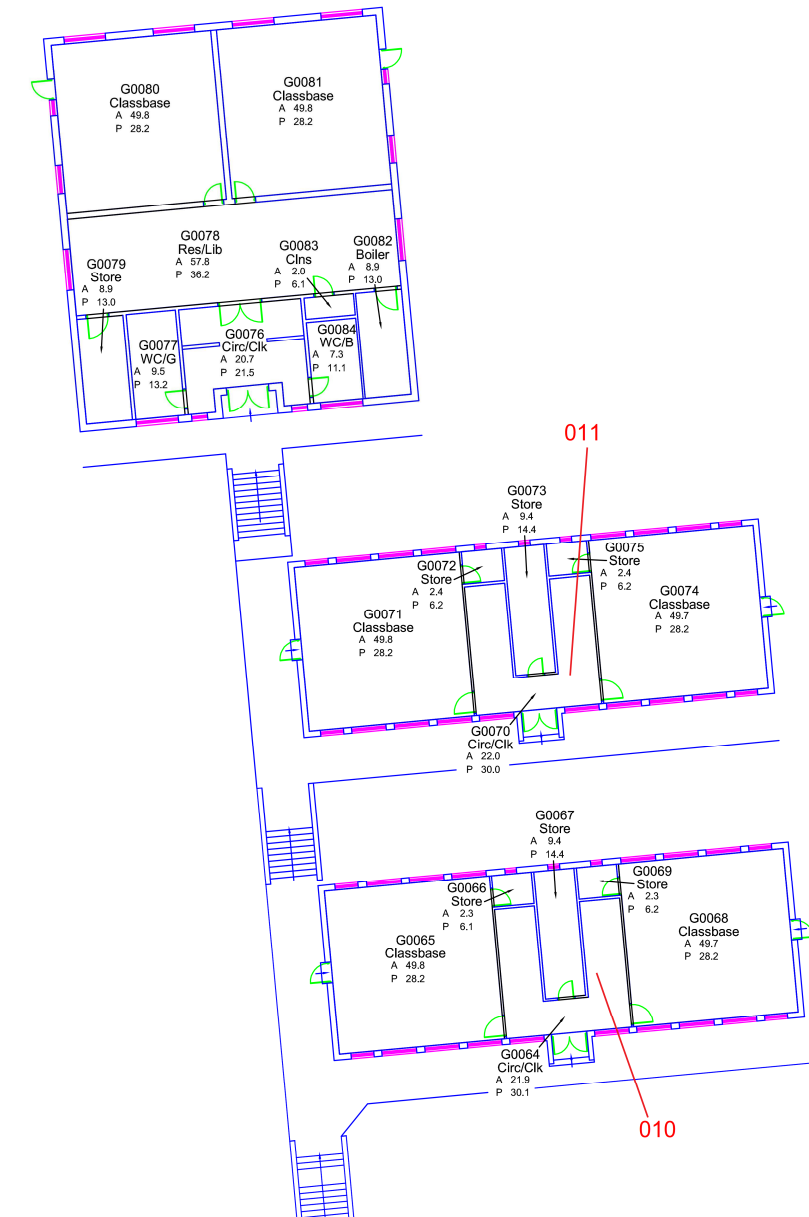
008  
009  
012

| Key: | |
|---|---|
| <span style="color: red;">■</span> | Asbestos Containing Material |
| <span style="color: blue;">■</span> | Removed Asbestos Containing Material |
| Floor: Ground Floor & Boiler Room | |

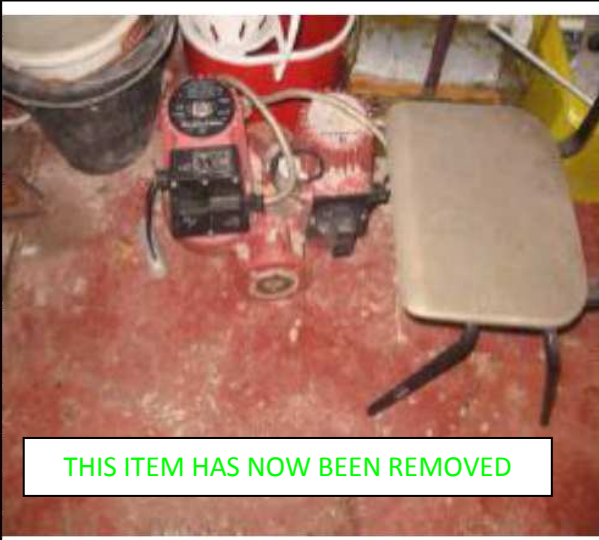
| <b>Asb Item ID:</b> | 204-AI-008 | | |

| <b>Item Description:</b> | Gaskets to redundant plant machinery | | |
| <b>Location:</b> | B0001/ Boiler Room | | |
| <b>Asbestos Fibres:</b> | Chrysotile | | |
| <b>Damage:</b> | Low Damage | | |

| <b>Recommendation</b> | Item Removed | | |

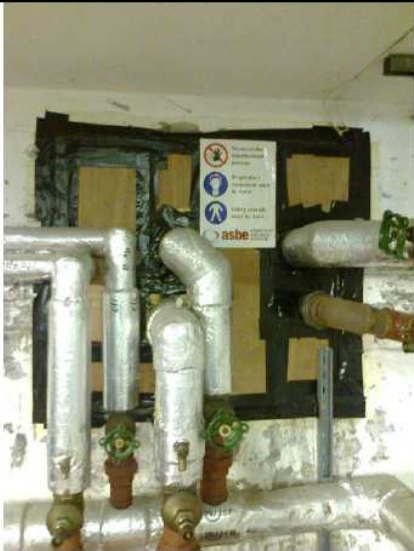
| <b>Item Description:</b> | Description: Pipe lagging to redundant pipework in wall void | | |
| <b>Location:</b> | B0001/ Boiler Room | | |
| <b>Asbestos Fibres:</b> | Crocidolite Presumed | | |
| <b>Material Risk:</b> | 9-12 | | |
| <b>Damage:</b> | Undeterminable | | |

| <b>Recommendation</b> | The item has been presumed to contain asbestos. The wall void, which is thought to be asbestos contaminated, was sealed off thus making it impossible to take a sample of the lagging. Should the void be unsealed and environmentally cleaned then a sample should be taken | | |

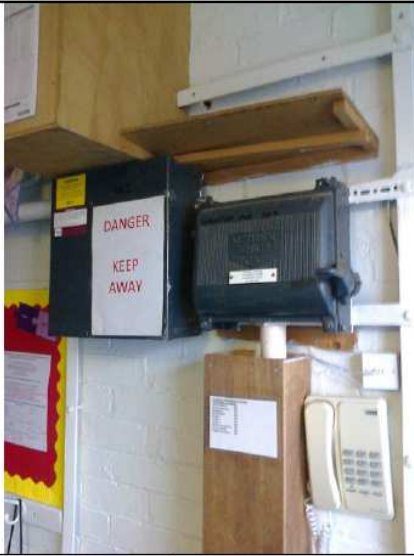
| <b>Asb Item ID:</b> | 204-AI-010 | |

| <b>Item Description:</b> | Description: Internal components within fuse boxes x 2 | |
| <b>Location:</b> | G0064/ Pre-fab 1 corridor | |
| <b>Asbestos Fibres:</b> | Crocidolite Presumed | |
| <b>Material Risk:</b> | 4-12 | |
| <b>Damage:</b> | Undeterminable | |

| <b>Recommendation</b> | Inspect by a competent person when the services have been isolated. Monitor condition and manage in situ until this is carried out. | |

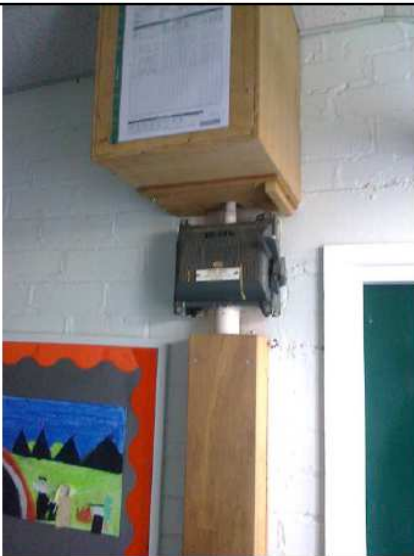
| <b>Asb Item ID:</b> | 204-AI-011 | |

| <b>Item Description:</b> | Internal components within fuse boxes x 2 | |
| <b>Location:</b> | Pre-fab Building G0070/ Pre-fab 2 corridor | |
| <b>Asbestos Fibres:</b> | Crocidolite presumed | |
| <b>Material Risk:</b> | 4-12 | |
| <b>Damage:</b> | Undeterminable | |

| <b>Recommendation</b> | Inspect by a competent person when the services have been isolated. Monitor condition and manage in situ until this is carried out. | |

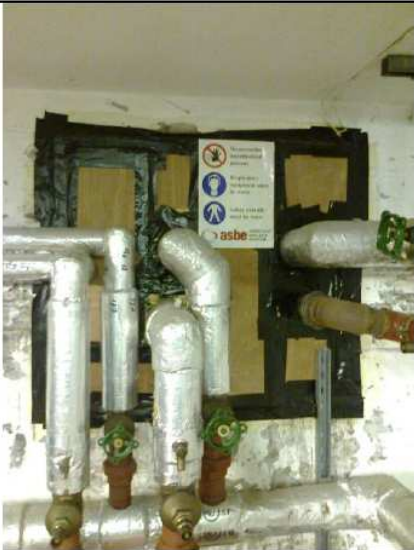
| <b>Asb Item ID:</b> | 204-AI-012 | |

| <b>Item Description:</b> | Wall void | |
| <b>Location:</b> | Ground B0001/ Boiler Room | |

| <b>Recommendation</b> | Reason for Exclusion: The area has been sealed as it is asbestos contaminated. It is also a confined space. | |
