# JAMES STREET NORTH RADCLIFFE

## FINAL PHASE 2 GEO-ENVIRONMENTAL INVESTIGATION, RISK ASSESSMENT AND REMEDIATION STRATEGY

**Job Number:** LKC 20 1984

**Date:** November 2021

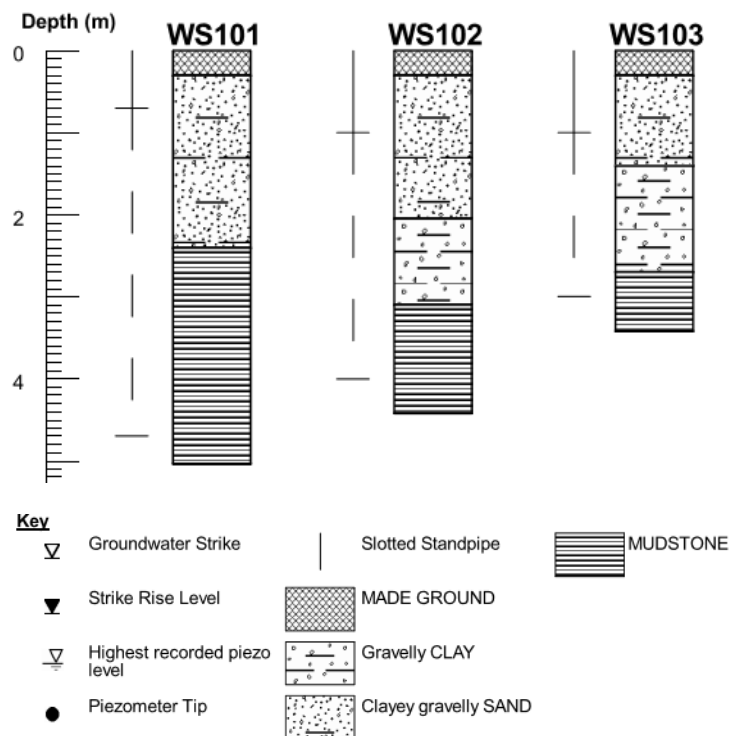
Plate 4-1: Summary of ground conditions.

The ground conditions beneath the site comprised made ground underlain by natural gravelly clayey sand / slightly gravelly clay. A summary section of the logs is provided in Plate 4-1, with additional comments below.

Ground conditions identified at the site are detailed in Section 4.1, and typically comprises Made Ground or topsoil to 0.30mbgl over medium dense variably clayey/silty gravelly SAND to 1.40m - 2.40mbgl. At the location of WS101 this is underlain by extremely weak MUDSTONE to the completion depth of the exploratory hole. At the locations of WS102 and WS103 the SAND is underlain by very stiff slightly gravelly CLAY to 2.70m - 3.10mbgl over extremely weak MUDSTONE to the depths of the exploratory holes.

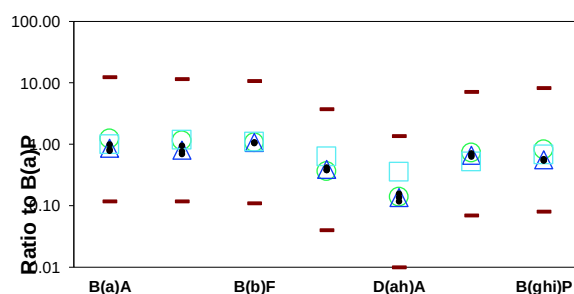
Graph 6-1 summarises the study site data with respect to how the ratios of carcinogenic PAHs relate to B(a)P, within the confidence limits provided in the HPA document.

Graph 6-1: The ratio of PAH to B(a)P in soil for all available data at the site based on 3 samples (where values were >LOD to allow the calculation of a ratio).

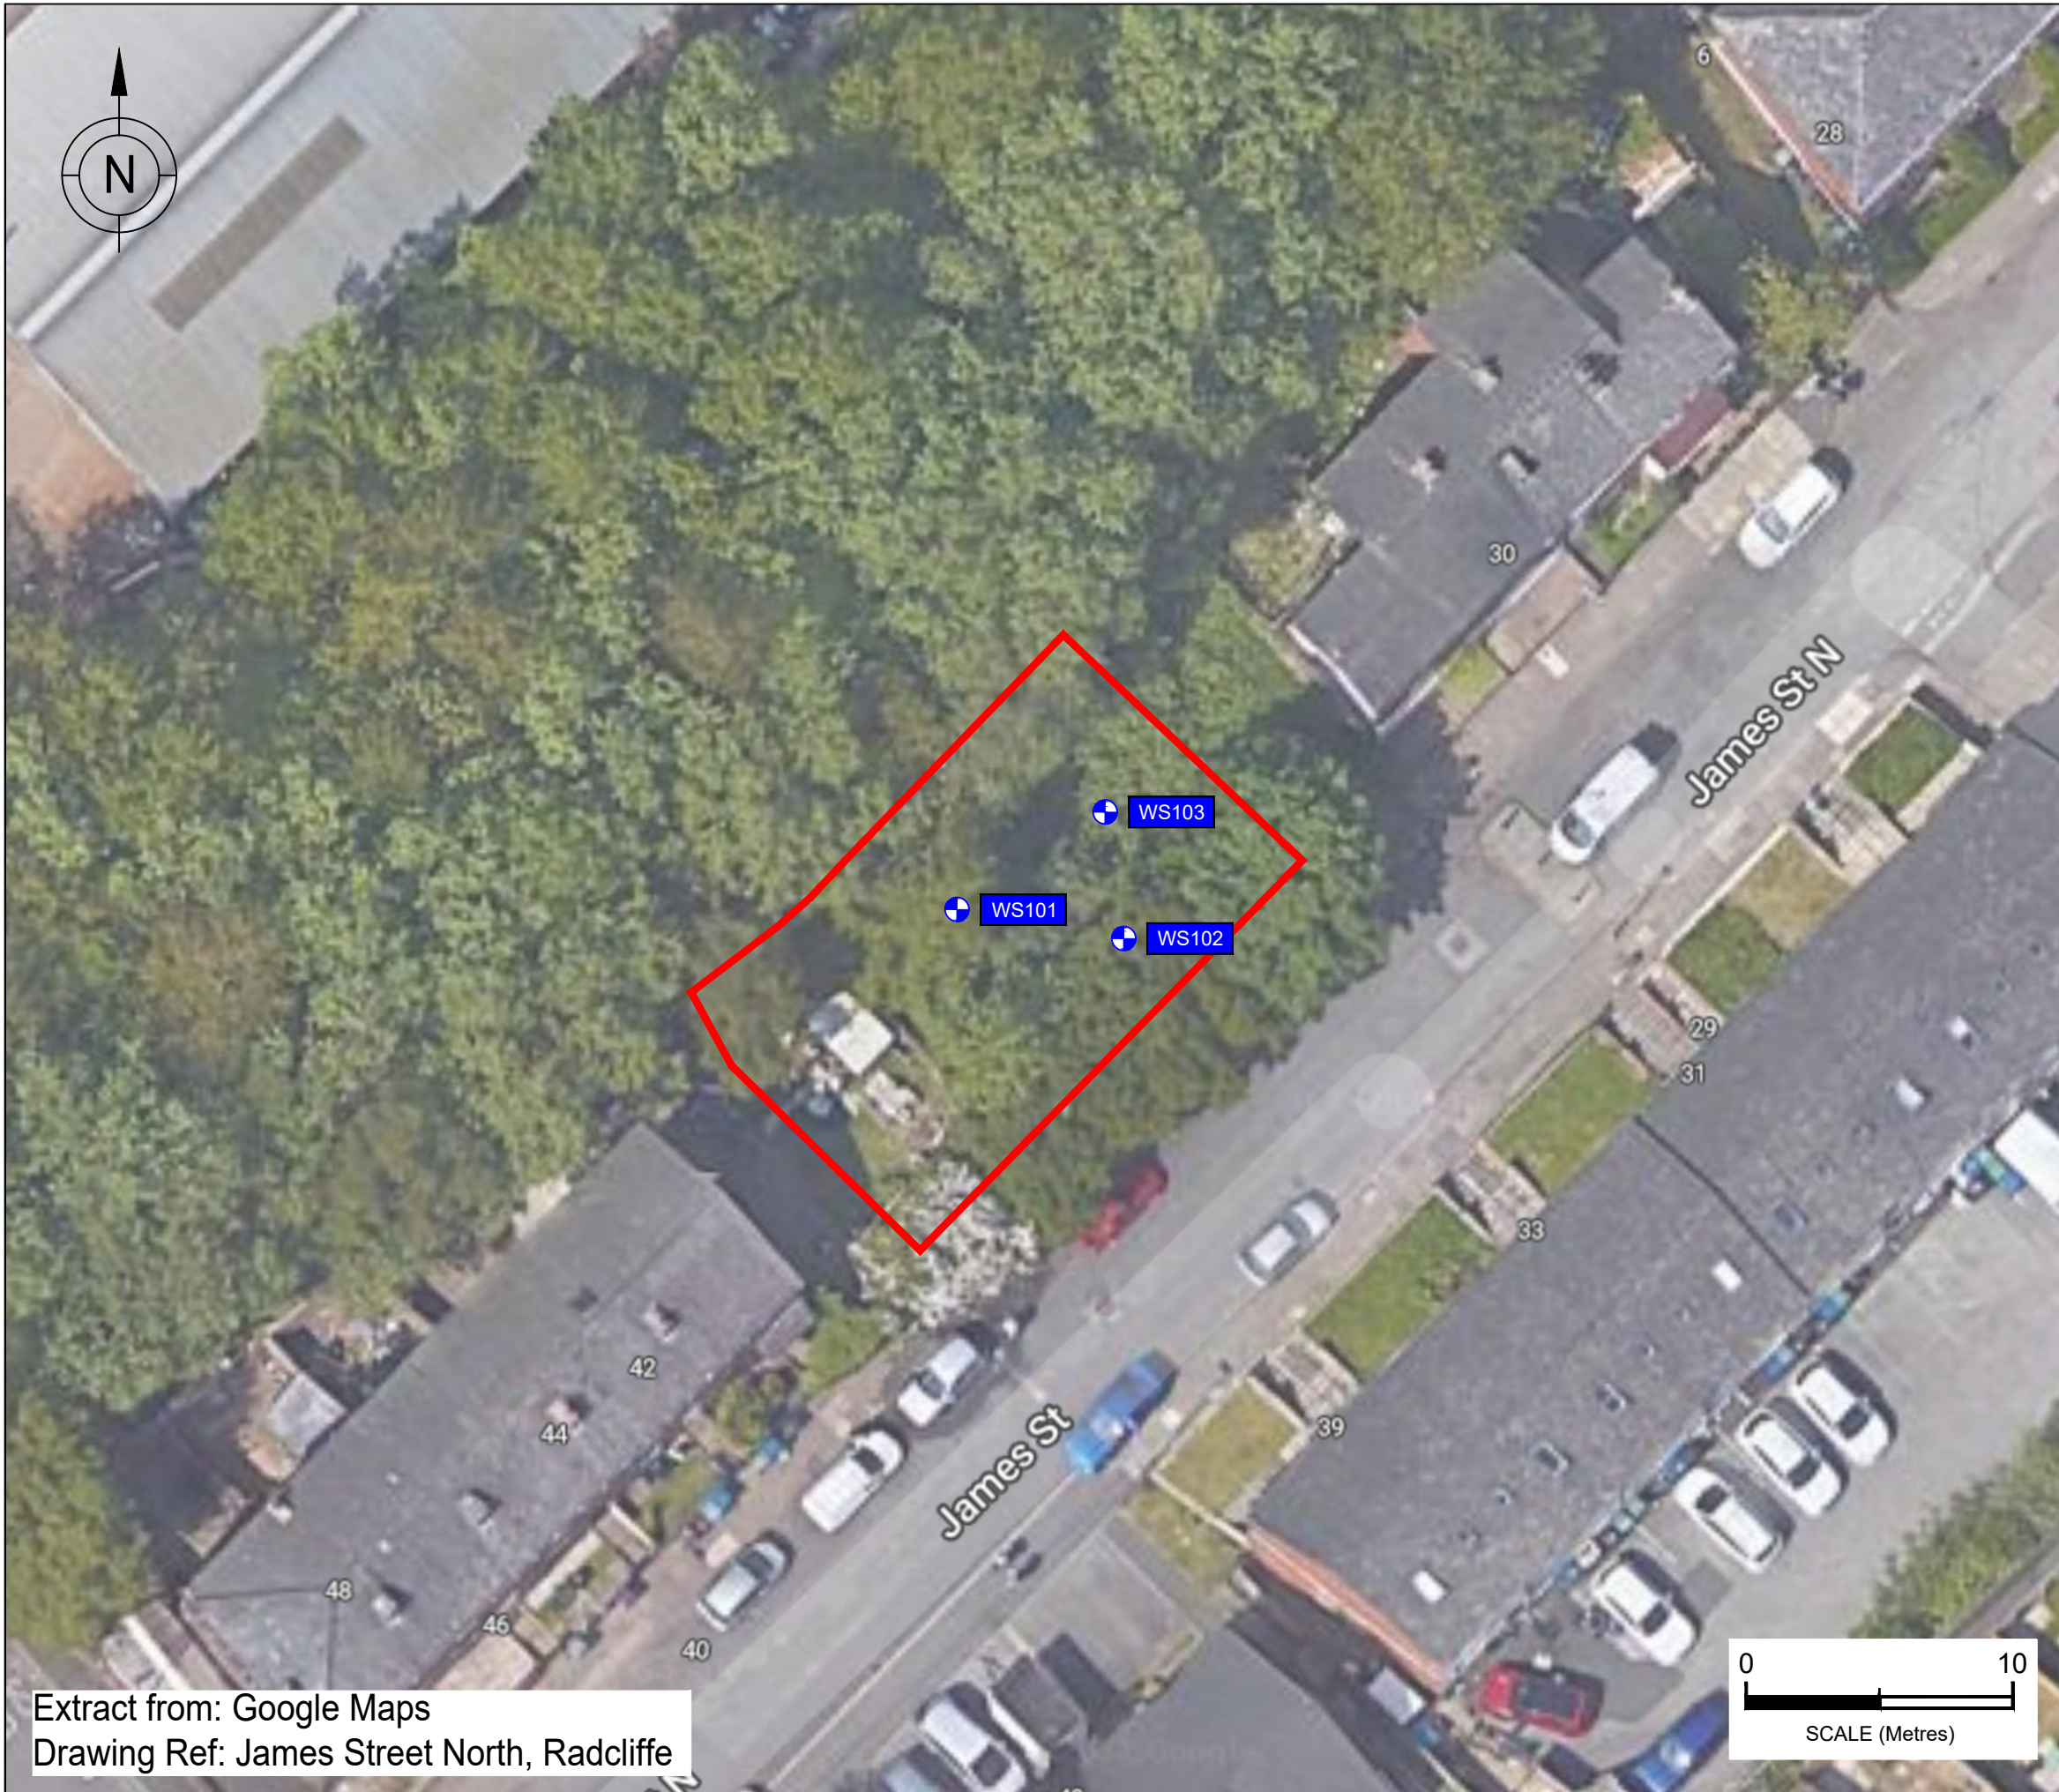
Window Sample Borehole (WS)

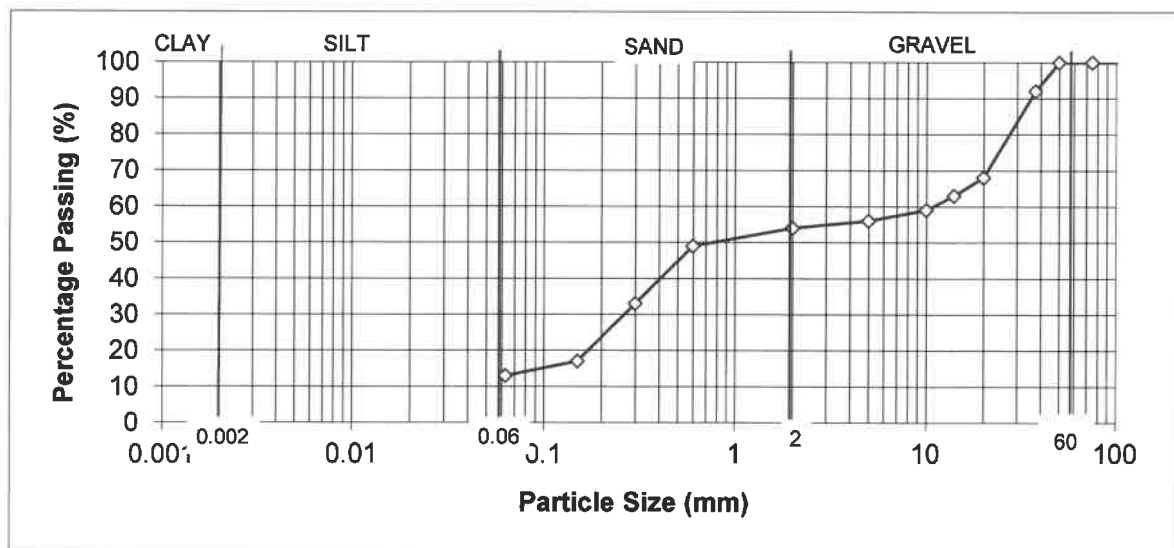
As received moisture content = 13%

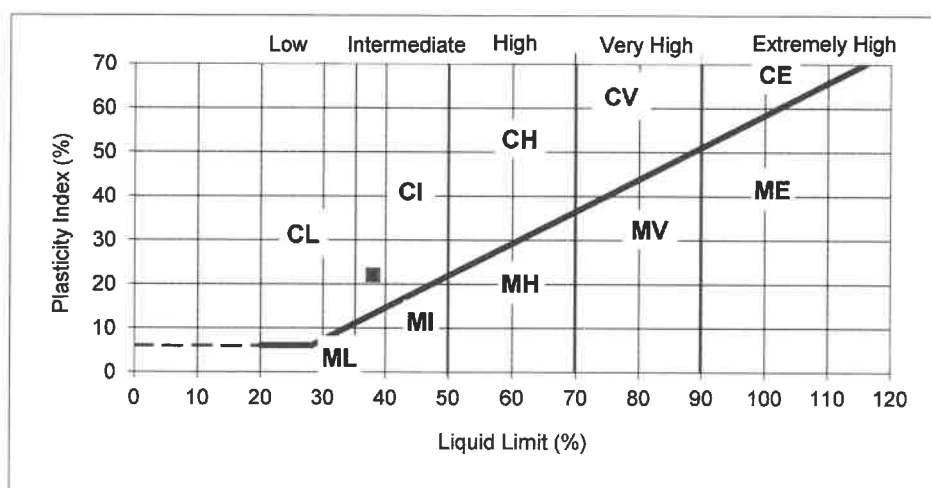
| Moisture Content<br>(Natural)<br>(%) | Liquid Limit<br>(%) | Plastic Limit<br>(%) | Plasticity Index<br>(%) | Passing<br>425 micron<br>(%) |
| 18 | 35 | 14 | 21 | 87 |

Sample tested after wet sieving
