Ref: 3524/08

13<sup>th</sup> November 2025

## COAL MINING STATEMENT – LAND OFF STOPEs ROAD, LITTLE LEVER (PLOTS 01 – 72 ONLY)

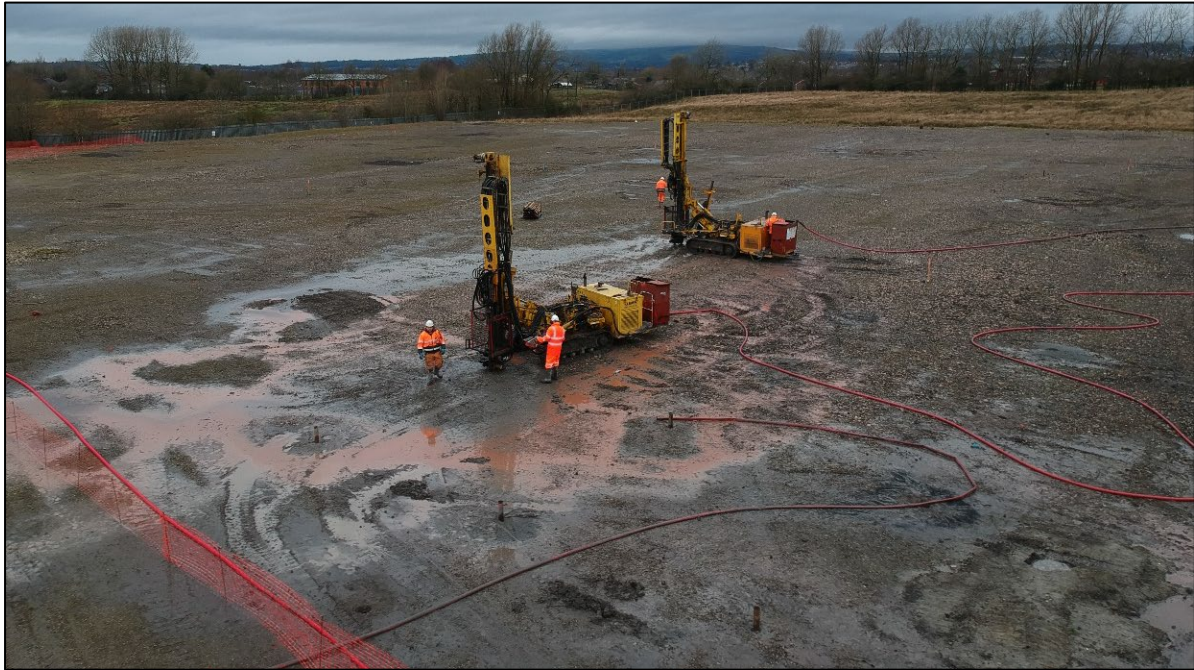
*Rotary drilling rigs undertaking drilling in the northern site section in February 2025.*

The drill and grout works were undertaken by 2 No. Klemm 802-2 rotary drilling rigs utilising water flush as a drilling medium. Temporary 101mm diameter steel casing was installed into the bedrock to allow grout to be injected at target depths and prevent the overlying Made Ground and Glacial Till from collapsing into the holes.

All holes were injected with a 10:1 (PFA:OPC) grout mix which was connected via a screwed T connection and pressure meter attached to the temporary casing. Boreholes were pressure grouted to 0.2bar (3psi) per metre of hole. Daily drill and grout records were produced. Areas of broken ground and loss of flush were encountered during the drilling works which were attributed to historical workings. These areas would typically require secondary grout holes due to grout takes in excess of 5T. The central site section typically required a greater proportion of secondary holes which suggests that there may have been more shallow workings in this area. Low grout takes were recorded in the northern and southwestern site areas. An extract of the completed grouting grid drawing with areas requiring secondary drill and grout holes highlighted, is shown below.

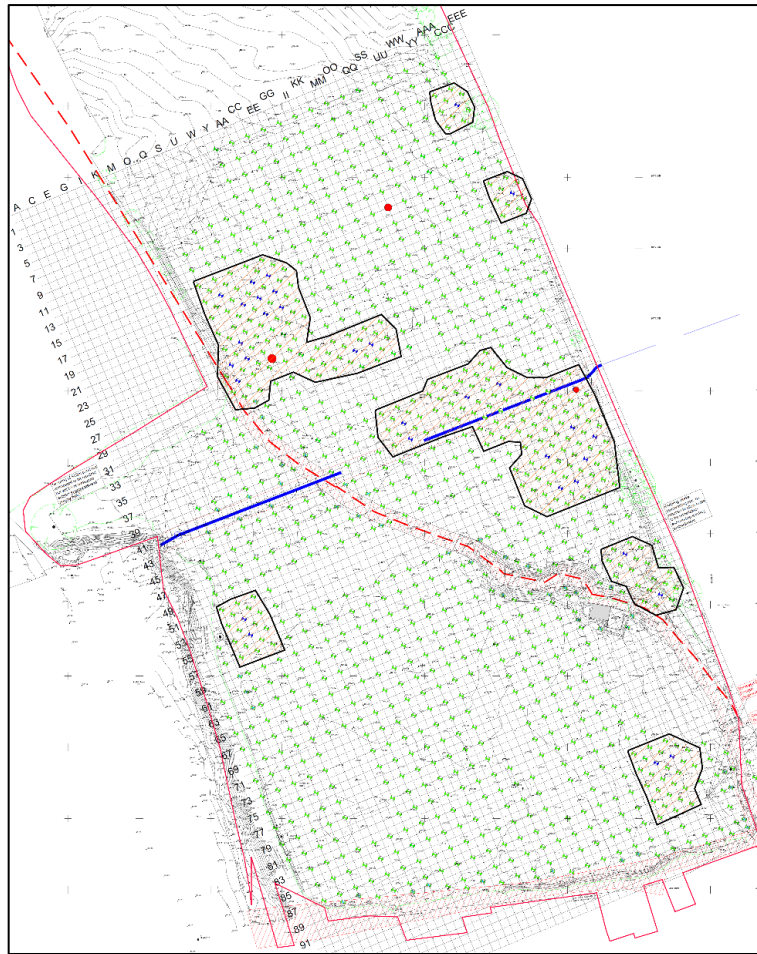
*Extract of the completed drill and grout grid with areas requiring secondary holes outlined and highlighted in orange.*

Drill and grout works to stabilise the site were undertaken from the 6<sup>th</sup> January to the 4<sup>th</sup> April 2025. In total, 1,122 No. grout holes were undertaken across the site. The drill and grout holes consisted of 993 No. primary holes undertaken on the proposed 6m grid and a further 129 No. secondary (or centre) holes which were undertaken due to grout takes in the corresponding primary holes being greater than or close to 5 tonnes (5T).
