**Remediation Strategy for East Lancashire Paper Mill Island  
Site, Rectory Lane, Radcliffe, M26 2QU**

**Project No: NX418/R1**

**Phase 1 & Phase 2 Geoenvironmental Desk Study & Ground Stability Risk Assessment for East Lancashire Paper Mill Island Site, Rectory Lane, Radcliffe, M26 2QU**

**Project No: NX418**

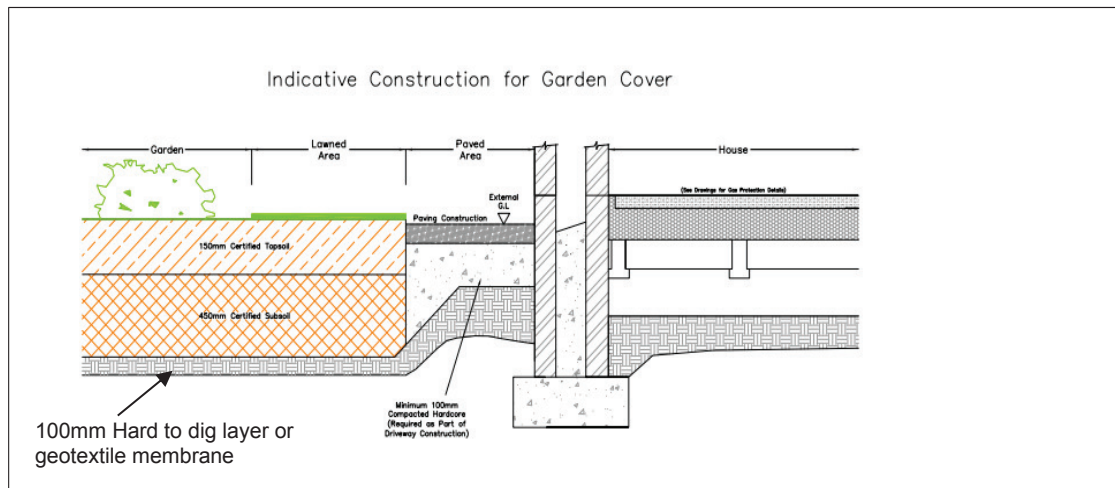
**Figure 6.3.1 – Clean Cover System Example within Plots 1 to 6 Garden areas.**

Although not shown above, best practice states that the 'clean cover system' layer should comprise a capillary break layer/hard to dig layer comprising 100mm of compacted stone or geotextile membrane beneath the 450mm of clean imported subsoil and 150mm of topsoil to form the 600mm the cover system thickness. We recommend that hard to dig layers or geotextile membrane are placed in gardens of proposed plots 1 to 6. Given the nature of recorded contamination, we consider that hard to dig layers are not required in landscaped areas. However, future contractors should be notified to ensure that appropriate PPE is adopted when future excavation works are carried out within proposed landscaped areas.

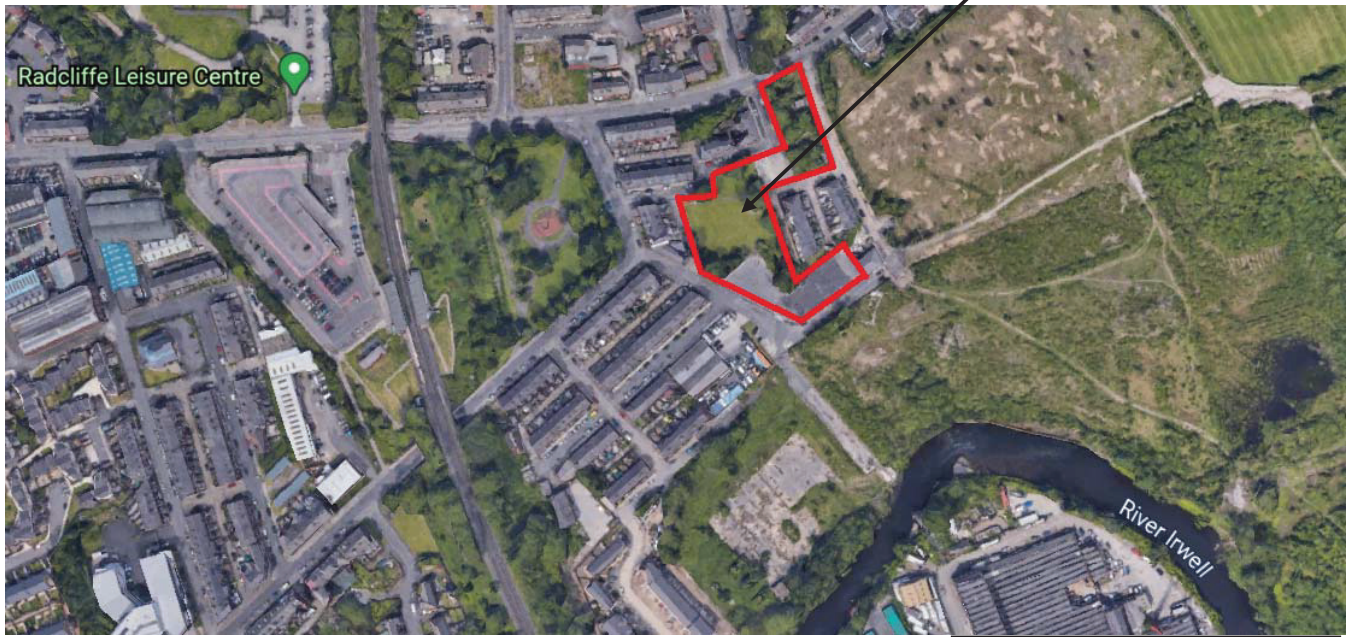
Site Location Plan

Site Centre:  
OS X (Easting) 379021  
OS Y (Northing) 407407
