# **KNOTWEED ERADICATION**

## **EXCAVATION REPORT FOR**

### **FORMER TETROSYL SITE**

| <b>Report number</b> | IWMP2172B |

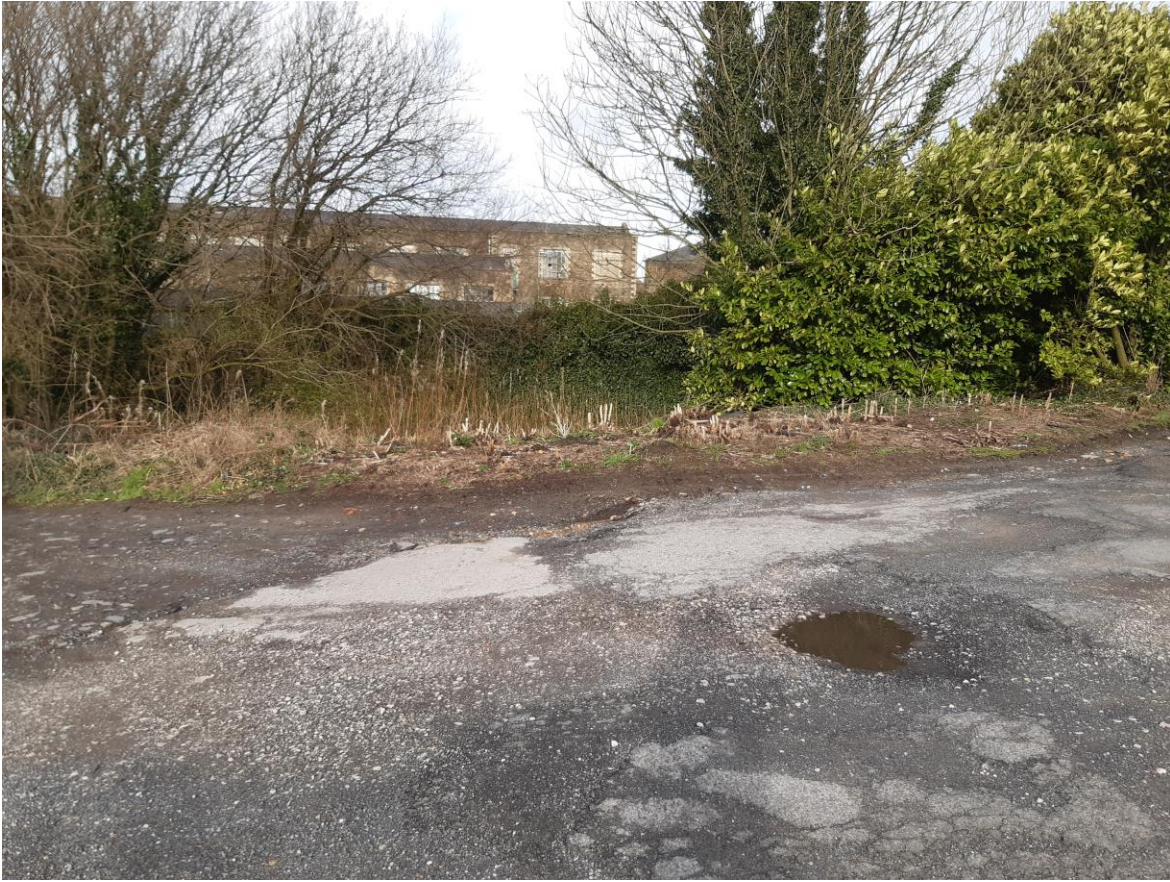
Pic 1- JK area before

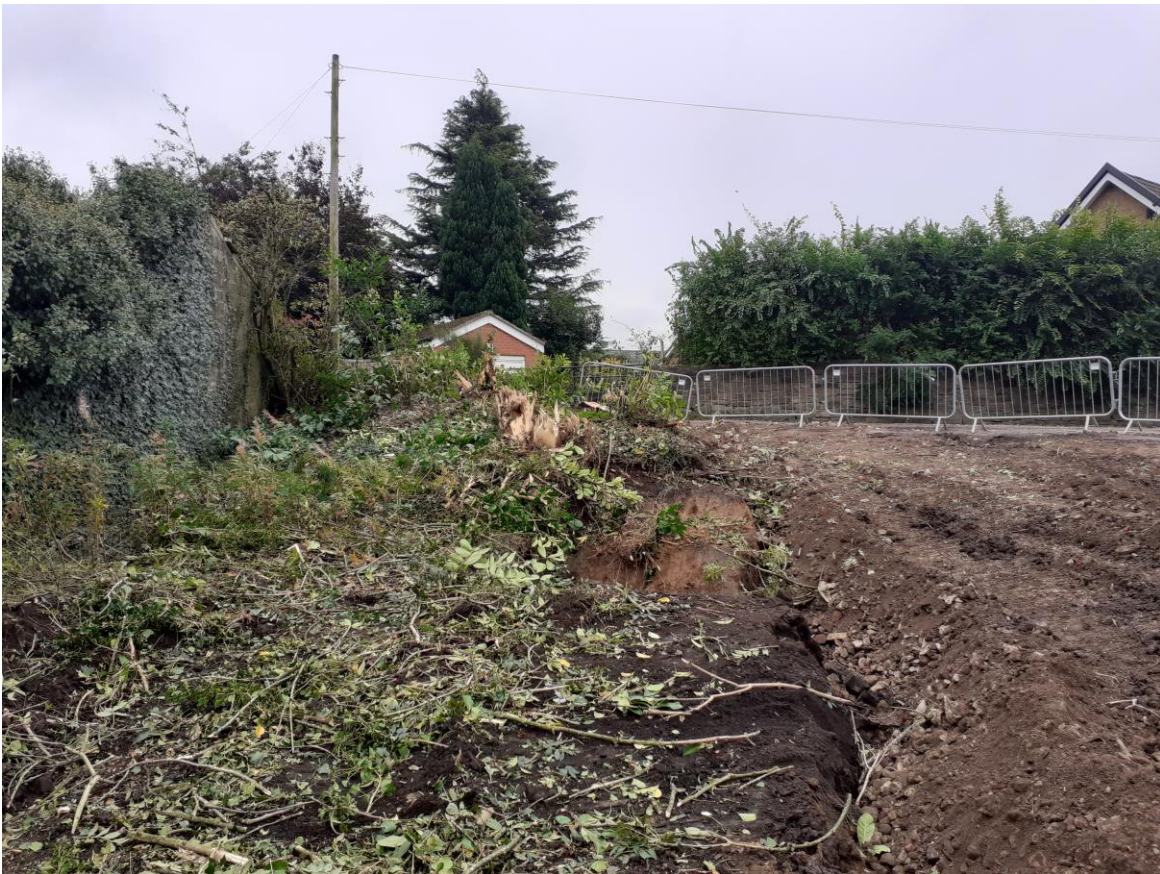
Pic 2 – JK area during excavation

- 1.8 The soil was tipped and once the cell floor was getting full it was civilised with the excavator to compact and maximise space. This process was repeated with the remaining excavated and moved soil until the knotweed had been excavated fully.

- 1.9 The excavation was completed over two days once a remaining tree and other vegetation was removed from the affected area. The area was back-filled each day with hardcore so there wasn't an open hole left outside of the secure site.

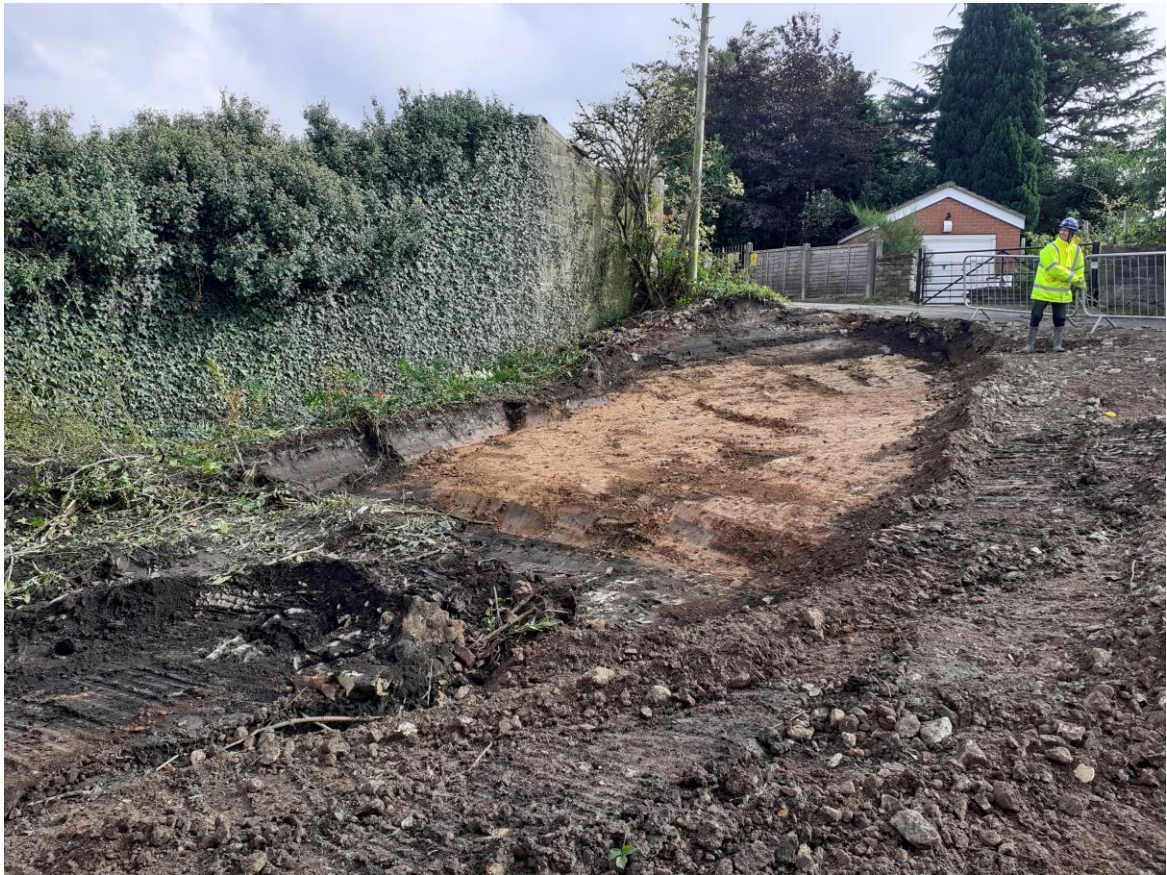
Pic 3 – Jk area Excavated

- 5.1.1 Excavation of knotweed material was undertaken by Urban Regen on the 1<sup>st</sup> and 2<sup>nd</sup> October 2020 under supervision by Knotweed Eradication with the contaminated material being placed into a burial cell and covered with CuTex geomembrane.
- 5.1.2 Depth of excavation for the area was 0.7 to 1.4m deep.
- 5.1.3 Continued monitoring of site will be undertaken as part of ongoing maintenance prior to the commencement of a five year warranty period.

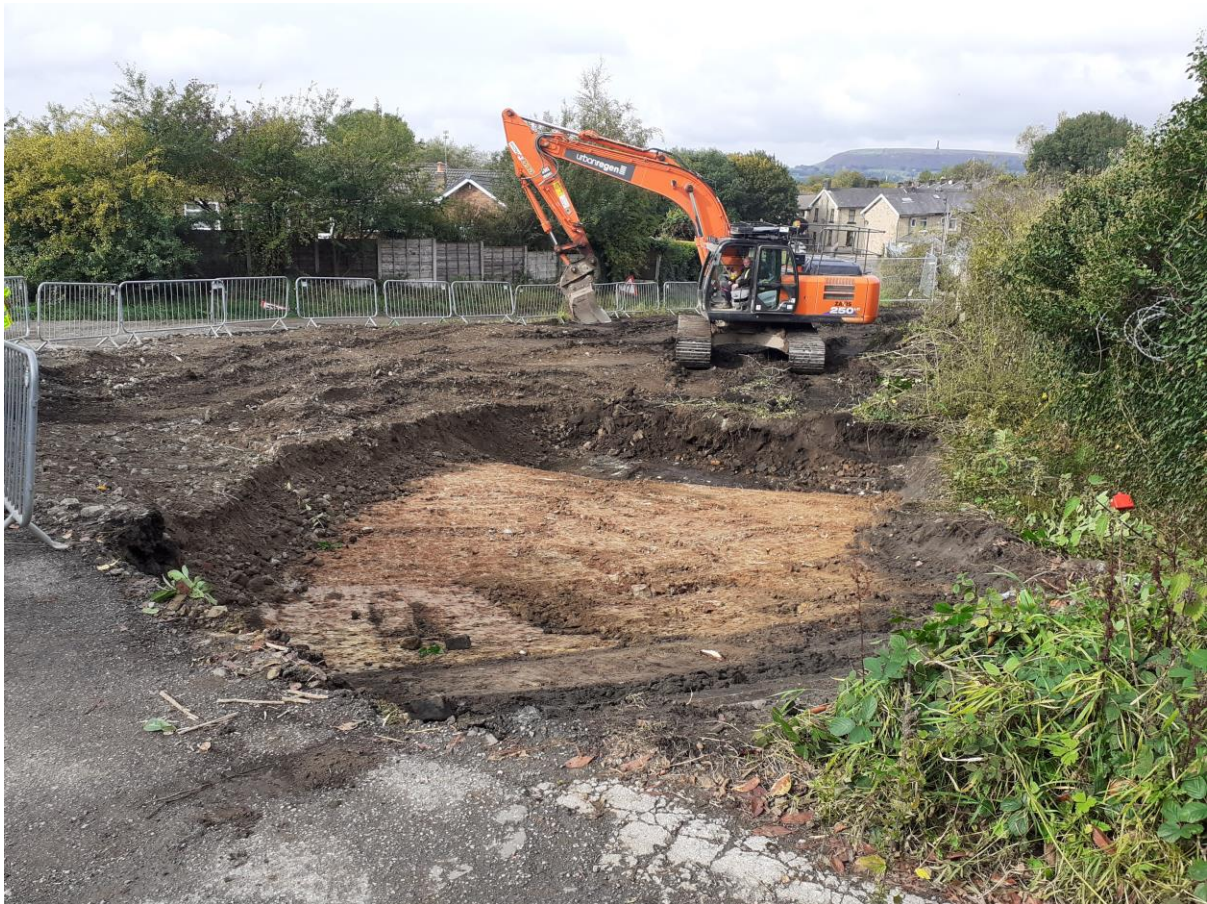
Pic 4 – JK area completed

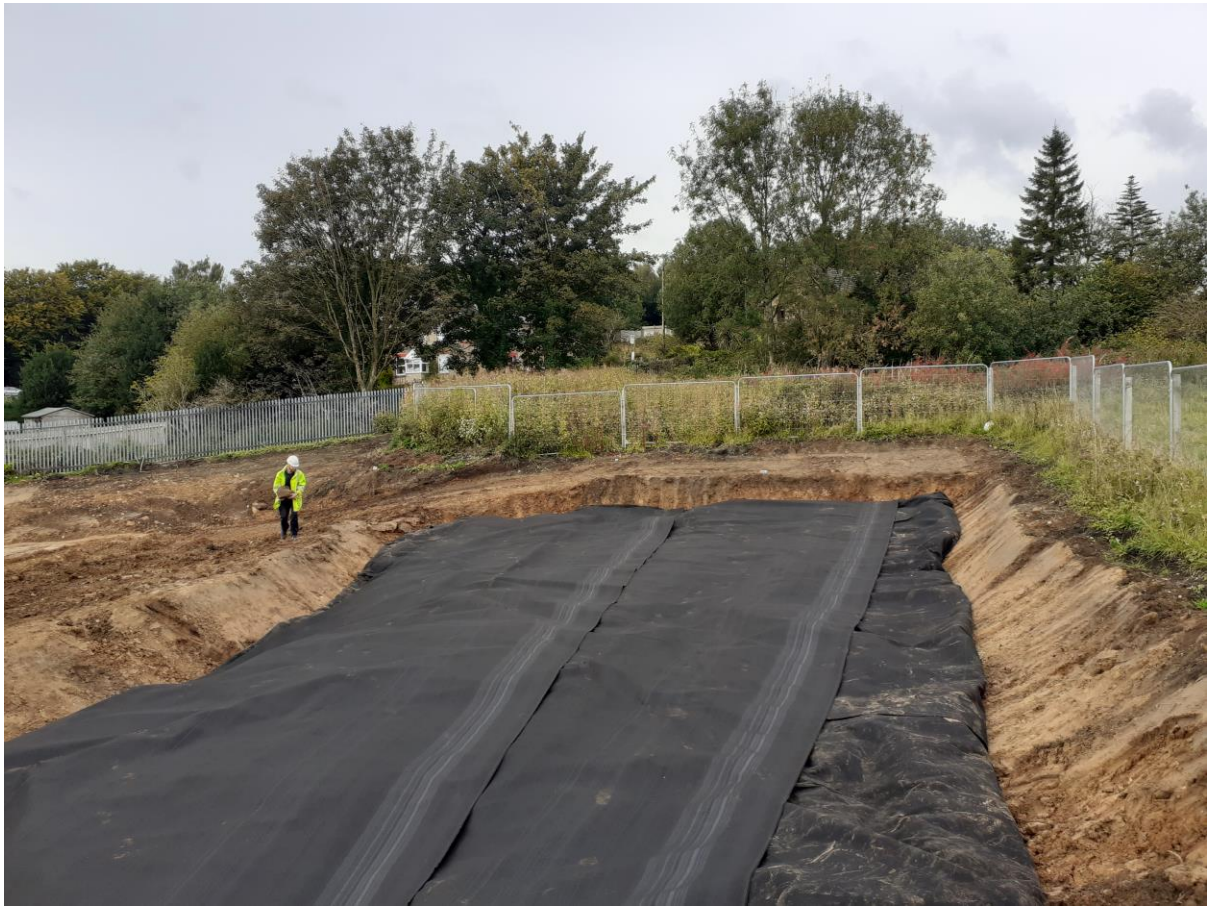
Pic 5 – Burial cell covered in Cutex

- 1.6 In April 2020 Urban Regen appointed Knotweed Eradication to act on their behalf with regards to the treatment of the knotweed within the site.
- 1.7 The area of knotweed that was located beyond the site wall was excavated under supervision and loaded into ADT for moving to a burial cell that had been created at the northern end of site adjacent an open area of POS. The cell was prepared prior to the excavation with a hole measuring approximately 20 x 12 m being dug to a depth of 2.0m. The cell was lined with CuTex geomembrane prior to any knotweed-impacted soil being moved and placed in the cell.

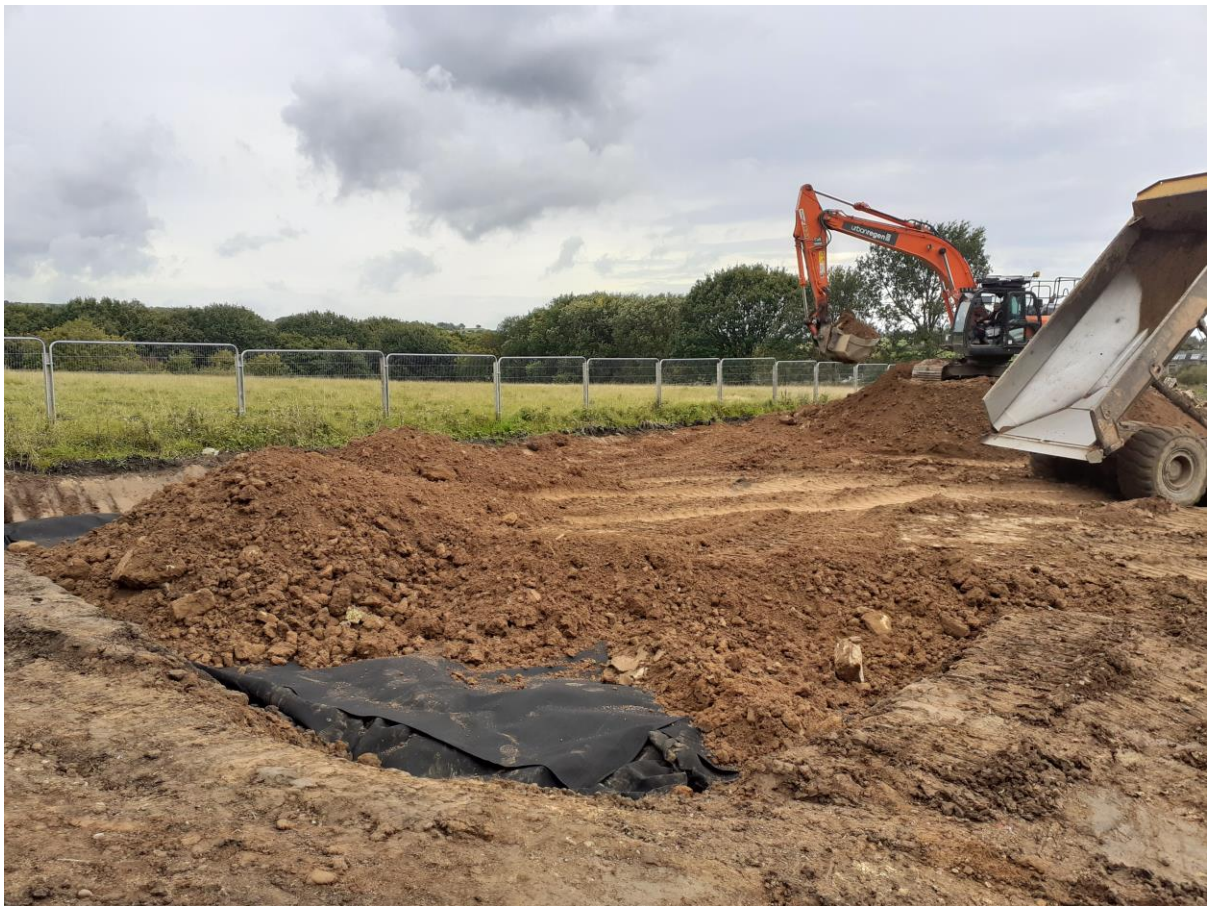
Pic 6 – Burial cell covered in clean soil prior to completion of finished surface levels (+ 1.0m minimum)

- 1.10 The cell was completed and covered over with clean material to weight it down in preparation for final levels to be created.
- 1.11 Original JK areas have been marked on the attached plan (fig 1)

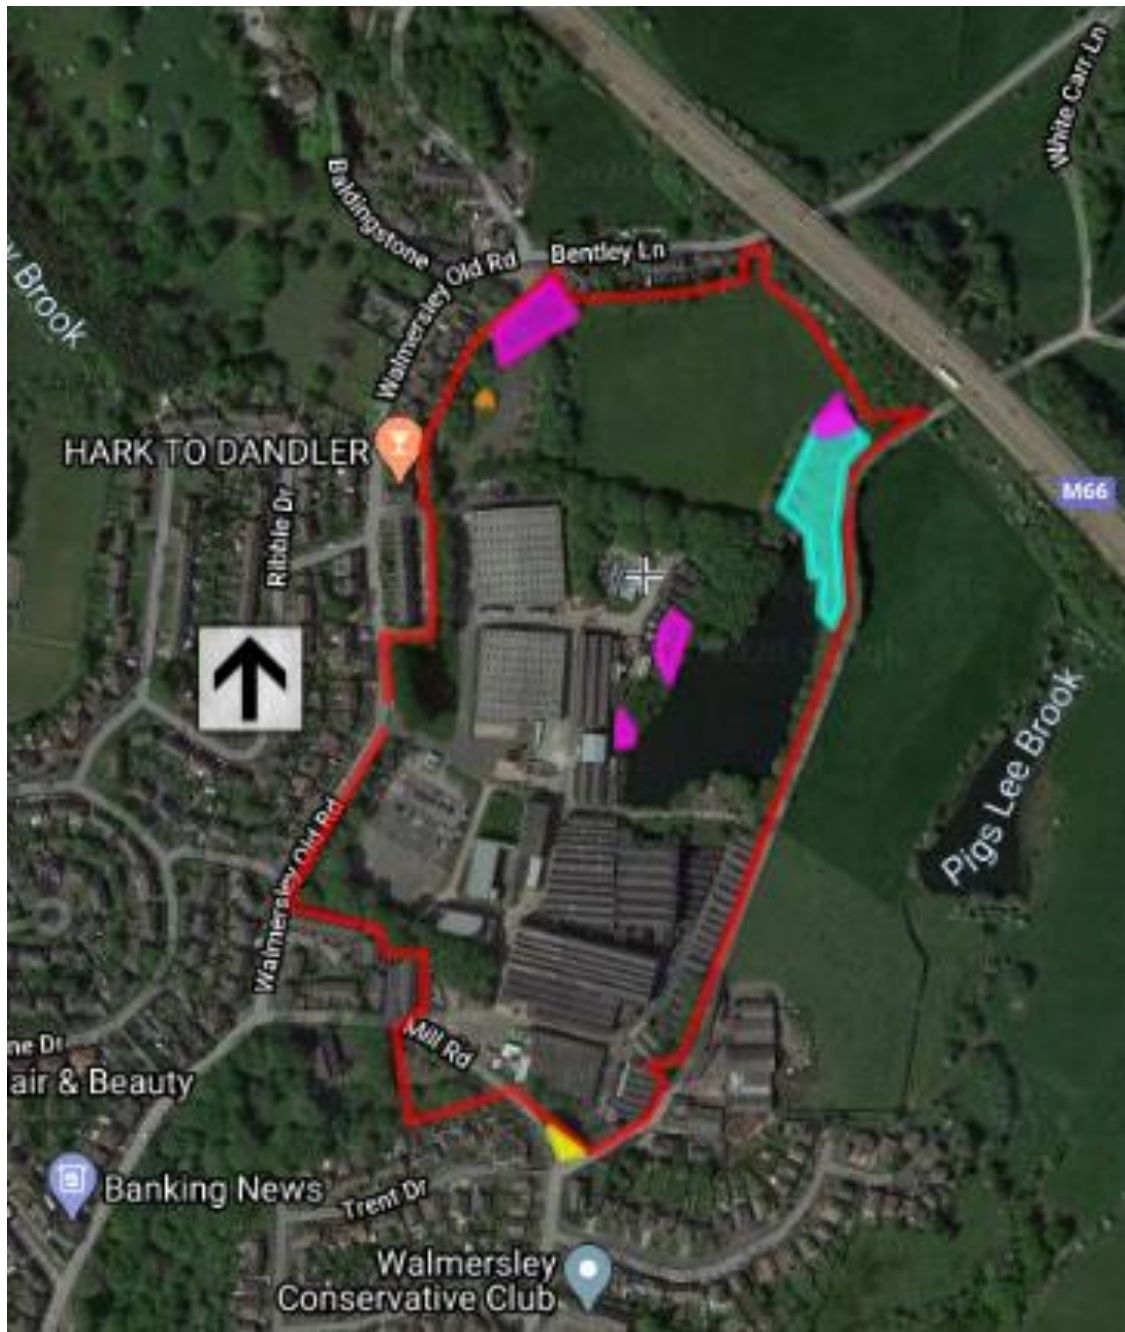
- 1.3 Surrounding areas comprise of agricultural land to the north, east and residential dwellings to the south, west.
- 1.4 The site was inspected on 10th February 2020 outside of the expected growing season with no areas of visible knotweed being identified within the site. However, Knotweed was visible beyond the site boundary wall at the southern point of site in an area immediately adjacent site and Mill Road.

Fig 1. Original JK location
