Site Investigation Report  
for Land Adjacent to  
Bealey Industrial Estate,  
Radcliffe

For: Westchurch Homes Ltd  
Kennedy House  
31 Stamford Street  
Altrincham  
Cheshire  
WA14 1ES

Date of Report: 8 November 2024

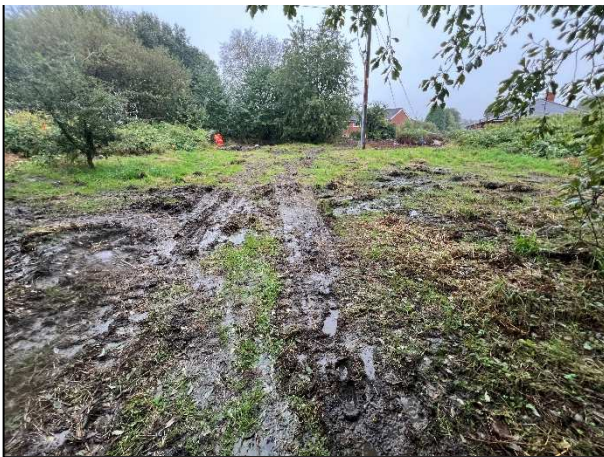
*Photograph 1: Showing the northern most point of the site, an opened grassed area with vegetation surrounding and the overhead power line that crosses the site*

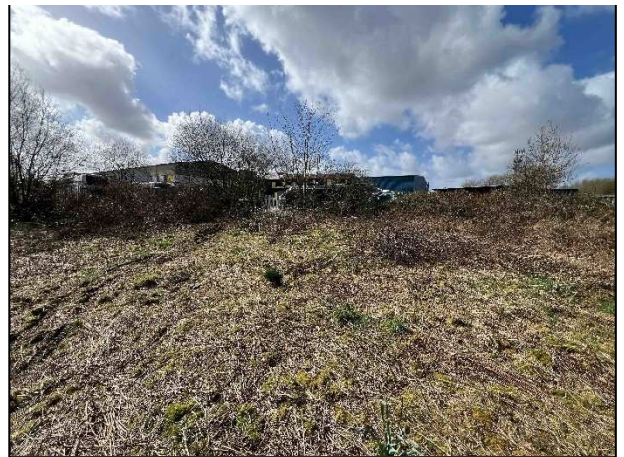
*Photograph 2: Showing the central part of the site with a mixture of grassed areas with dense vegetation, mature trees and self-seeded saplings*

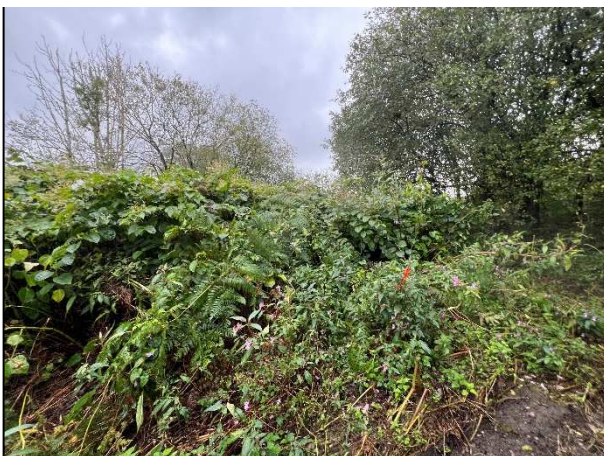
Further assessment of the vegetation in these areas identified the presence of the invasive species, Himalayan Balsam (refer to Photograph 3) and Japanese Knotweed as both early growth and last year's dead vegetation (refer to Photograph 4). This became more prominent in the north western areas of the site.

*Photograph 3: Showing the presence of Himalayan Balsam an invasive species in the north of the site, located adjacent to Japanese Knotweed*

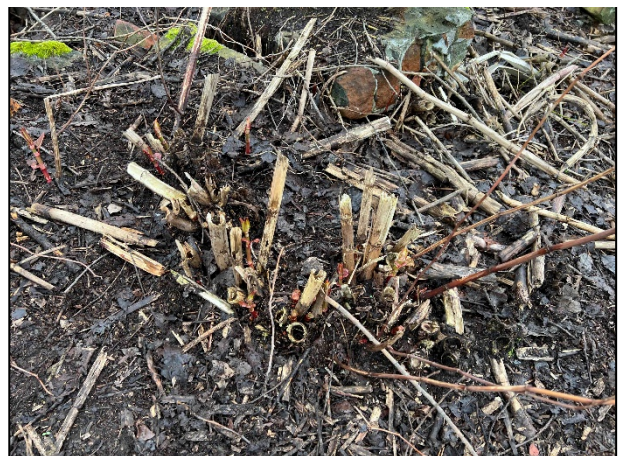
*Photograph 4: Showing the visible signs of Japanese Knotweed as both early growth and last year's dead vegetation*

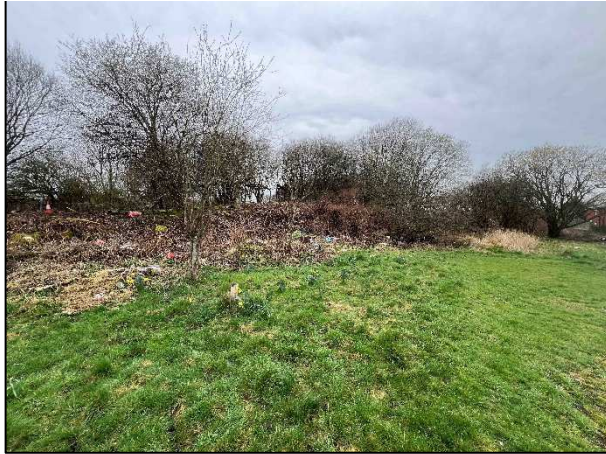
A security fence dissected the central area of the site originating from the south eastern boundary before terminating at the western boundary. An embankment was present in the northern area of the site prompting a rise in topography towards the north west (refer to Photograph 5). Beyond the embankment a dilapidated steel framed structure and a large low level concrete structure were present (refer to Photograph 6), dense vegetation prevented further access towards the south and the possibility of uncovering any other features in this area.

*Photograph 5: Showing the embankment in the central part of the site prompting a rise in the topography*

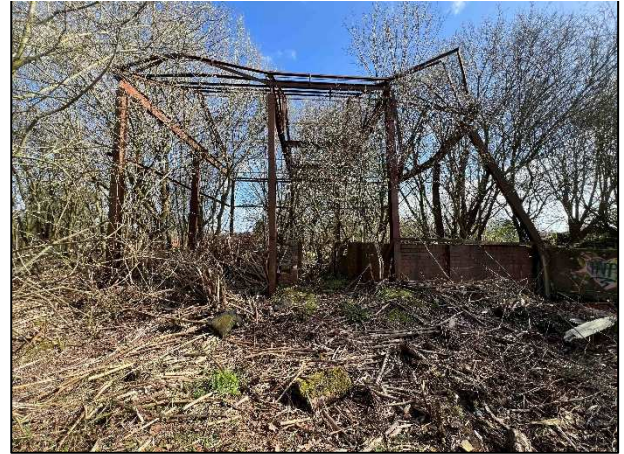
*Photograph 6: Showing the dilapidated steel framed structure and large low level concrete structure*

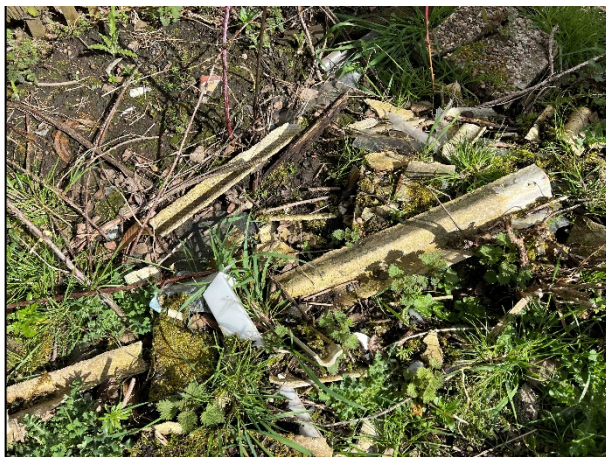
There were significant signs of fly tipping across the eastern and central parts of the site with a variety of household waste including possible ACMs (refer to Photograph 7). A large shipping style container was also present in the central area of the site again containing household waste (refer to Photograph 8).

*Photograph 7: Showing the presence of possible ACMs within the fly tipping present on site*

**Hazardous Building Materials:** As detailed within Coopers' site description (Section 5), at the time of the walkover there were buildings within the site which are considered to potentially comprise of Asbestos Containing Materials (ACMs), and areas of suspected fly tipped ACMs were also observed.

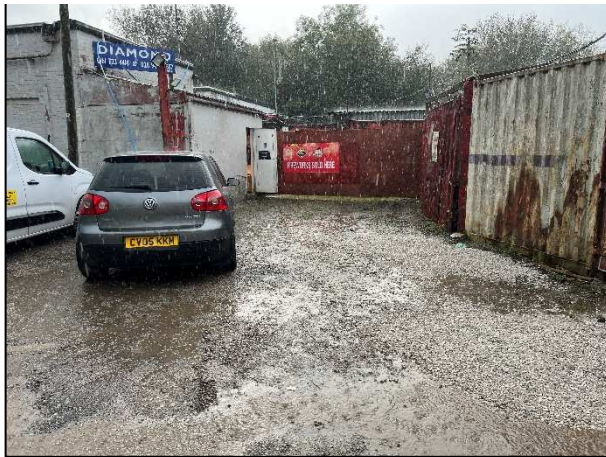
The central and southern area of the site was part of Bealey Industrial Estate with storage compounds consisting of steel containers, storage for vehicles and a fireworks shop operating out of a unit in the central areas (refer to Photograph 9).

*Photograph 9: Showing the firework shop located in one of the units as part of Bealey Industrial Estate located in the central area of the site*

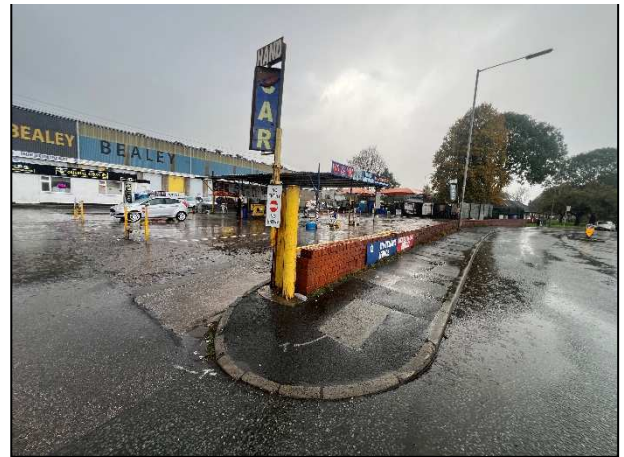
Moving towards the south, areas were occupied by parking for both coaches and cars. A hand car washing business was present along with a takeaway business again operating out of a small unit in the southern most part of the site (refer to Photograph 10).

*Photograph 10: Showing the businesses at the southern most part of the site, a hand carwash and a takeaway*

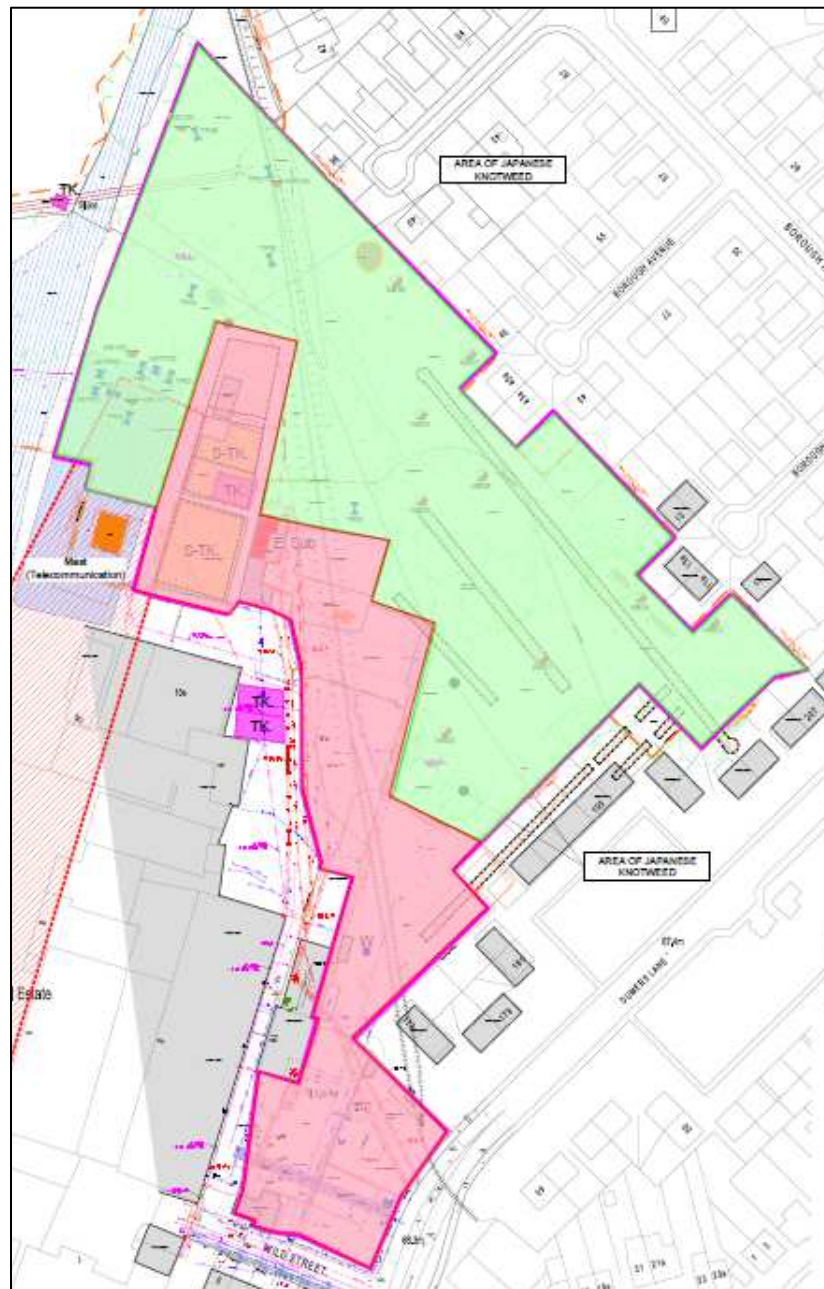
Parts of the site was largely considered inaccessible for ground investigations due to either existing commercial use, fencing or vegetation. Westchurch Homes undertook works to clear the eastern part of the site for access by a small diameter drilling rig, although areas were still limited by topography, vegetation and suspected invasive plant species (Japanese Knotweed). The limitations on investigation are referenced on Coopers Drawing No. 8353/01 - Site Plan in Appendix 13 and areas permitted for investigation are highlighted green in Figure 2 (below).

Figure 2: Annotated Extract of Coopers Site Plan, with shading of investigation areas, green shading defining area available for investigation, and pink defining inaccessible areas

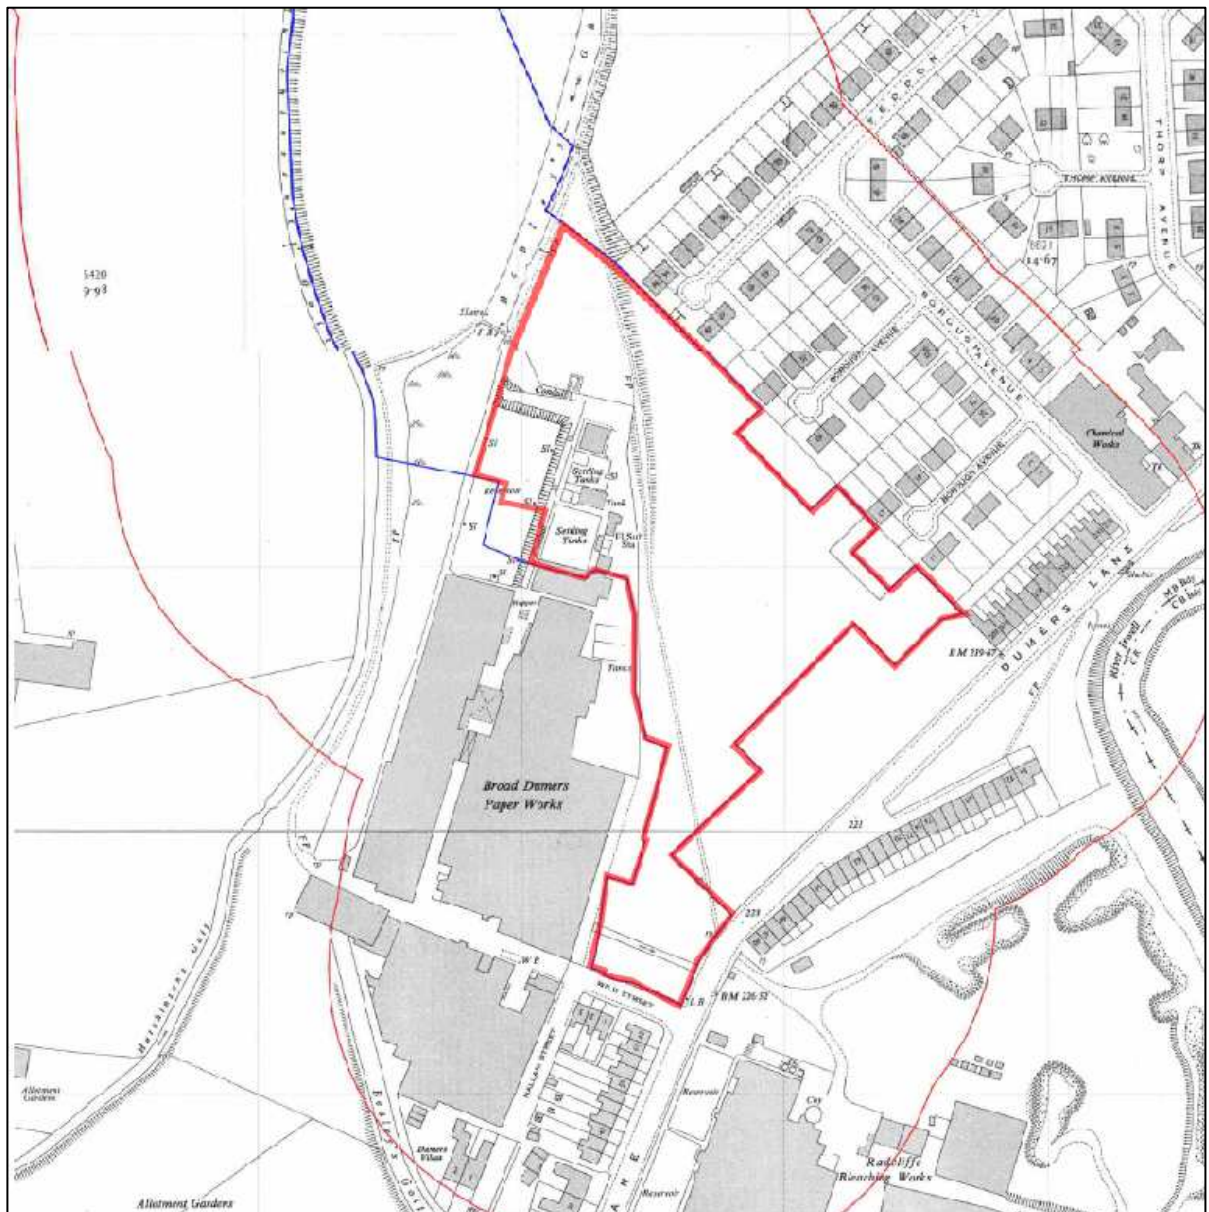
**1955/1956 (1:1,250, 1:2,500 and 1:10,560):** The maps record changes to the filter beds in the north west of the site, which were referenced as 2 No. settling tanks, smaller outbuilding, a tank and an electrical substation (refer to Figure 3). The former tramway through the site was recorded as a footpath.

Figure 3: Extract of stitched versions of the 1955/1956 OS Map, 1:1,250 and 1:2,500 scale editions with approximate site boundary recorded in red

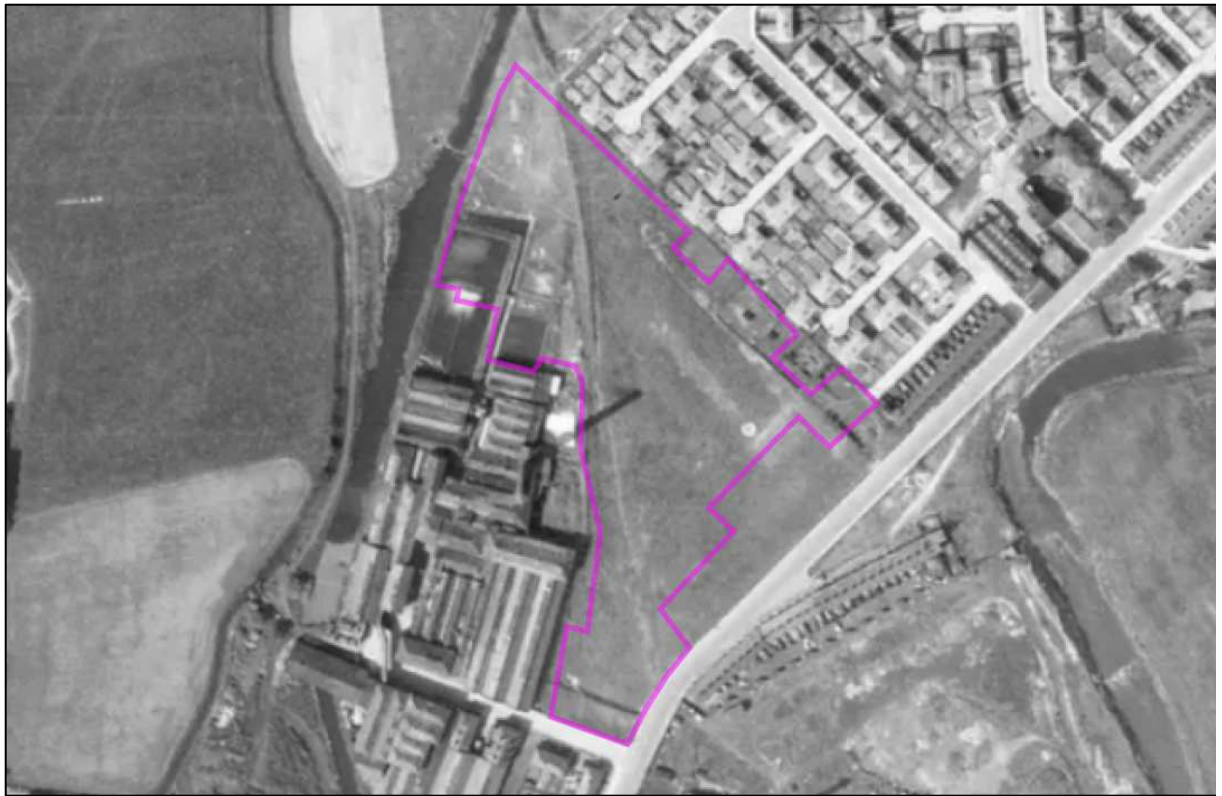
*Figure 4: Annotated aerial photograph of the site on 12 June 1948 with approximate site boundary (image from Historic England)*

The first aerial photographs obtained for the site are from 1948 (Figure 4) with evidence of potential disturbed ground within open parts of the site. The subsequent images from 1979 and 1989 (supplied by Bury Council – Appendix 1) record the changes between the paper mill and the industrial estate, including infilling of sections of Bealey's Goit adjacent to the site and the reservoir/settling tanks within the site.

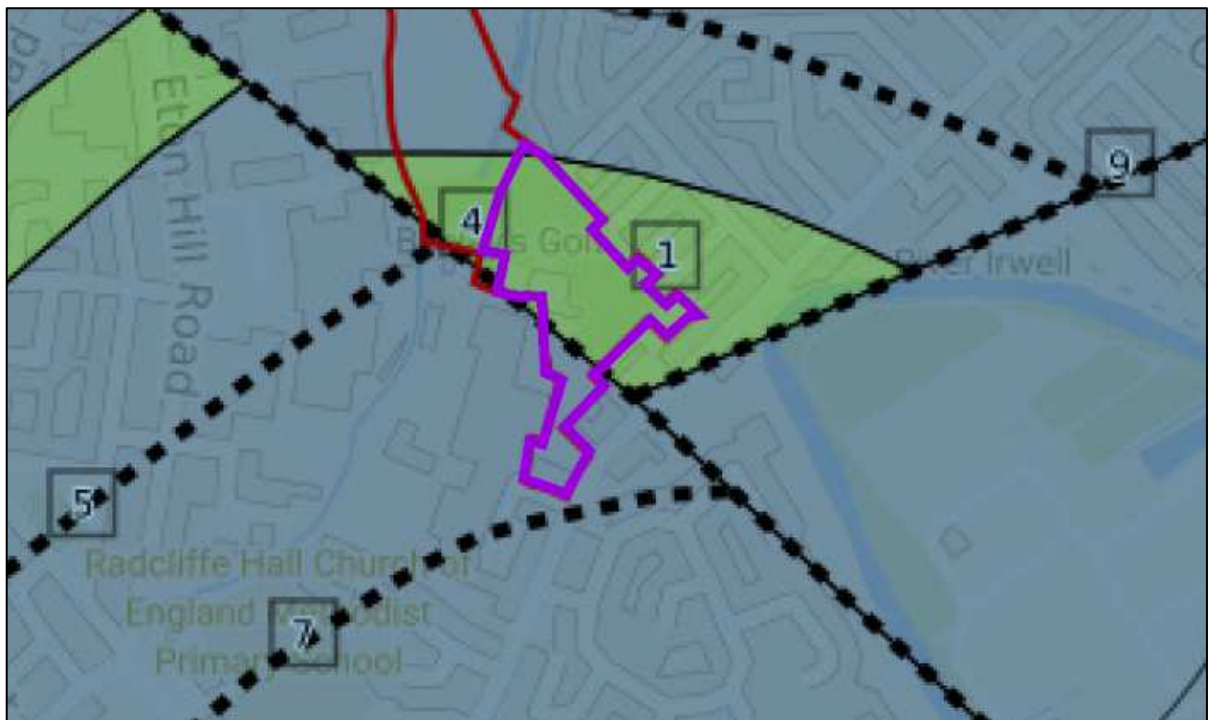
Geological mapping records the north eastern half of the site to be underlain by Sandstone (Peel Hall Rock Unit) of the Pennine Middle Coal Measures, which is Carboniferous in age (315.2-318 Ma). The south western half of the site is underlain by undifferentiated Mudstone, Siltstone and sandstone of the Pennine Middle Coal Measures which are carboniferous in age (309.5-318Ma). No coal seams outcrop beneath the site.

Figure 5: Extract of Groundsure 1:50,000 scale bedrock geology map

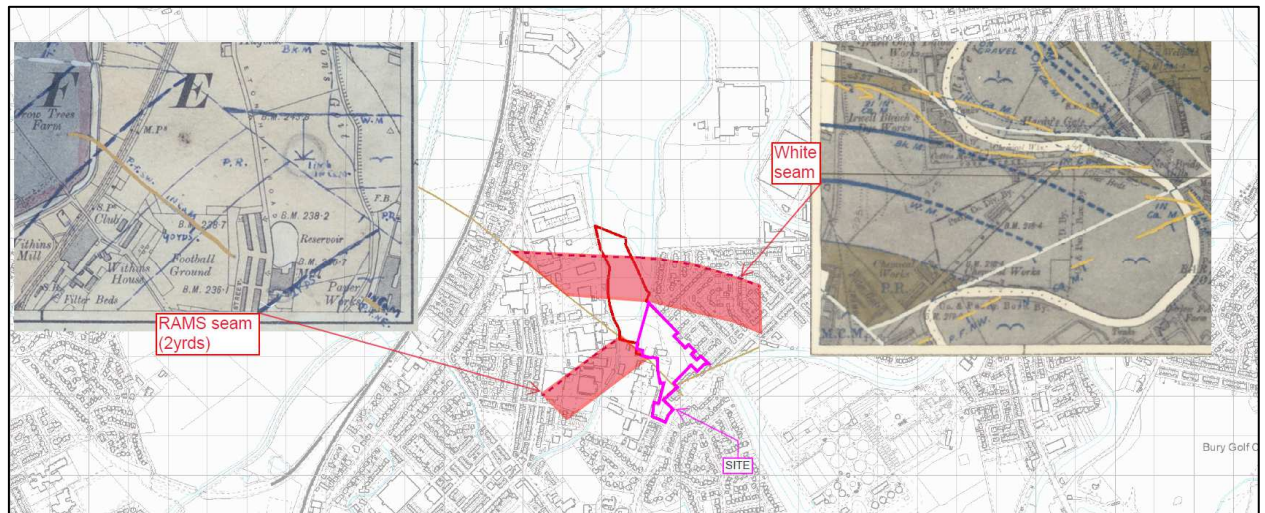
The Coal Authority Consultants Coal Mining Report (Appendix 4). The report referenced the presence of the outcrop of coal seams within the original search area including the White seam and RAMS seam. The seams are separated by a geological fault which downthrows to the south west. The revised site boundary now identifies the seams to outcrop approximately 100m north (White seam) and 80m to the west (Rams seam). The seams dip to the south and south east with defined zones of probable shallow coal mining not impacting the site. The outcrop locations have been correlated with 1:10,560 scale BGS maps (site spans 4 No. map editions), with annotations recording the revised site boundary and seams in relation to Coal Authority and BGS maps provided in Figure 6 (below).

Figure 6: Annotated extract of The Coal Authority map with overlays of BGS 1:10,560 scale maps, referenced coal seams and names, and revised site boundary (pink)

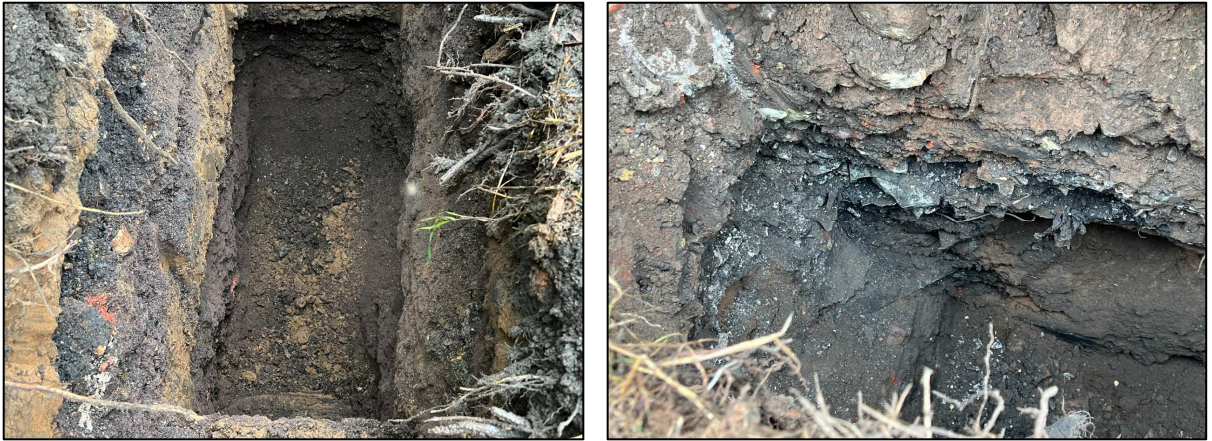
Photographs 11 and 12: Showing nature of general made ground within trial pit TP02 (left) and the infill reservoir TP09 (right)

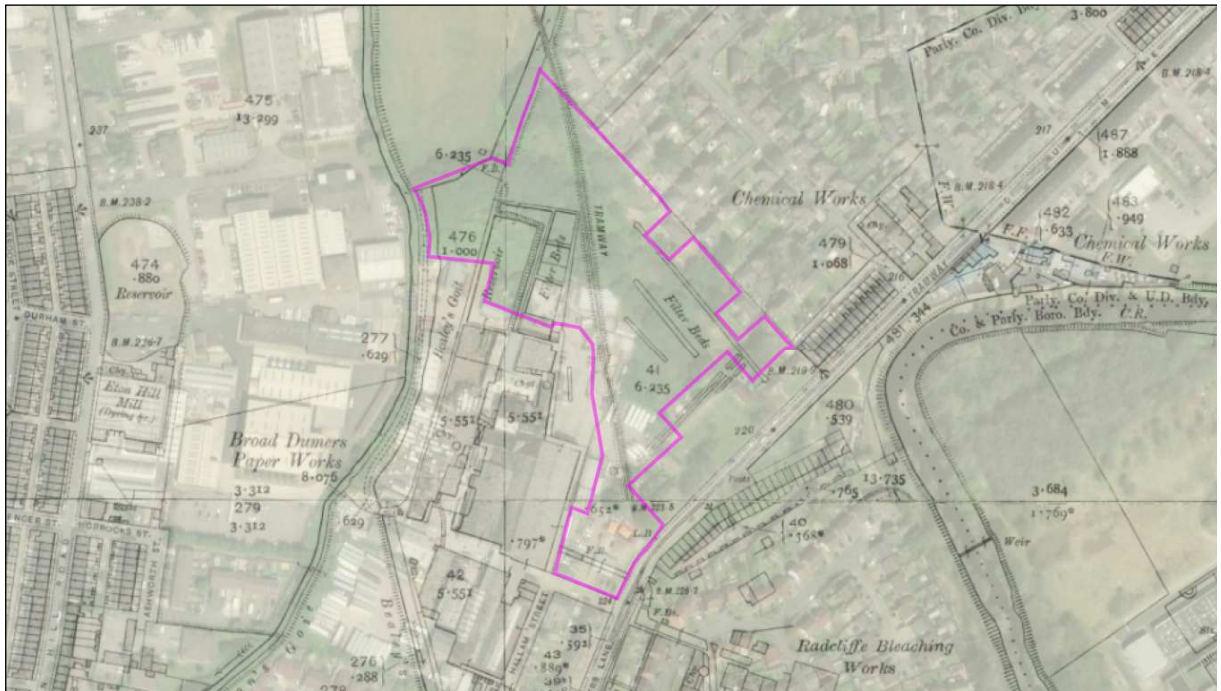
The historical OS maps (Appendix 3) and Local Authority Consultation (Appendix 1) demonstrate the site to have been utilised as open land, filter beds, and reservoirs from the former Dumers Paper Works (subsequently Broad Dumers Paper Works). A tramway connecting to Radcliffe Bleach and Chemical Works, electricity substations, and Bealeys Goit (part infilled). The historical maps/Local Authority response record surrounding area to include Eaton Hill Cotton Mill (later a dye works, then dye and finishing), a gasometer, Dumers Paper Works, Radcliffe Bleach and Chemical Works (later bleaching works), a chemical works, engineering works, infilled reservoirs, areas of waste disposal activity and a sewage works (refer to Figure 7, below and Figure 4 in Section 7.4).

Figure 7: Overlay of historical Ordnance Survey map with current aerial photography and approximate site boundary

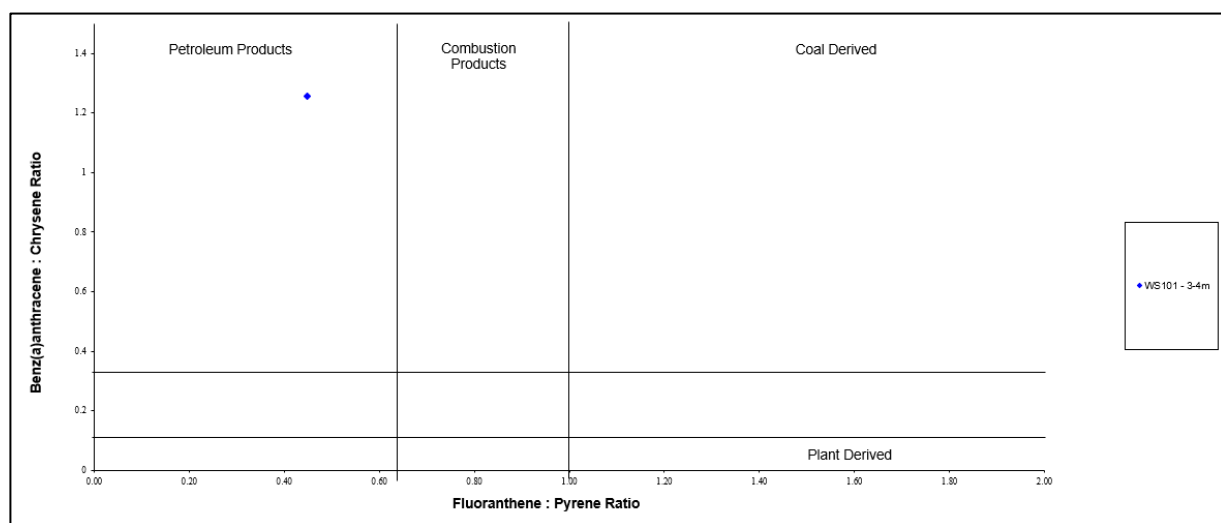
Coopers have completed a source signature double ratio plot to identify the potential source of the PAH compounds within the former reservoir. The print sheet and explanation sheet are contained in Appendix 10 and annotated extract contained within Figure 8 (below). The results show the PAH compounds are within the petroleum range class, inferred to be characteristic of used engine oils. A larger population size would be required to better characterise the provenance, however the presence of TPH concentrations within the soils and nature of the materials (inert landfill wastes and demolition derived materials could include materials with fuels.

Figure 8: Extract of Source Signation Double Ratio Plot of PAH profile

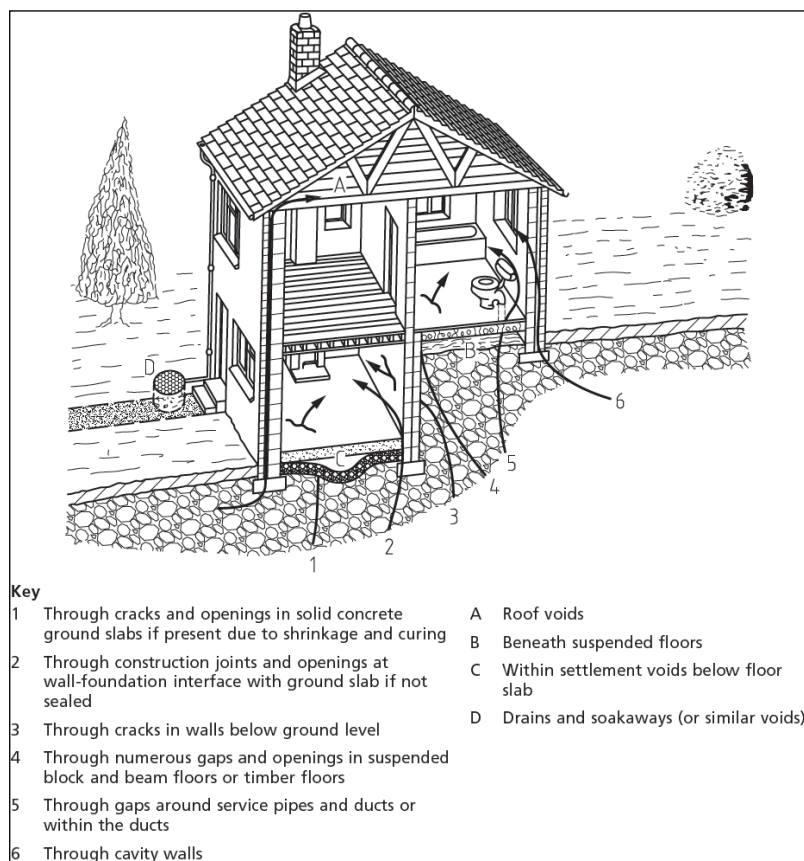
Figure 9: Potential pathways for hazardous ground gas to ingress into residential buildings (from BS8485)

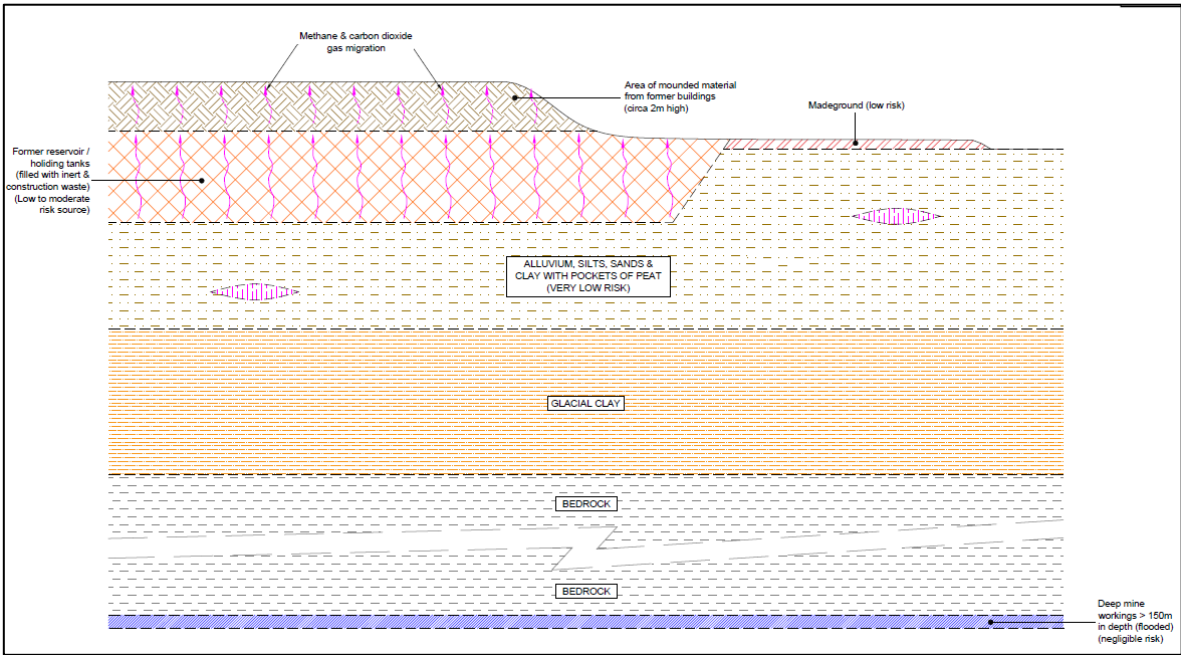
Figure 10: Extract of Coopers Ground Gas Conceptual Model

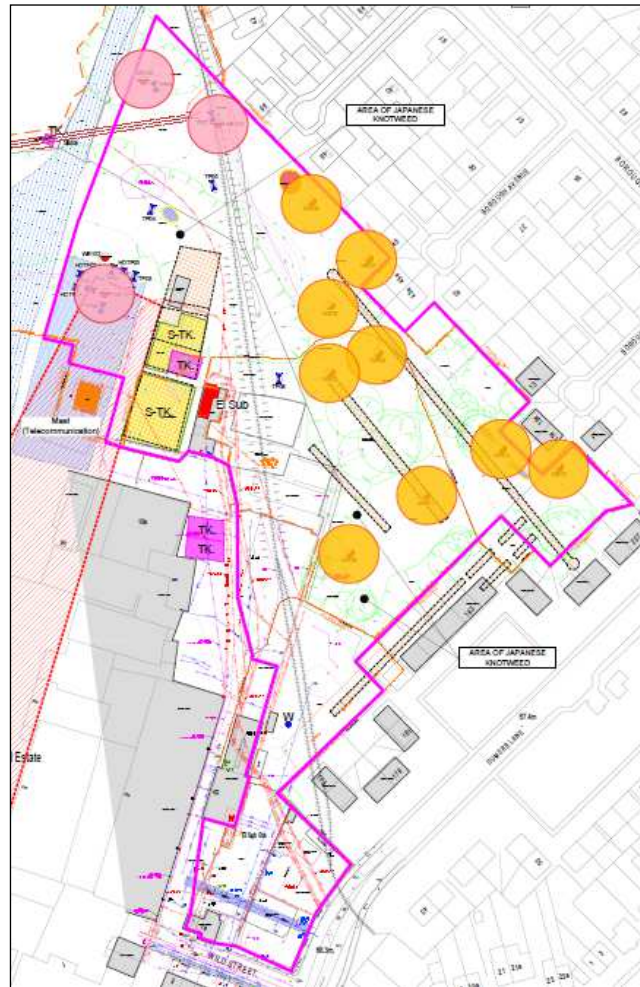
Figure 11: Showing gas monitoring positions in relation to varying sources. The orange circles represent the initial phase of investigation and the red circles are the secondary phase

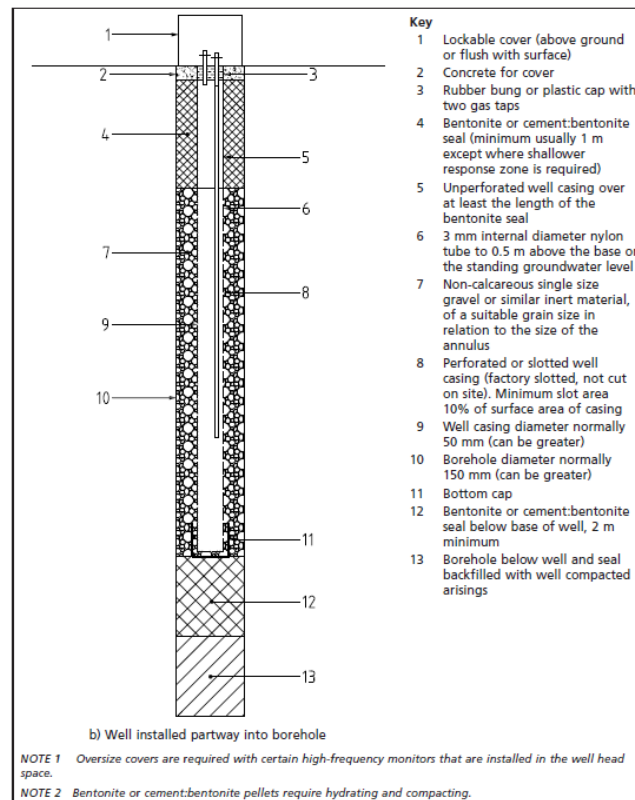
Details of the monitoring wells and response zones are provided in the borehole logs, contained in Appendix 6 and summarised in Table 13 within Section 17.8. The gas monitoring wells constructed on behalf of Coopers consisted of 50mm HDPE pipe with slotted sections, geosoc surround to prevent silting up and inert gravel surround. Bentonite seals were constructed above the response zone to limit atmospheric gas ingress. A dual valve system with down feed was constructed to homogenise stratified gases, compliant with BS8576 (2013), was included, as shown in Figure 12, with flush stopcock cover.

Figure 12: Extract of borehole monitoring well installation as recommended by BS8576

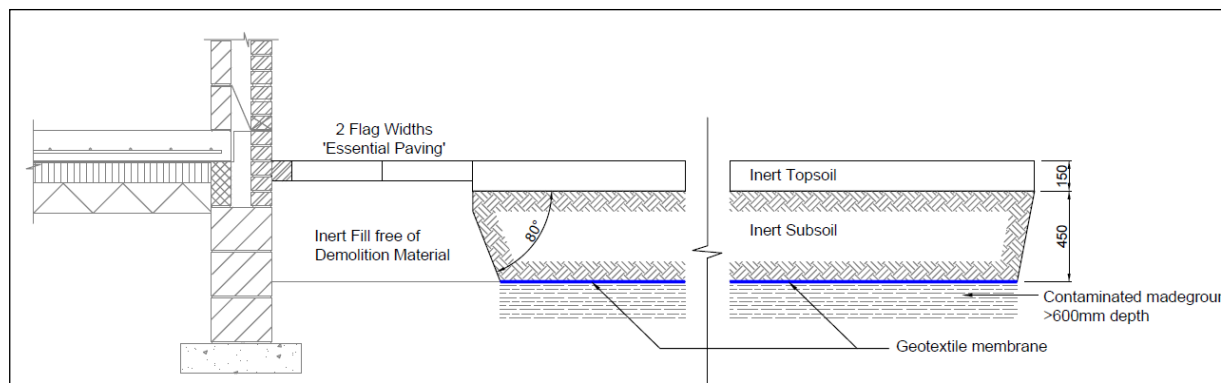
Figure 13: Inert Cover within Proposed Gardens where Contaminants are >600mm in Depth

To protect the future residents from exposure to contaminants the madeground can be excavated from the 0.6m growing medium in rear gardens and 0.45m in frontages for replacement with inert subsoil and topsoil. Subject to the proposals for cutting and filling as part of regrading site levels the madeground depth within parts of the site the natural strata may be less than 0.6m deep, where the inert cover would in places remove the entirety of the madeground. Where the madeground is removed prior to the 0.6m inert cover depth the proposed gardens would be as demonstrated in Figure 13. Where madeground is still present at the base of the 0.6m cover layer a high tensile strength geotextile will be placed at the base to prevent inadvertent exposure to the underlying contaminants or cross-mixing. The cover system for the proposed gardens would be as demonstrated in Figure 14.

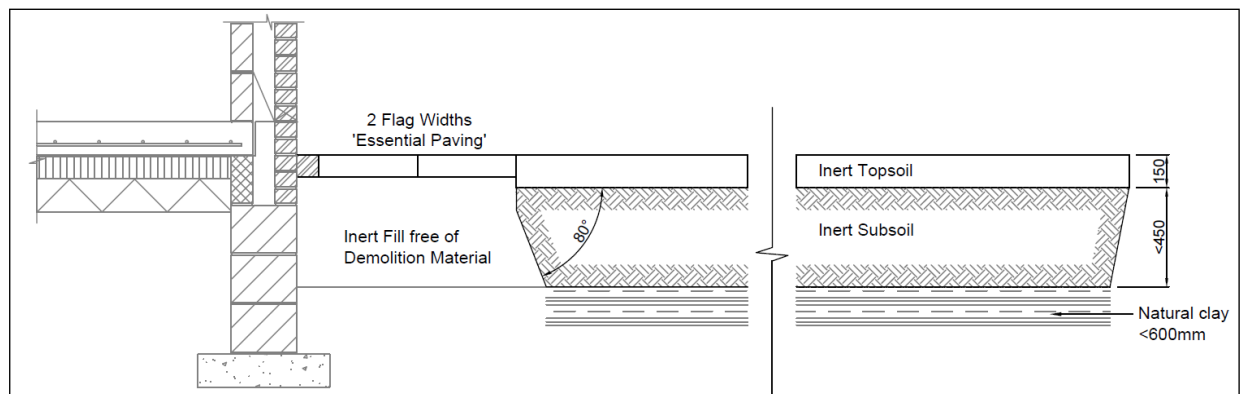
Figure 14: Inert Cover within Proposed Gardens where Contaminants are <600mm in Depth

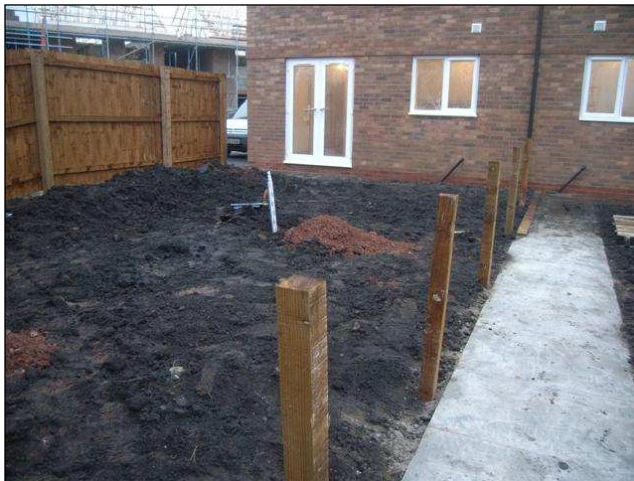
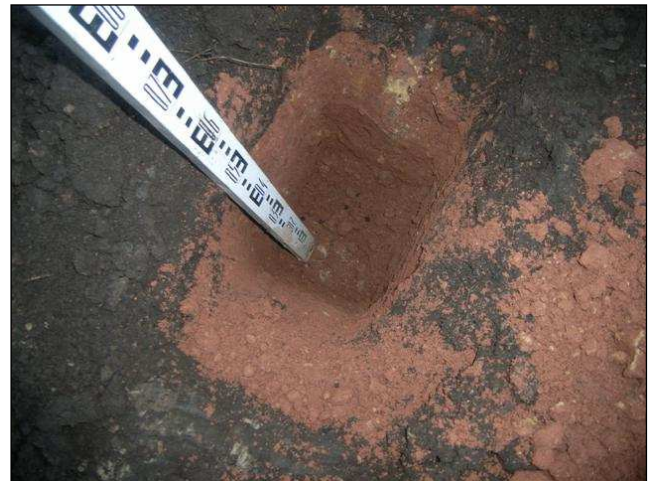
Photographs 13 and 14: Examples of validation photographs demonstrating validation hole location and soils forming inert cover

- Photographic evidence to demonstrate the location of the validation hole, the nature of the inert material and the depth of cover (refer to Photographs 13 to 16).

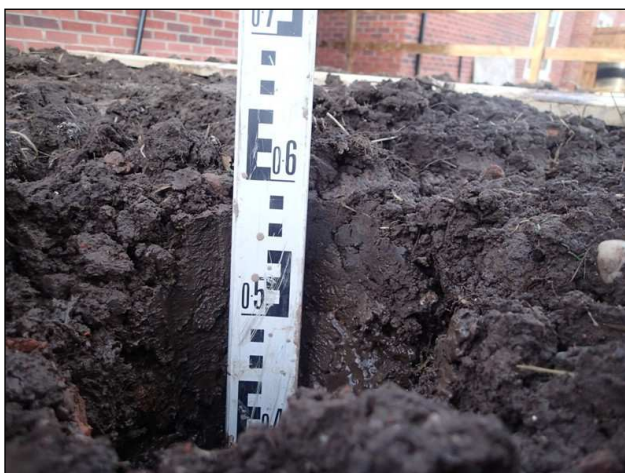
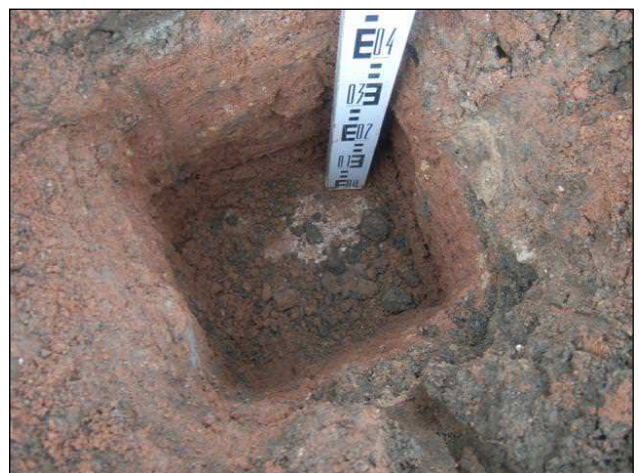
Photographs 15 and 16: Examples of validation photographs demonstrating inert cover depth and geotextile

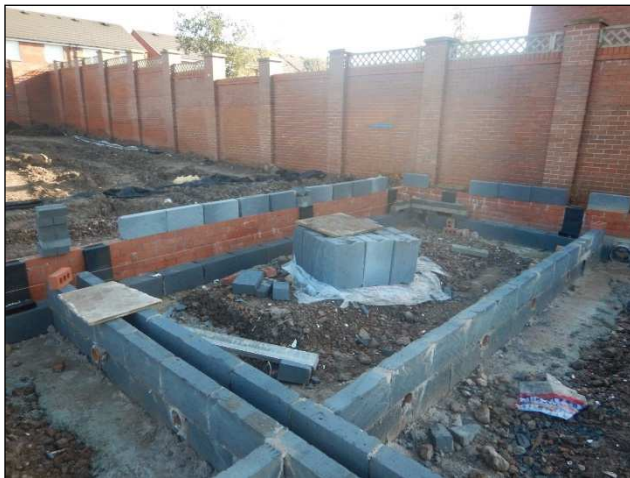
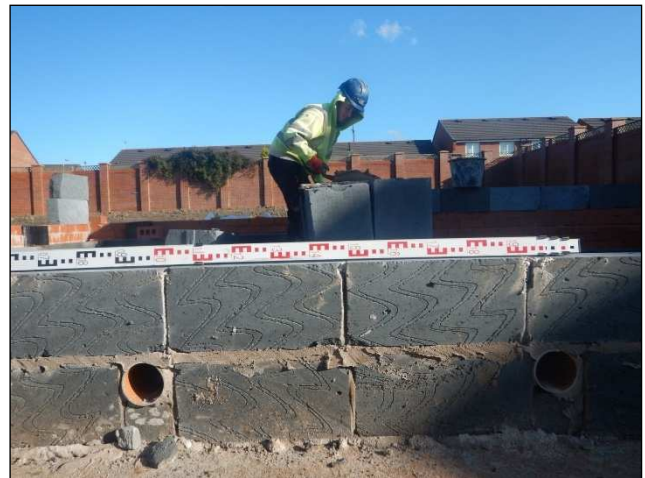
Photographs 17 and 18: Confirm presence of internal venting pipes, diameter and spacing. The typical spacing is 1 No. 75mm diameter pipe every 1m. This can change depending upon the pipe diameter, and the presence of spaces below the blocks and between the beams (dependant upon site specific construction variations) or changes by . This may not be able to be directly observed on each plot, depending upon the site specific design of gas protection measures. If not recorded then observation of other plots under construction, or requesting photographs to be taken by construction management can be deemed appropriate depending upon confidence in the construction as site progresses

| <b>21. Internal/Partition Wall Venting</b> | | Check the spacing and dimensions of any interconnecting pipes between the subfloor venting medium. This can vary by size of building and design approaches so be careful to check against the gas details |

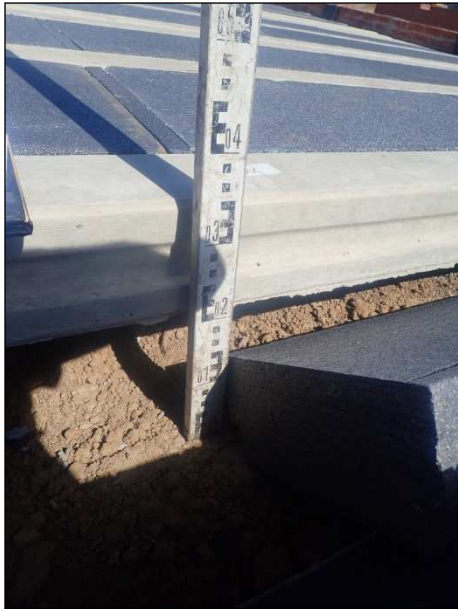
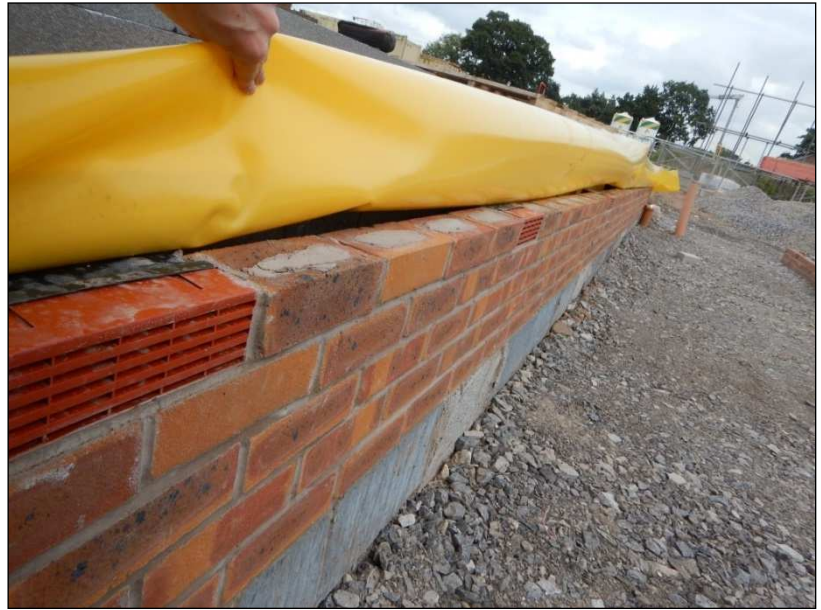
*Photographs 19 and 20: Verify presence of cranked vents along the external walls and sufficient spacing. Areas of access points to internal garages or external adjoining garages may not be possible to have cranked venting and alternative construction options should be discussed where necessary. Plots with stone venting to include photographs demonstrating the cranked vents are aligned with the stone*

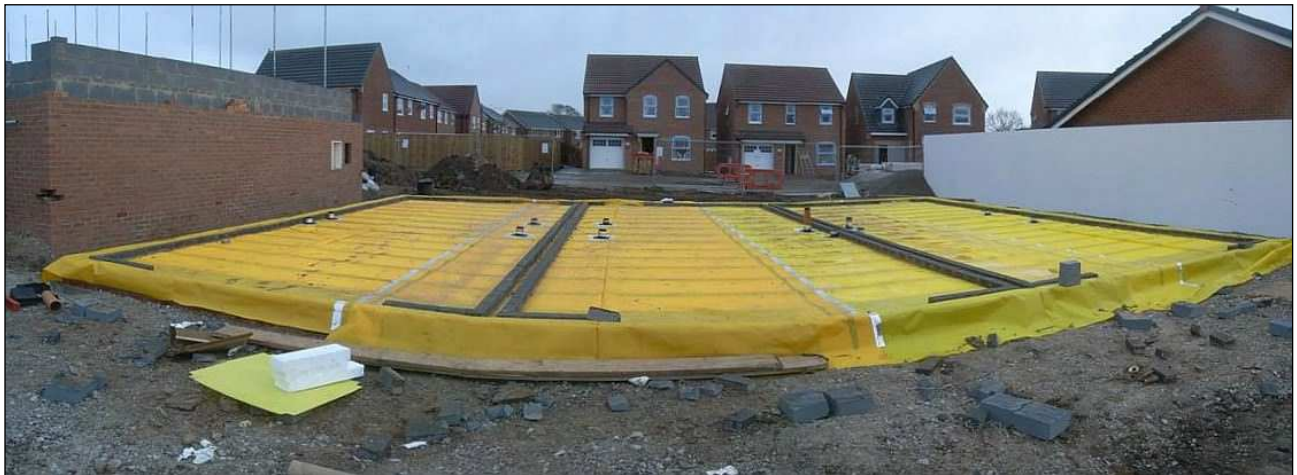
*Photograph 21: Check general condition of membrane for punctures/tears etc – take panoramic photograph showing general condition*

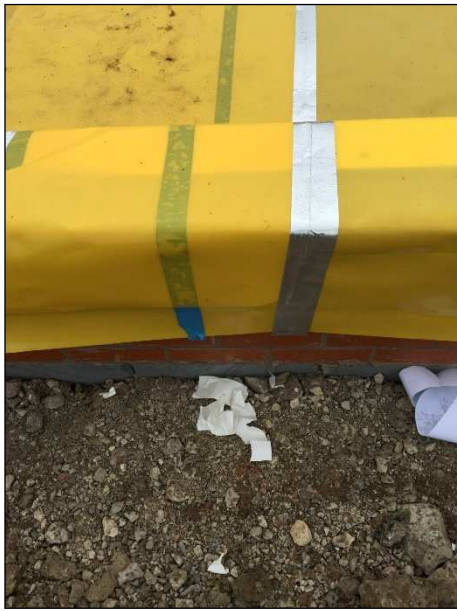
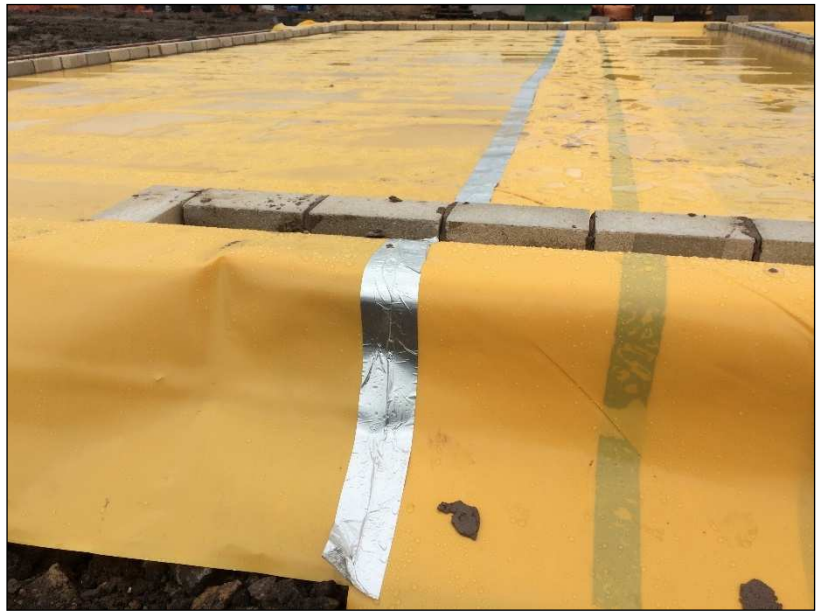
Photographs 22 and 23: Check >150mm overlaps of membranes and proprietary tapes placed and sealed with photographs taken

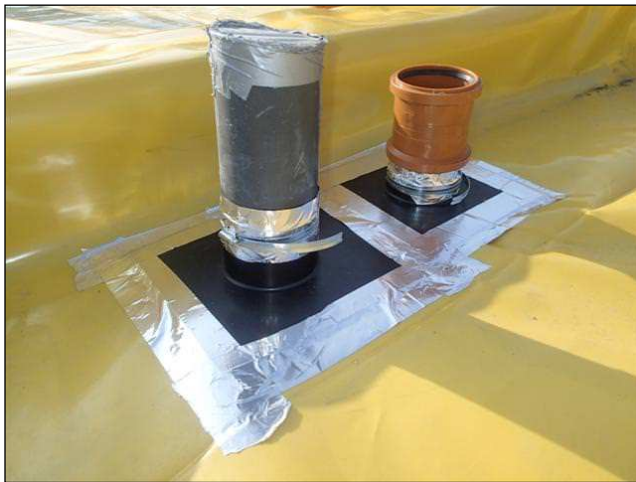
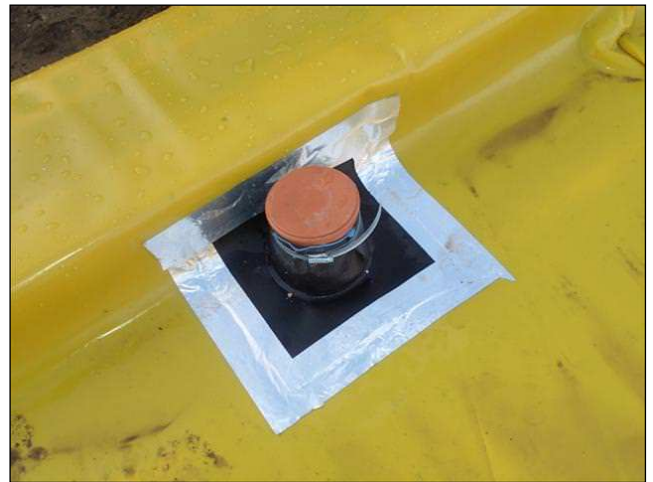
Photographs 24 and 25: Check tophat is sealed to membrane and pipework with tapes, and Jubilee clip

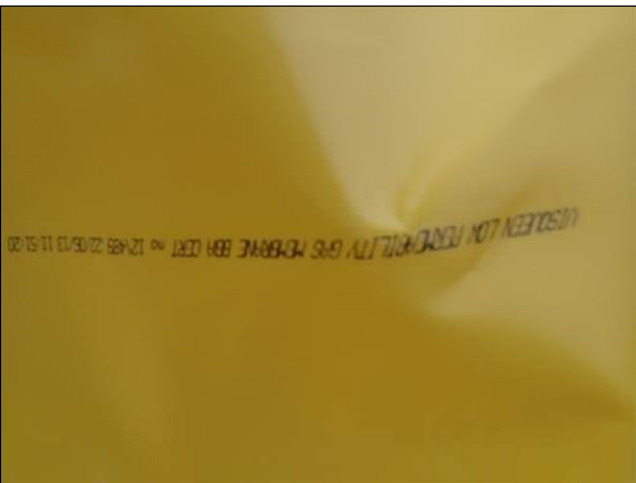
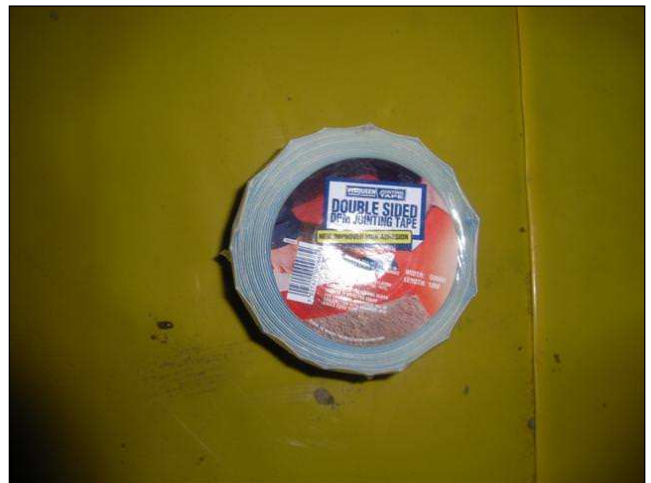
Photographs 26 and 27: If new delivery of product types is present and copies of supply tickets are not available then inspect product labels to confirm manufacturers and product types

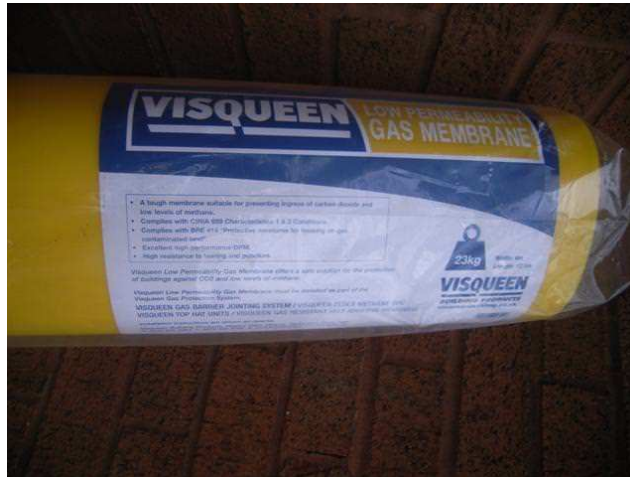
*Photograph 28: If no product labels are present then inspect stores for product types*

| | | Page<br>No. |
|---|---|---|
| Photograph 28 | - If no product labels are present then inspect stores for product types | 78 |
