Site Investigation Report  
for Land Adjacent to  
Bealey Industrial Estate,  
Radcliffe

For: Westchurch Homes Ltd  
Kennedy House  
31 Stamford Street  
Altrincham  
Cheshire  
WA14 1ES

Date of Report: 8 November 2024

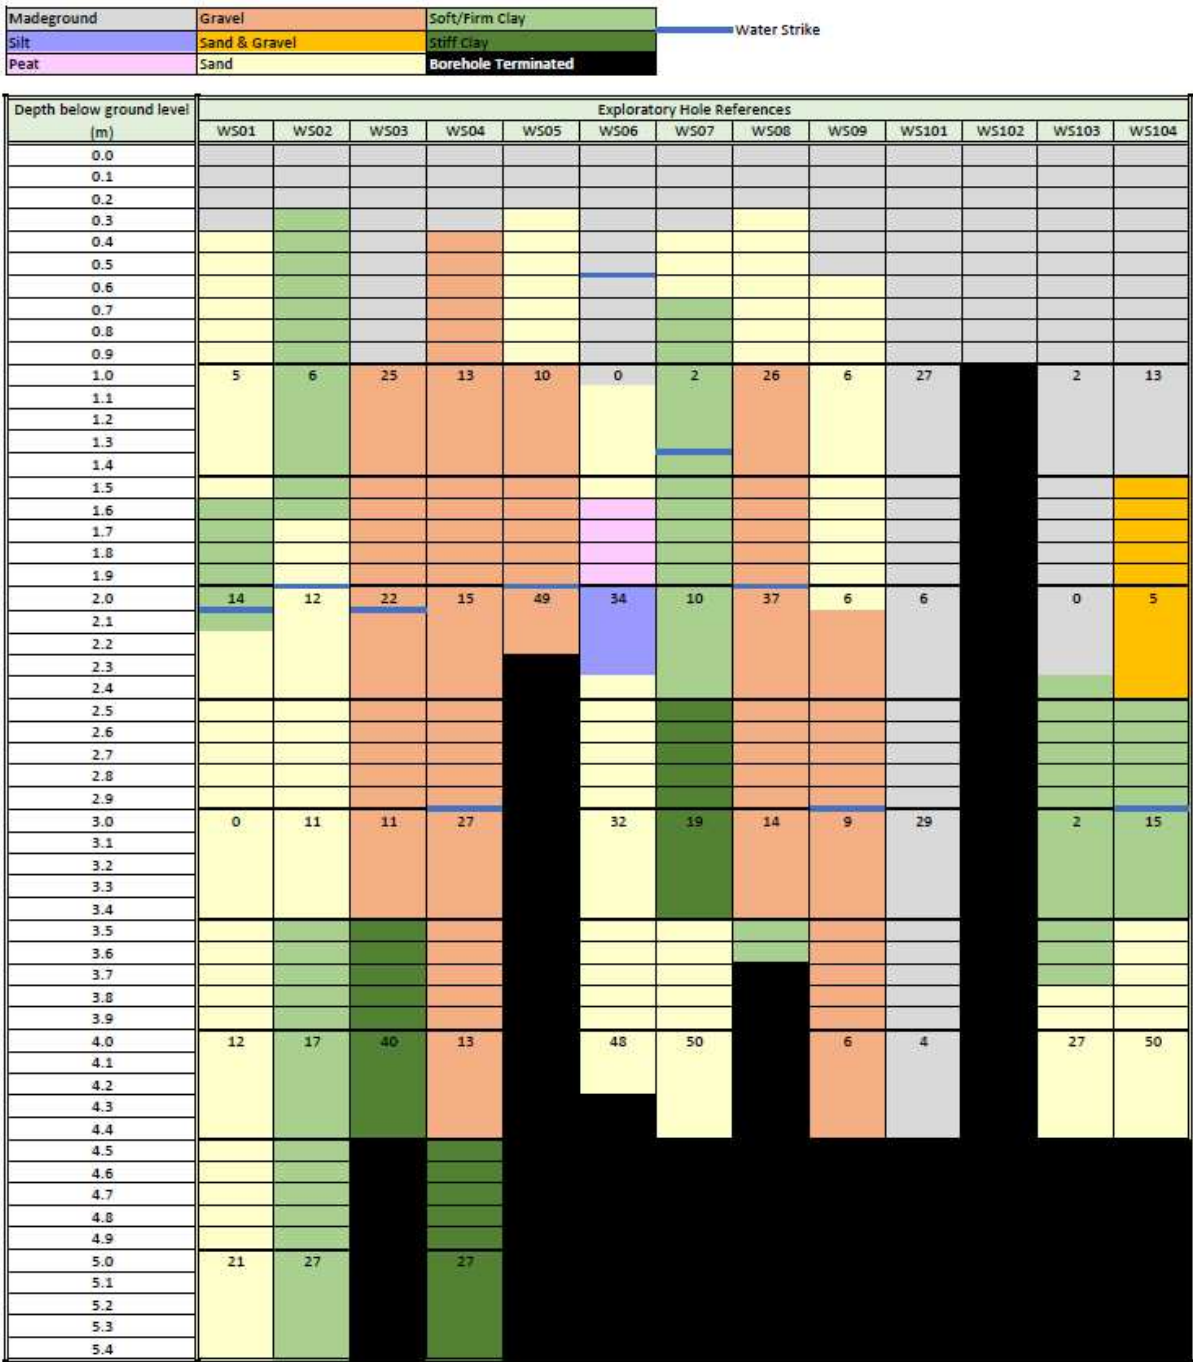
Figure 15: Summary of SPT N values by strata type and depth

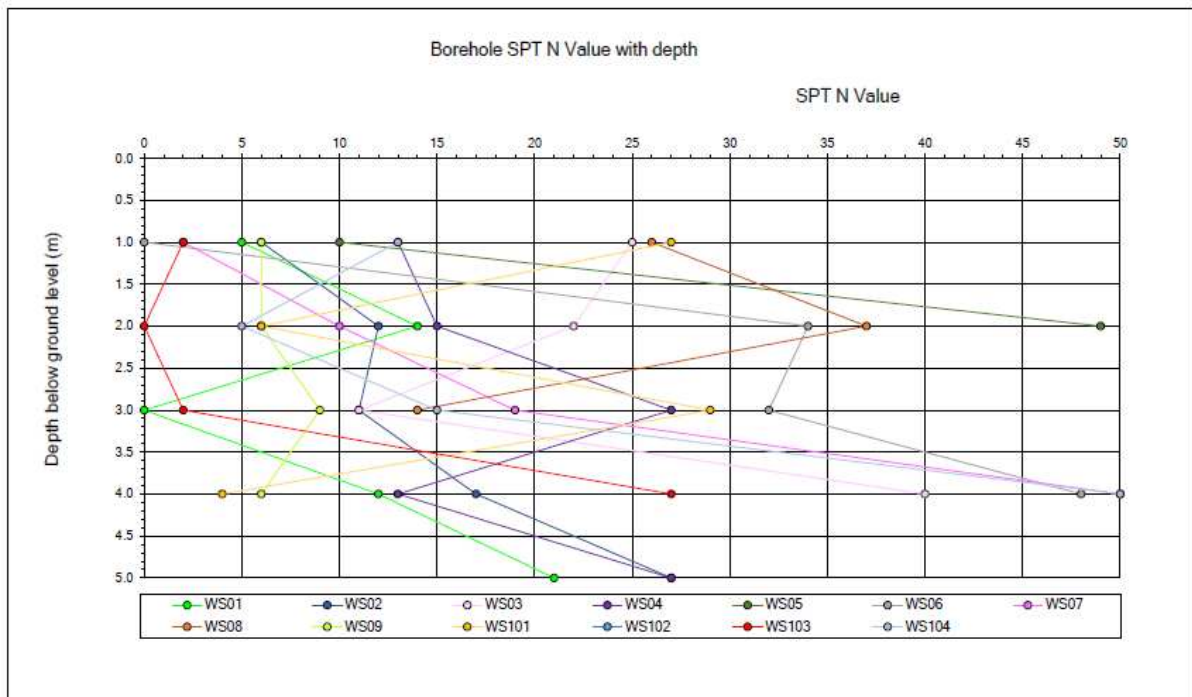
Figure 16: SPT N value with depth
