# ARBORICULTURAL IMPLICATIONS ASSESSMENT

SPRING STREET SAW MILL  
SPRING STREET  
RAMSBOTTOM  
BL0 9JQ

Author: C. Salisbury  
Date: 29 March 2022  
Ref: TRE/SSSM

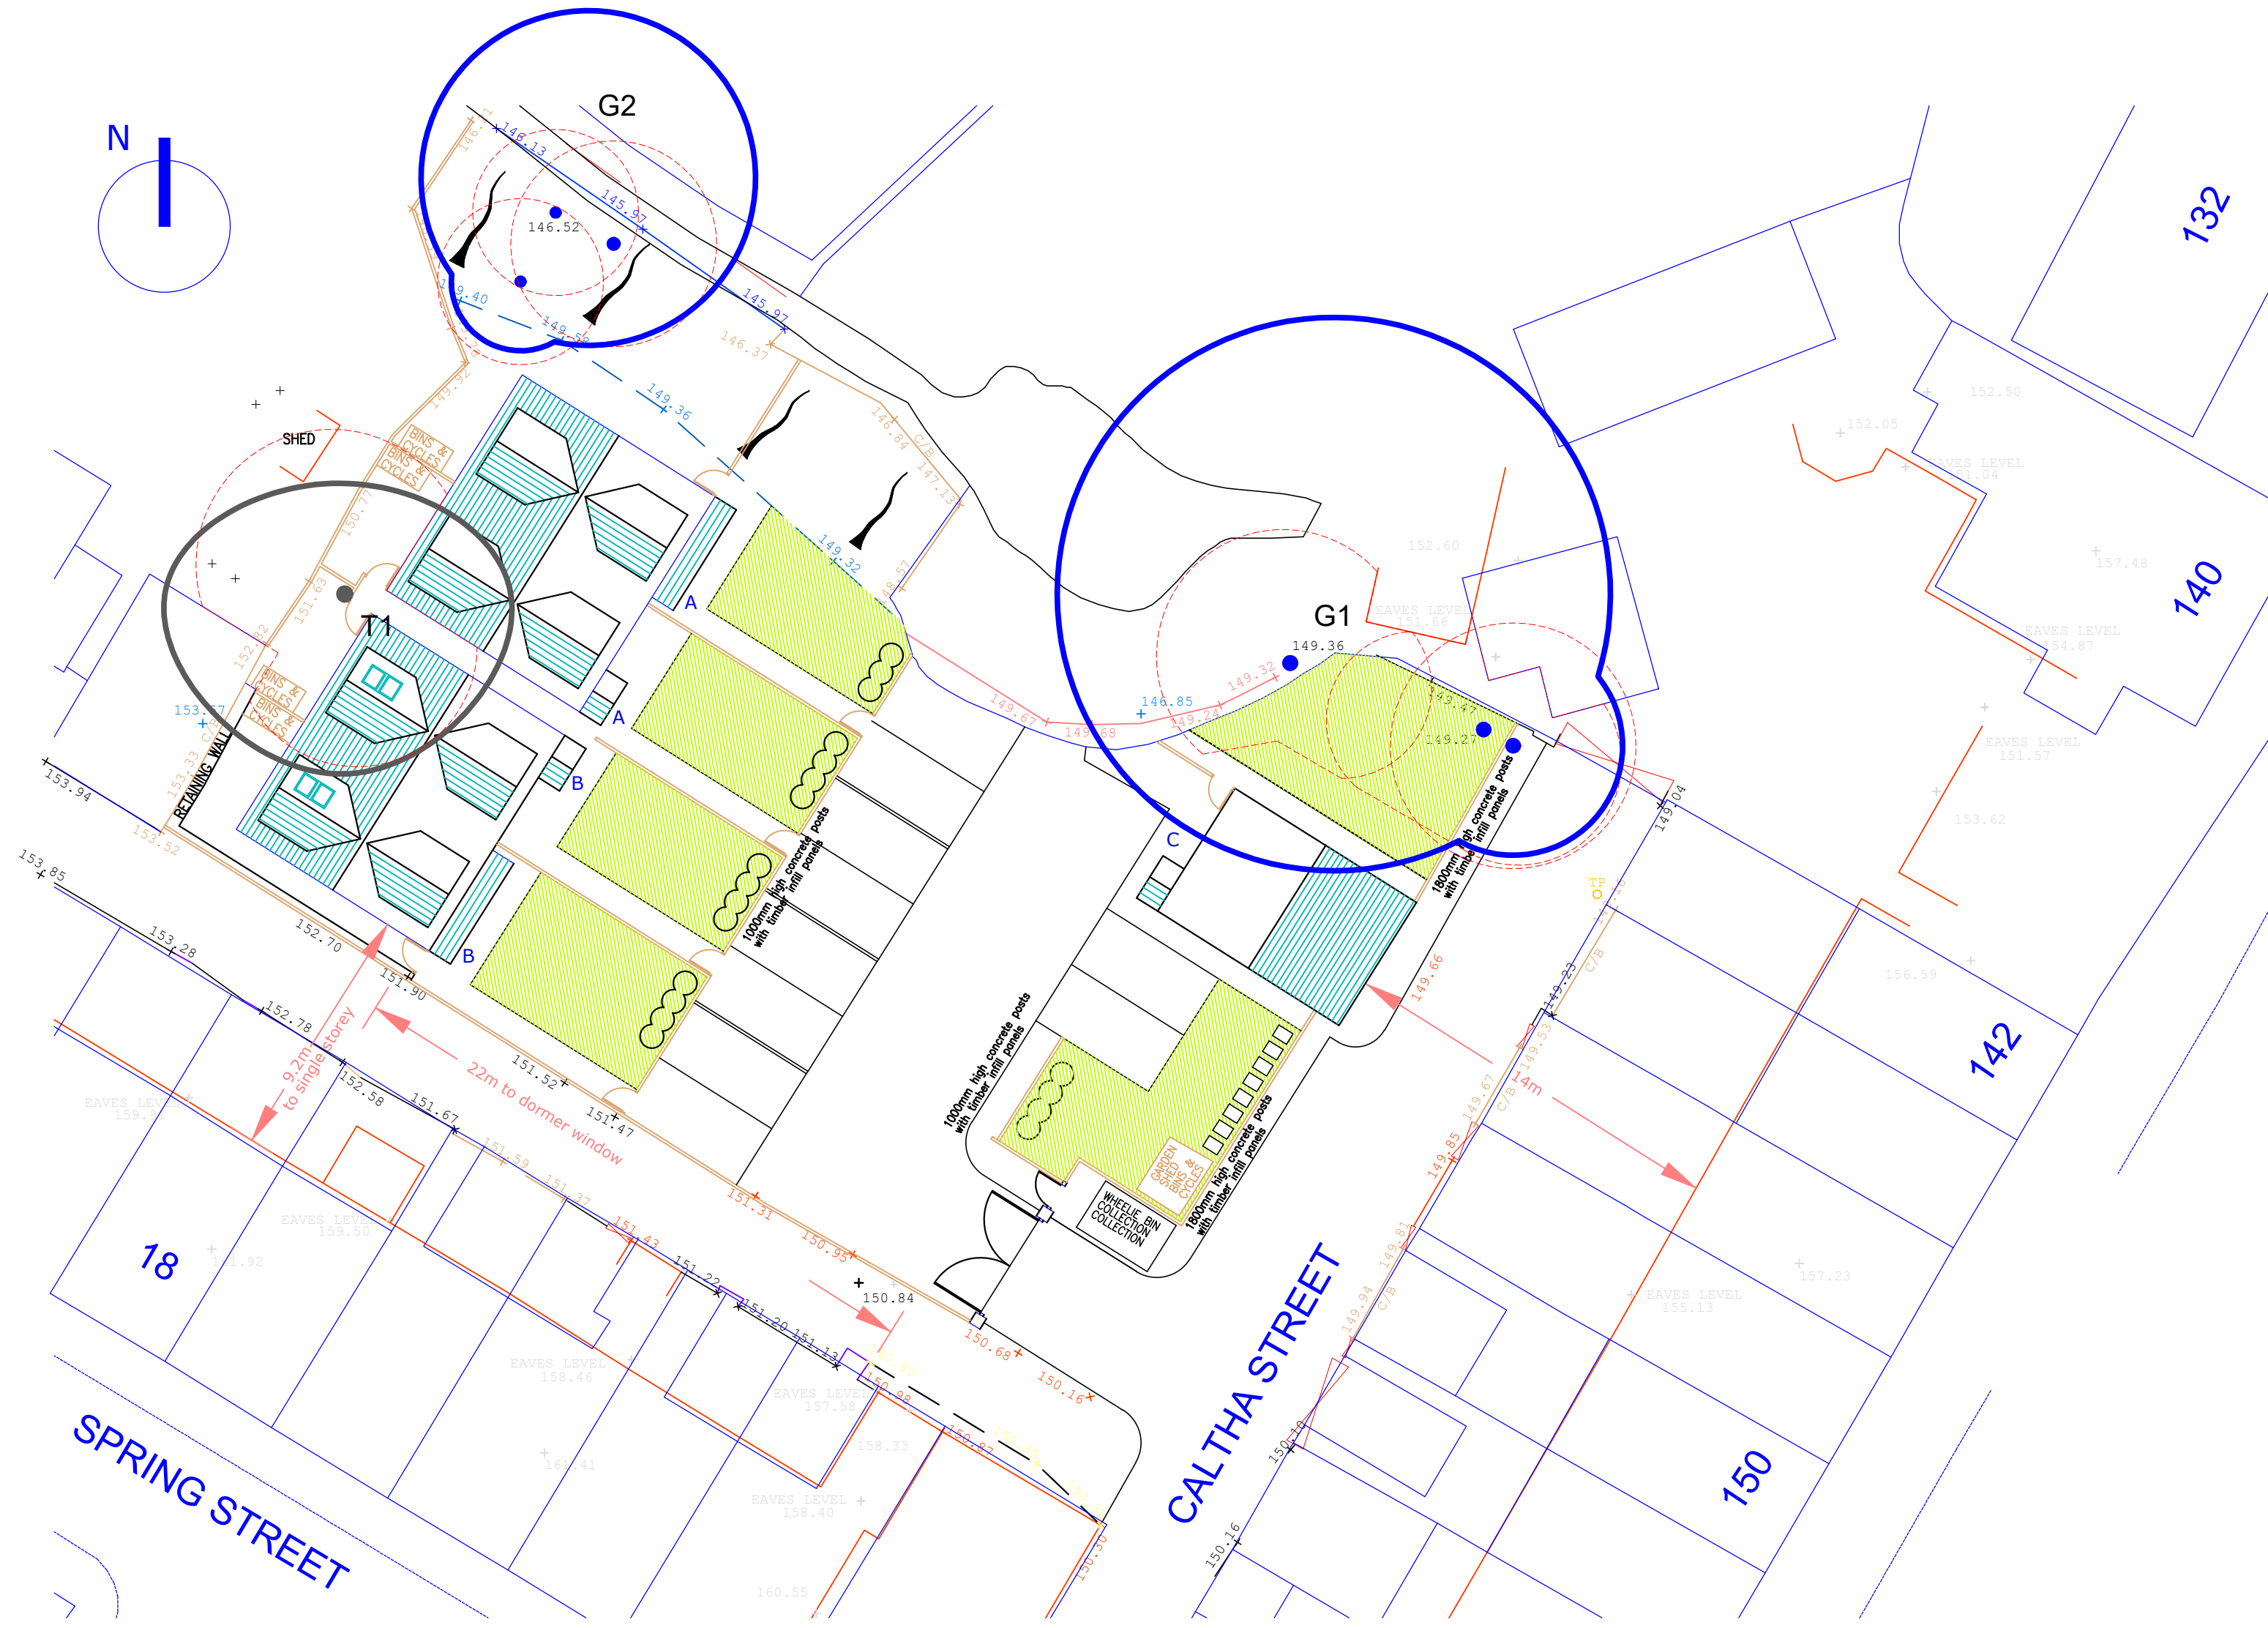
| Drawing No:<br>SSR/AIS/01 | | |

| Drawing Title:<br>AIS Plan | | |
