Project Title  
Adil Sedik, 15 Penrhyn Drive M25 1LW

Drawing Title  
Floor plan

| Drawing number<br>04/15/24/A | Do not Scale :<br>1:50&1:100 | Revision : 3 |

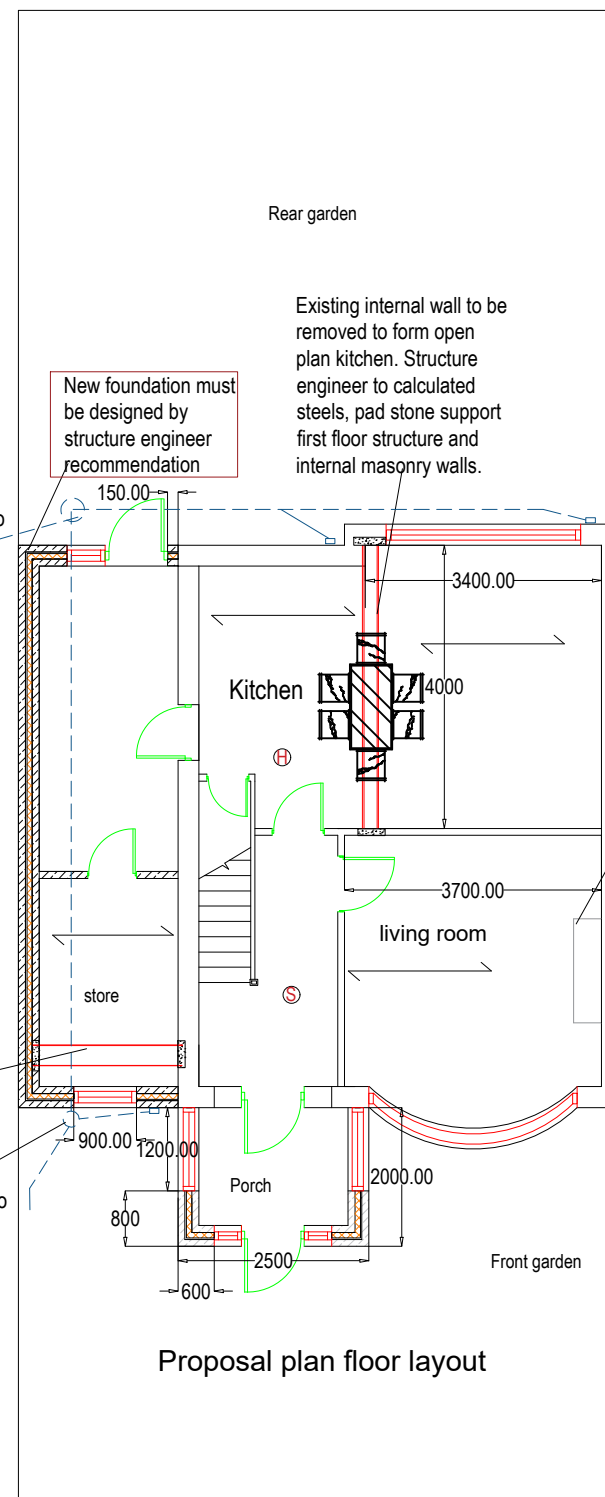
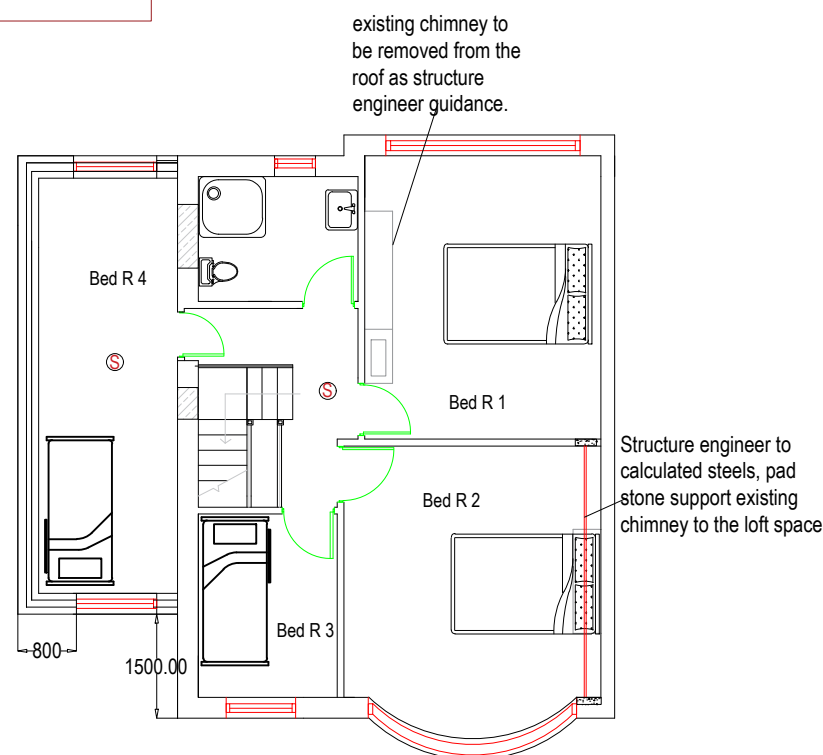
Note: The existing building foundation appear to be failed. Rear and side external walls leaning and internal floor structure uneven. Therefore existing structure including existing foundation must be investigate by qualified structure engineer before the work start. All the work must be done as satisfaction of the Building control officer and structure engineer
