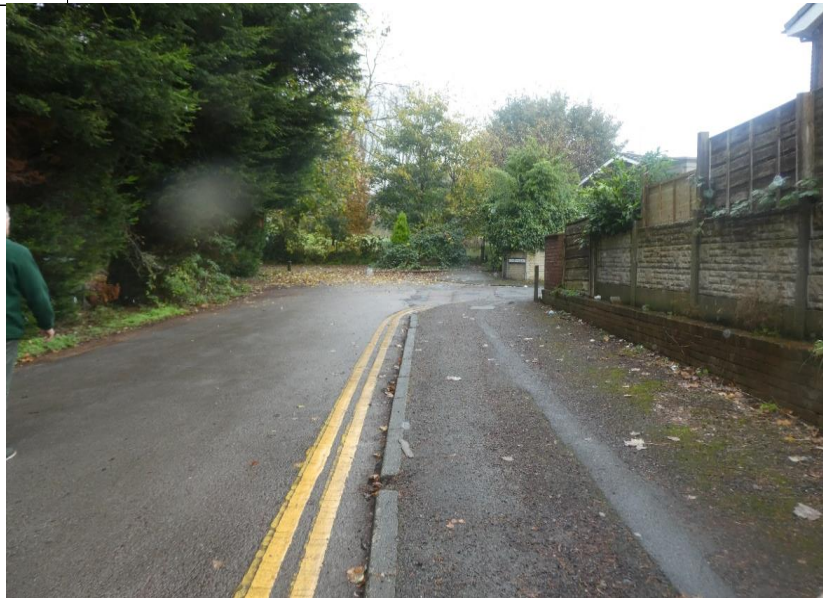
Photograph 12. Roadway directly adjacent to the site entrance area

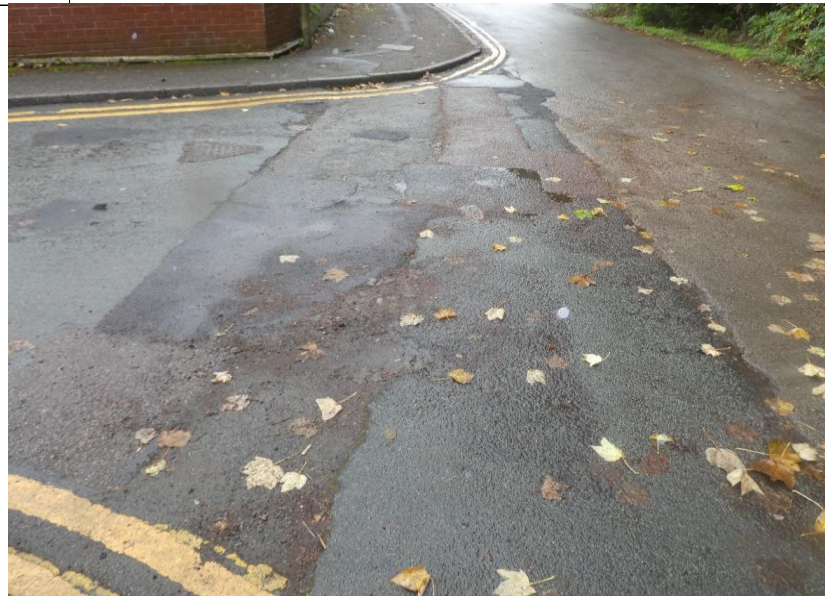
Photograph 16. Localised reinstatement of road surfacing to Norwood junction slightly eroded

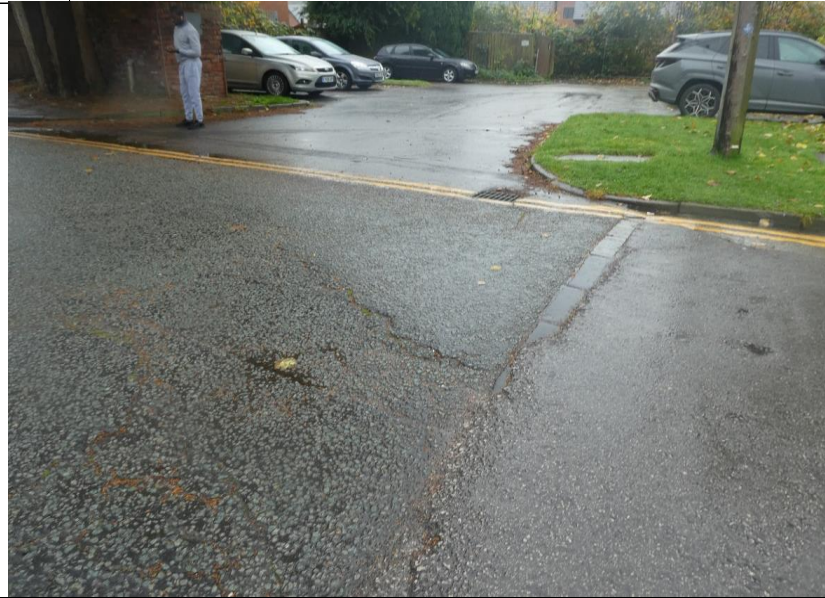
Photograph 32. Erosion to road surfacing near to site entrance on George Street

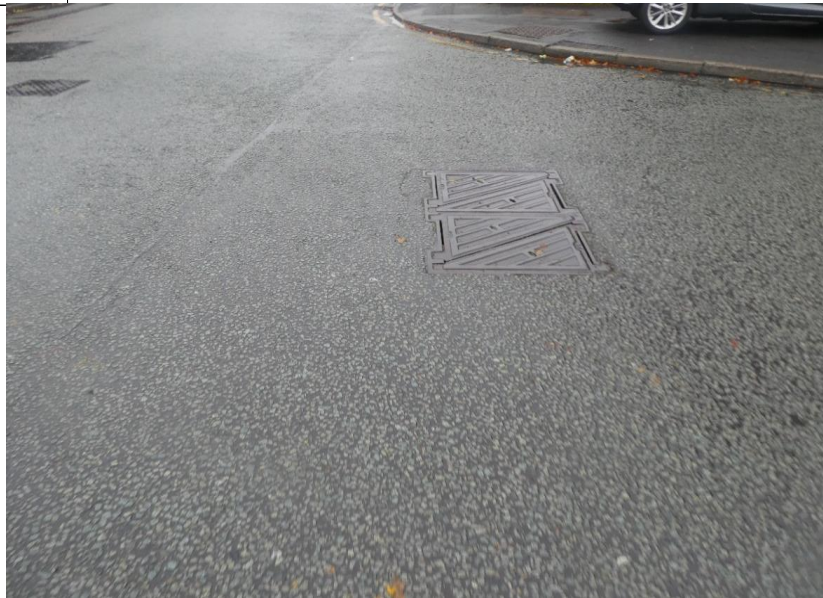
Photograph 80. Junction to industrial estate.

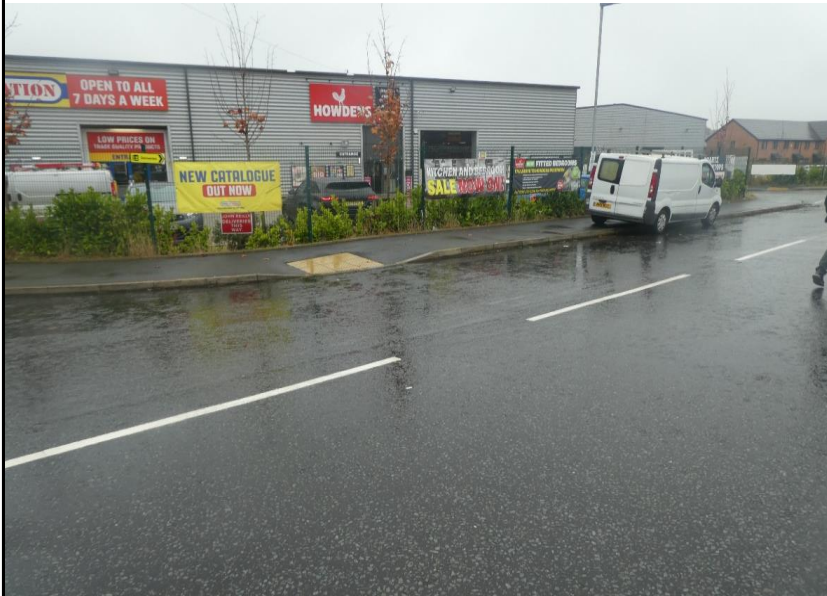
Photograph 91. Junction with industrial estate to the east of George Street
