## Asbestos Demolition Survey

**Blocks 54, 55, 56 & 57  
Fairfield General Hospital  
Rochdale Old Road  
Bury  
BL9 7TD**

**Northern Care Alliance NHS Group**

| Project Number: | Survey Date: | Issue Date: |
|---|---|---|
| B-38673s3 | 12 May 2023 | 16 May 2023 |

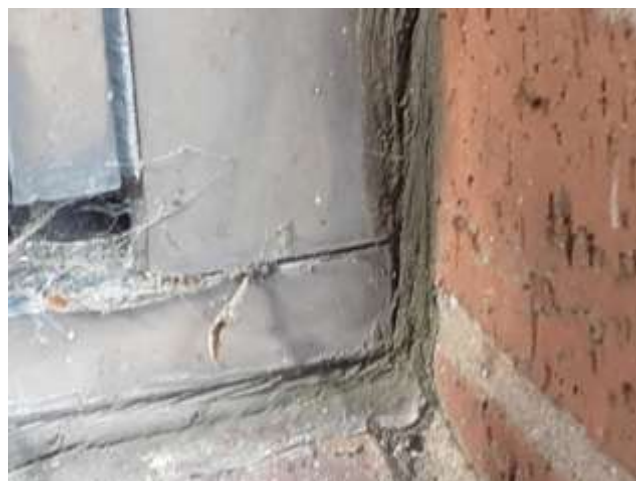
| Quantity | 100 Units |

| Analysis Result | Chrysotile | 1 |
| Condition | Good Condition | 0 |

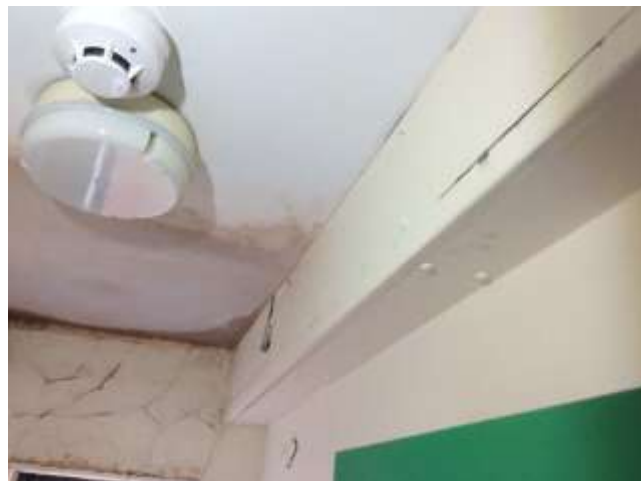
| Analysis Result | No Asbestos Detected | 0 |
| Condition | Medium Damage | 2 |

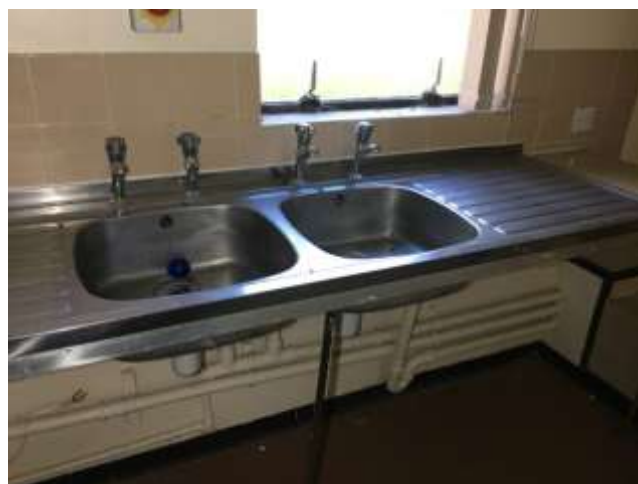
| Analysis Result | Chrysotile | 1 |
| Condition | Good Condition | 0 |

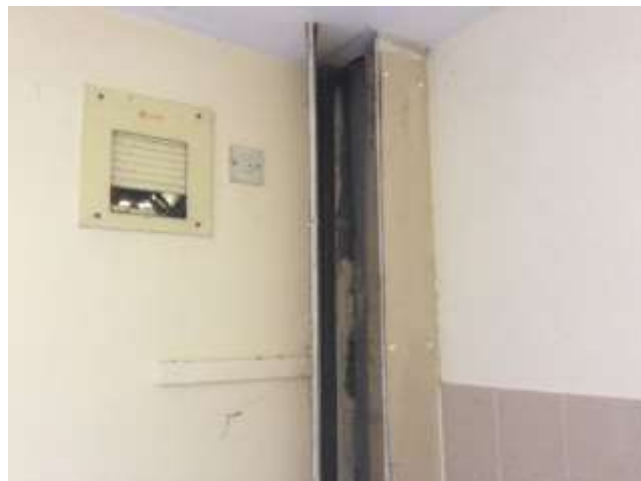
| Analysis Result | No Asbestos Detected | 0 |
| Condition | Low Damage | 1 |

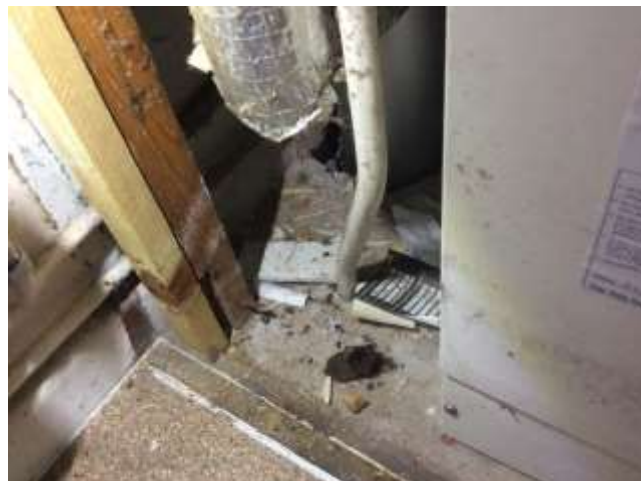
| Analysis Result | No Asbestos Detected | 0 |
| Condition | High Damage | 3 |

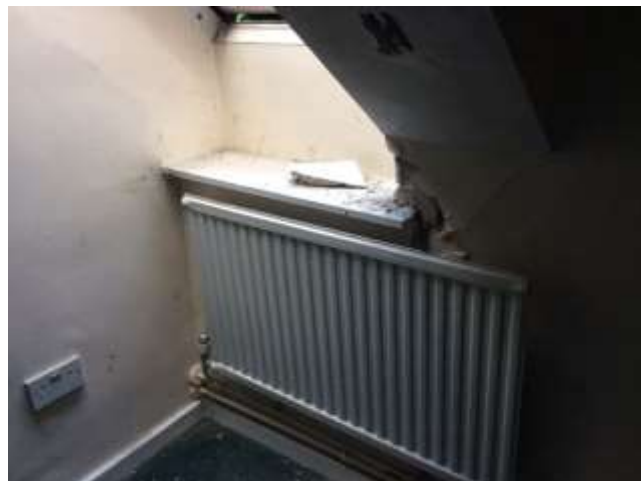
| Analysis Result | No Asbestos Detected | 0 |
| Condition | Good Condition | 0 |

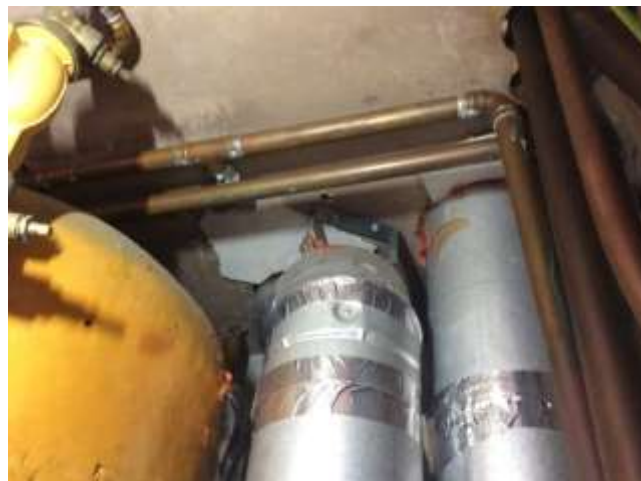
| Analysis Result | No Asbestos Detected | 0 |
| Condition | Low Damage | 1 |

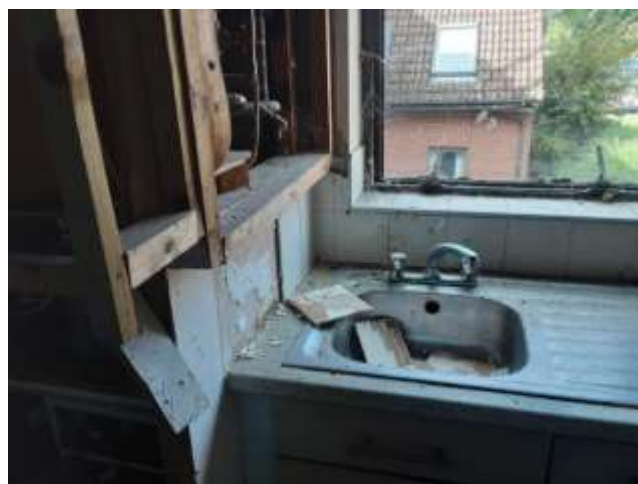
| Analysis Result | No Asbestos Detected | 0 |
| Condition | Low Damage | 1 |

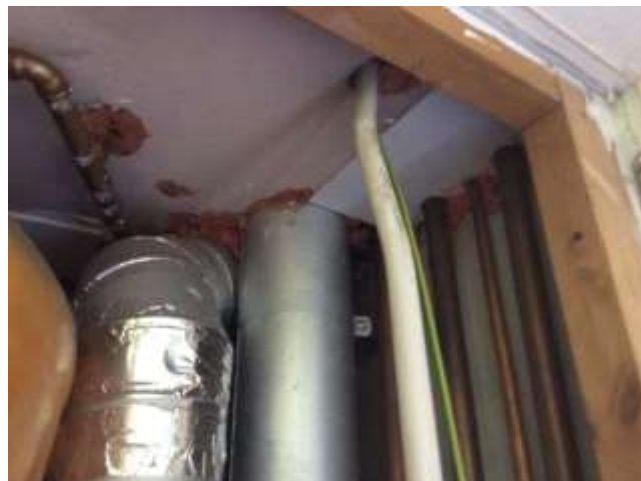
| Analysis Result | No Asbestos Detected | 0 |
| Condition | Low Damage | 1 |

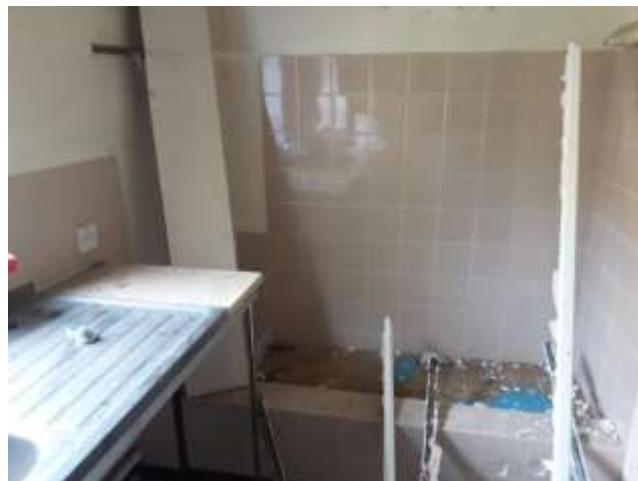
| Analysis Result | No Asbestos Detected | 0 |
| Condition | Low Damage | 1 |

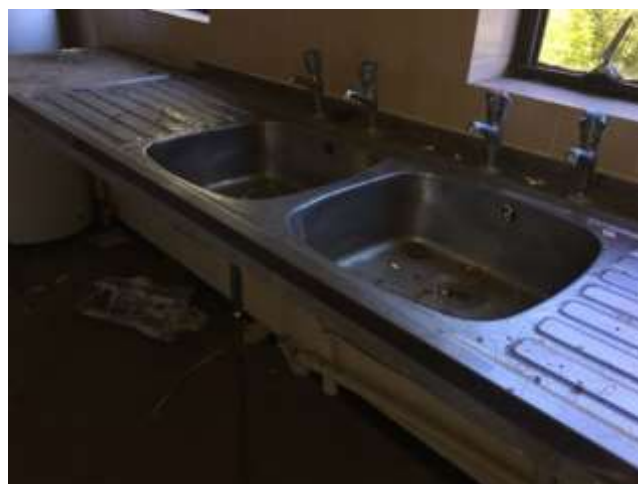
| Analysis Result | Chrysotile | 1 |
| Condition | Good Condition | 0 |

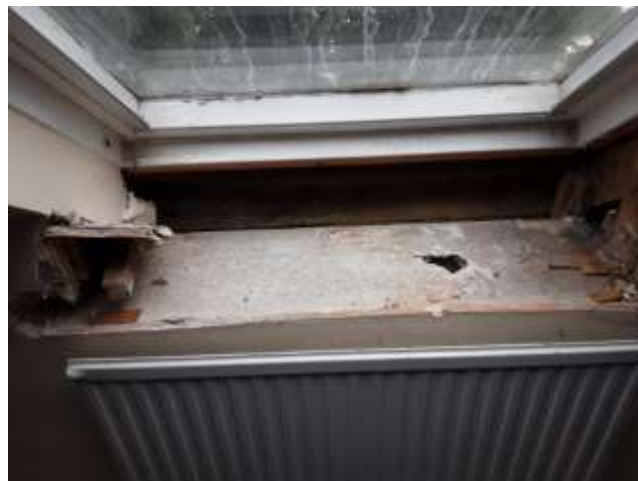
| Analysis Result | No Asbestos Detected | 0 |
| Condition | Low Damage | 1 |

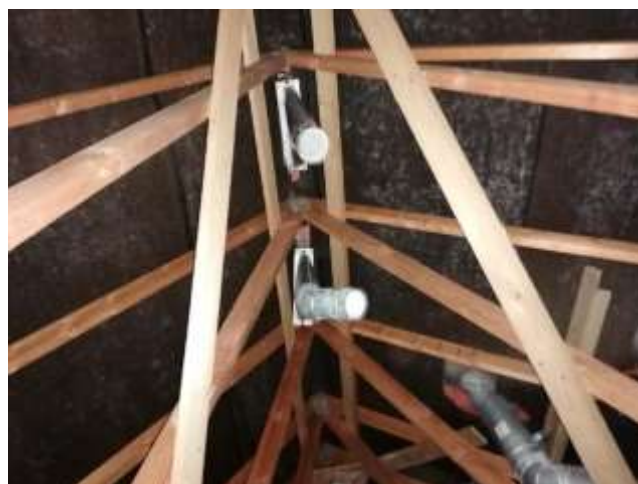
| Analysis Result | Chrysotile | 1 |
| Condition | Low Damage | 1 |

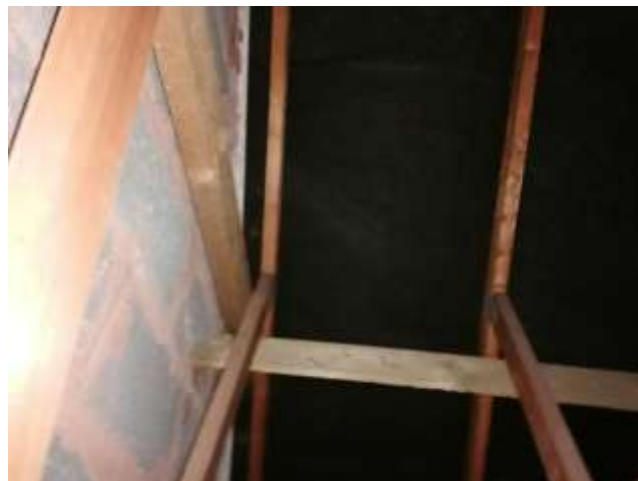
| Analysis Result | No Asbestos Detected | 0 |
| Condition | Low Damage | 1 |

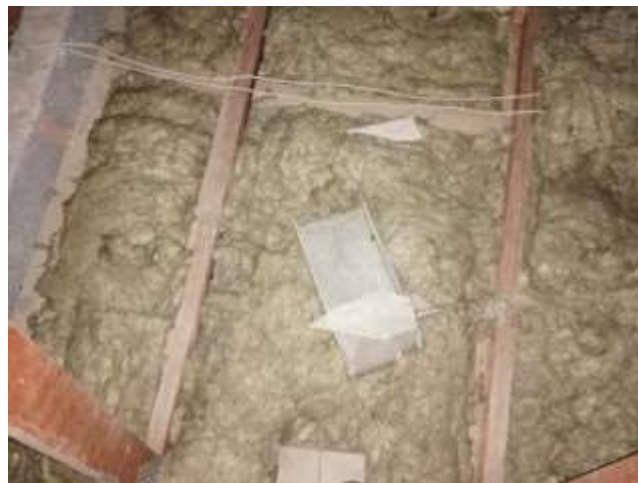
| Analysis Result | Chrysotile | 1 |
| Condition | High Damage | 3 |

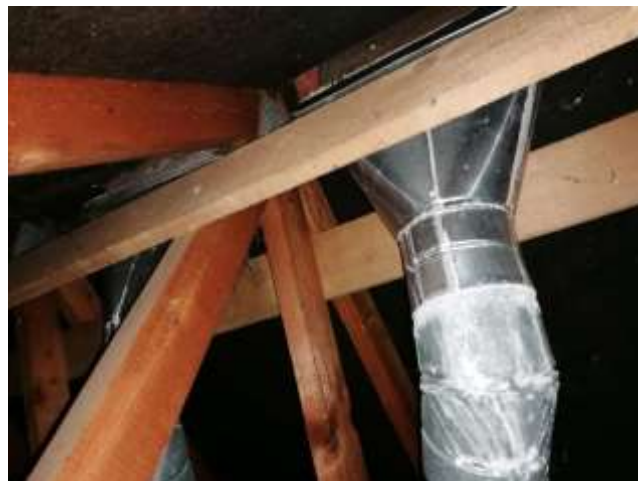
| Analysis Result | Chrysotile | 1 |
| Condition | Low Damage | 1 |

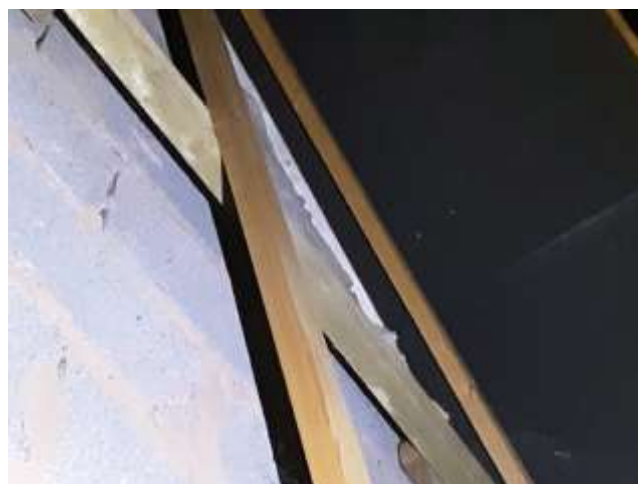
| Analysis Result | No Asbestos Detected | 0 |
| Condition | Low Damage | 1 |

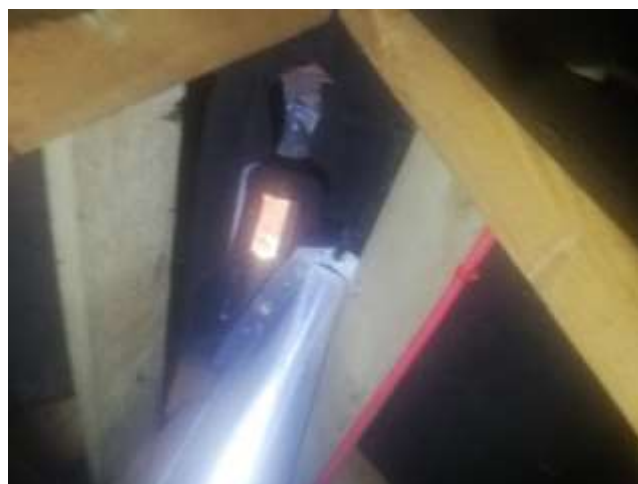
| Analysis Result | Chrysotile | 1 |
| Condition | Low Damage | 1 |

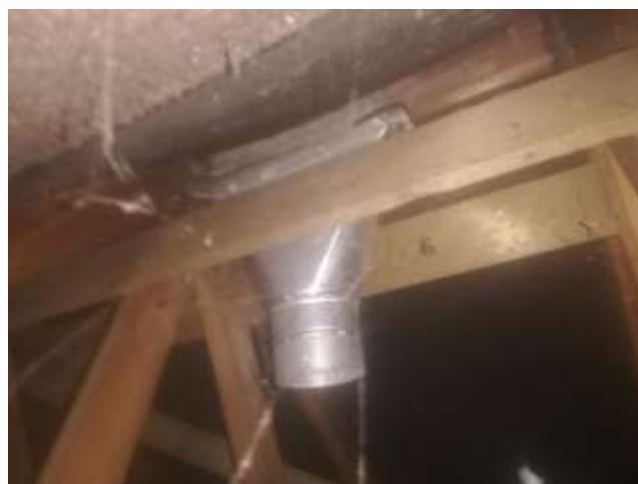
| Analysis Result | Chrysotile | 1 |
| Condition | Low Damage | 1 |

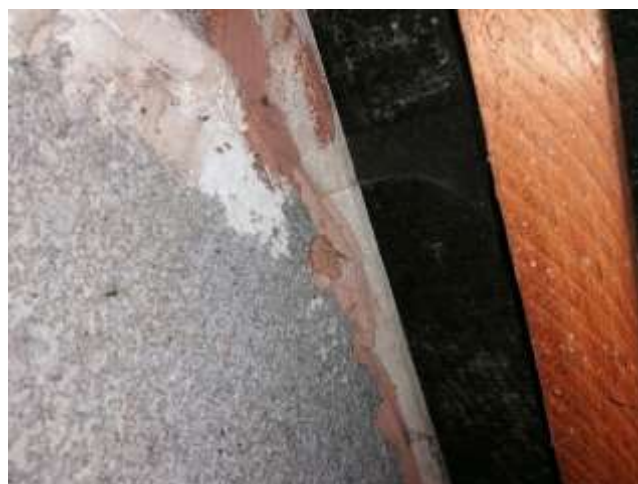
| Analysis Result | No Asbestos Detected | 0 |
| Condition | Low Damage | 1 |

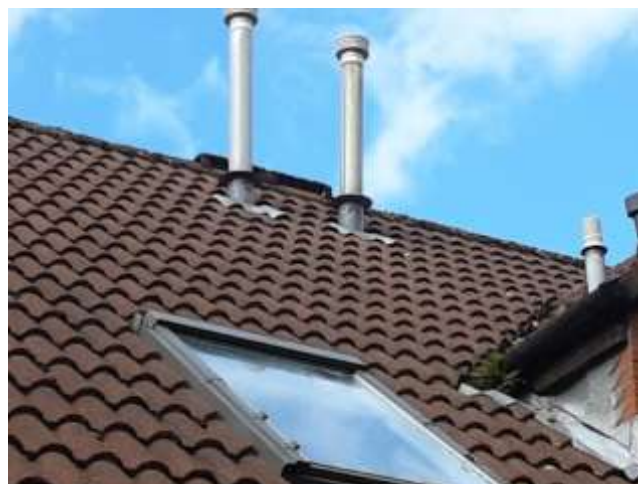
| Analysis Result | Chrysotile | 1 |
| Condition | Good Condition | 0 |

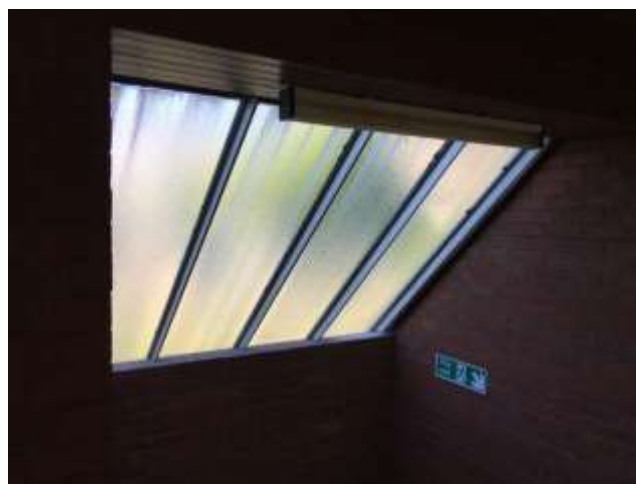
| Analysis Result | Chrysotile | 1 |
| Condition | Good Condition | 0 |

Whilst the asbestos containing material continues to remain undisturbed, no immediate action is required. However a system of ongoing management should be implemented which includes routine condition inspections.

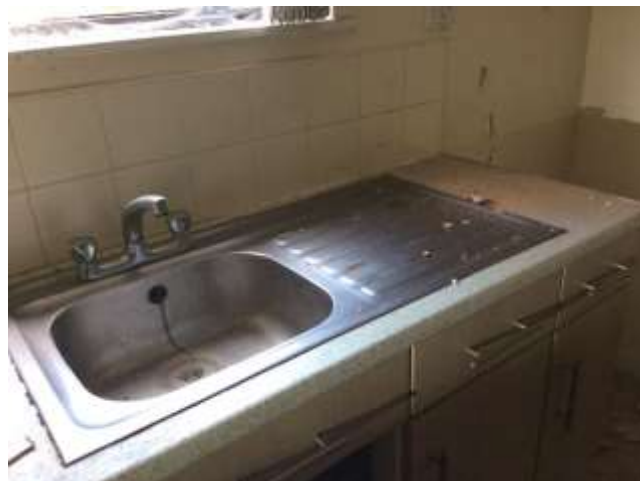
| Analysis Result | No Asbestos Detected | 0 |
| Condition | Good Condition | 0 |

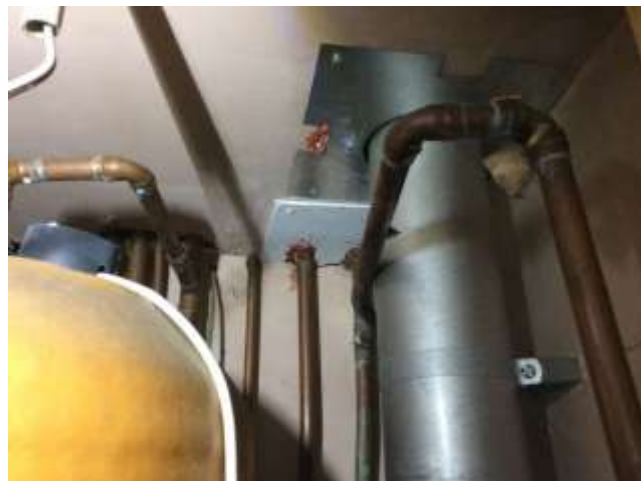
| Analysis Result | No Asbestos Detected | 0 |
| Condition | Good Condition | 0 |

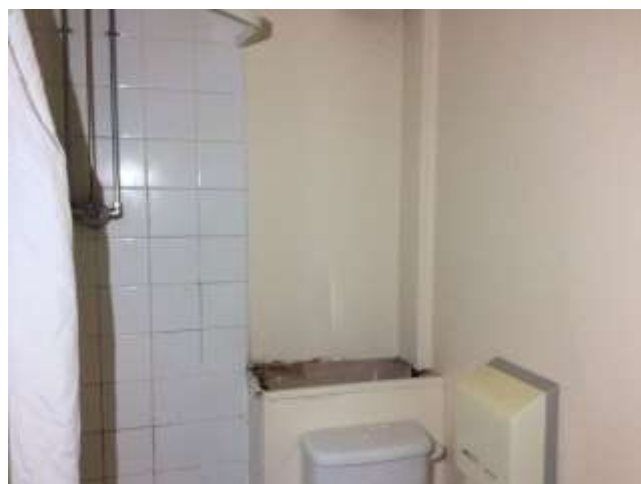
| Analysis Result | No Asbestos Detected | 0 |
| Condition | Good Condition | 0 |

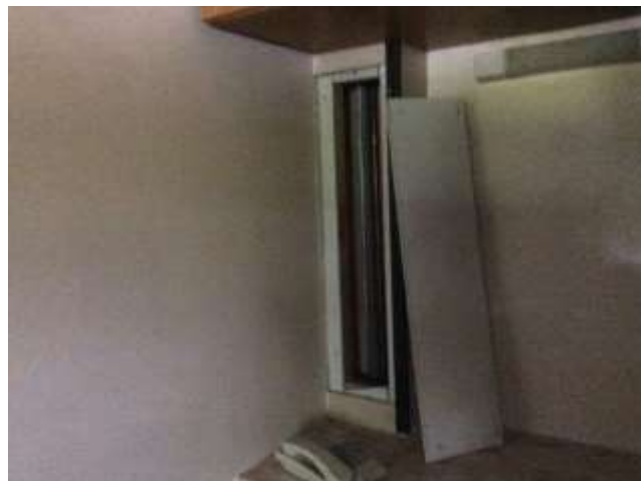
| Analysis Result | No Asbestos Detected | 0 |
| Condition | Good Condition | 0 |

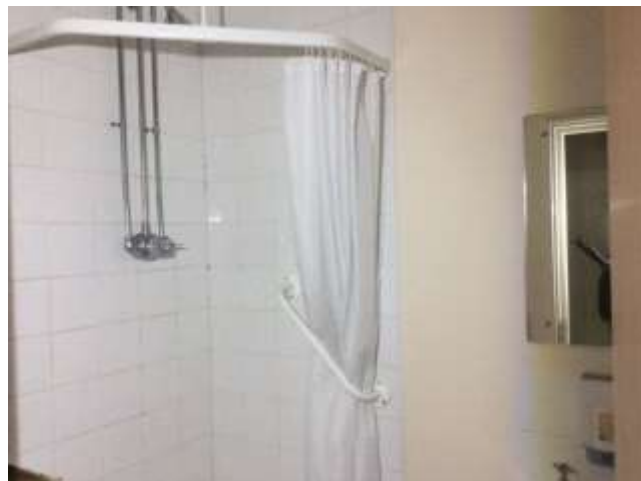
| Analysis Result | No Asbestos Detected | 0 |
| Condition | Good Condition | 0 |

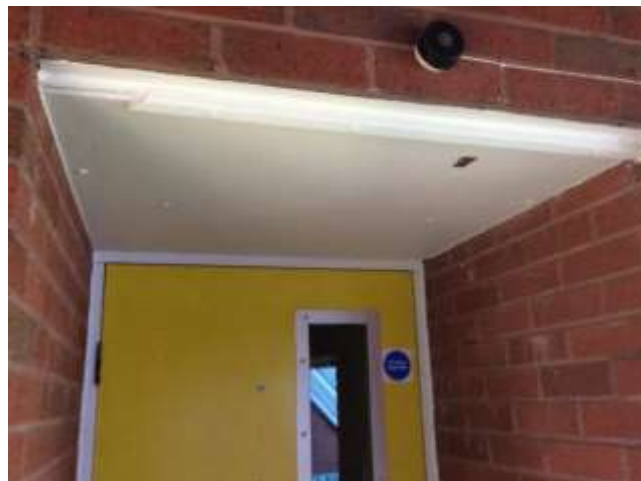
| Analysis Result | No Asbestos Detected | 0 |
| Condition | Good Condition | 0 |

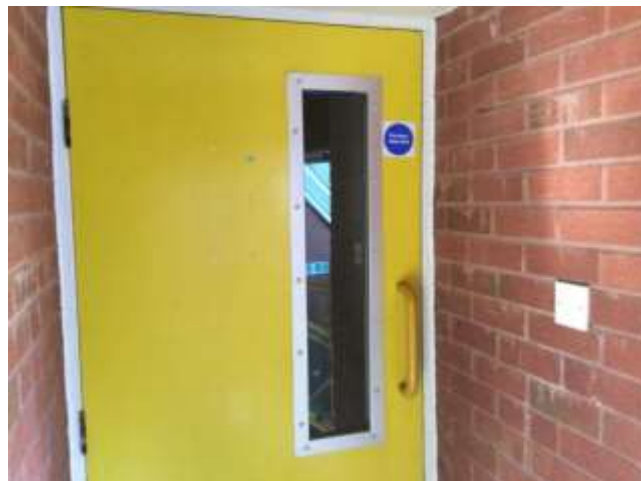
| Analysis Result | No Asbestos Detected | 0 |
| Condition | Good Condition | 0 |

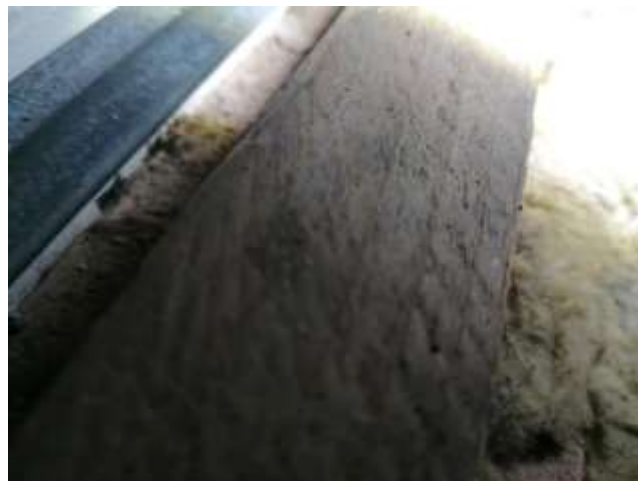
| Analysis Result | No Asbestos Detected | 0 |
| Condition | Good Condition | 0 |

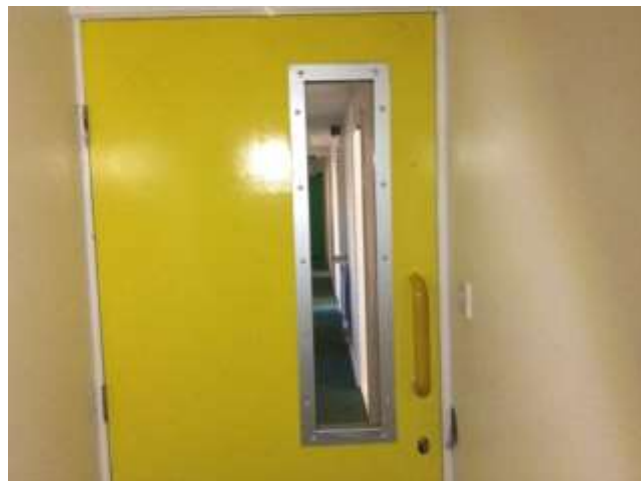
| Analysis Result | No Asbestos Detected | 0 |
| Condition | Good Condition | 0 |

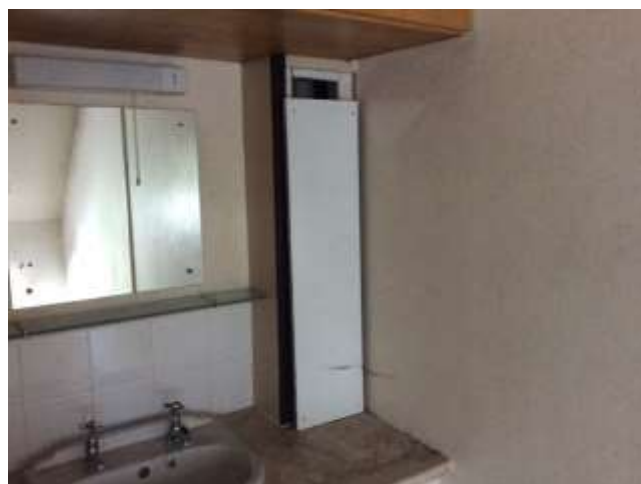
| Analysis Result | No Asbestos Detected | 0 |
| Condition | Low Damage | 1 |

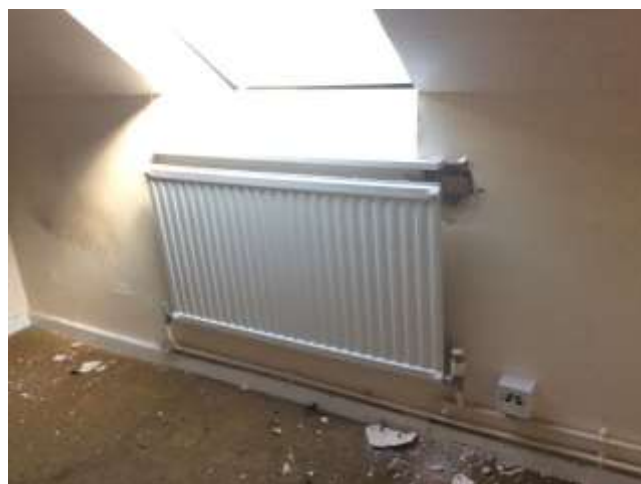
| Analysis Result | No Asbestos Detected | 0 |
| Condition | Good Condition | 0 |

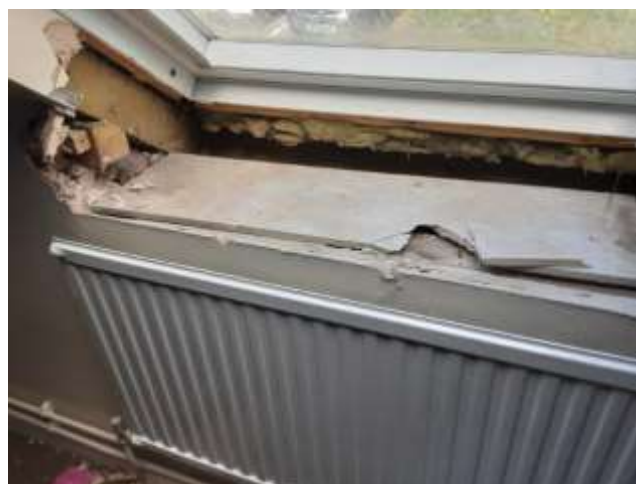
| Analysis Result | No Asbestos Detected | 0 |
| Condition | Good Condition | 0 |

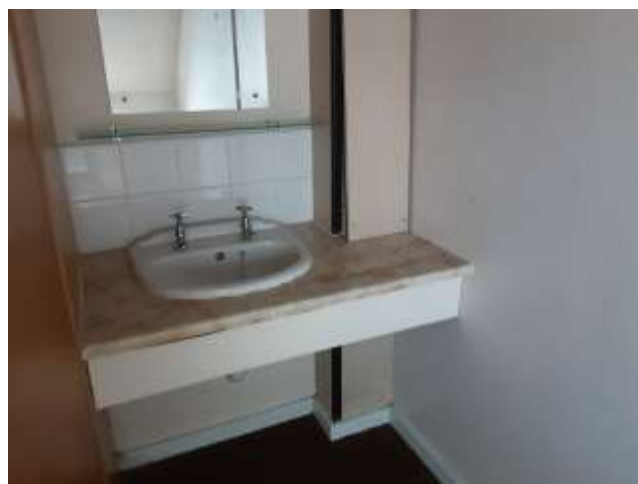
| Analysis Result | No Asbestos Detected | 0 |
| Condition | Good Condition | 0 |

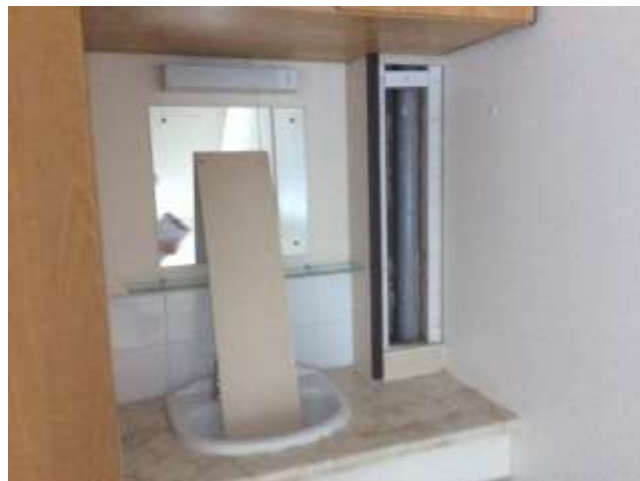
| Analysis Result | No Asbestos Detected | 0 |
| Condition | Good Condition | 0 |

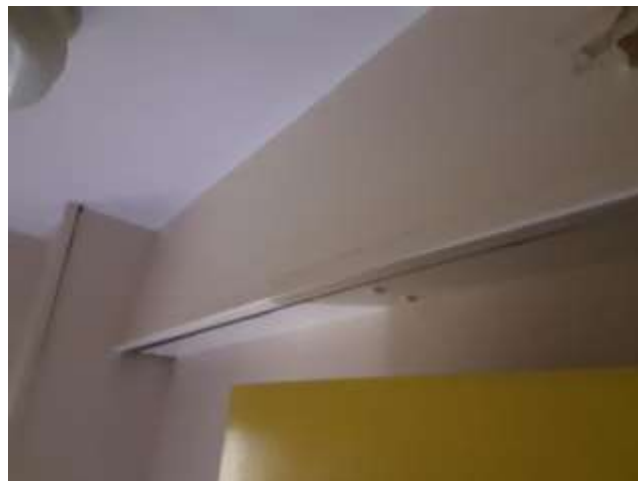
| Analysis Result | No Asbestos Detected | 0 |
| Condition | Good Condition | 0 |

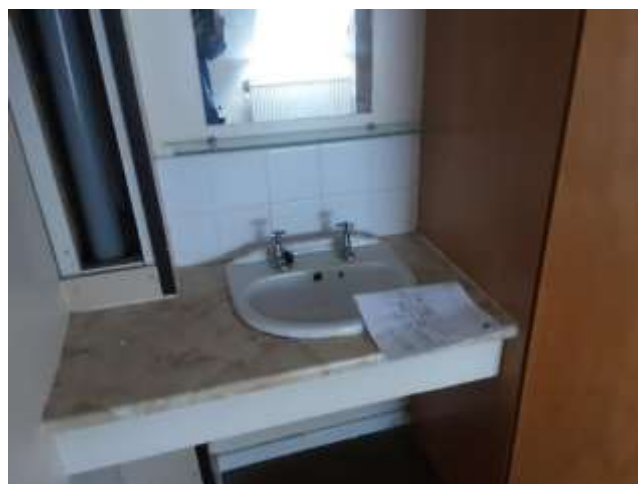
| Analysis Result | No Asbestos Detected | 0 |
| Condition | Good Condition | 0 |

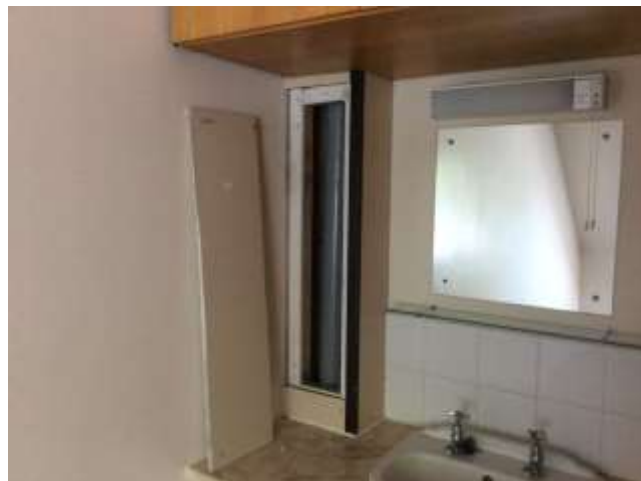
| Analysis Result | No Asbestos Detected | 0 |
| Condition | Good Condition | 0 |

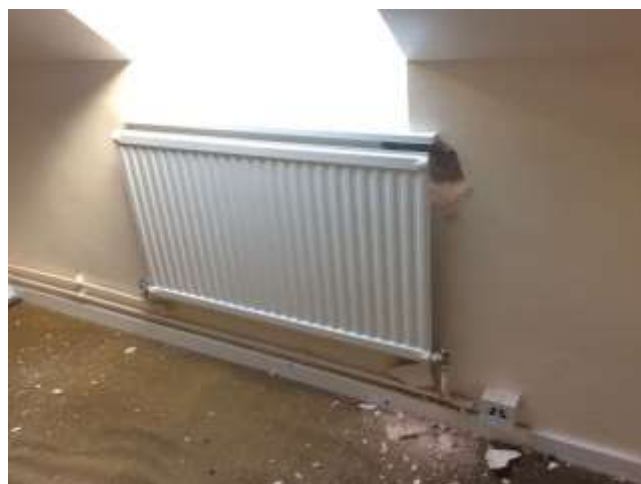
| Analysis Result | No Asbestos Detected | 0 |
| Condition | Good Condition | 0 |

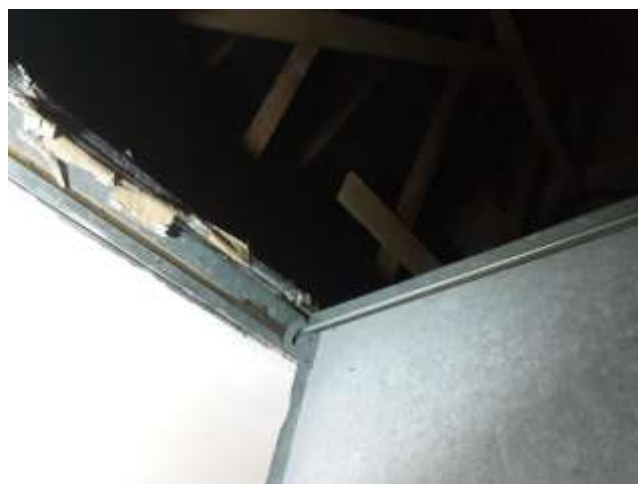
| Analysis Result | No Asbestos Detected | 0 |
| Condition | Good Condition | 0 |

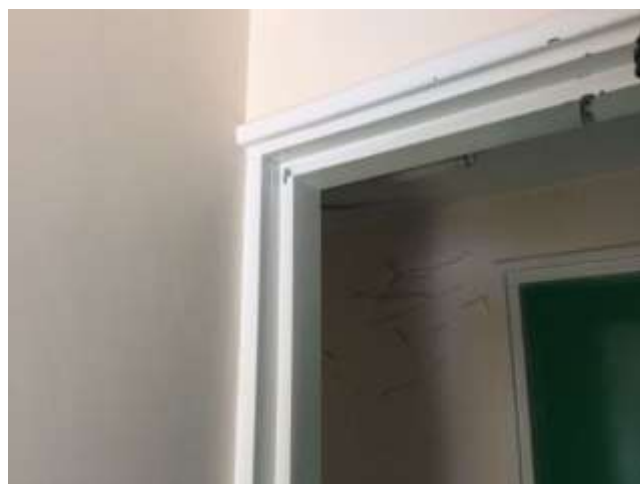
| Analysis Result | No Asbestos Detected | 0 |
| Condition | Good Condition | 0 |

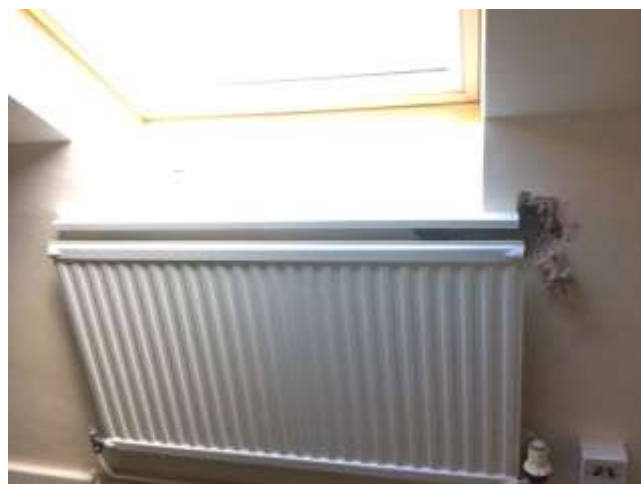
| Analysis Result | No Asbestos Detected | 0 |
| Condition | Good Condition | 0 |

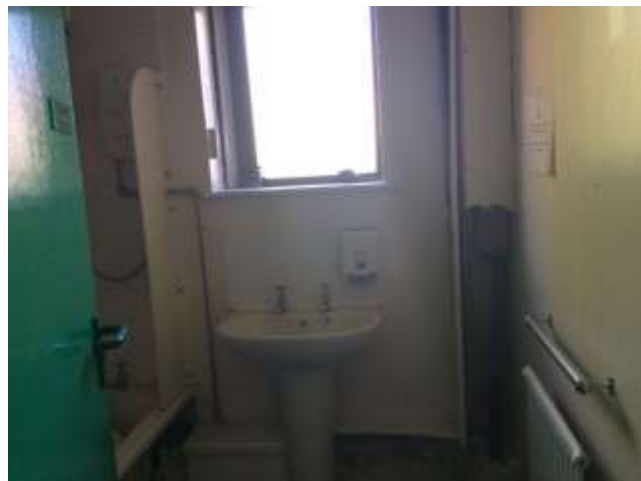
| Analysis Result | No Asbestos Detected | 0 |
| Condition | Good Condition | 0 |

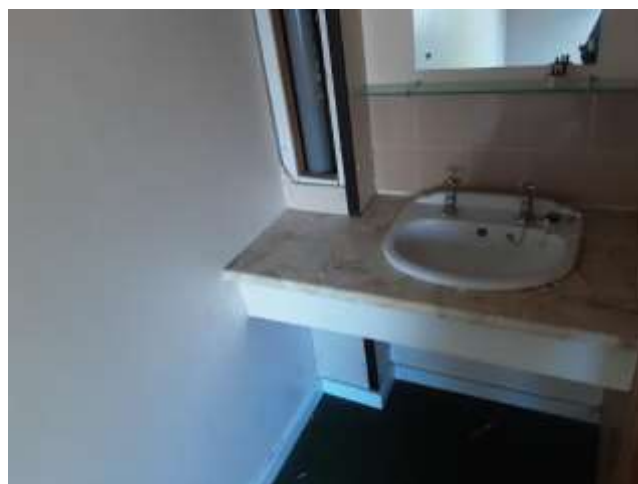
| Analysis Result | No Asbestos Detected | 0 |
| Condition | Good Condition | 0 |

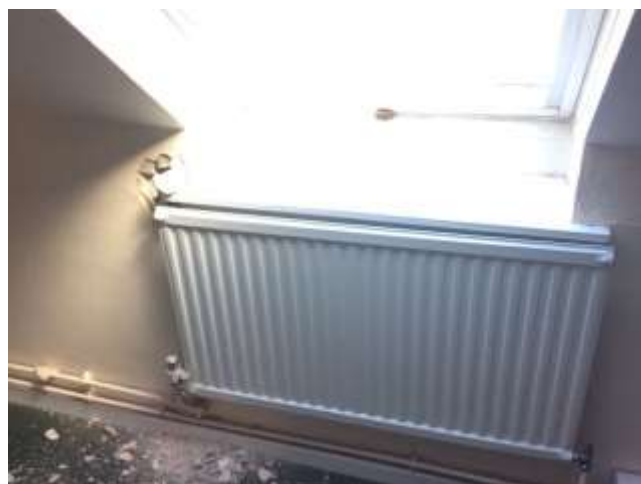
| Analysis Result | No Asbestos Detected | 0 |
| Condition | Good Condition | 0 |

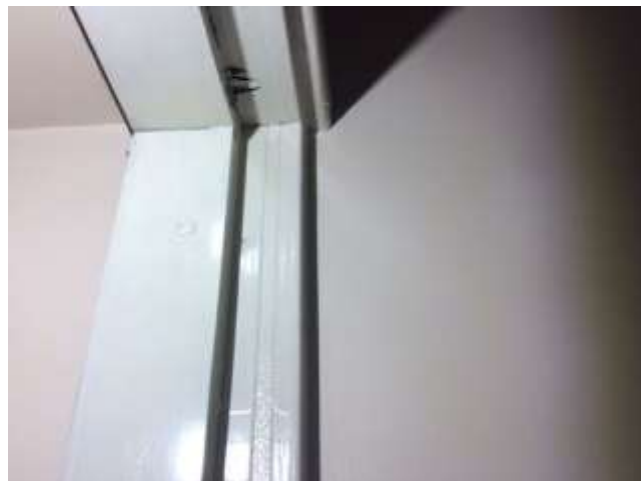
| Analysis Result | No Asbestos Detected | 0 |
| Condition | Good Condition | 0 |

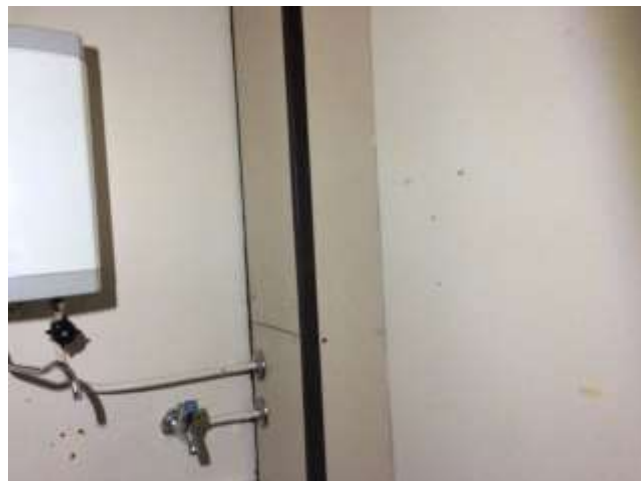
| Analysis Result | No Asbestos Detected | 0 |
| Condition | Good Condition | 0 |

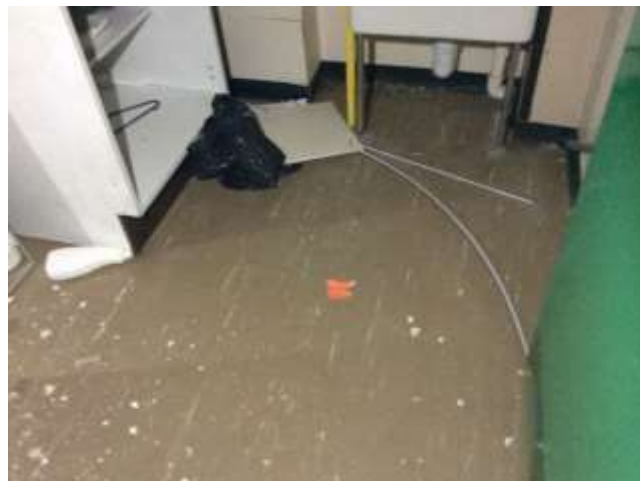
| Analysis Result | No Asbestos Detected | 0 |
| Condition | Good Condition | 0 |

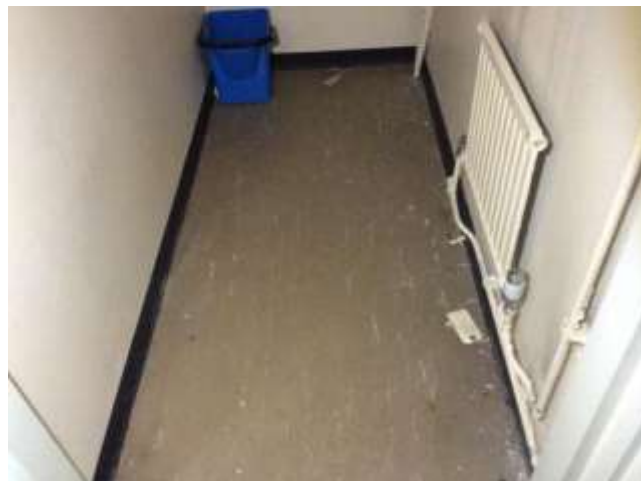
| Analysis Result | No Asbestos Detected | 0 |
| Condition | Good Condition | 0 |

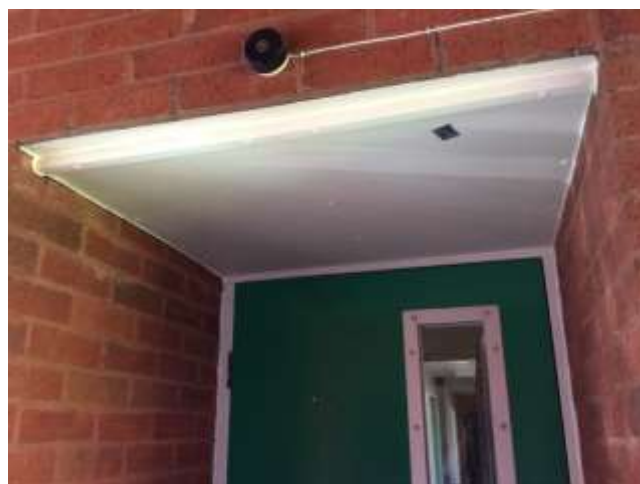
| Analysis Result | No Asbestos Detected | 0 |
| Condition | Good Condition | 0 |

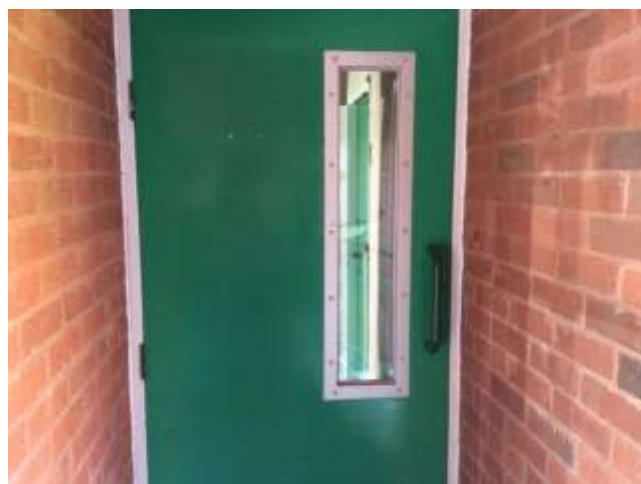
| Analysis Result | No Asbestos Detected | 0 |
| Condition | Good Condition | 0 |

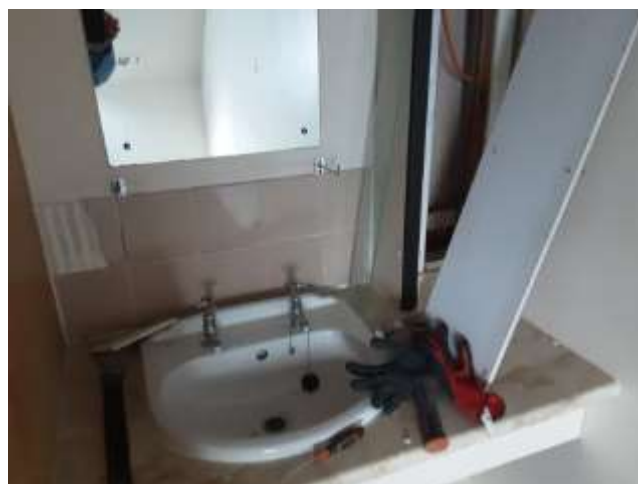
| Analysis Result | No Asbestos Detected | 0 |
| Condition | Good Condition | 0 |

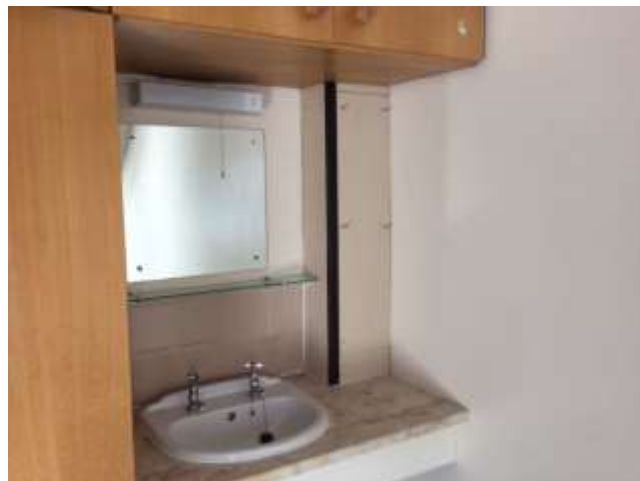
| Analysis Result | No Asbestos Detected | 0 |
| Condition | Good Condition | 0 |

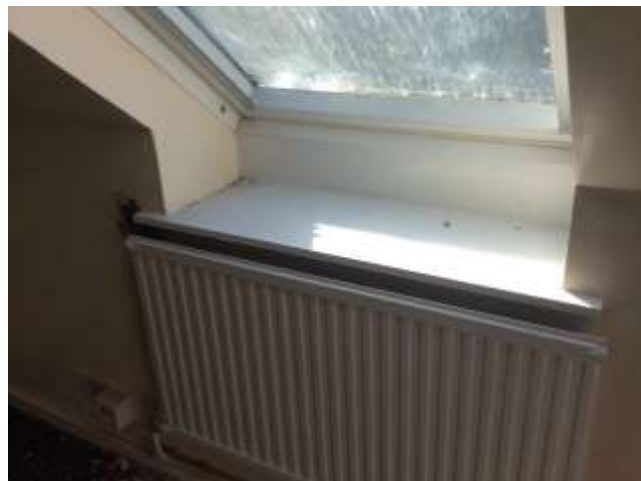
| Analysis Result | No Asbestos Detected | 0 |
| Condition | Good Condition | 0 |

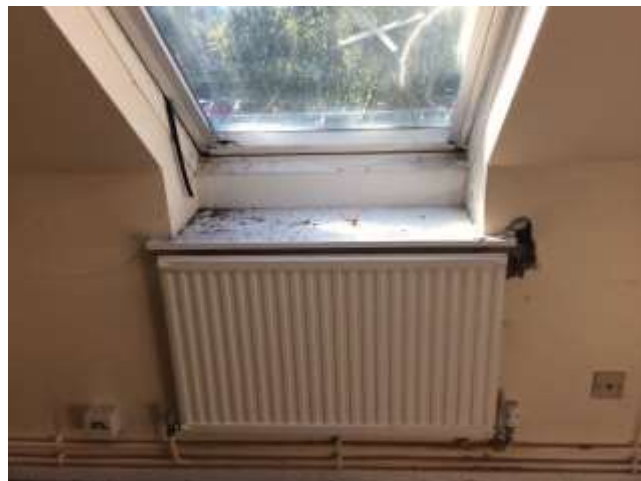
| Analysis Result | No Asbestos Detected | 0 |
| Condition | Good Condition | 0 |

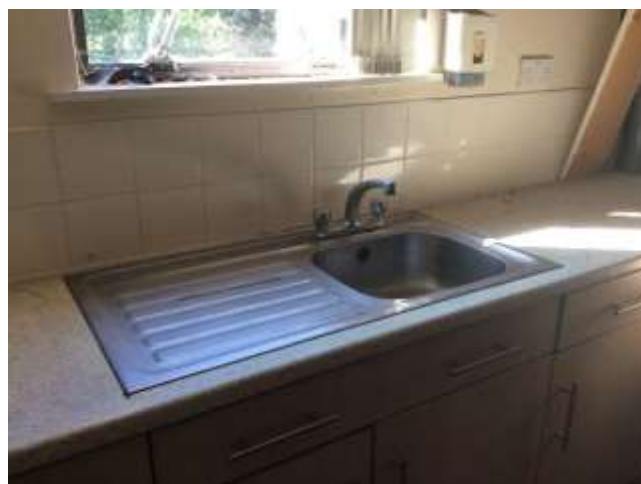
| Analysis Result | No Asbestos Detected | 0 |
| Condition | Good Condition | 0 |

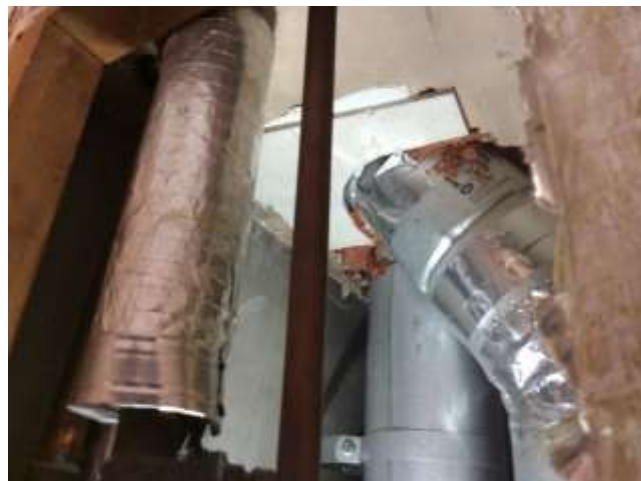
| Analysis Result | No Asbestos Detected | 0 |
| Condition | Good Condition | 0 |

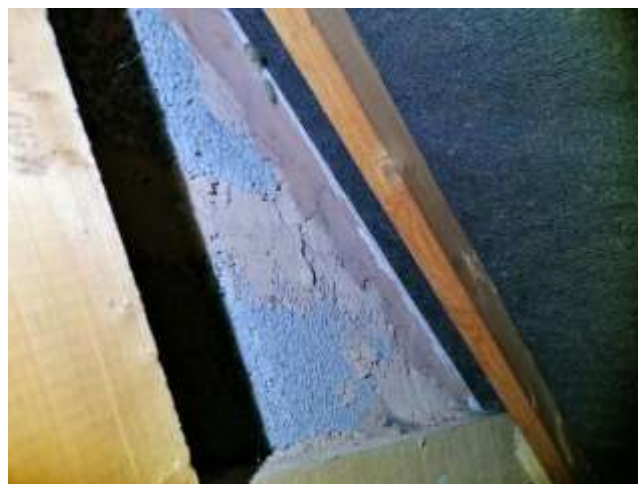
| Analysis Result | No Asbestos Detected | 0 |
| Condition | Low Damage | 1 |

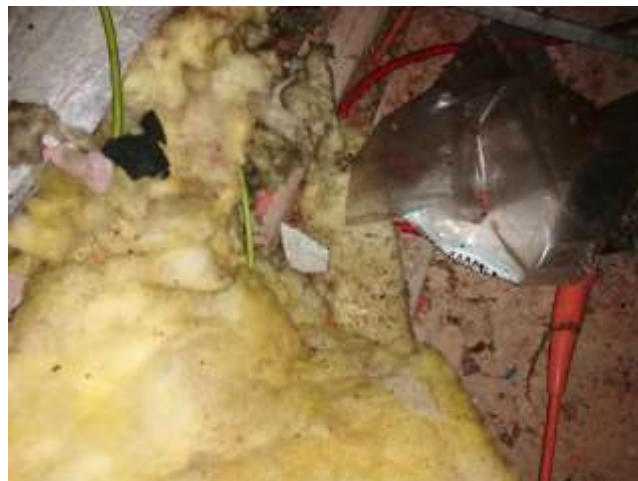
| Analysis Result | Chrysotile | 1 |
| Condition | High Damage | 3 |

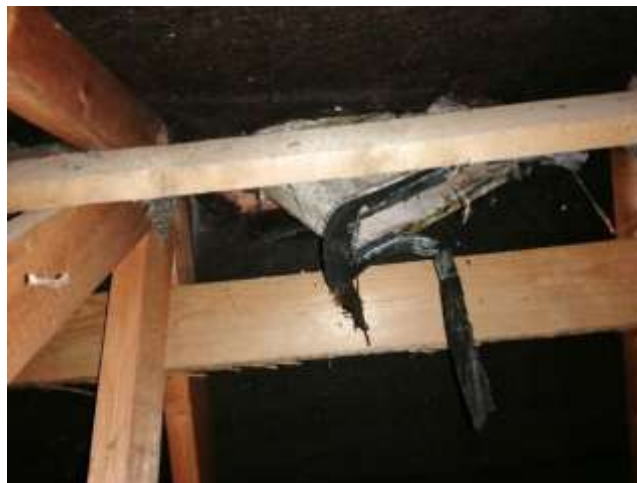
| Analysis Result | Chrysotile | 1 |
| Condition | Low Damage | 1 |

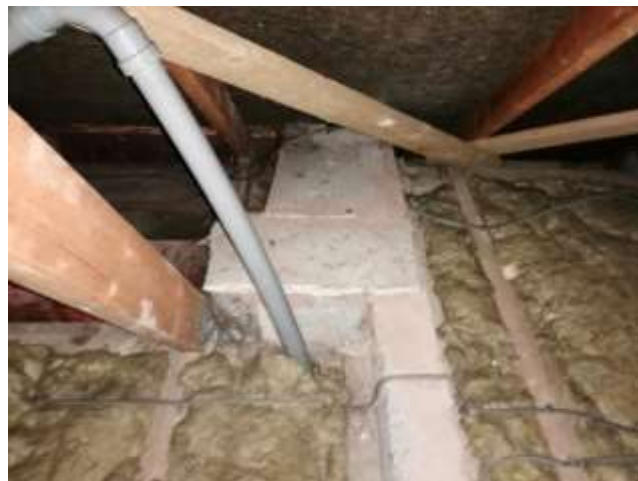
| Analysis Result | No Asbestos Detected | 0 |
| Condition | Medium Damage | 2 |

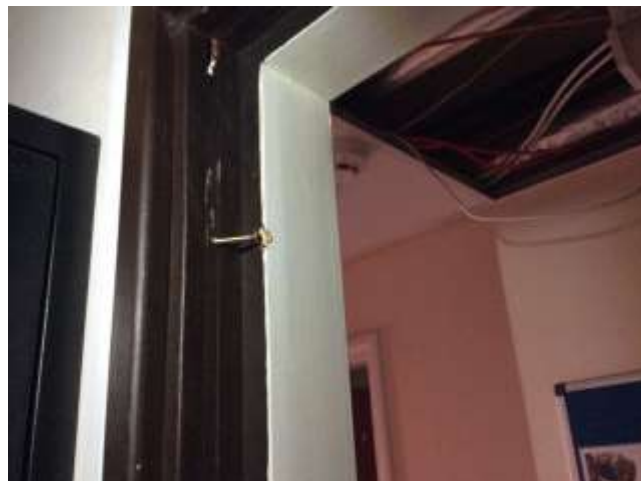
| Analysis Result | No Asbestos Detected | 0 |
| Condition | Good Condition | 0 |

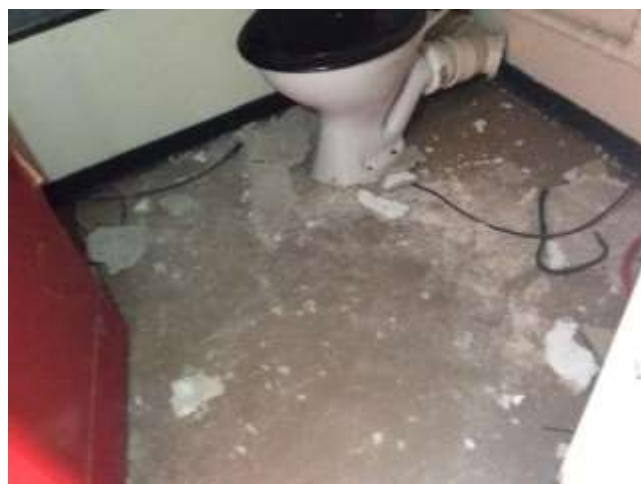
| Analysis Result | No Asbestos Detected | 0 |
| Condition | Good Condition | 0 |

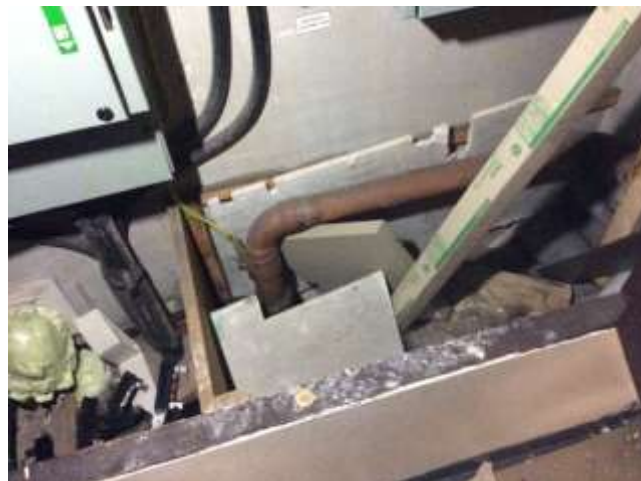
| Analysis Result | No Asbestos Detected | 0 |
| Condition | High Damage | 3 |

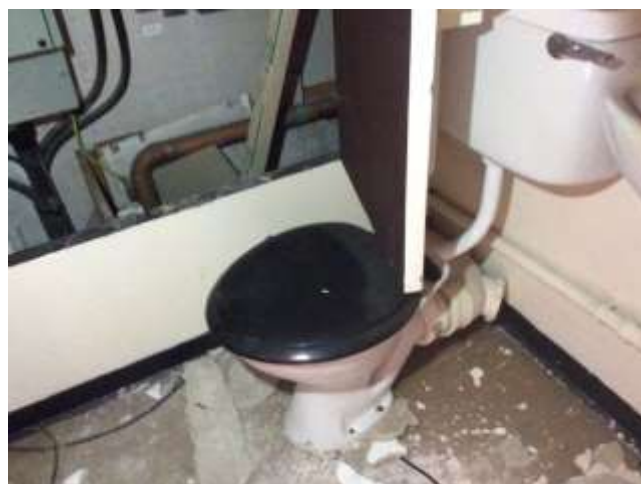
| Analysis Result | No Asbestos Detected | 0 |
| Condition | Good Condition | 0 |

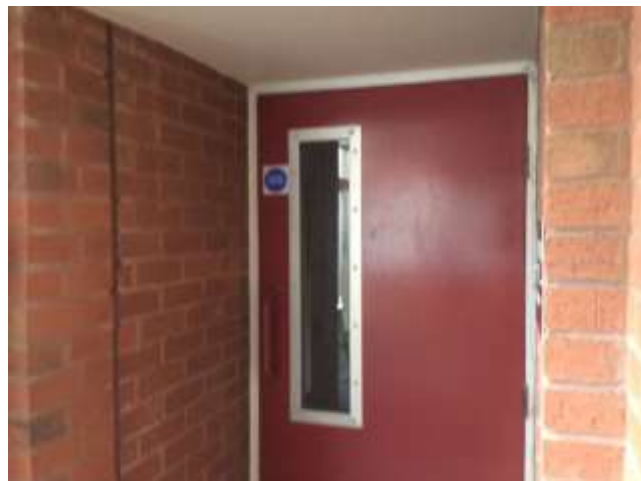
| Analysis Result | No Asbestos Detected | 0 |
| Condition | Good Condition | 0 |

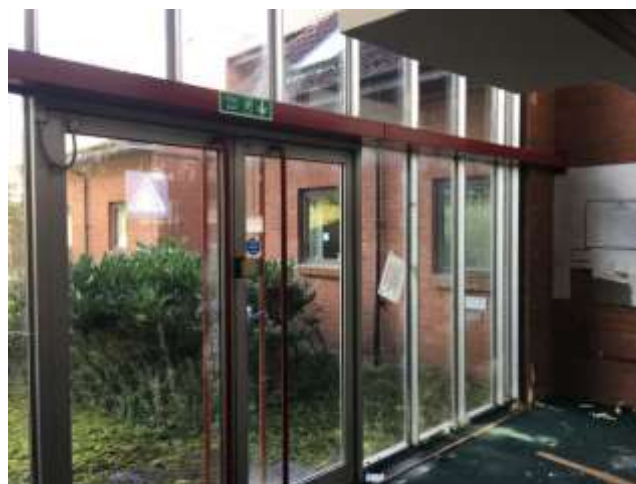
| Analysis Result | Chrysotile | 1 |
| Condition | Good Condition | 0 |

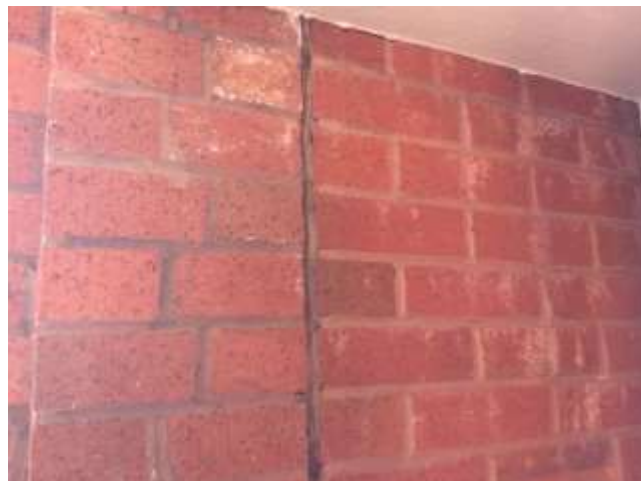
| Analysis Result | No Asbestos Detected | 0 |
| Condition | Good Condition | 0 |
