## Asbestos Demolition Survey

**Blocks 54, 55, 56 & 57  
Fairfield General Hospital  
Rochdale Old Road  
Bury  
BL9 7TD**

**Northern Care Alliance NHS Group**

| Project Number: | Survey Date: | Issue Date: |
|---|---|---|
| B-38673s3 | 12 May 2023 | 16 May 2023 |

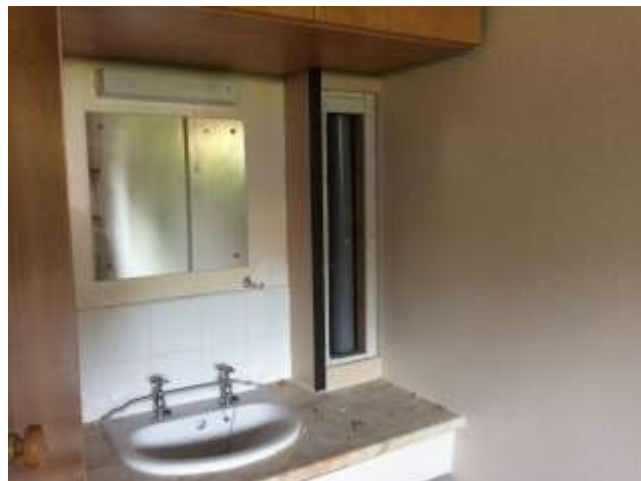
| Analysis Result | No Asbestos Detected | 0 |
| Condition | Good Condition | 0 |

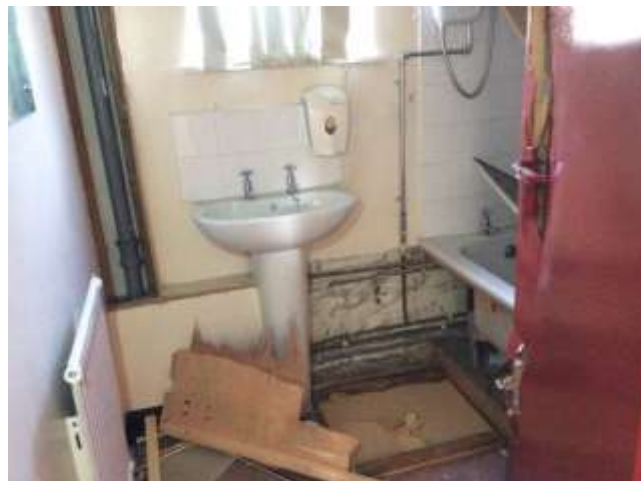
| Analysis Result | No Asbestos Detected | 0 |
| Condition | Good Condition | 0 |

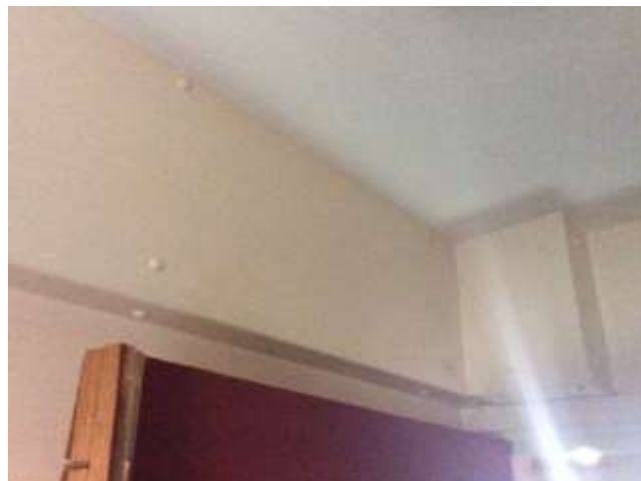
| Analysis Result | No Asbestos Detected | 0 |
| Condition | Good Condition | 0 |

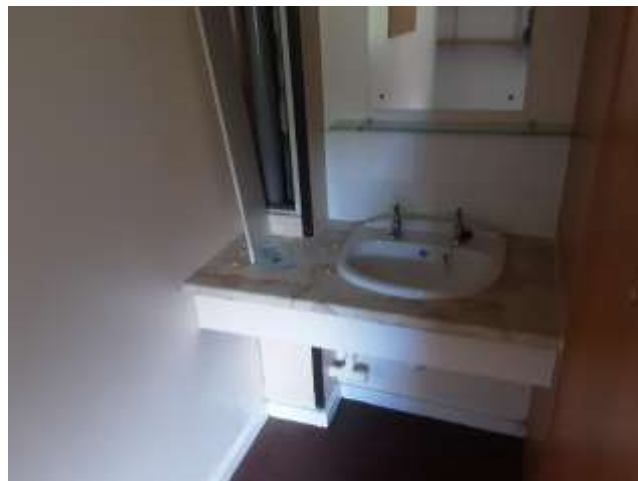
| Analysis Result | No Asbestos Detected | 0 |
| Condition | Good Condition | 0 |

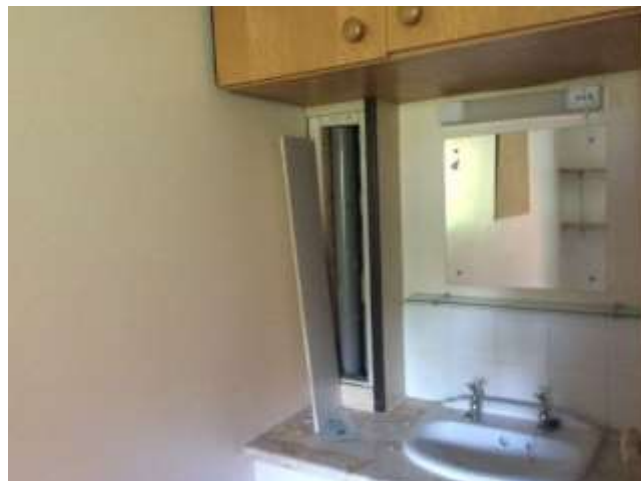
| Analysis Result | No Asbestos Detected | 0 |
| Condition | Good Condition | 0 |

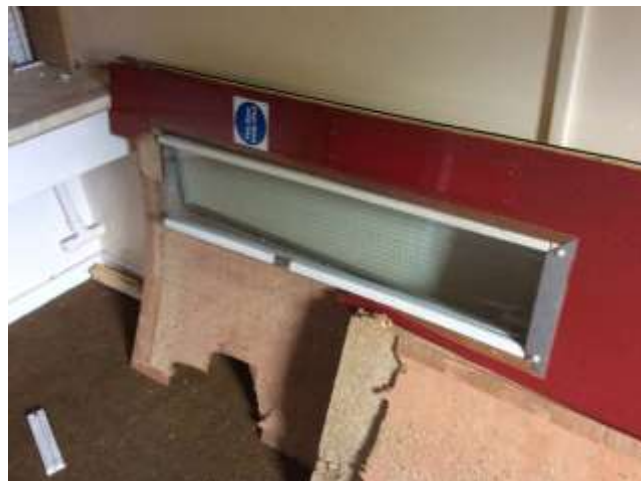
| Analysis Result | No Asbestos Detected | 0 |
| Condition | Good Condition | 0 |

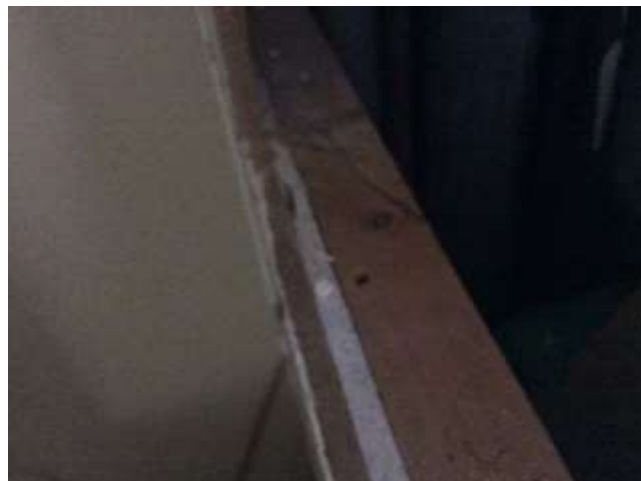
| Analysis Result | No Asbestos Detected | 0 |
| Condition | Good Condition | 0 |

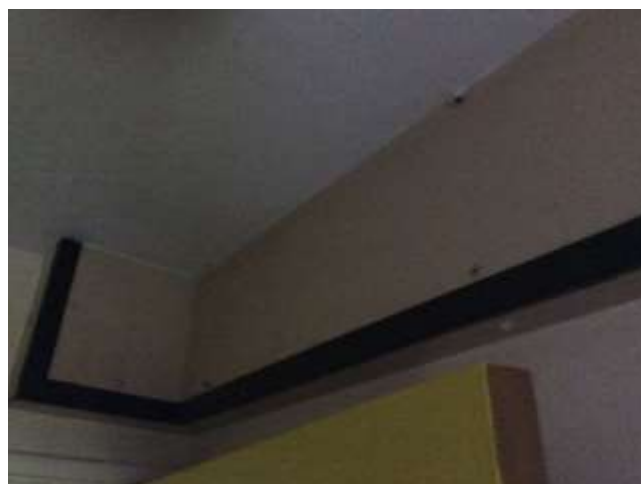
| Analysis Result | No Asbestos Detected | 0 |
| Condition | Good Condition | 0 |

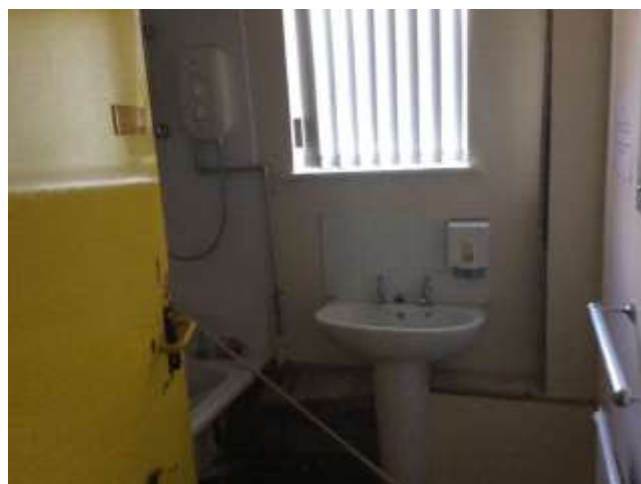
| Analysis Result | No Asbestos Detected | 0 |
| Condition | Good Condition | 0 |

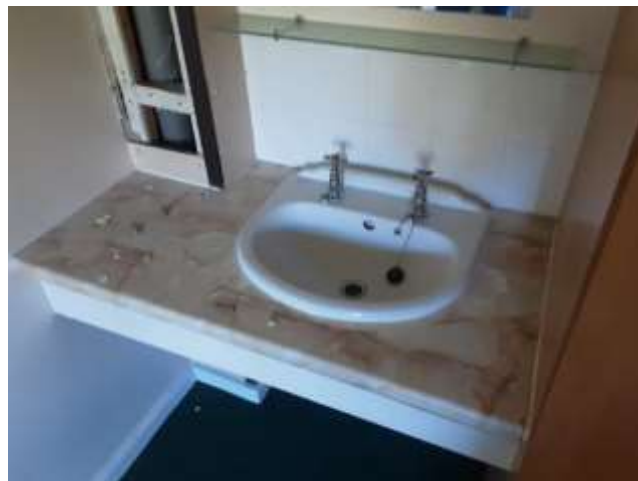
| Analysis Result | No Asbestos Detected | 0 |
| Condition | Good Condition | 0 |

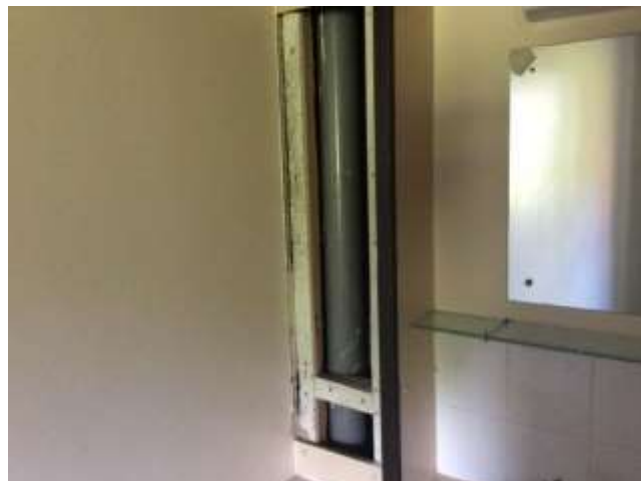
| Analysis Result | No Asbestos Detected | 0 |
| Condition | Good Condition | 0 |

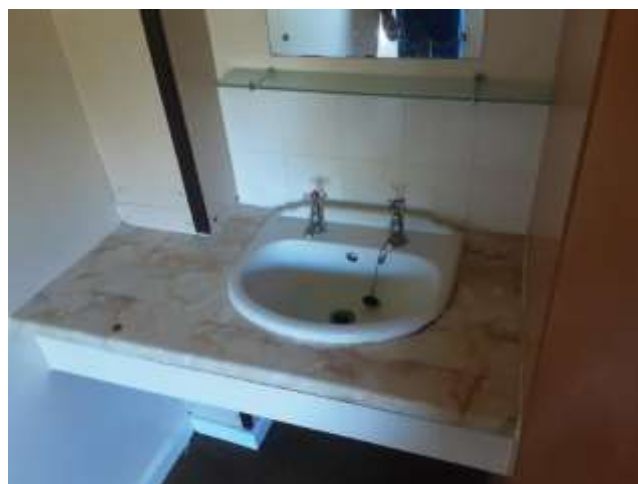
| Analysis Result | No Asbestos Detected | 0 |
| Condition | Good Condition | 0 |

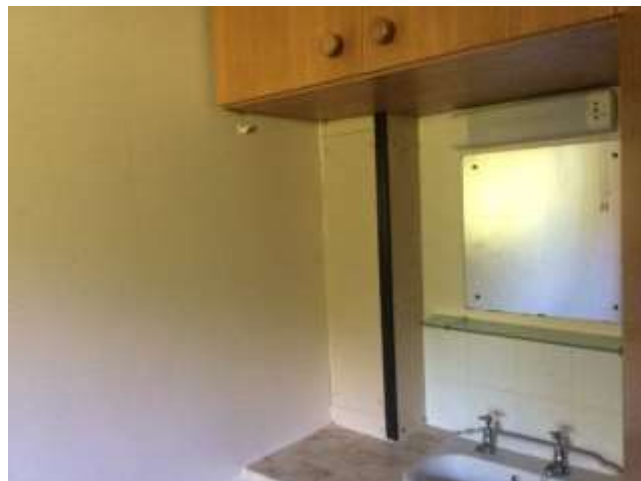
| Analysis Result | No Asbestos Detected | 0 |
| Condition | Good Condition | 0 |

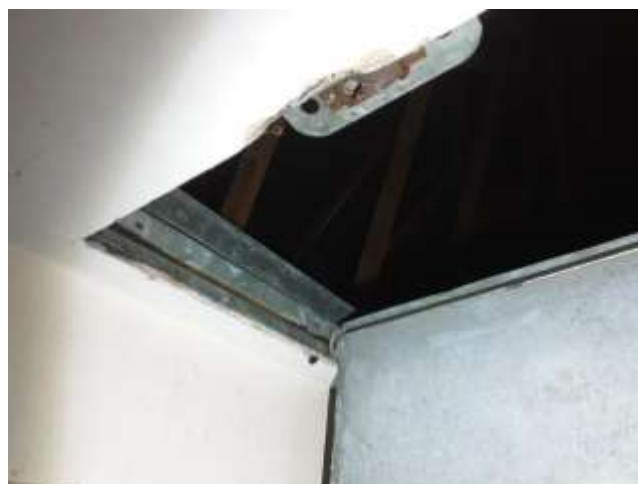
| Analysis Result | No Asbestos Detected | 0 |
| Condition | Good Condition | 0 |

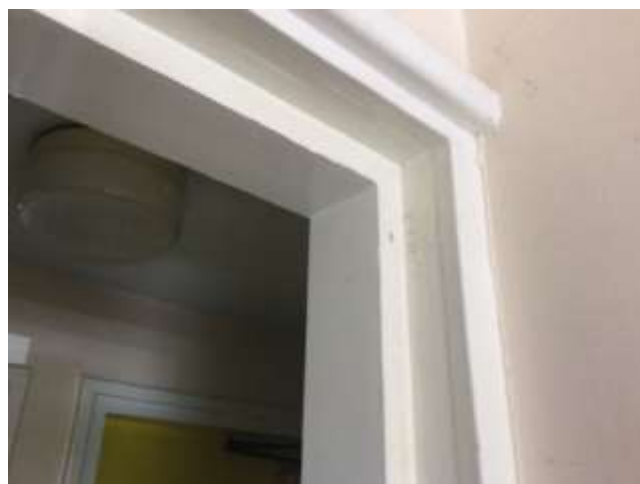
| Analysis Result | No Asbestos Detected | 0 |
| Condition | Good Condition | 0 |

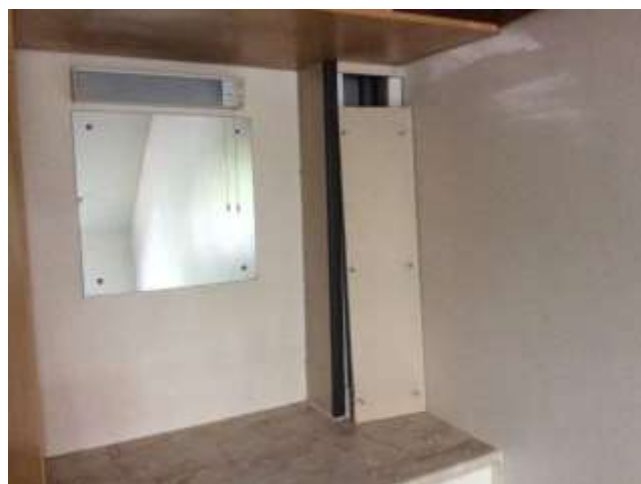
| Analysis Result | No Asbestos Detected | 0 |
| Condition | Good Condition | 0 |

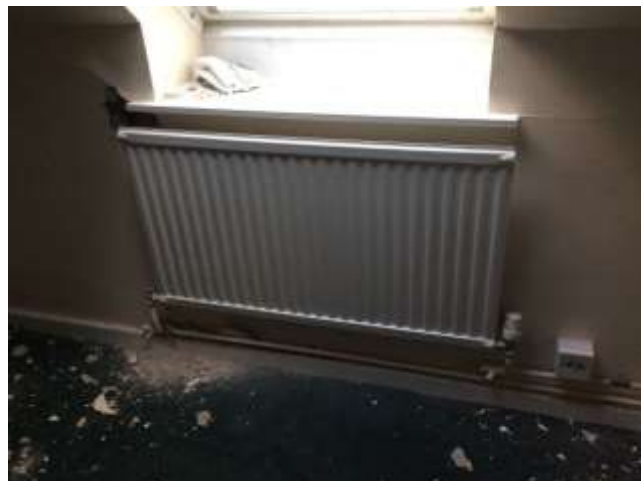
| Analysis Result | No Asbestos Detected | 0 |
| Condition | Good Condition | 0 |

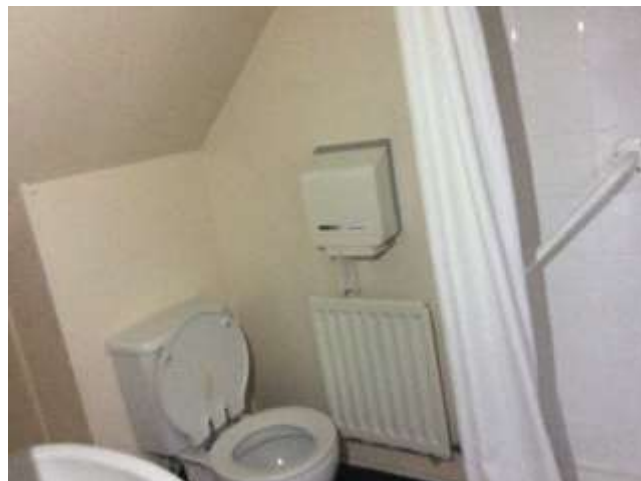
| Analysis Result | No Asbestos Detected | 0 |
| Condition | Good Condition | 0 |

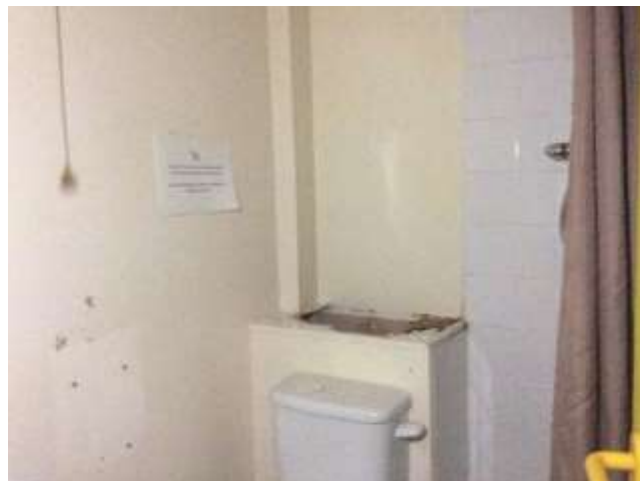
| Analysis Result | No Asbestos Detected | 0 |
| Condition | Good Condition | 0 |

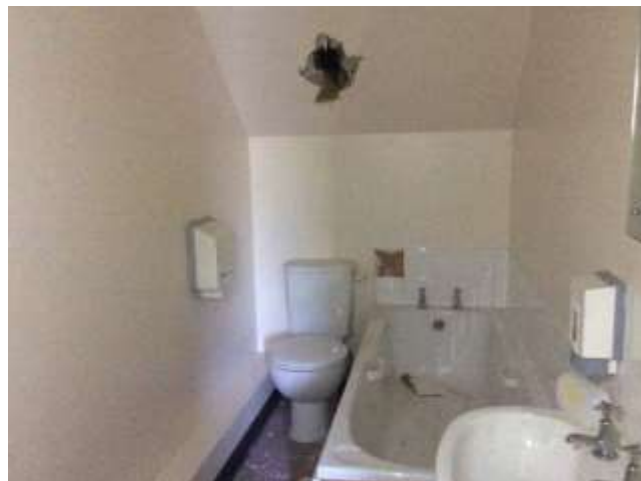
| Analysis Result | No Asbestos Detected | 0 |
| Condition | Good Condition | 0 |

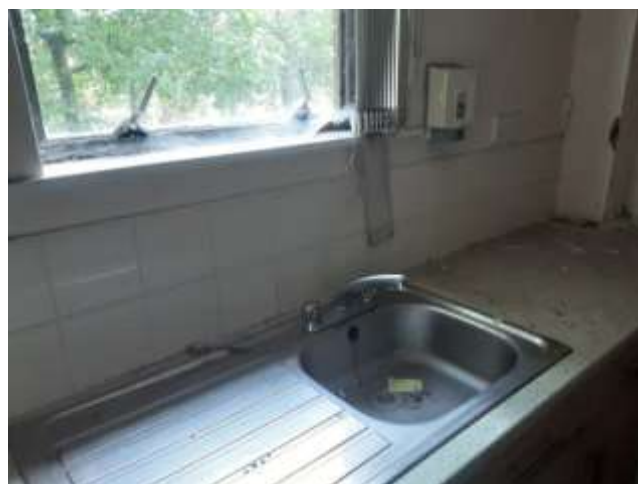
| Analysis Result | No Asbestos Detected | 0 |
| Condition | Good Condition | 0 |

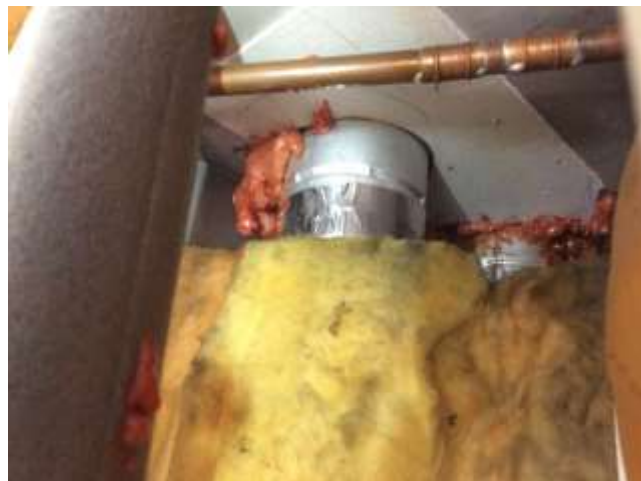
| Analysis Result | No Asbestos Detected | 0 |
| Condition | Good Condition | 0 |

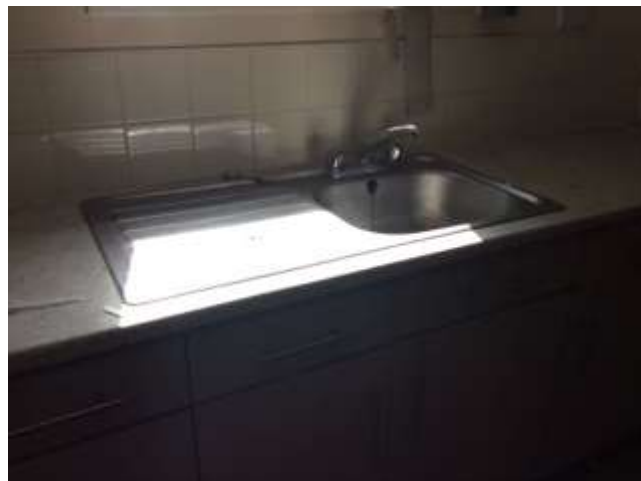
| Analysis Result | No Asbestos Detected | 0 |
| Condition | Good Condition | 0 |

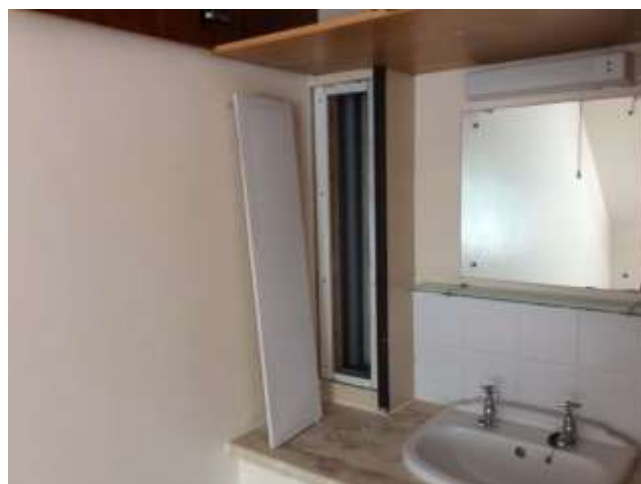
| Analysis Result | No Asbestos Detected | 0 |
| Condition | Good Condition | 0 |

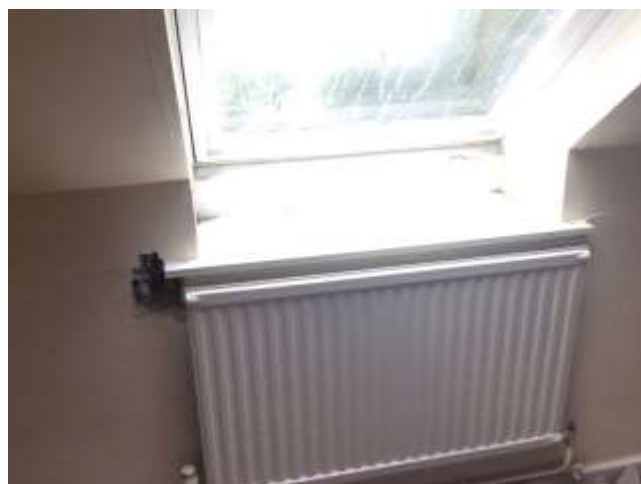
| Analysis Result | No Asbestos Detected | 0 |
| Condition | Good Condition | 0 |

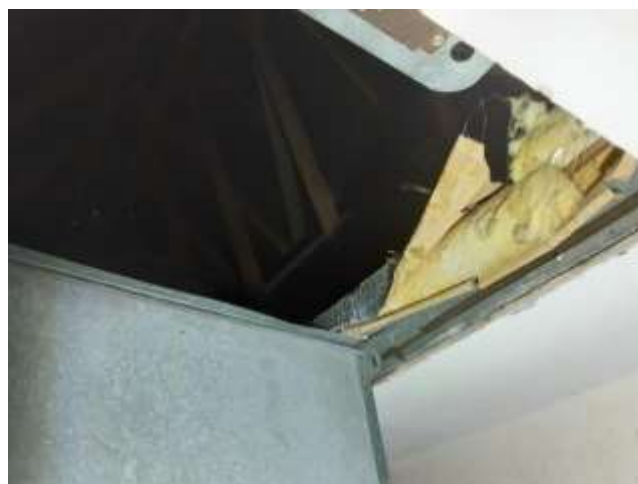
| Analysis Result | No Asbestos Detected | 0 |
| Condition | Good Condition | 0 |

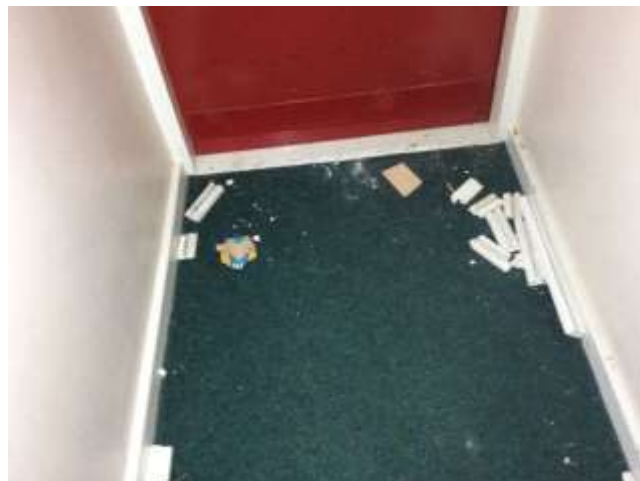
| Analysis Result | No Asbestos Detected | 0 |
| Condition | High Damage | 3 |

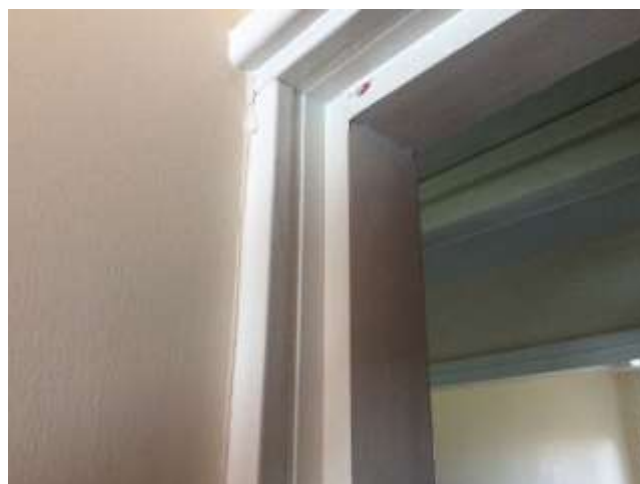
| Analysis Result | No Asbestos Detected | 0 |
| Condition | Good Condition | 0 |

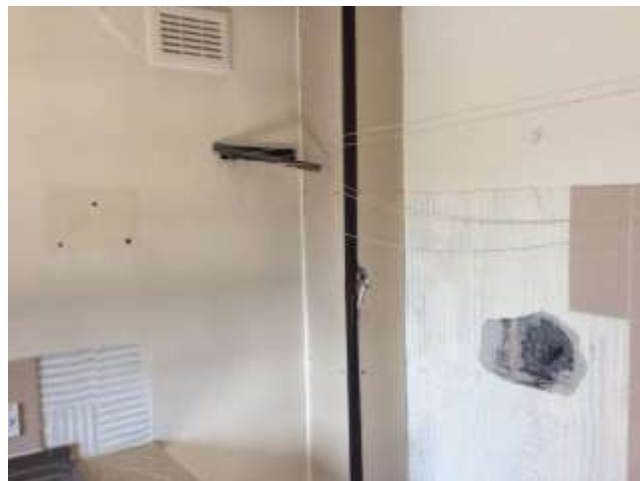
| Analysis Result | No Asbestos Detected | 0 |
| Condition | Low Damage | 1 |

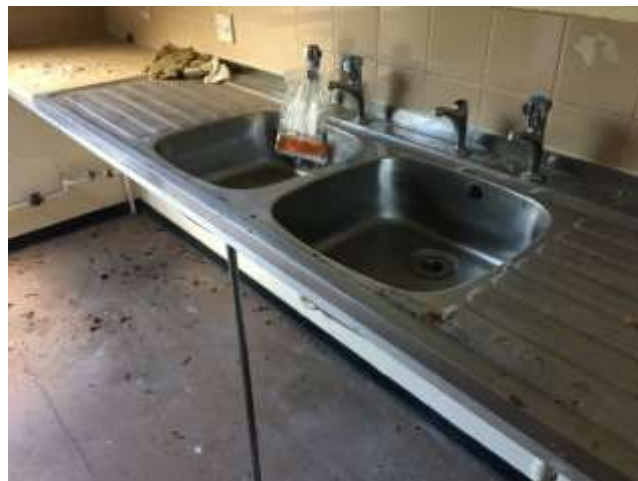
| Analysis Result | Chrysotile | 1 |
| Condition | Good Condition | 0 |

Whilst the asbestos containing material continues to remain undisturbed, no immediate action is required. However a system of ongoing management should be implemented which includes routine condition inspections.

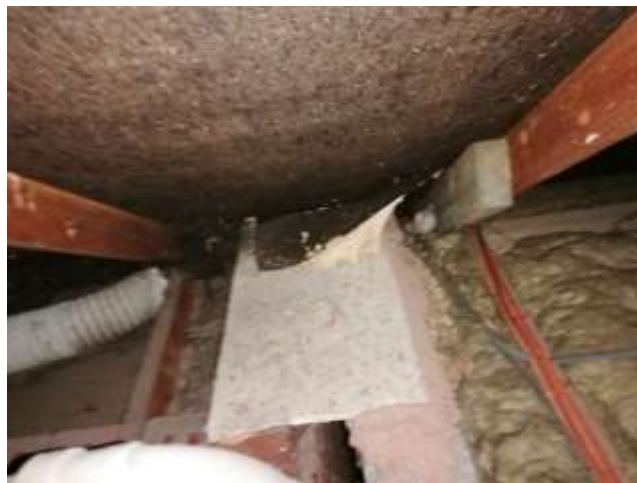
| Analysis Result | No Asbestos Detected | 0 |
| Condition | Medium Damage | 2 |

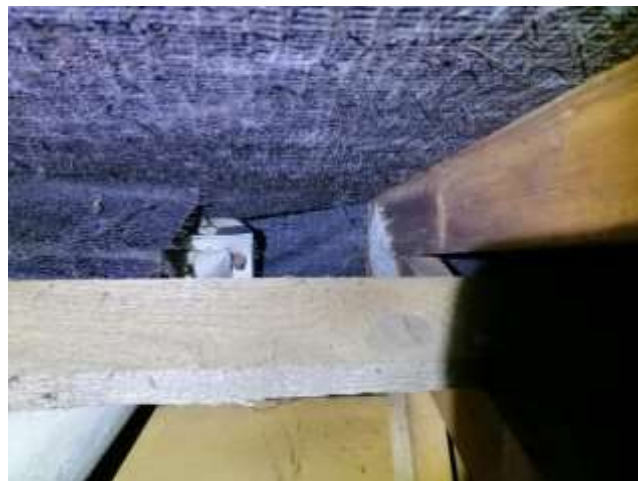
| Analysis Result | Chrysotile | 1 |
| Condition | Low Damage | 1 |

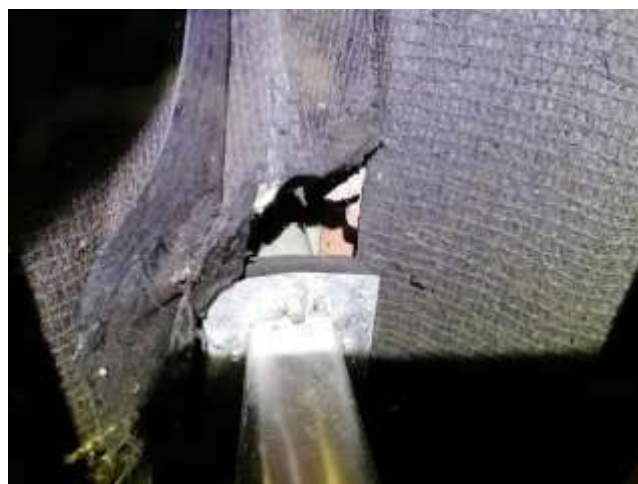
| Analysis Result | Chrysotile | 1 |
| Condition | Low Damage | 1 |

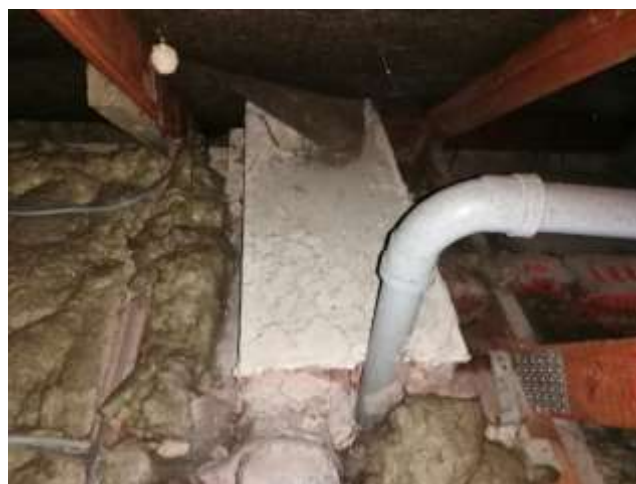
| Analysis Result | No Asbestos Detected | 0 |
| Condition | Medium Damage | 2 |

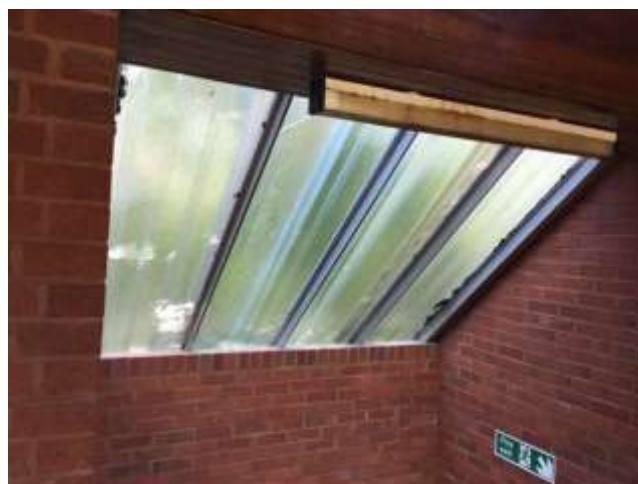
| Analysis Result | Chrysotile | 1 |
| Condition | Good Condition | 0 |

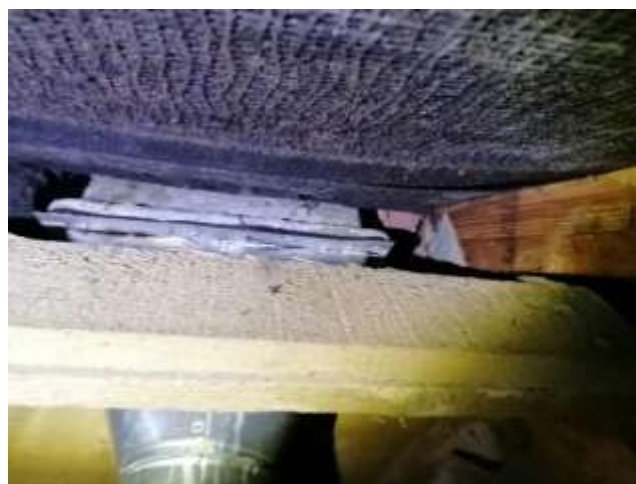
| Analysis Result | Chrysotile | 1 |
| Condition | Low Damage | 1 |

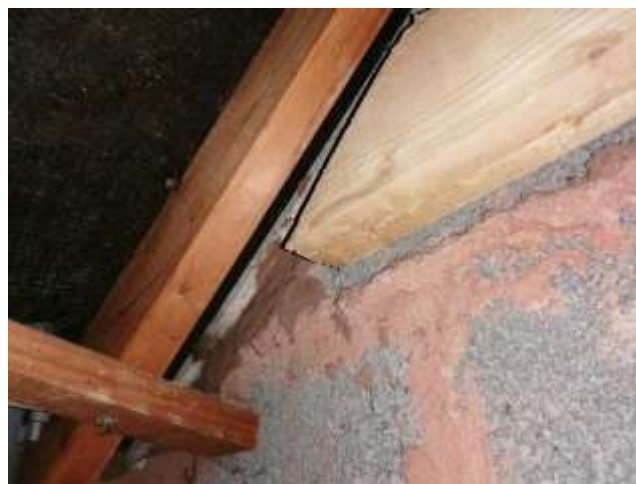
| Analysis Result | No Asbestos Detected | 0 |
| Condition | Low Damage | 1 |

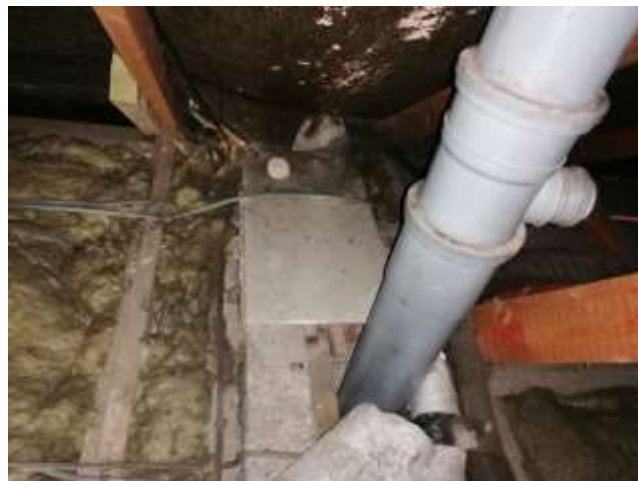
| Analysis Result | No Asbestos Detected | 0 |
| Condition | Medium Damage | 2 |

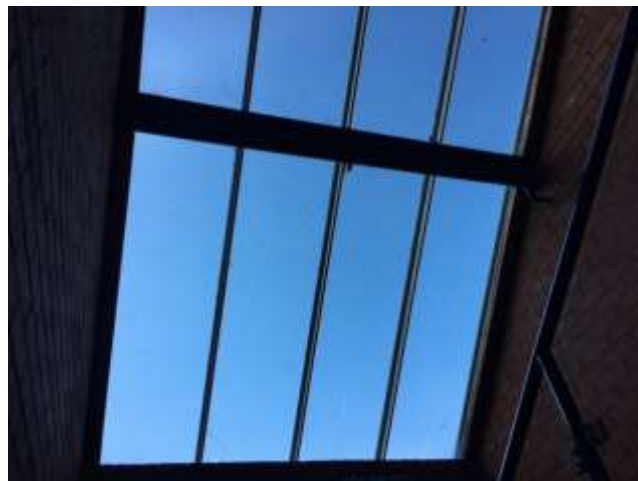
| Analysis Result | Chrysotile | 1 |
| Condition | Good Condition | 0 |

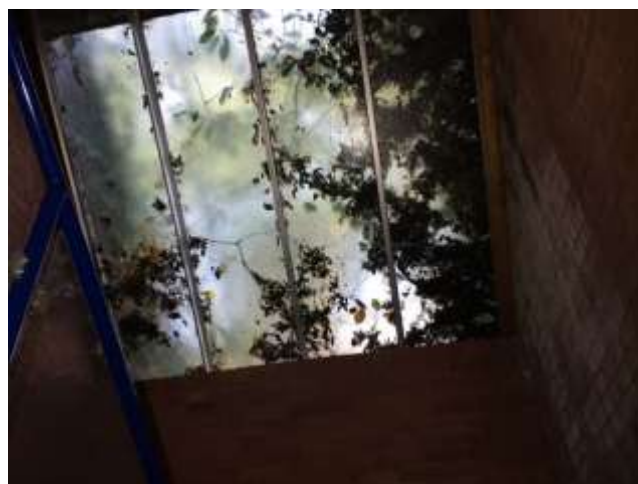
| Analysis Result | Chrysotile | 1 |
| Condition | Good Condition | 0 |

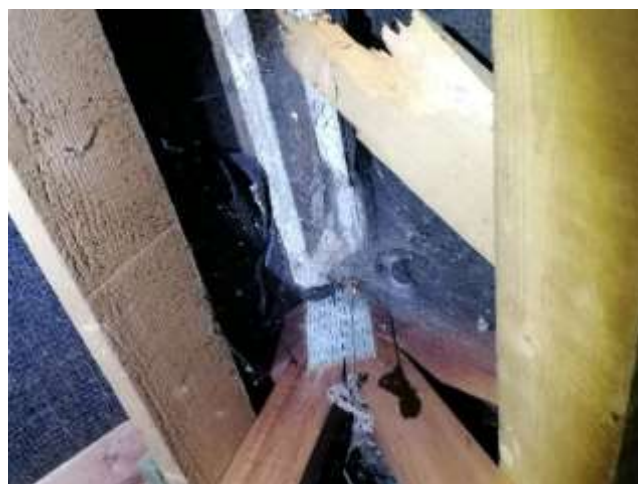
| Analysis Result | Chrysotile | 1 |
| Condition | Low Damage | 1 |

### Recommendations

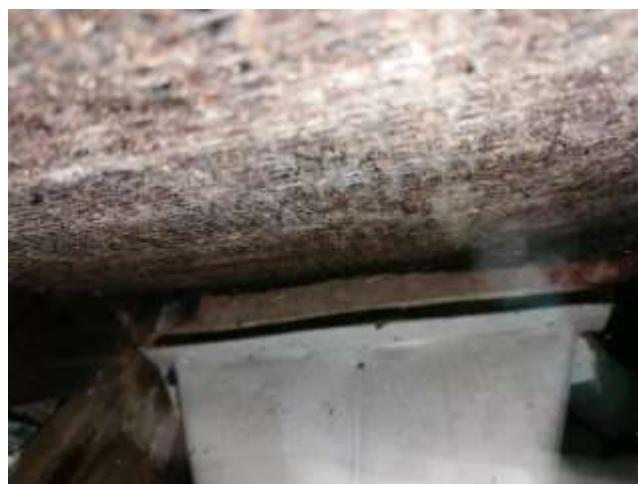
| Analysis Result | Chrysotile | 1 |
| Condition | Low Damage | 1 |

### Recommendations

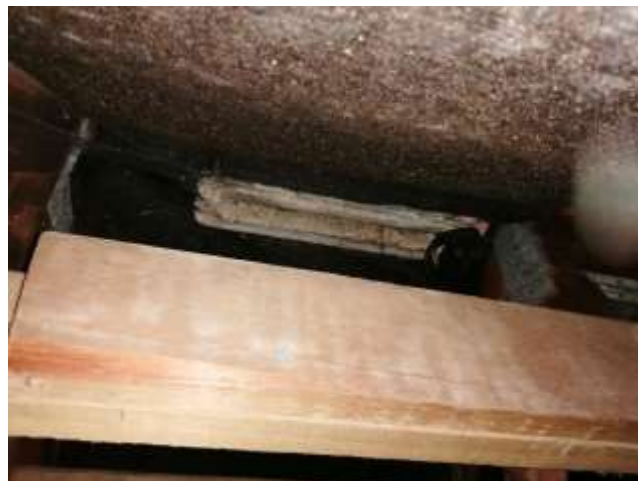
| Analysis Result | Chrysotile | 1 |
| Condition | Low Damage | 1 |

### Recommendations

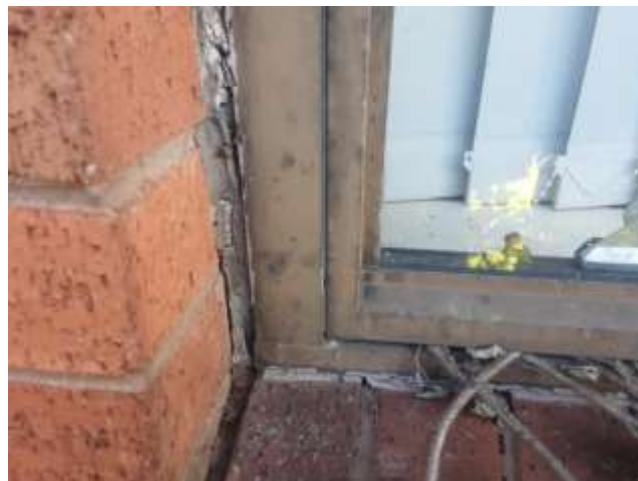
| Analysis Result | Chrysotile | 1 |
| Condition | Good Condition | 0 |

### Recommendations
