## **Remediation Verification Report for East Lancashire Paper Mill Island Site, Rectory Lane, Radcliffe, M26 2QU**

**Project No: NX418**

**Report Reference: NX418**

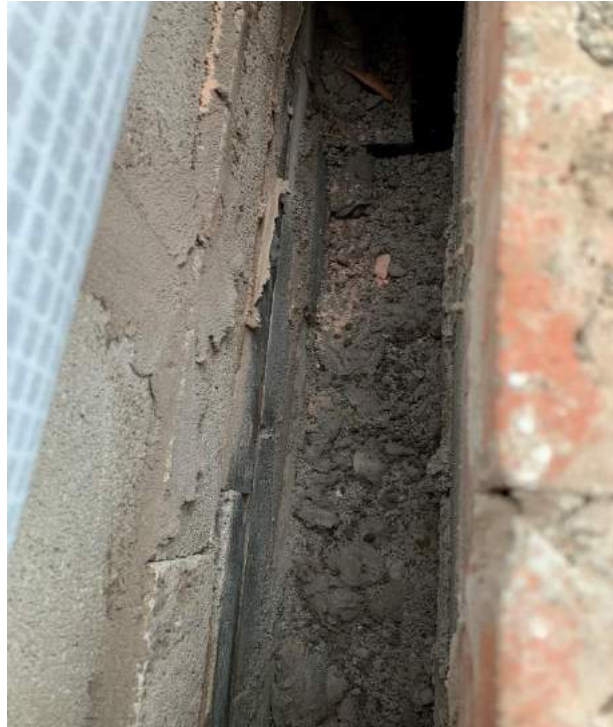
**PLATE 10: Clear Cavity**

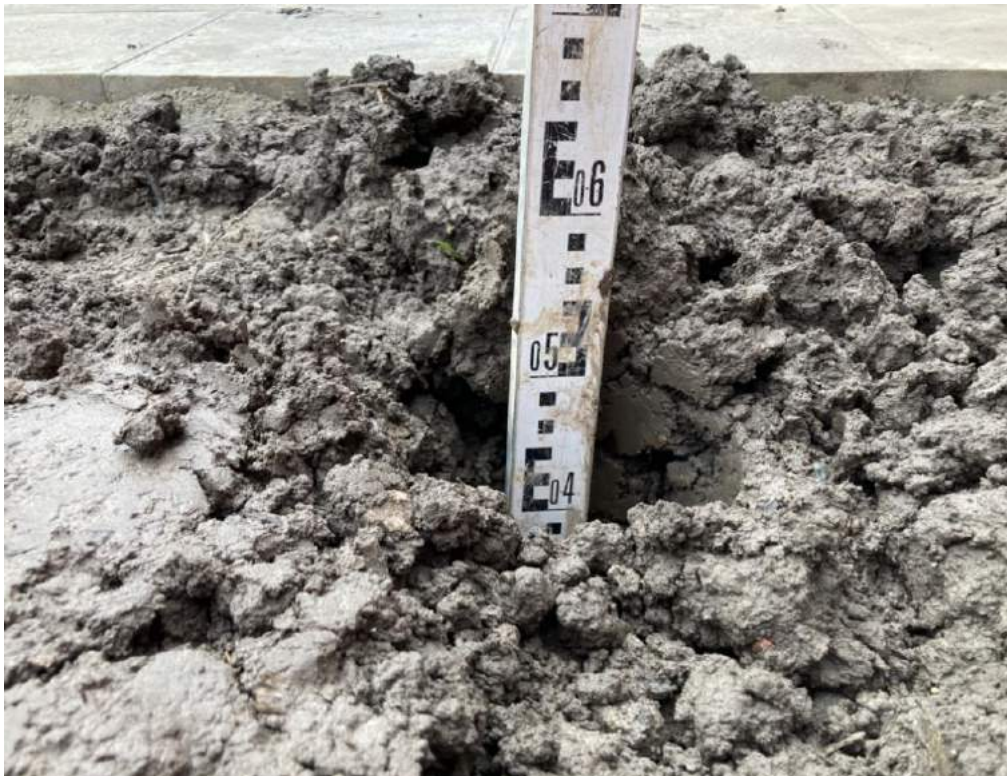
**Plate 8 – Plot 2 front garden cover system GL to 0.60mbgl with 0.15m of topsoil.**
