## Appendix E - CCTV Survey

| Reference | Title |
|---|---|
| LITTLE LEVEL - RADCLIFFE 000518 | CCTV Survey Report |

Project name :  
**LITTLE LEVER - RADCLIFFE 00051**

Date :  
**08-Sep-20**

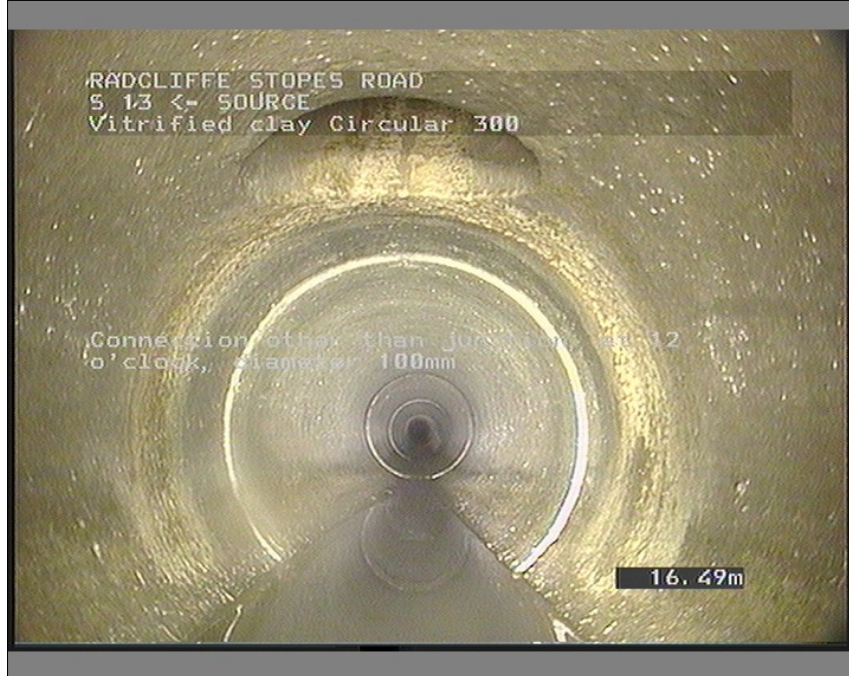
Photo: 6\_6\_21\_A.JPG

16.49m, Connection other than junction, at 12 o'clock, diameter 100mm

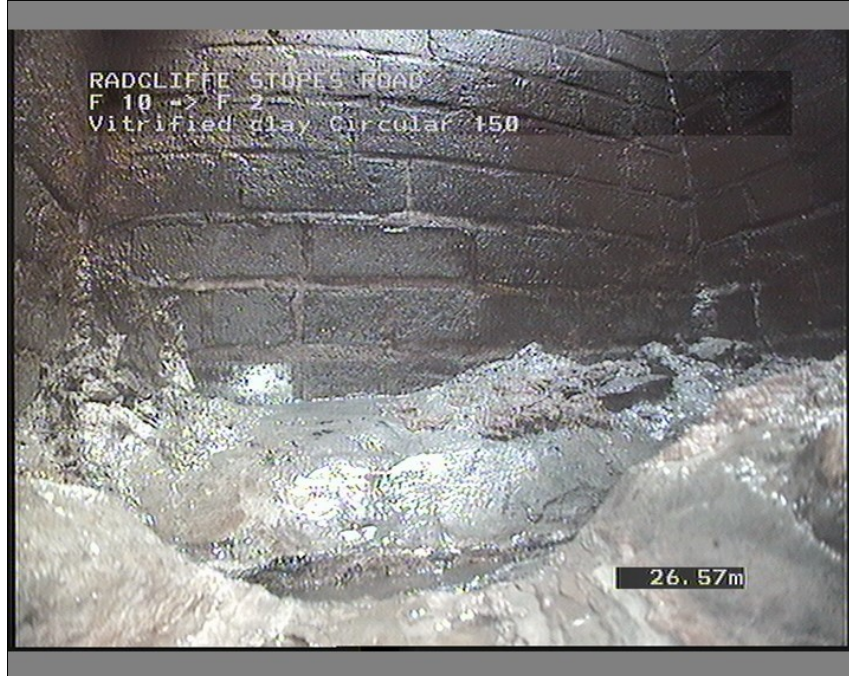
Photo: 12\_12\_74\_A.JPG

26.57m, Finish node type, manhole reference number: F 2
