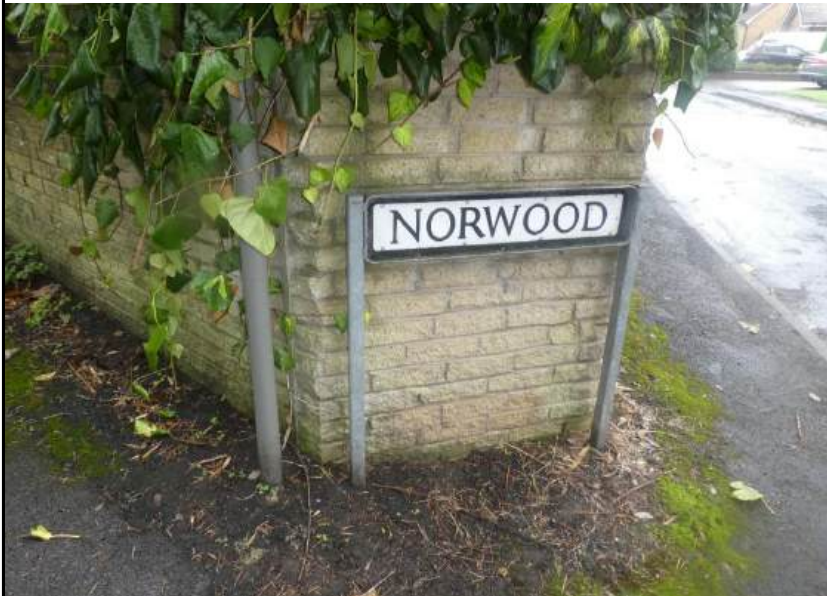
Photograph 15. Norwood located directly to the north of the site entrance

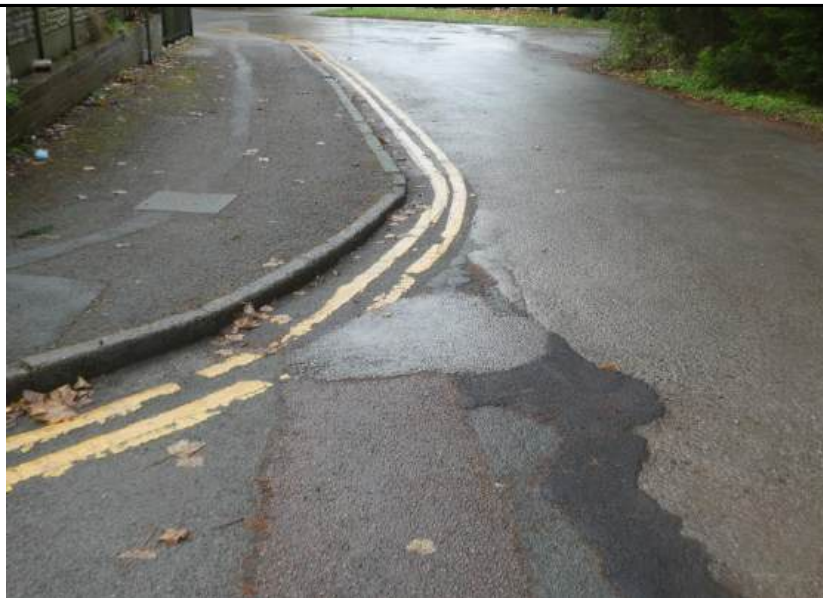
Photograph 18. Localised reinstatement of road surfacing to Norwood junction slightly eroded

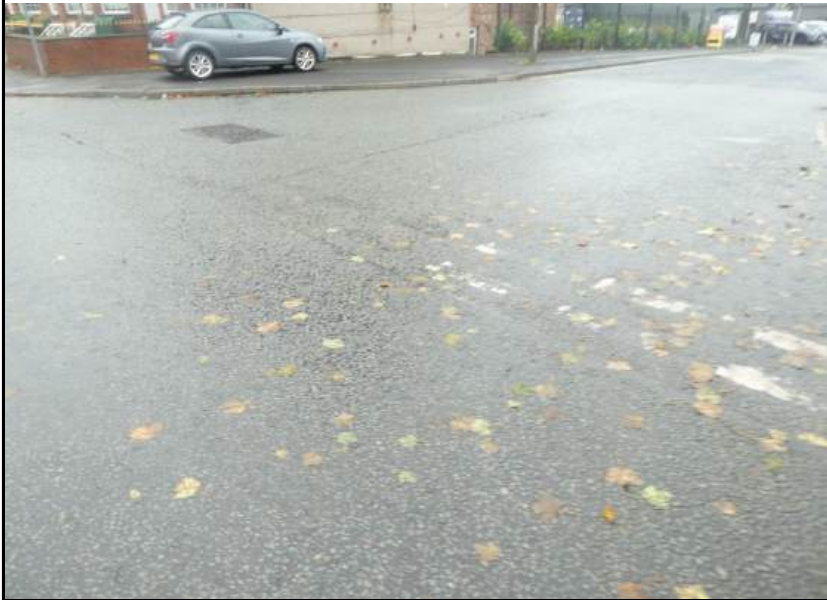
Photograph 79. Junction to industrial estate.

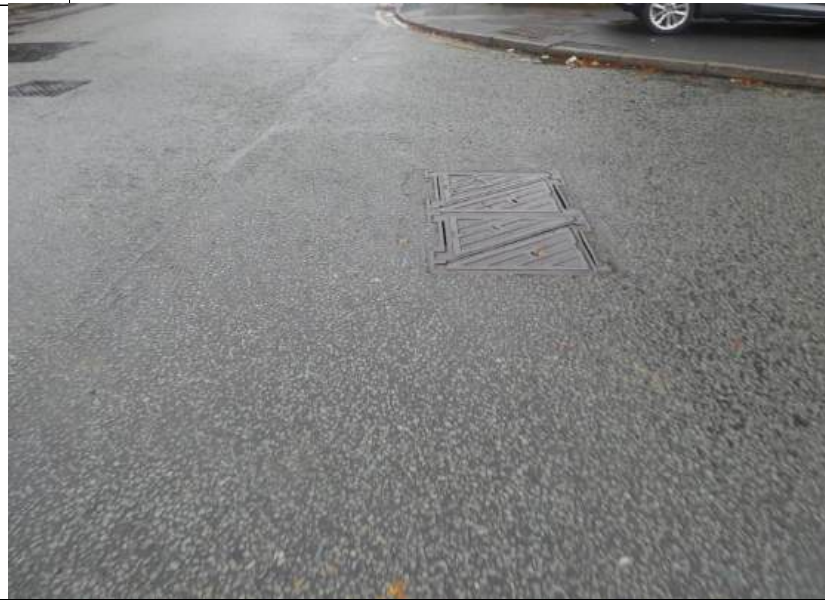
Photograph 80. Junction to industrial estate.

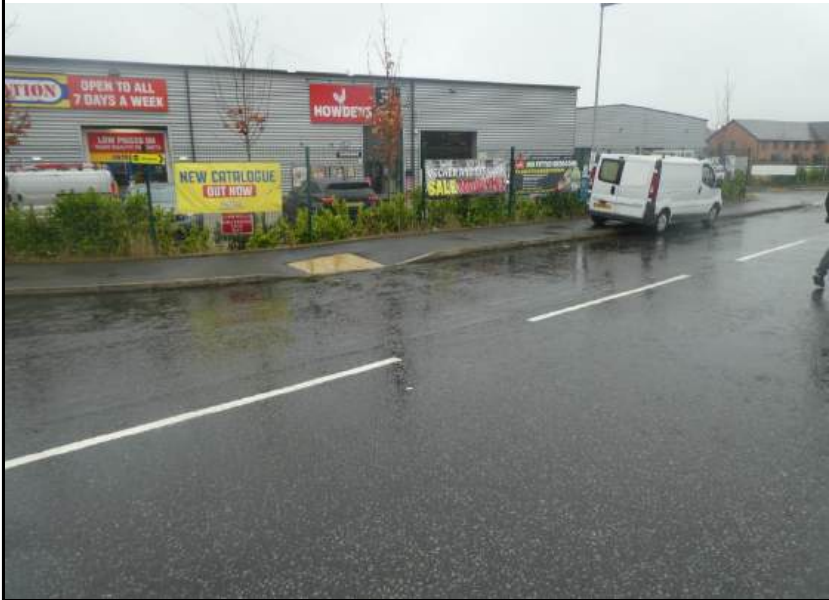
Photograph 91. Junction with industrial estate to the east of George Street
