**SITE VISIT REPORT 15220-HYD-XX-XX-SVR-GE-1018**

**SHEET NO.: 6 of 18**

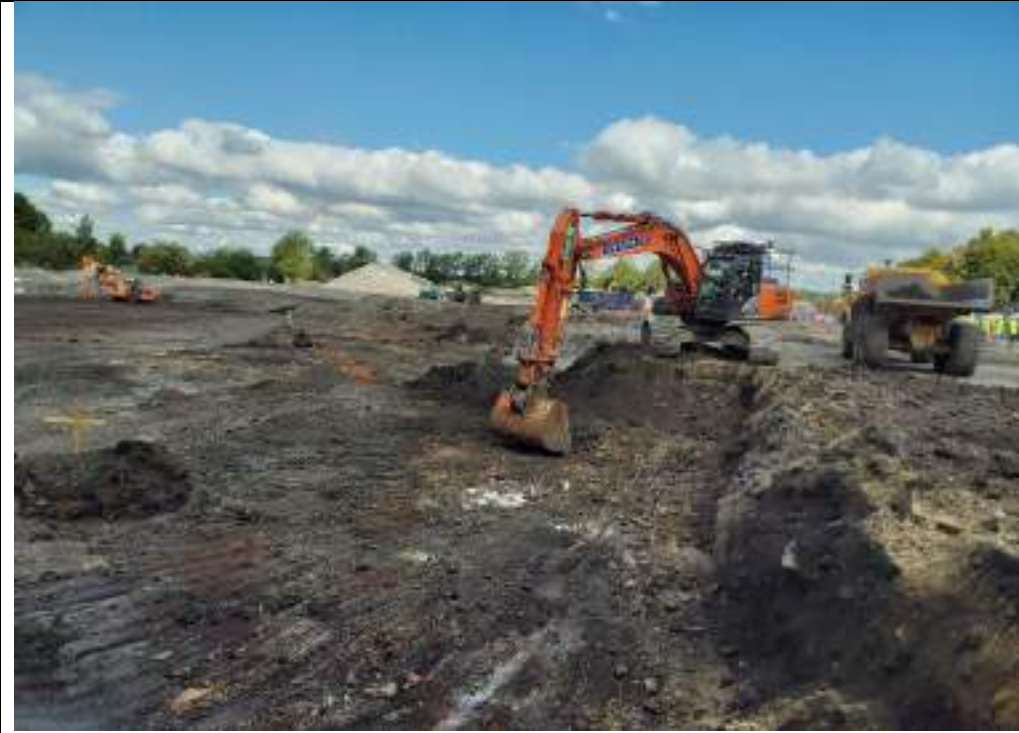
Photograph 1: Overview of the site. Looking towards the north.

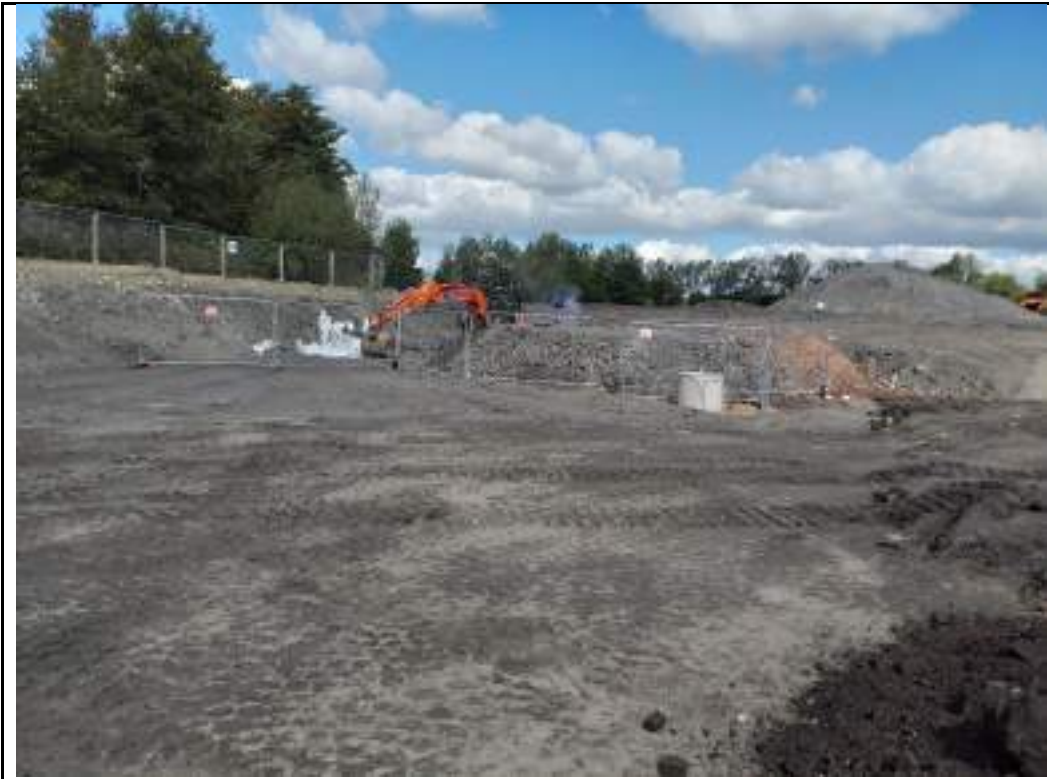
Photograph 113: Hand picking of asbestos in stockpile in western part of the site.

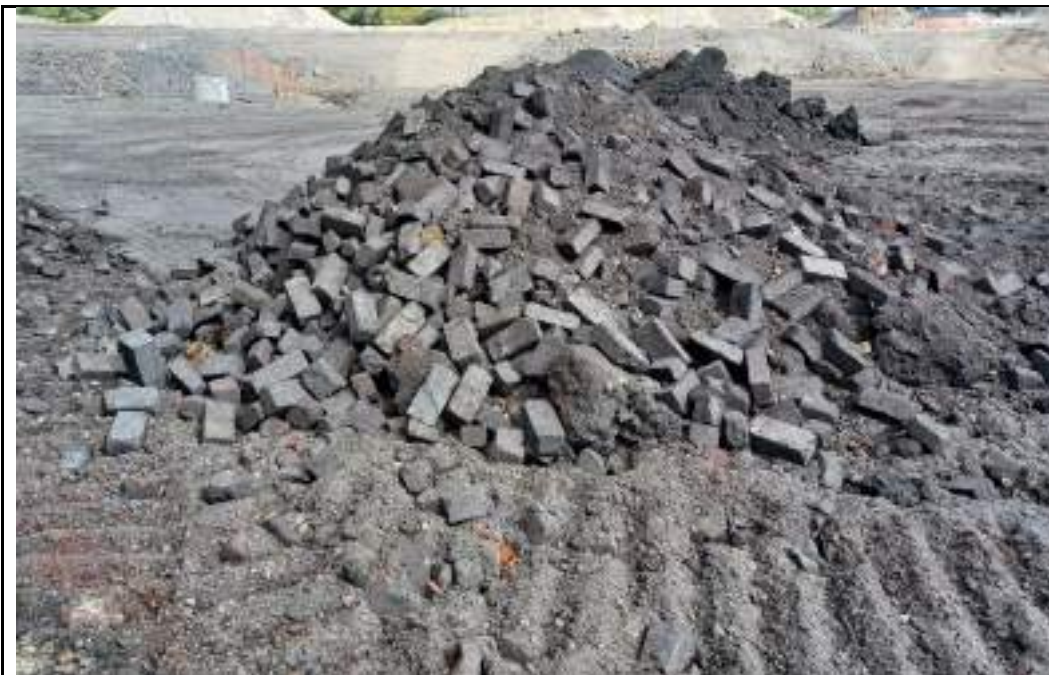
Photograph 14: High quantity of bricks in fill material in western part of the site. Material excavated from southern part of the site. Material with this quantity of brick not acceptable

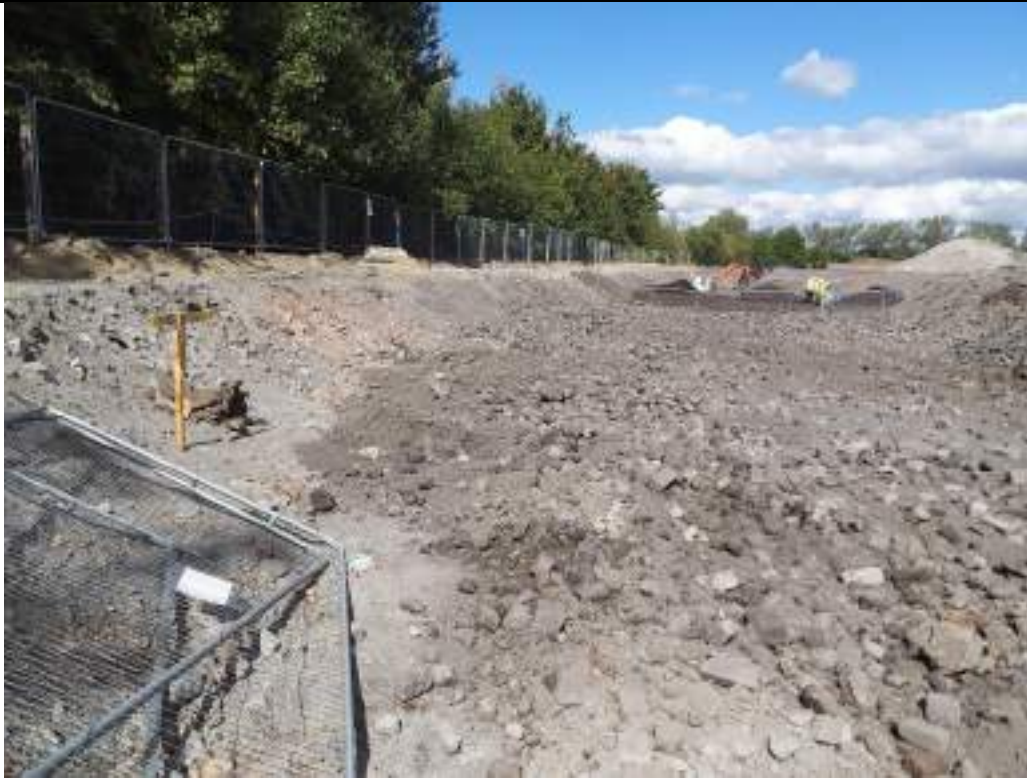
Photograph 147: Western boundary of the site. Looking towards the north.

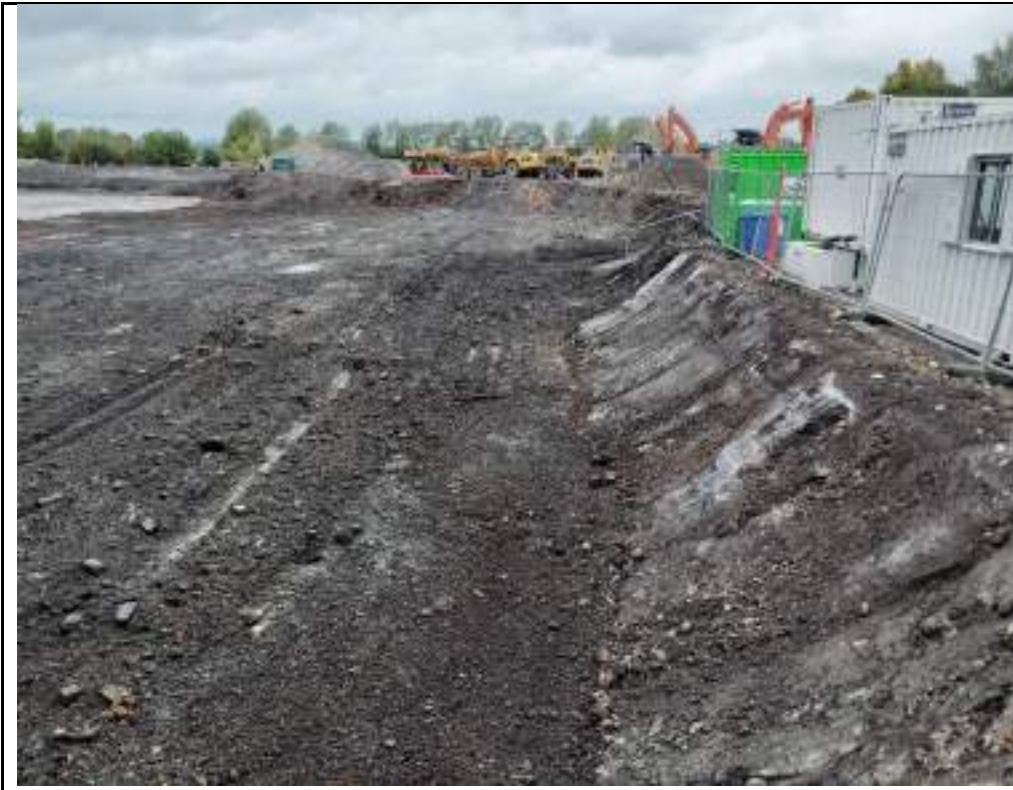
Photograph 1: Overview of the site. Looking towards the north.

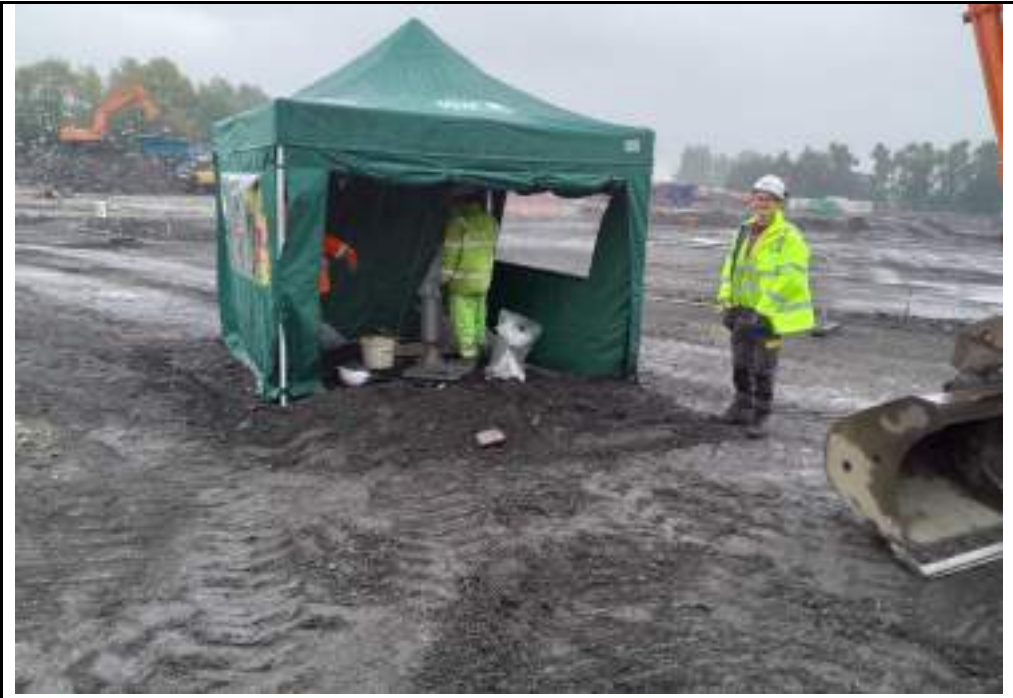
Photograph 5: SRD testing in central part of the site.

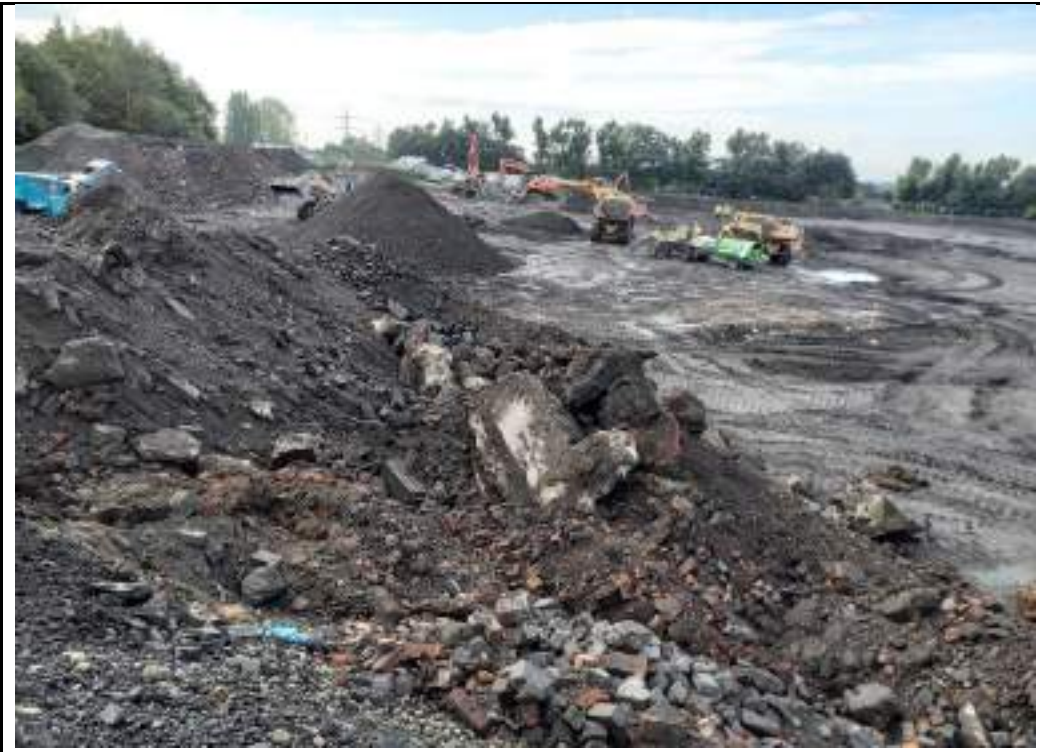
Photograph 1: Overview of the site. Looking towards the south.

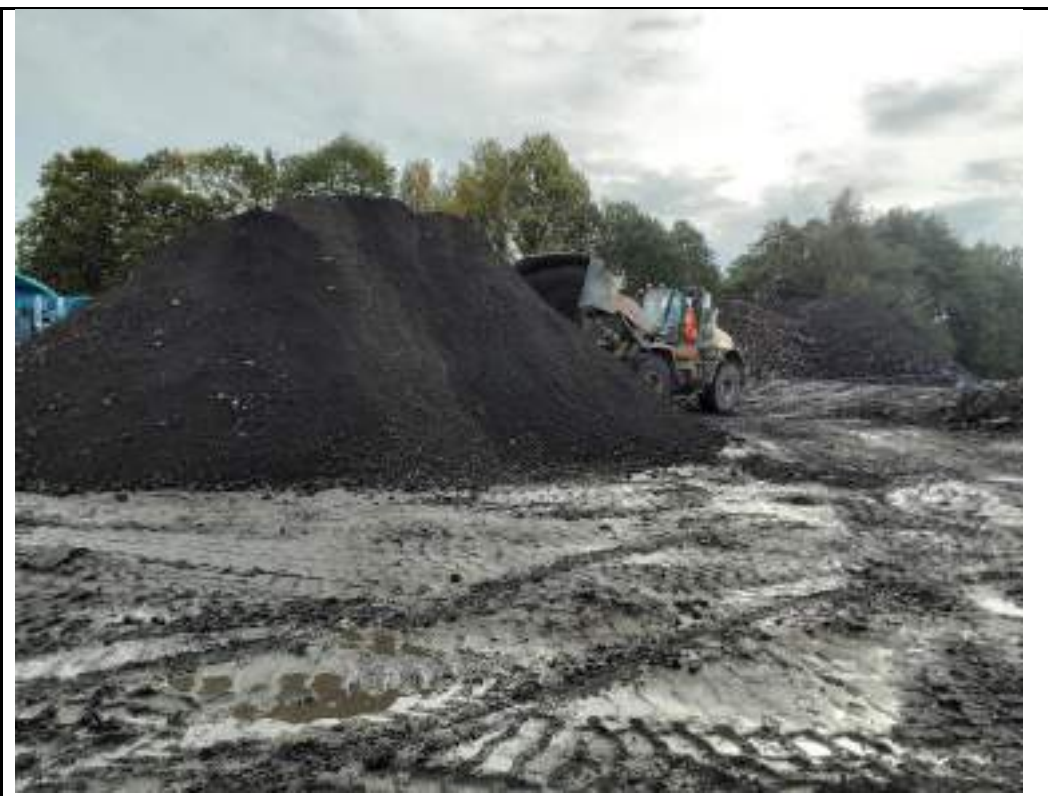
Photograph 10: Stockpile of screened material from the screener in northeastern part of the site.

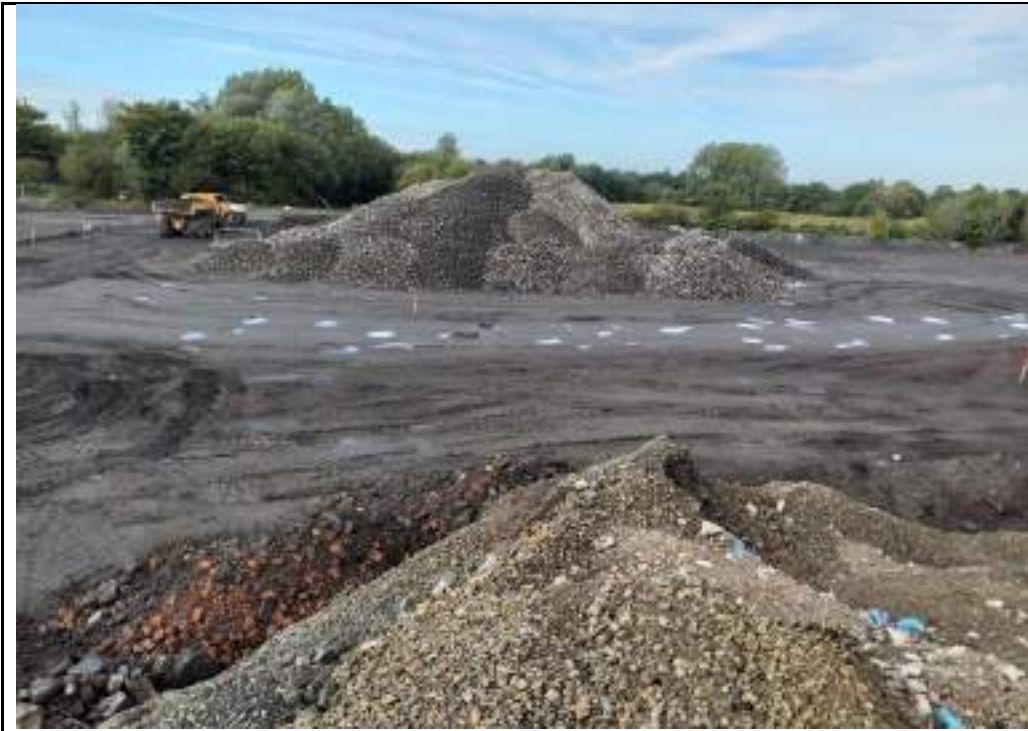
Photograph 189: Stockpile of crushed concrete and asphalt in northwest of the site.

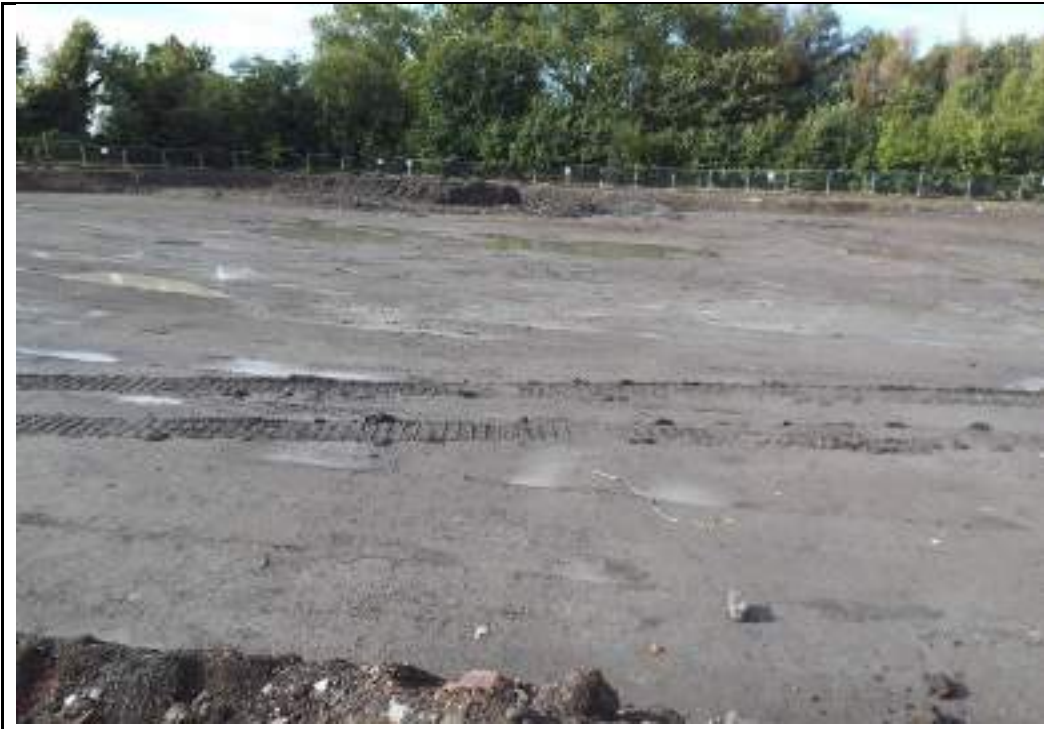
Photograph 199: Standing water in southwest of the site.

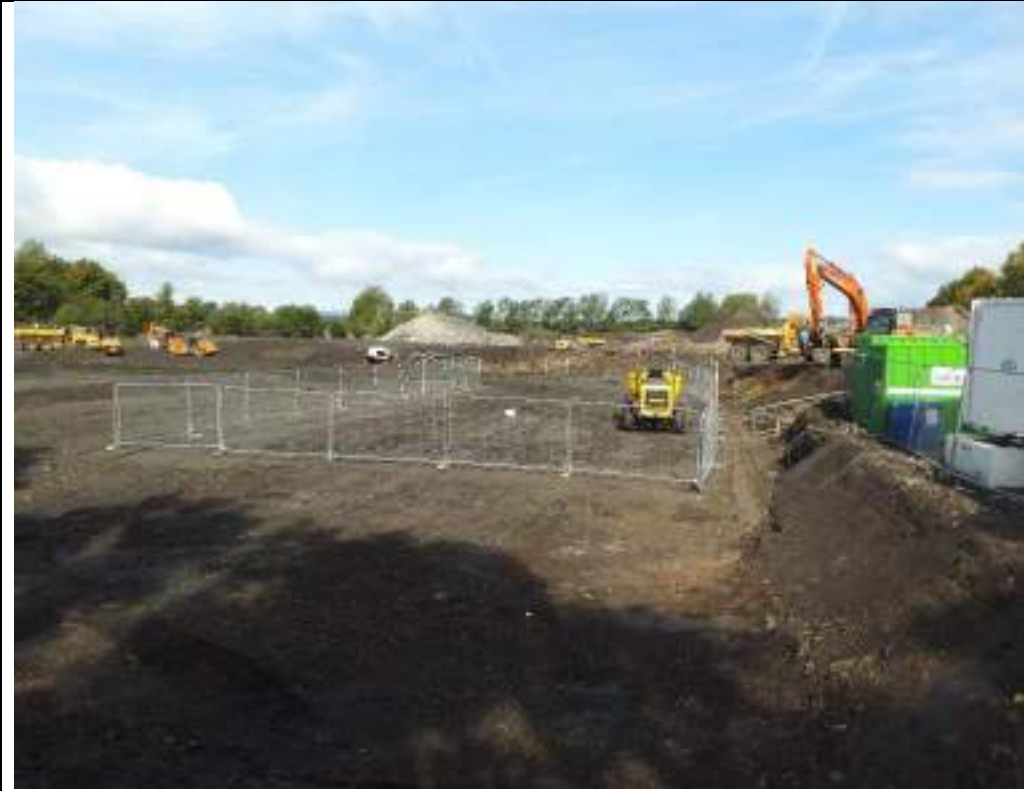
Photograph 1: Overview of the site. Looking towards the north.

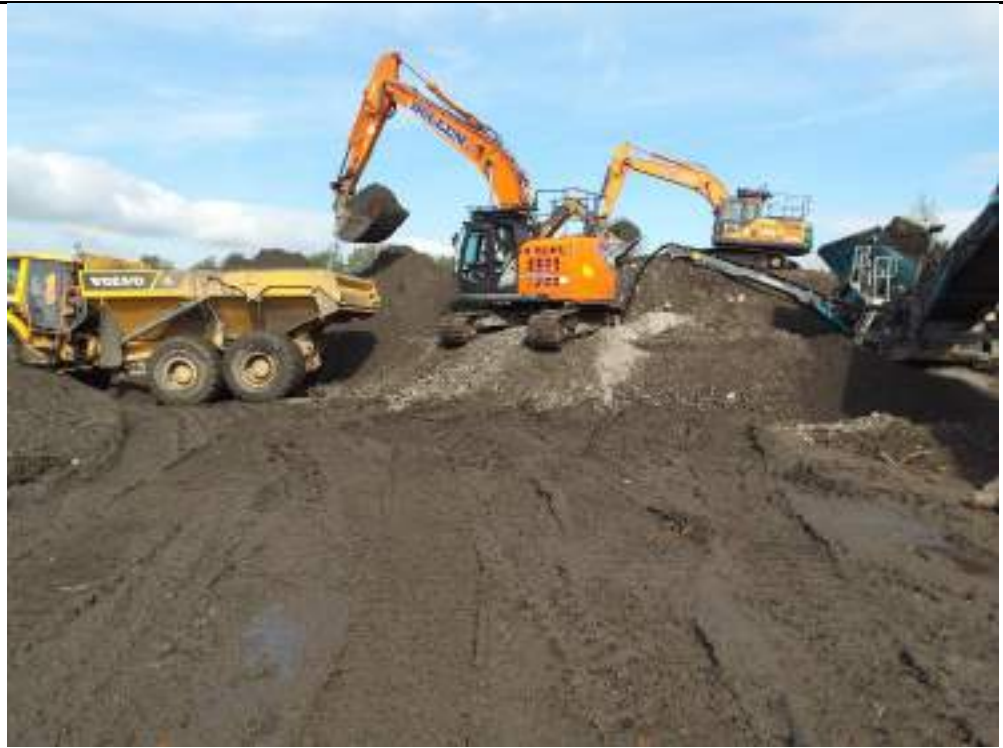
Photograph 6: Loading undersize material from screener to backfill southwest of the site.

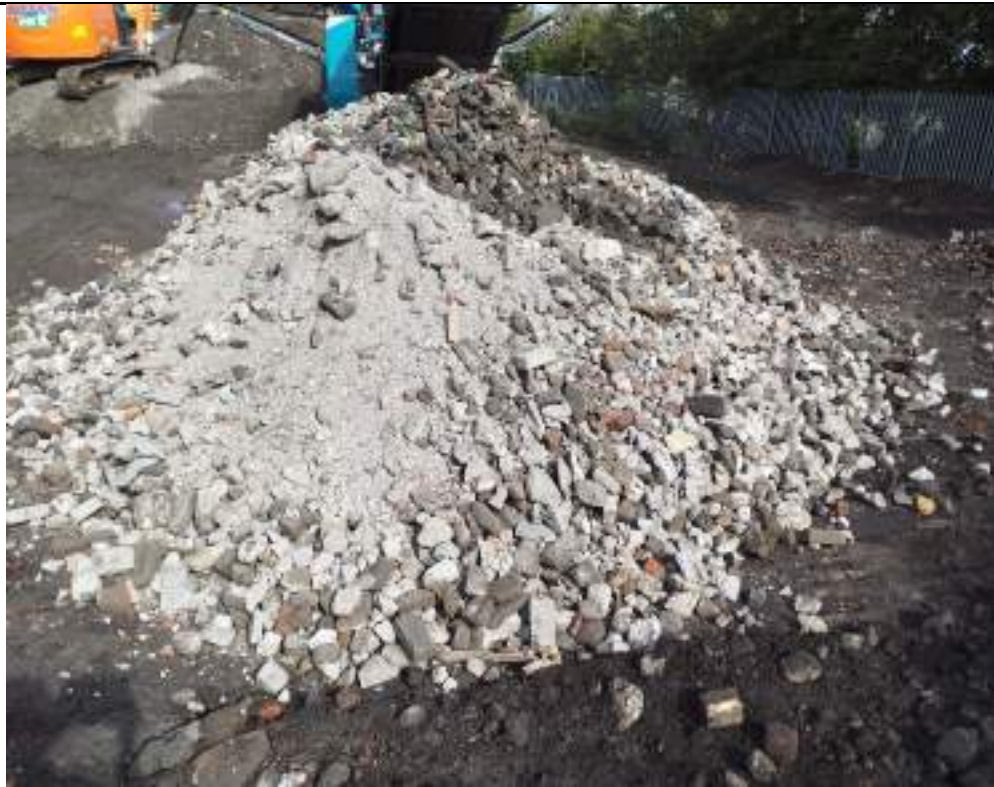
Photograph 8: Oversize material off screener after crushing by crusher in northeast of the site.

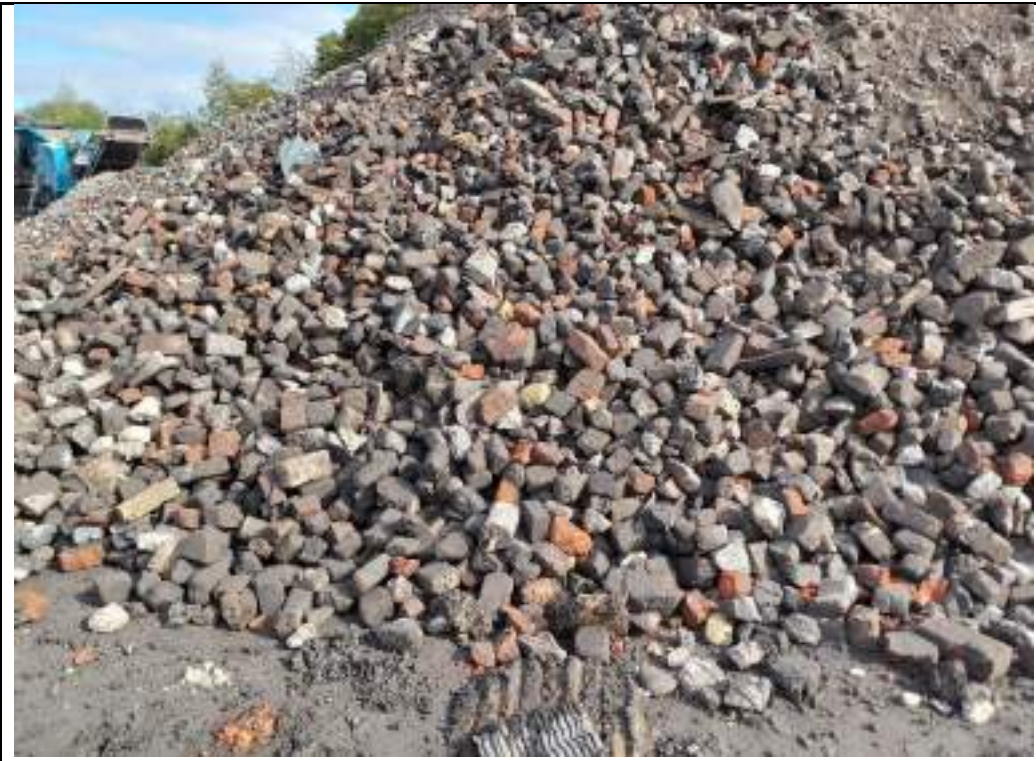
Photograph 9: Stockpile of crushed material from oversize of screener.

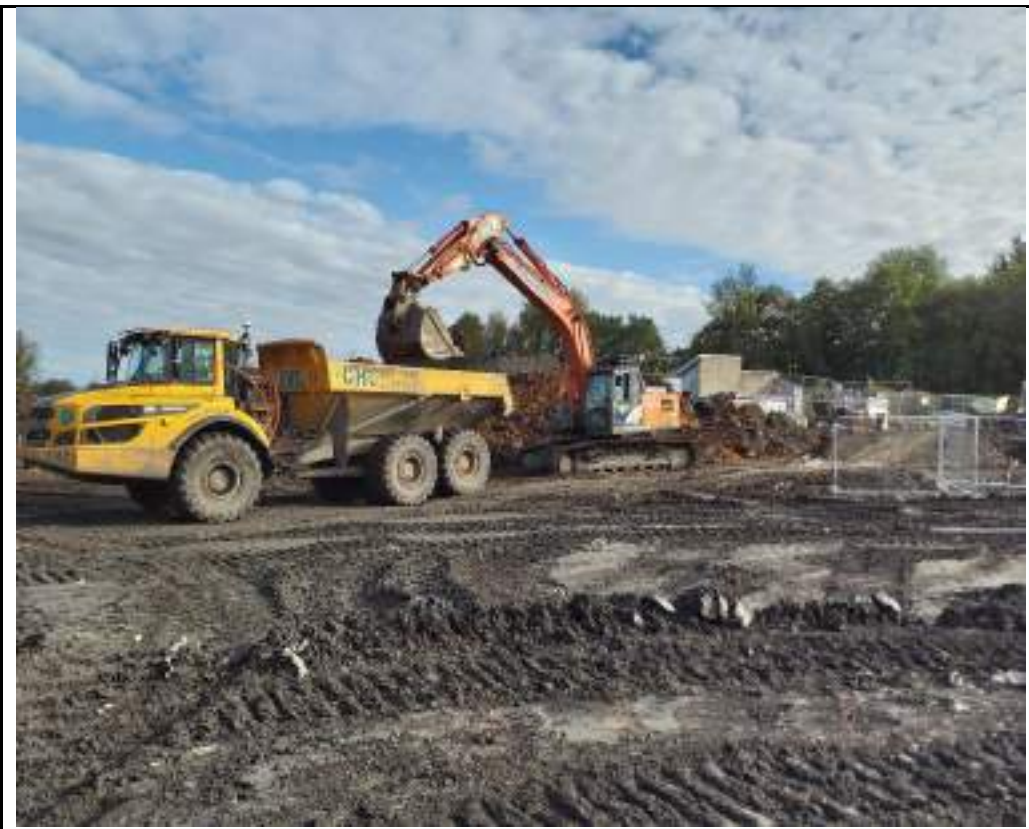
Photograph 2: Excavation of landfill Made Ground in southeastern part of the site.

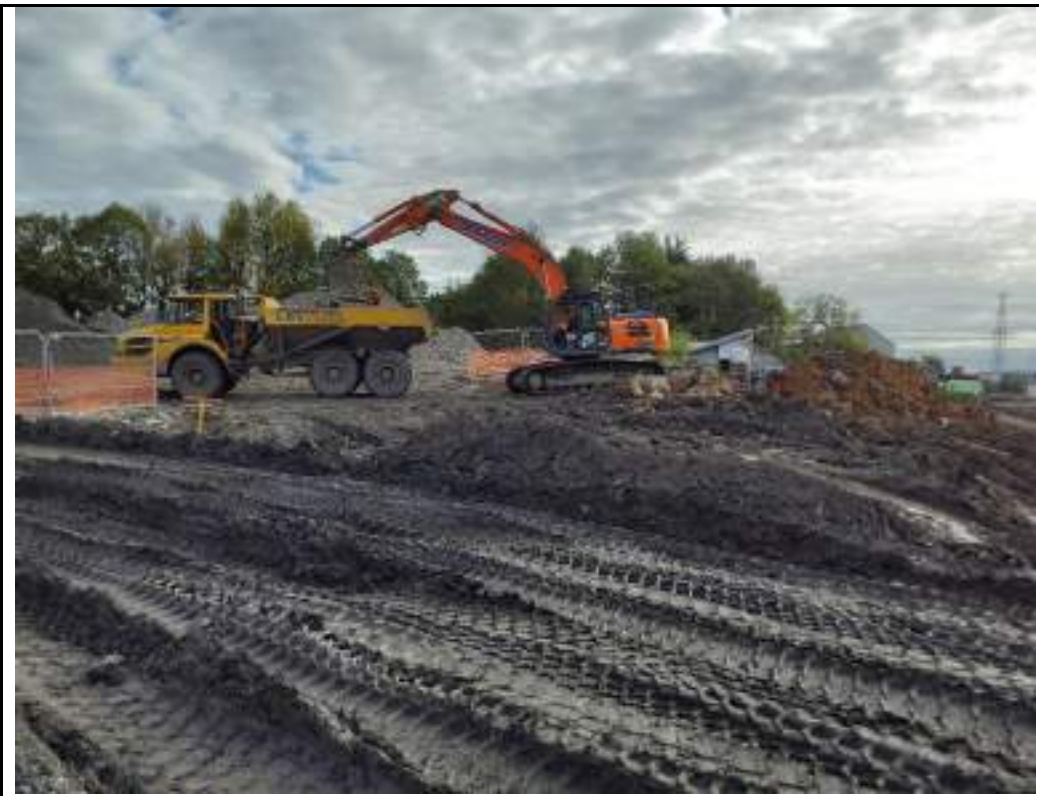
Photograph 10: Loading concert and oversize material in southeastern part of the site.

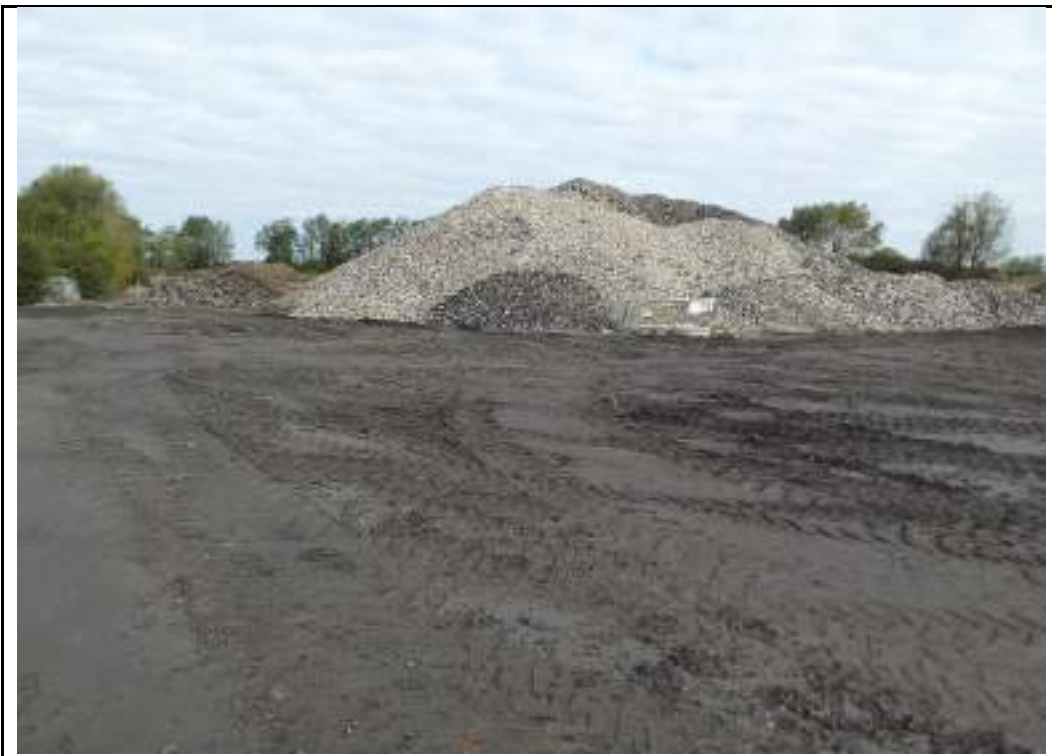
Photograph 110: Bricks and crushed concrete stockpiles in northwestern part of the site.

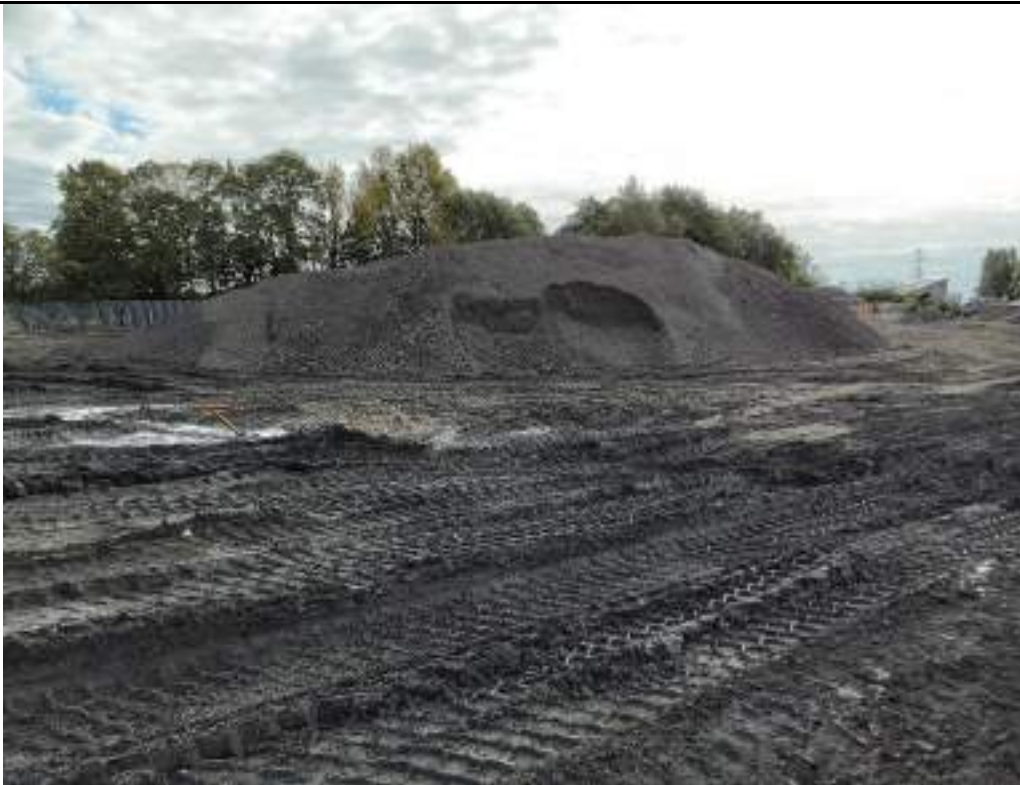
Photograph 136: Stockpile of undersize off the screener in eastern part of the site.

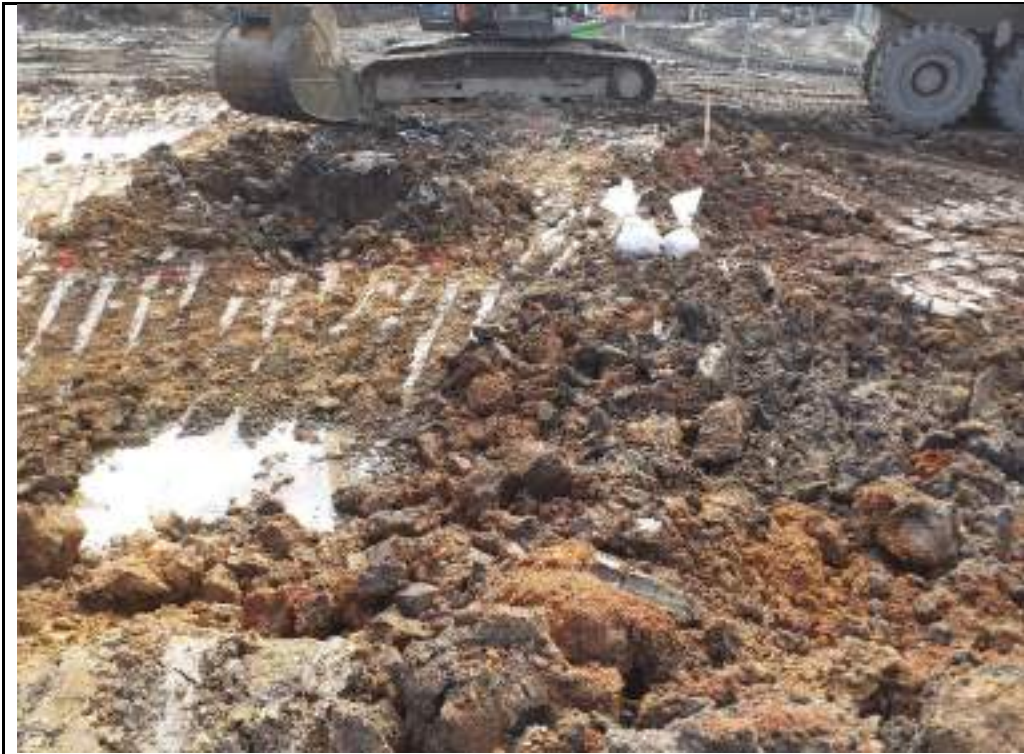
Photograph 23: Sample collection from potentially TPH contaminated area.

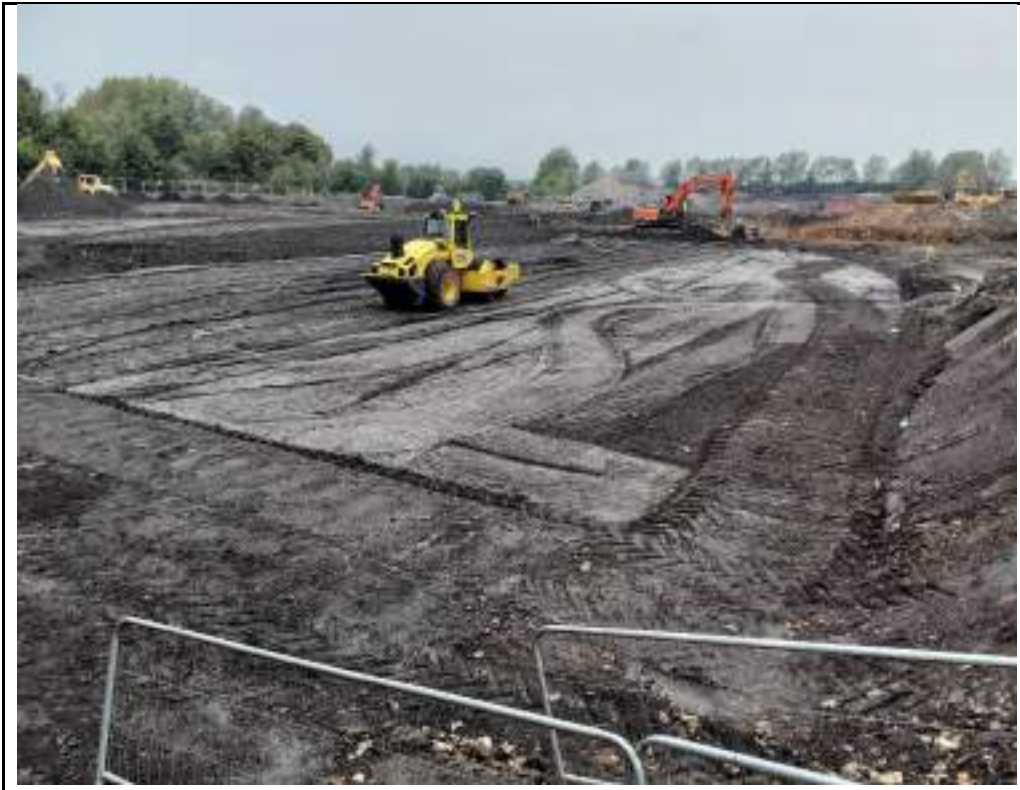
Photograph 1: Overview of the site. Looking towards the north.

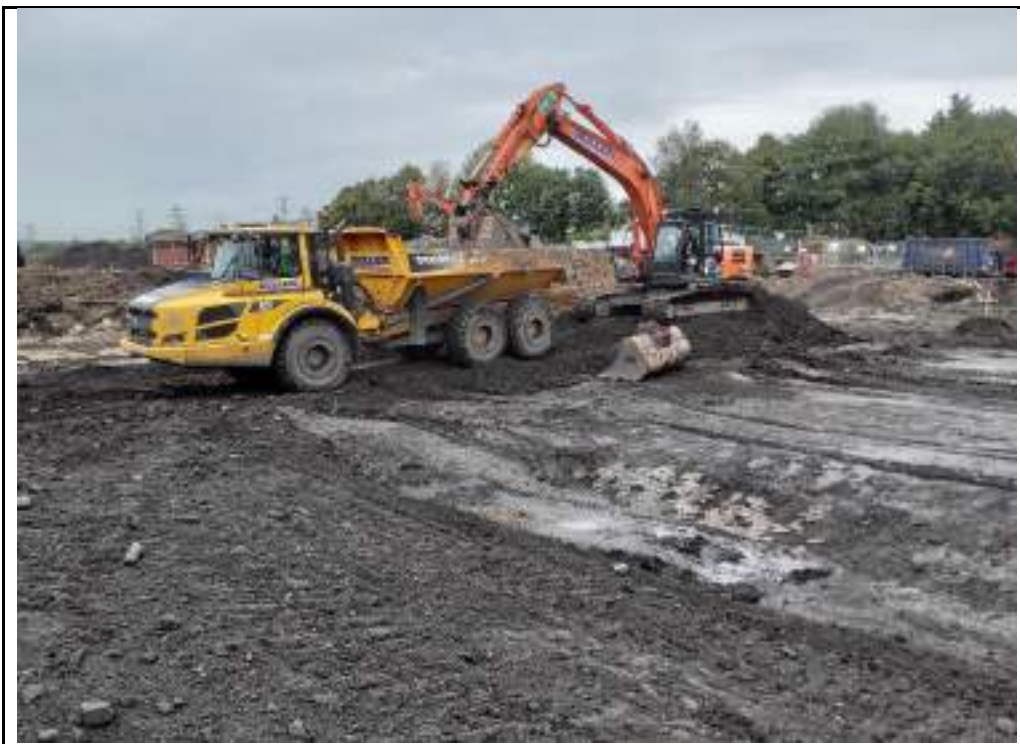
Photograph 2: Excavation of landfill Made Ground in southeastern part of the site.

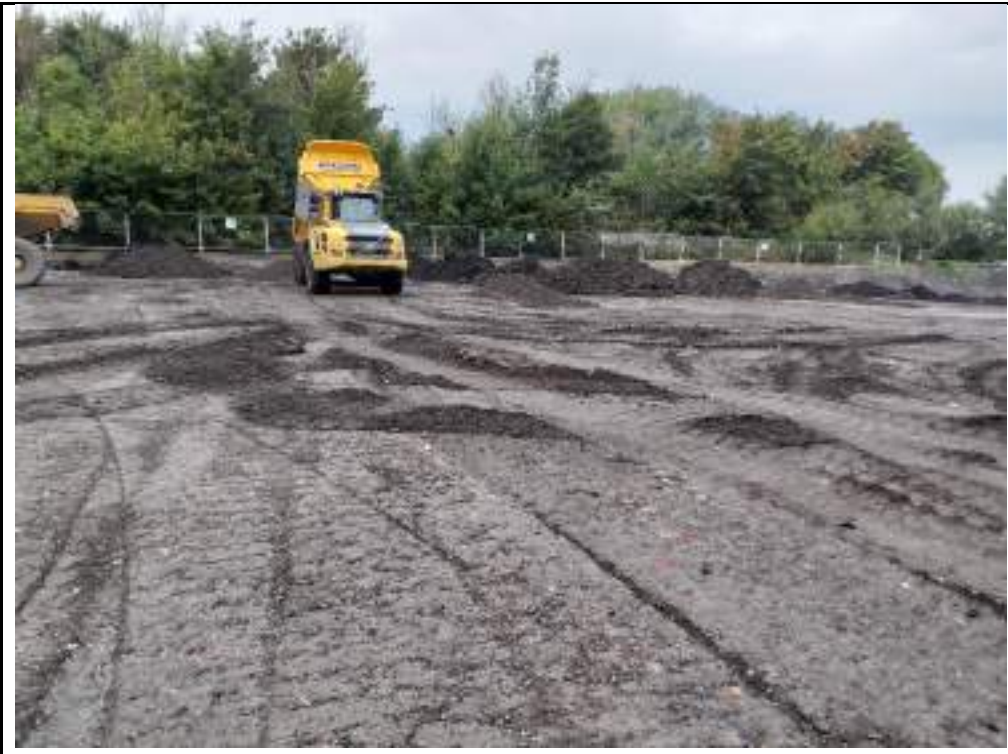
Photograph 3: Backfilling western part of the site with excavated material from southeast of the site.

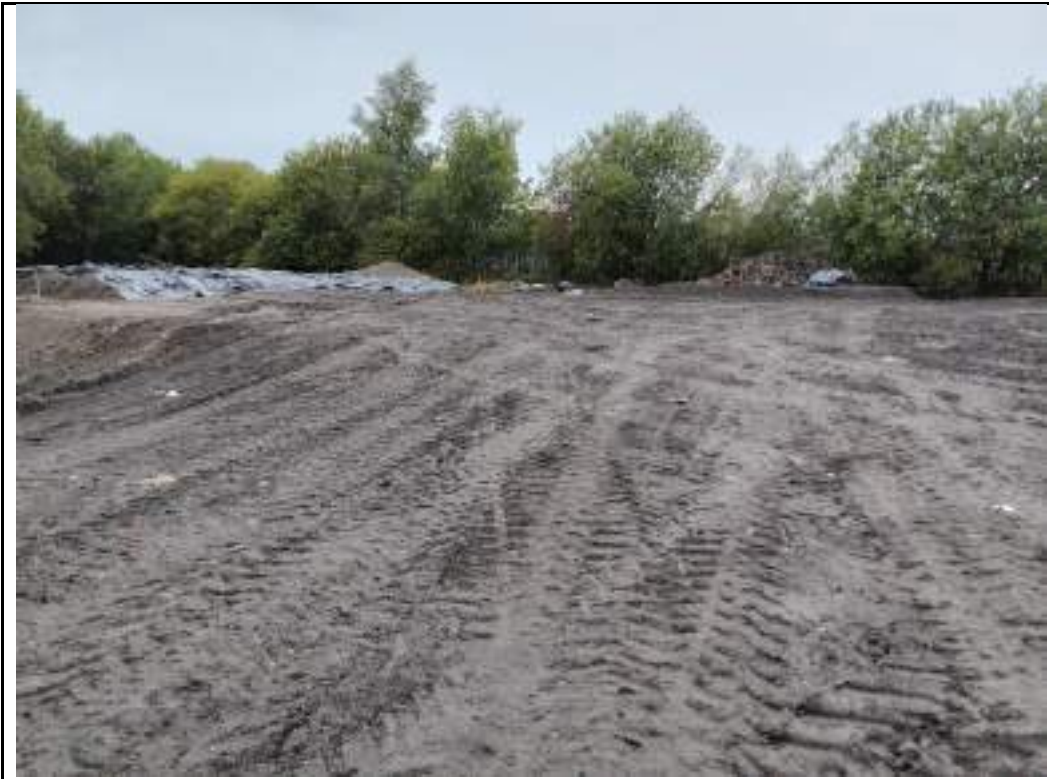
Photograph 113: Potentially TPH and asbestos contaminated stockpiles in northwestern part of the site.

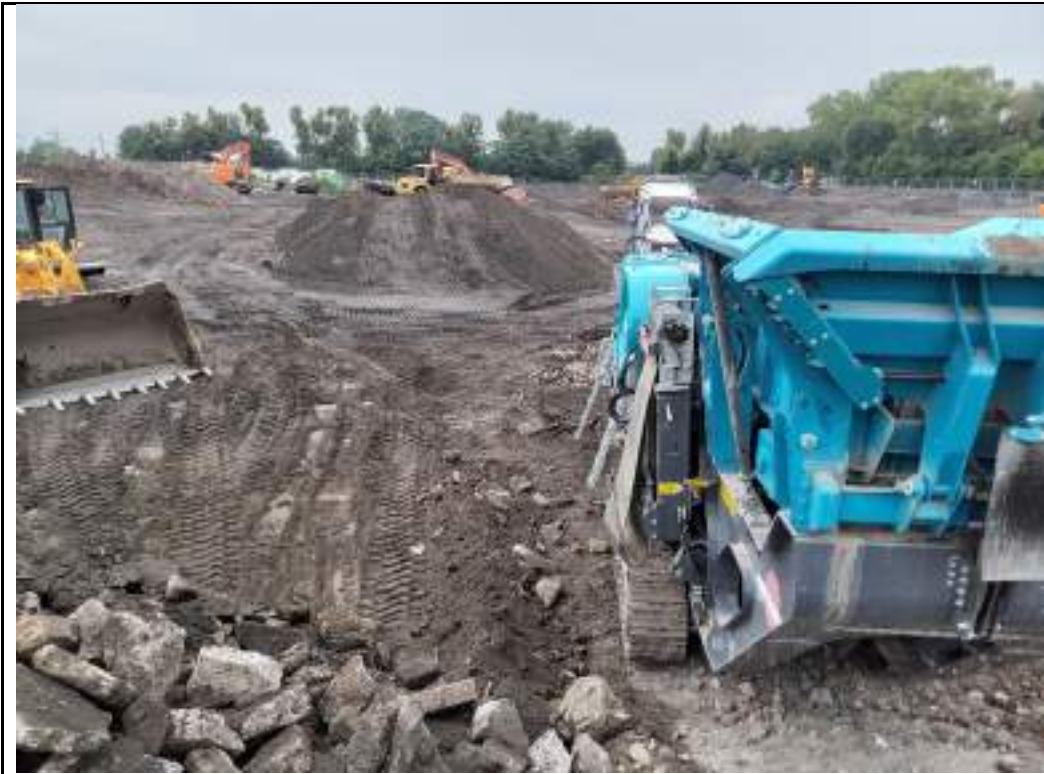
Photograph 169: Stockpile of processed material in eastern part of the site.

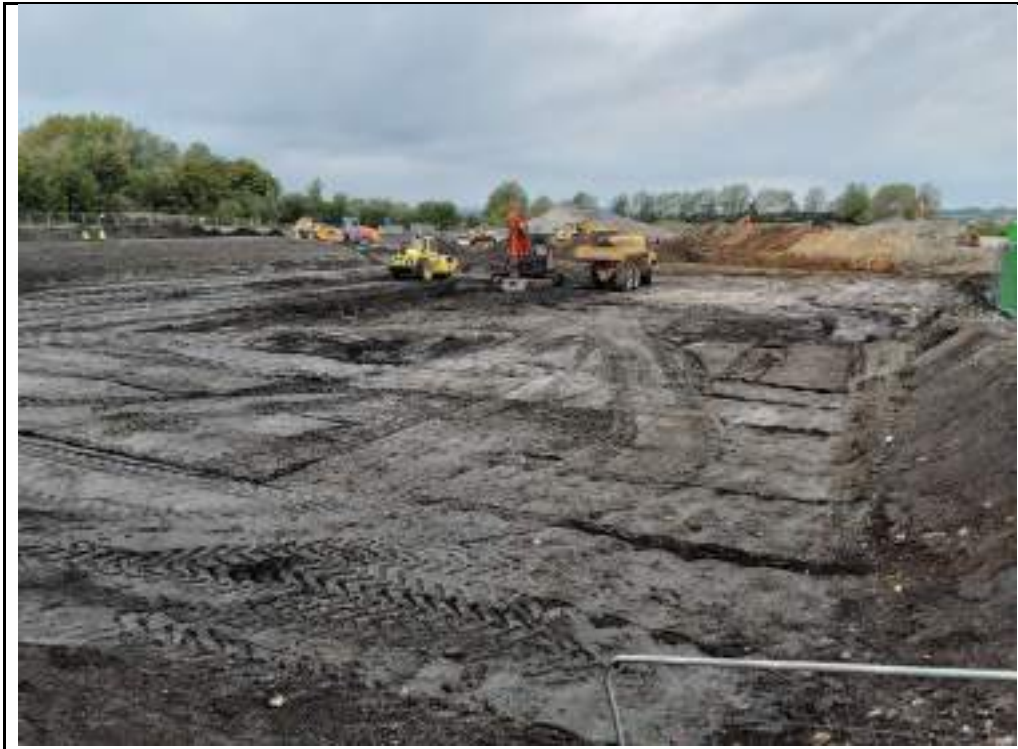
Photograph 1: Overview of the site. Looking towards the north.

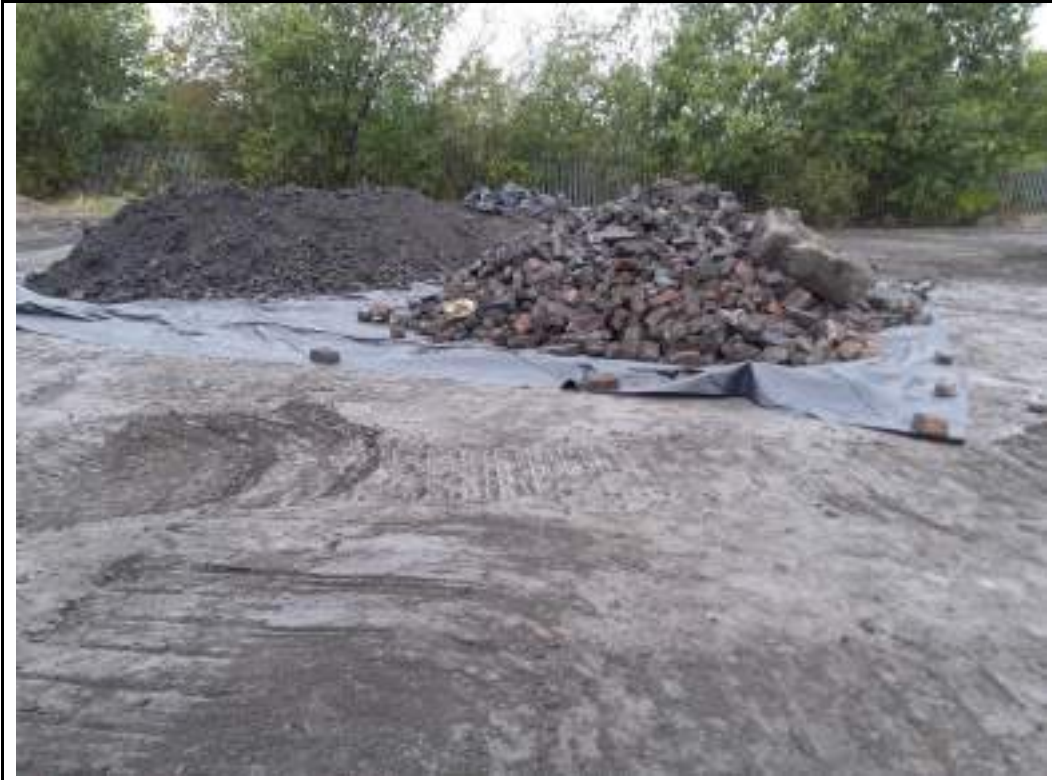
Photograph 93: Potentially TPH and asbestos contaminated stockpiles in northwestern part of the site.

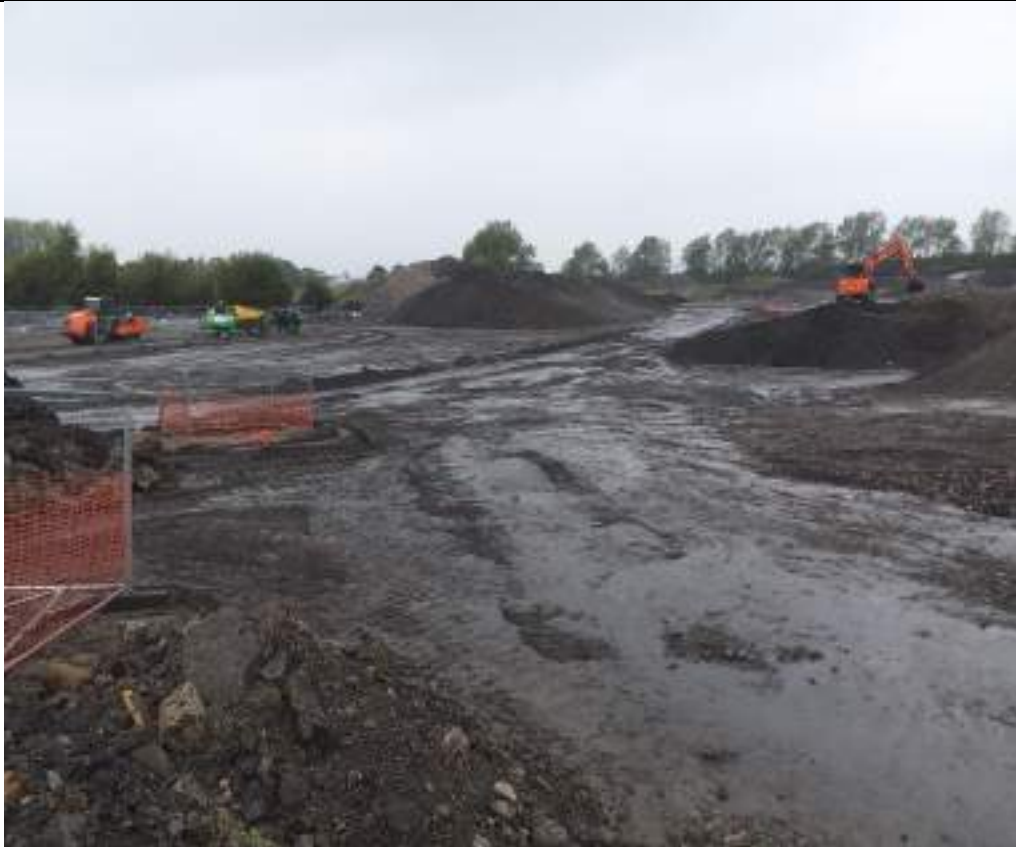
Photograph 18: Stockpile of crushed material in northwestern part of the site.

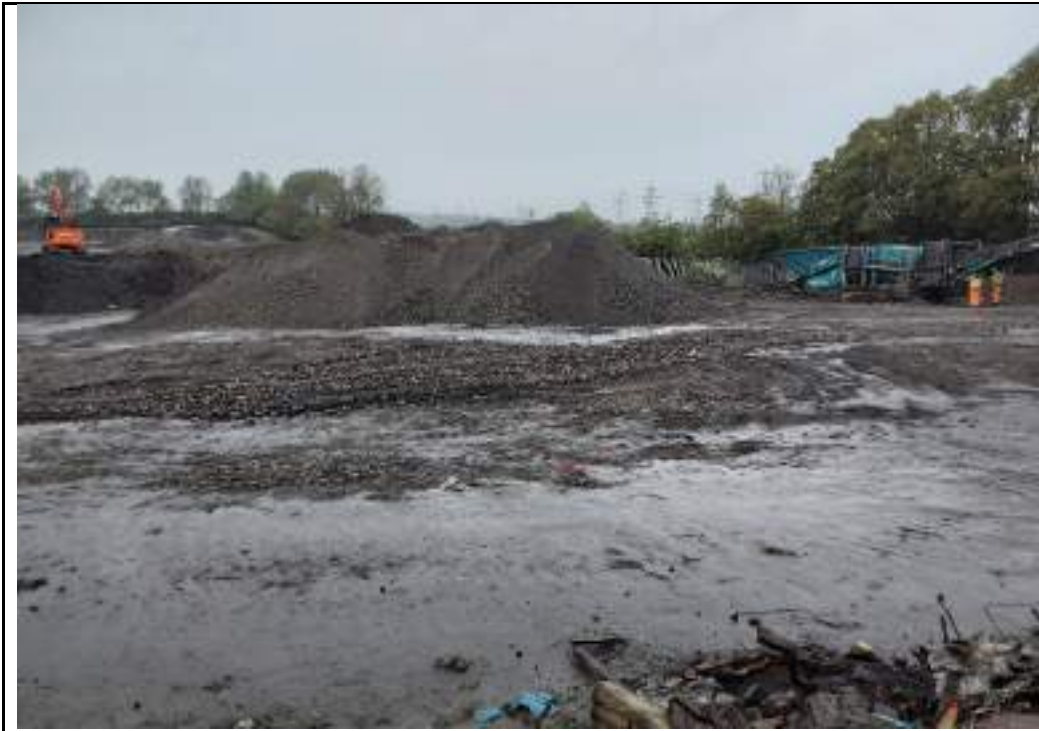
Photograph 19: Stockpile of processed material in eastern part of the site.
