**SITE VISIT REPORT 15220-HYD-XX-XX-SVR-GE-1018**

**SHEET NO.: 6 of 18**

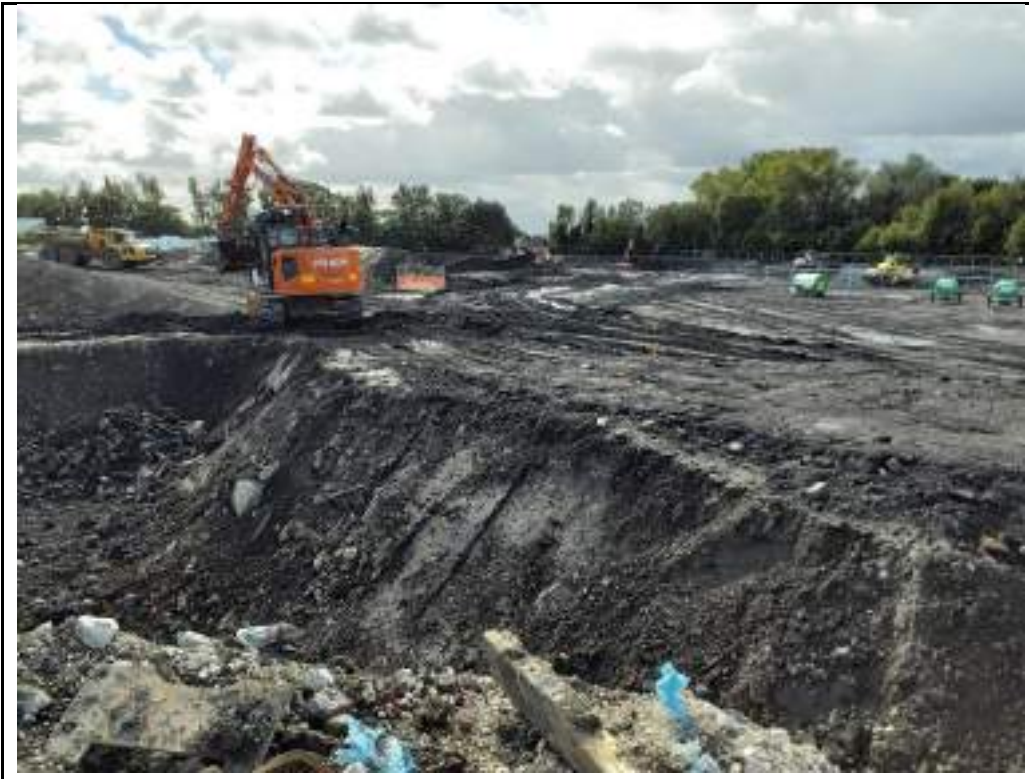
Photograph 1: Overview of the site. Looking towards the south.

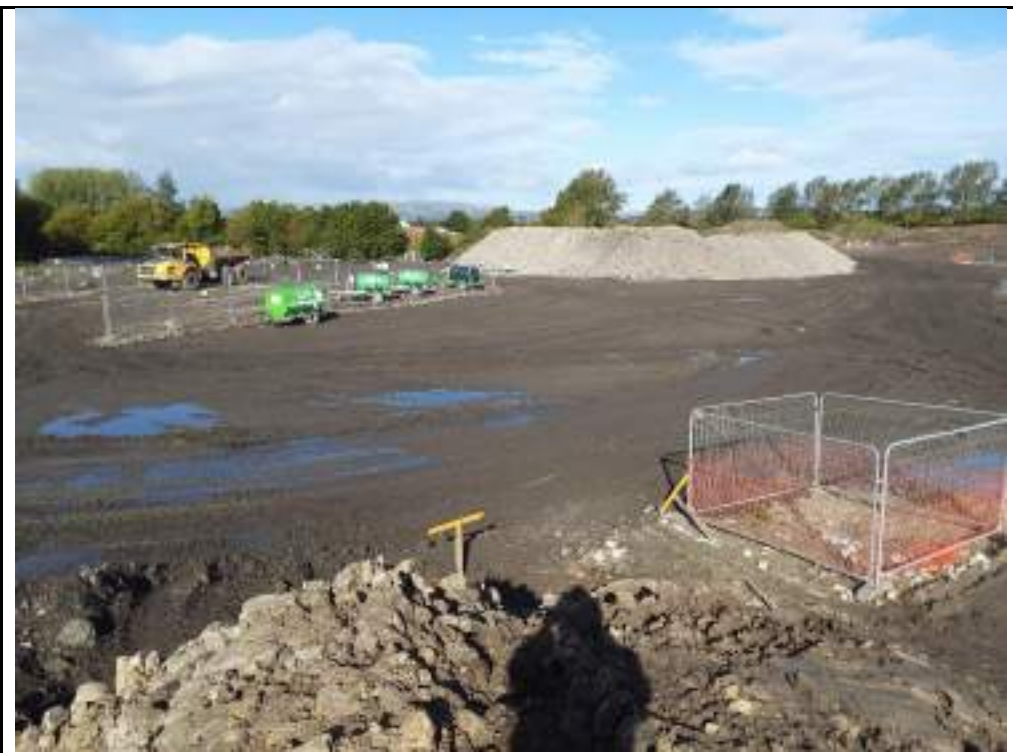
Photograph 4: Stockpile of crushed material in northwestern part of the site.

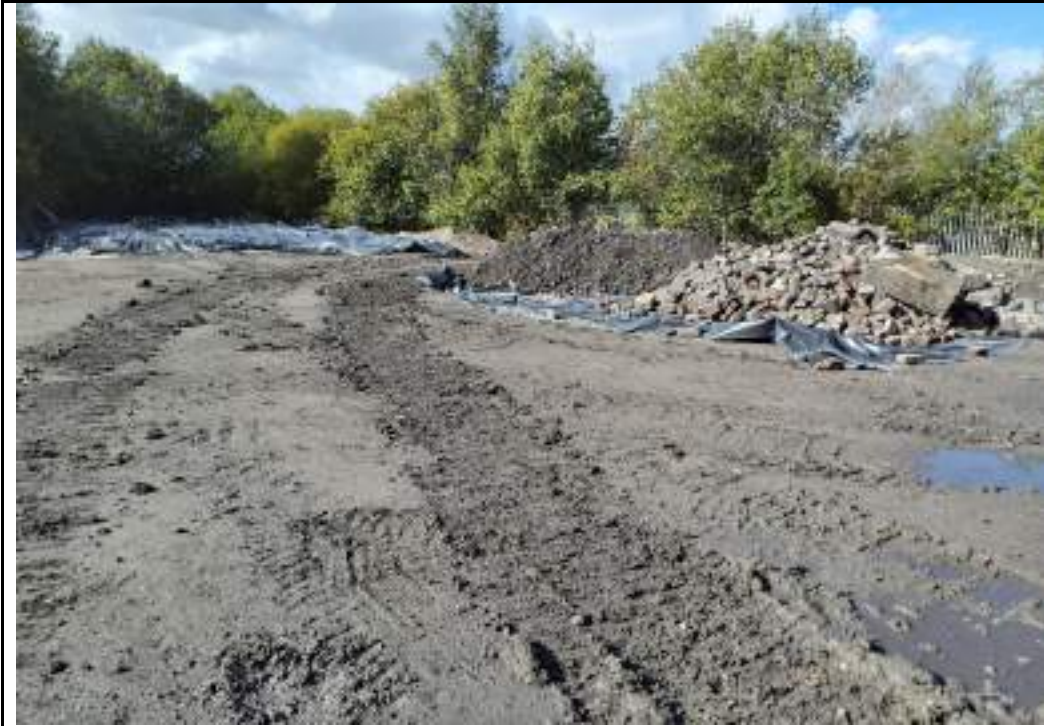
Photograph 15: Potentially TPH contaminated material stockpiles in northwestern part of the site.

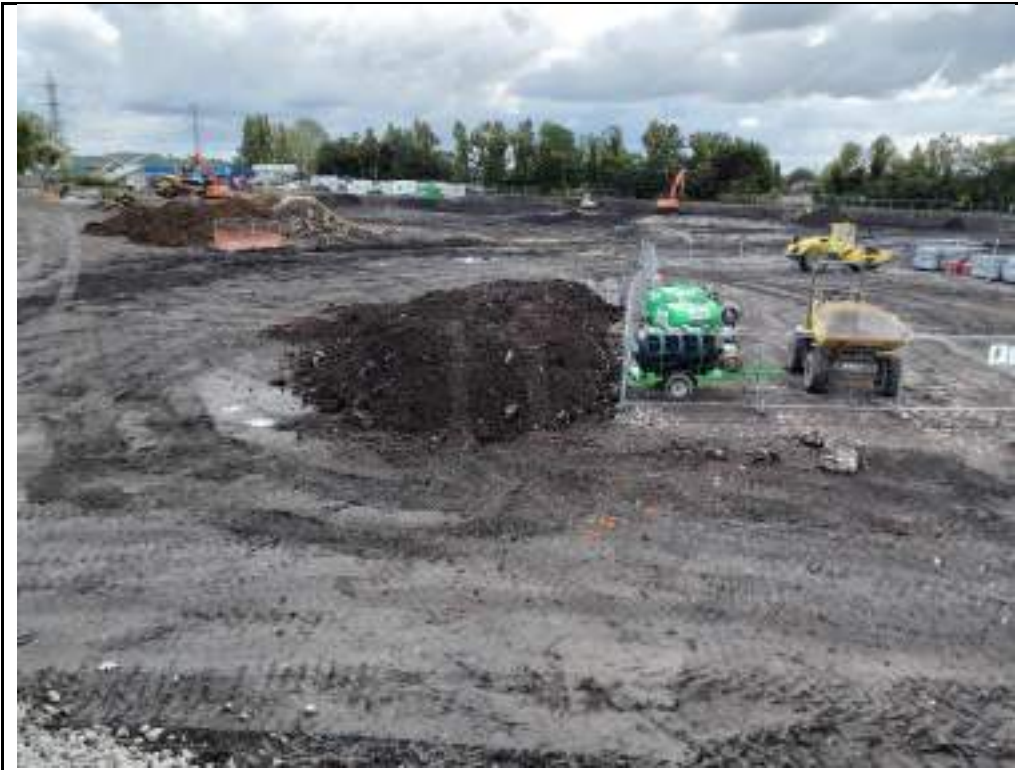
Photograph 1: Overview of the site. Looking towards the south.

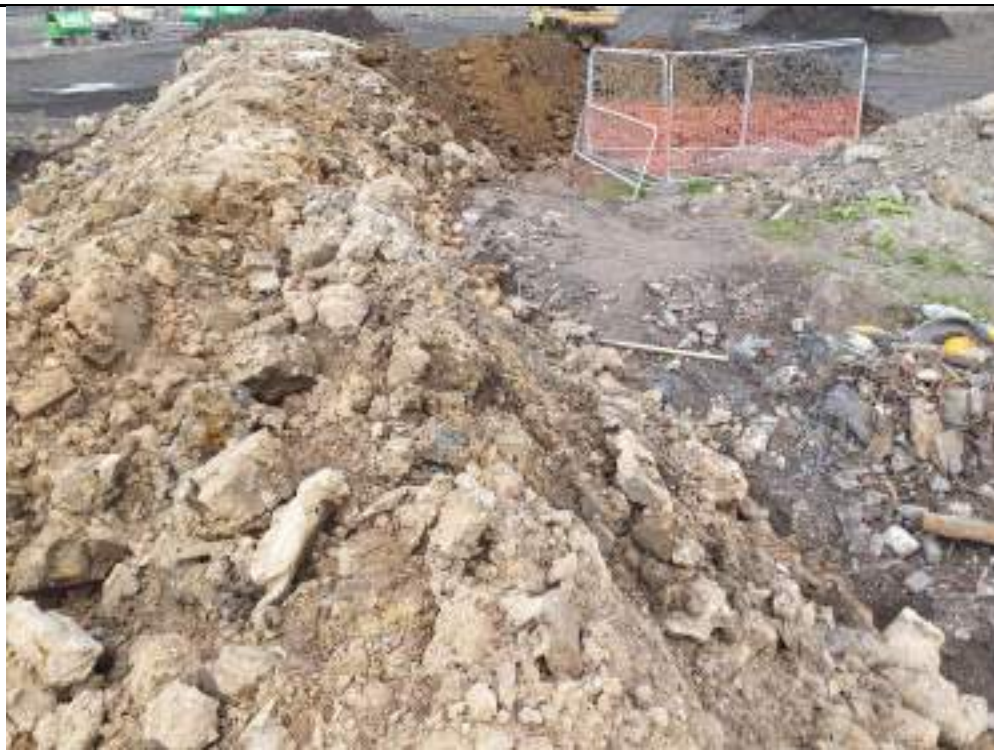
Photograph 6: Stockpile of Glacial Till material in southeastern part of the site.

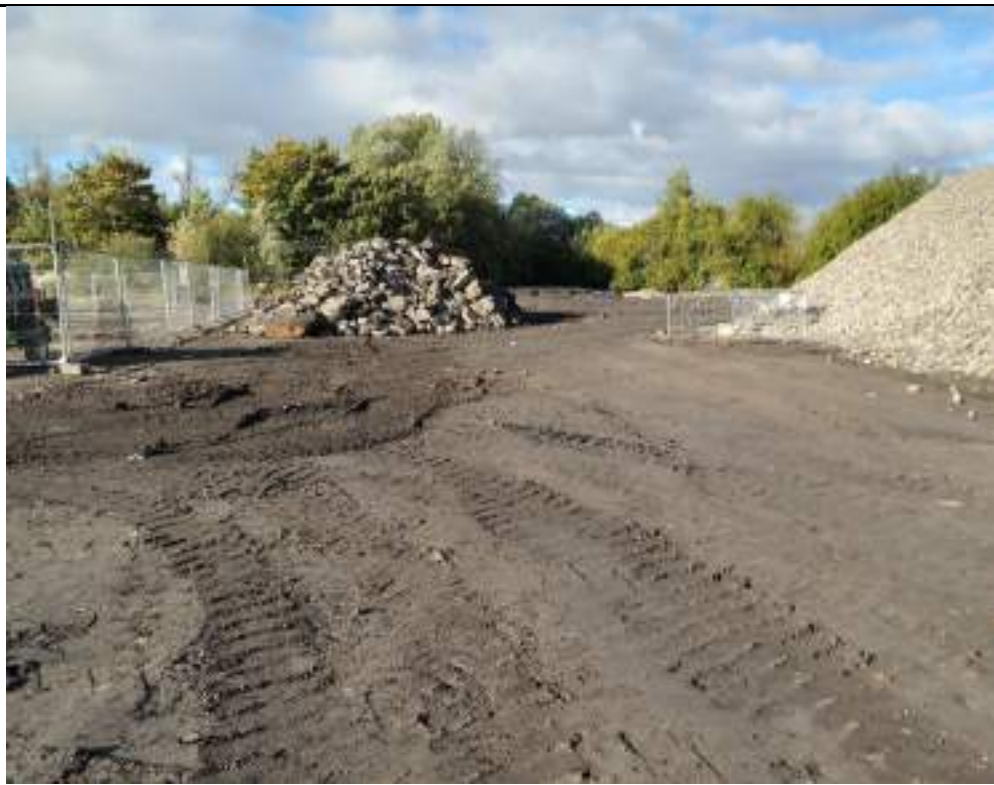
Photograph 8: Stockpile of excavated concrete in northwest of the site. Material from excavation in southeastern part of the site

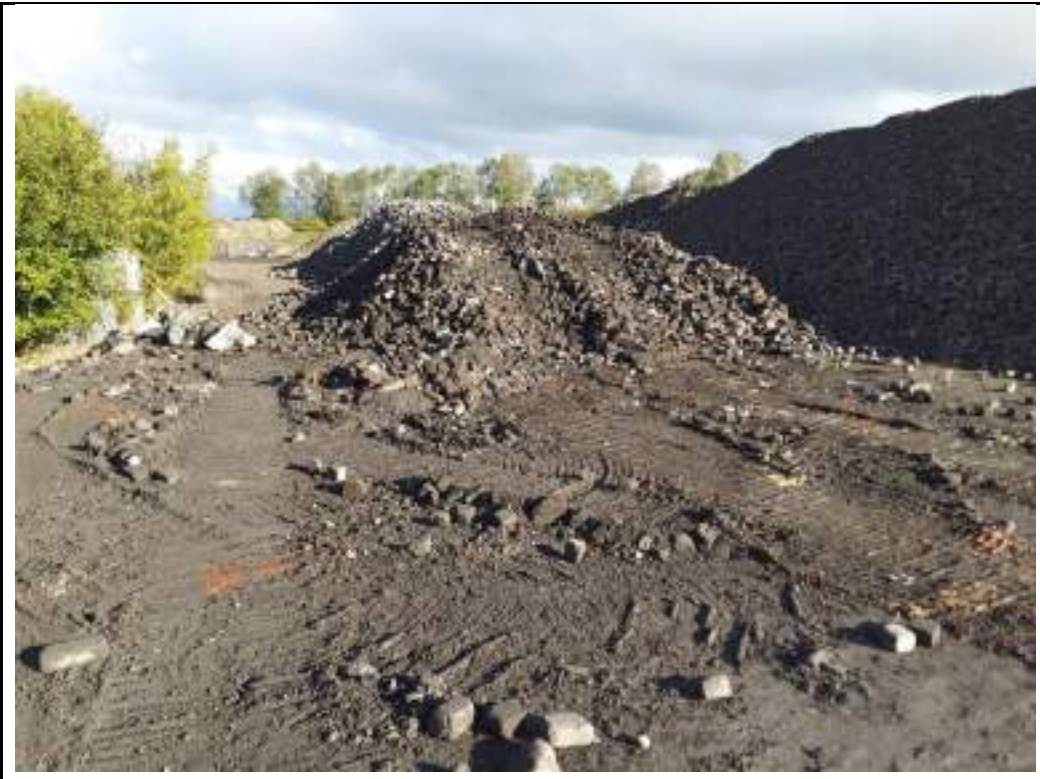
Photograph 9: Stockpile of bricks and crushed materials in northwestern part of the site.

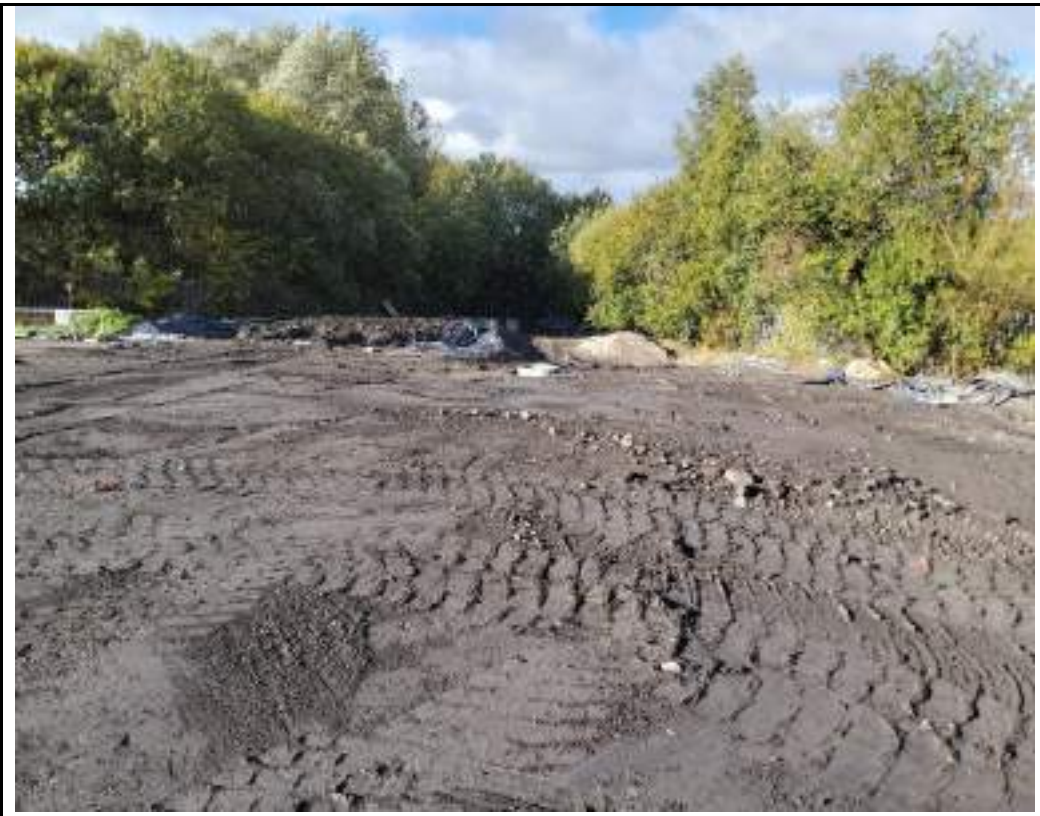
Photograph 10: Potentially TPH contaminated material stockpile in northwestern part of the site.

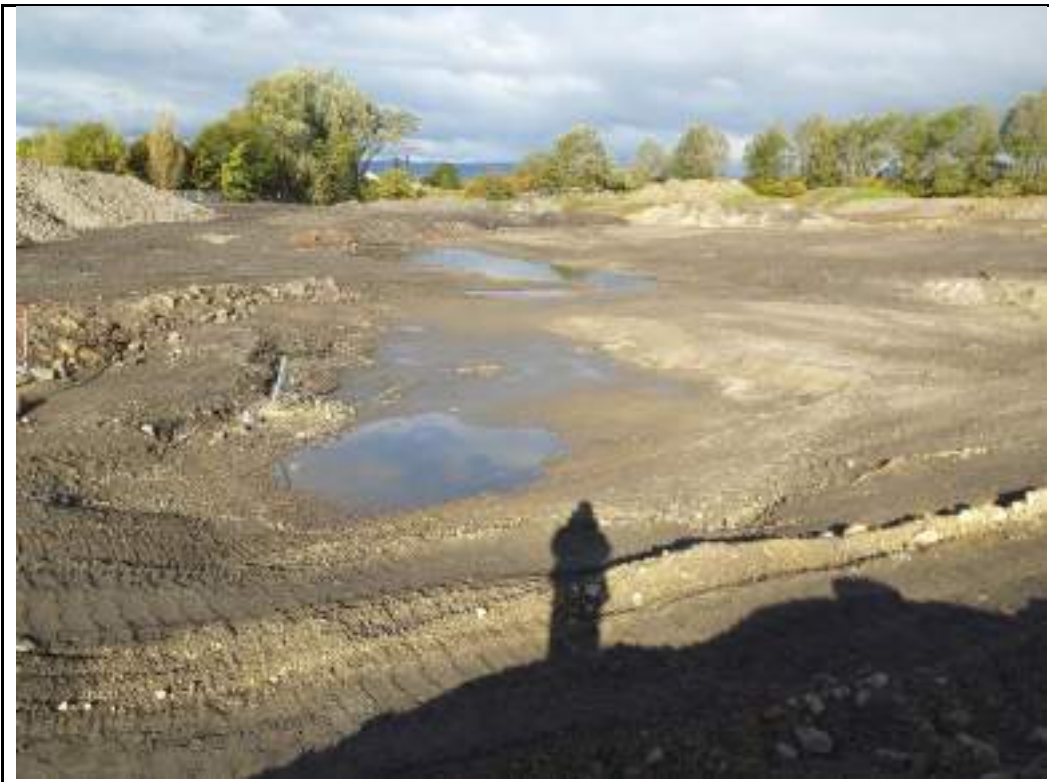
Photograph 14: Standing water in northern part of the site.

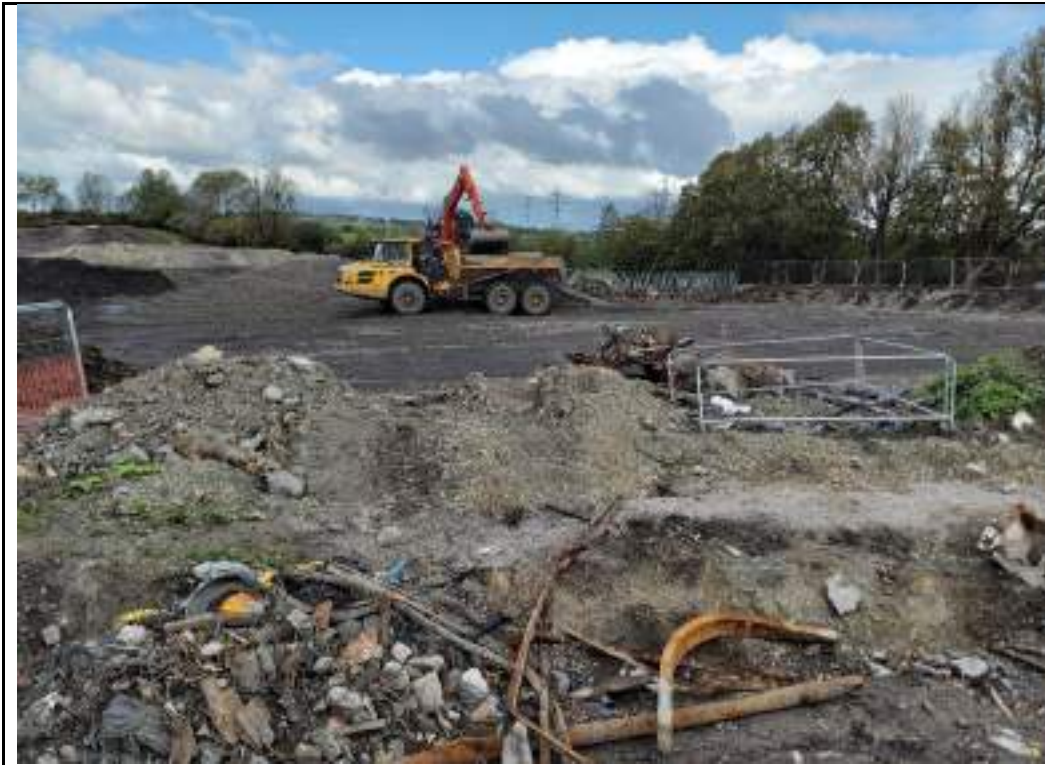
Photograph 21: transferring processed material from eastern stockpile to backfill southwestern part of the site.

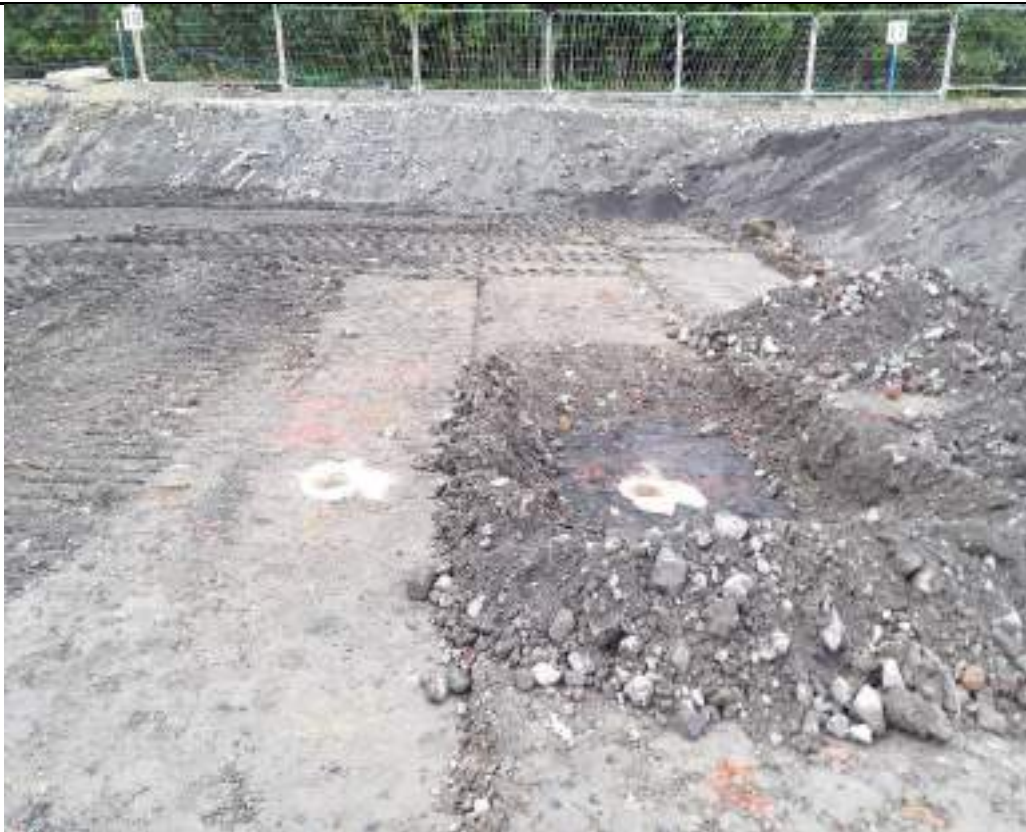
Photograph 26: Locations of SRD tests on fill material in southwestern part of the site.

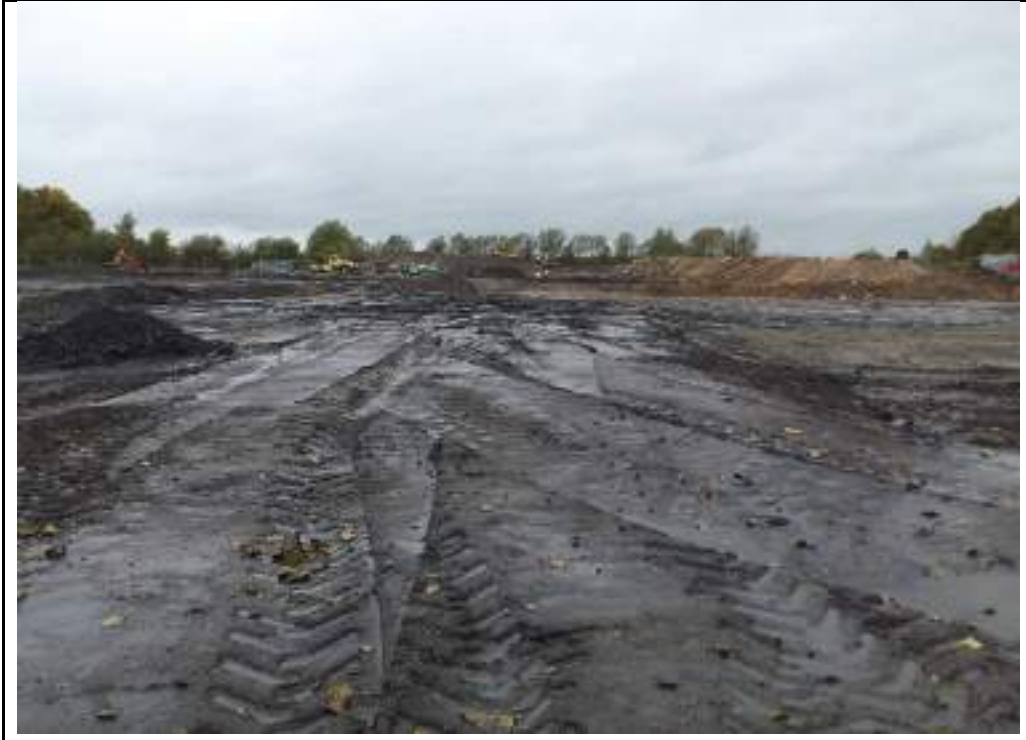
Photograph 1: Overview of the site. Looking towards the north.

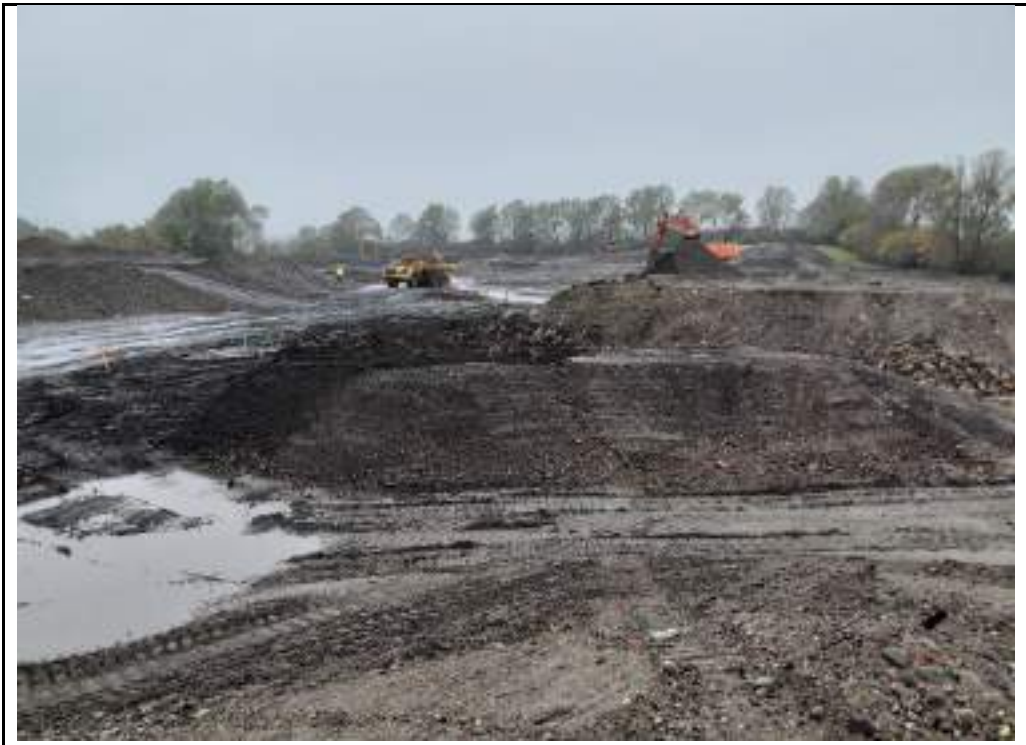
Photograph 2: Overview of northern part of the site. Looking towards the north.

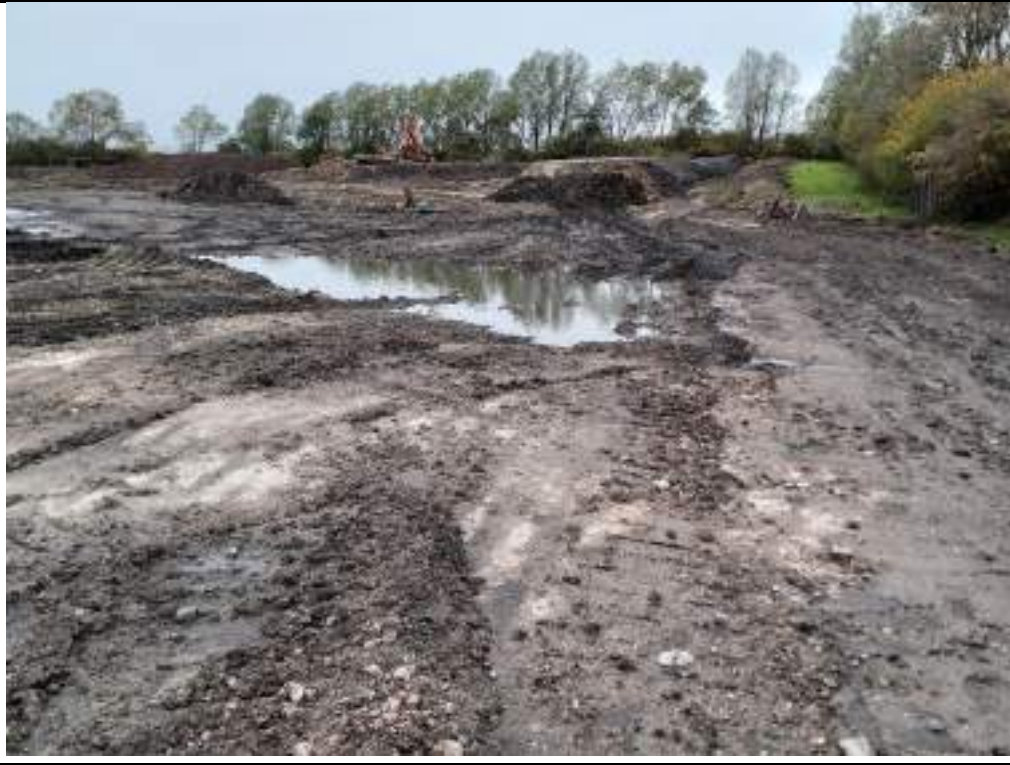
Photograph 5: Standing water in northeastern part of the site.

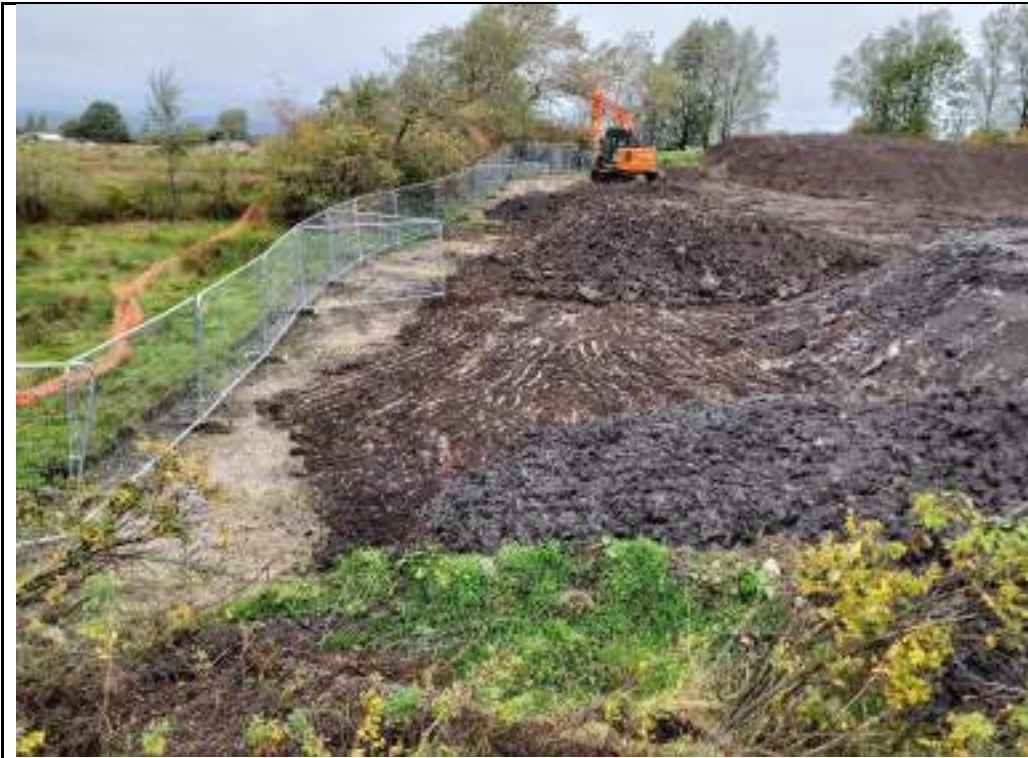
Photograph 25: Northwestern boundary of the site. Looking towards the north.

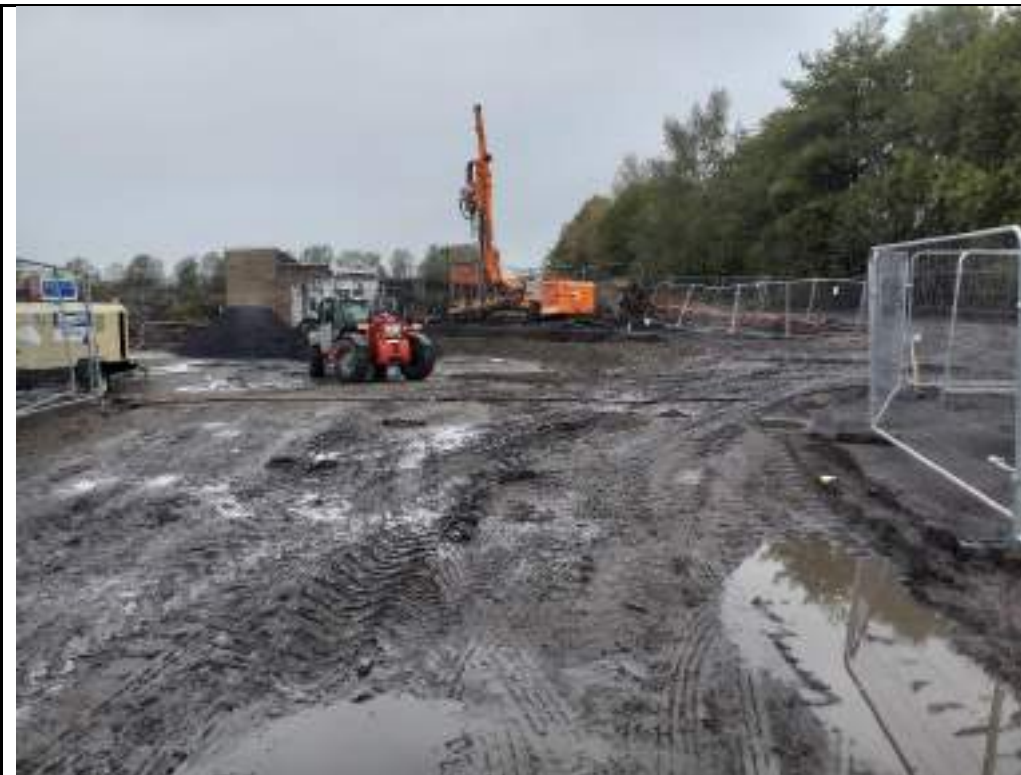
Photograph 2: Grouting shaft no.6 in eastern part of the site.

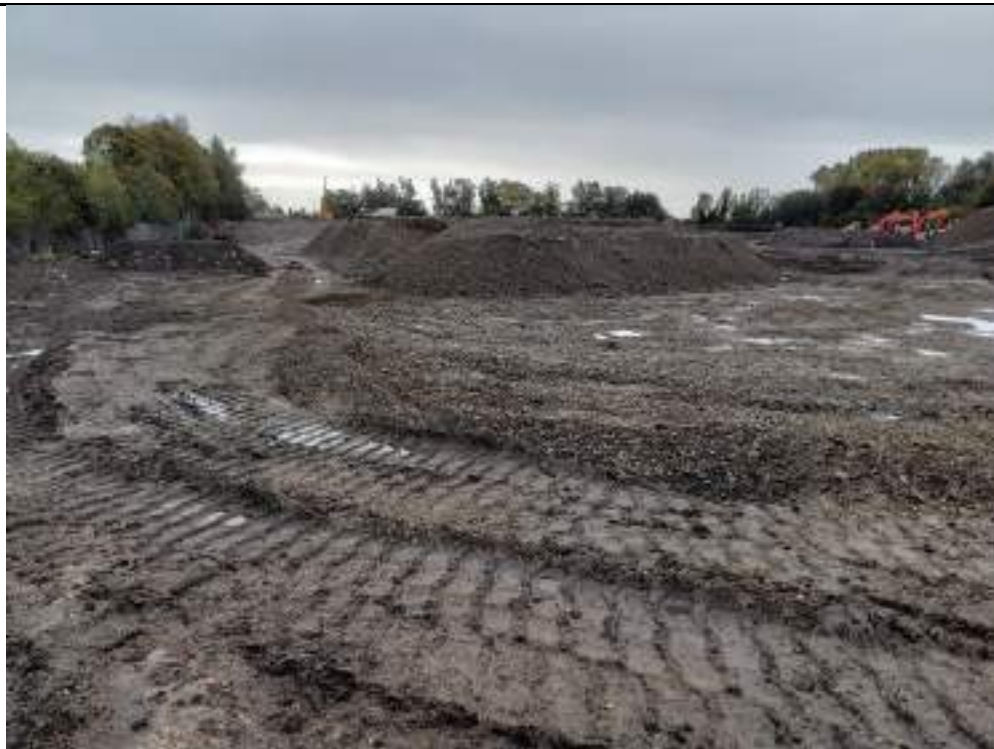
Photograph 6: Stockpiles in northeastern boundary of the site. Looking towards the south.

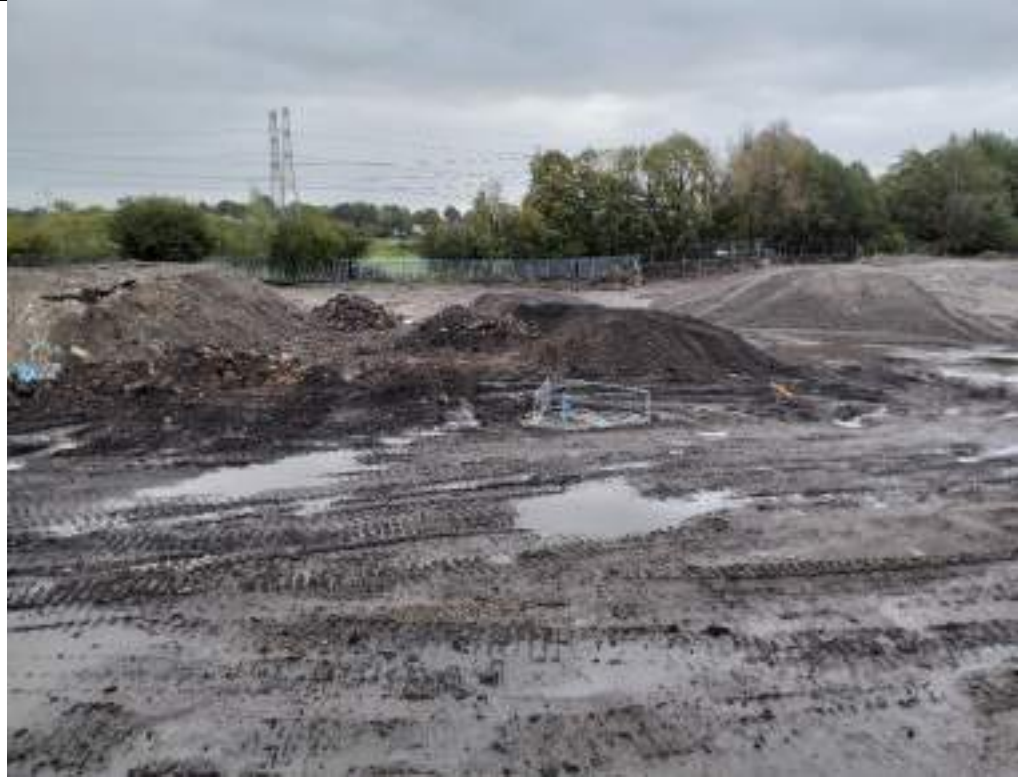
Photograph 11: Stockpiles in eastern boundary of the site. Looking towards the east.

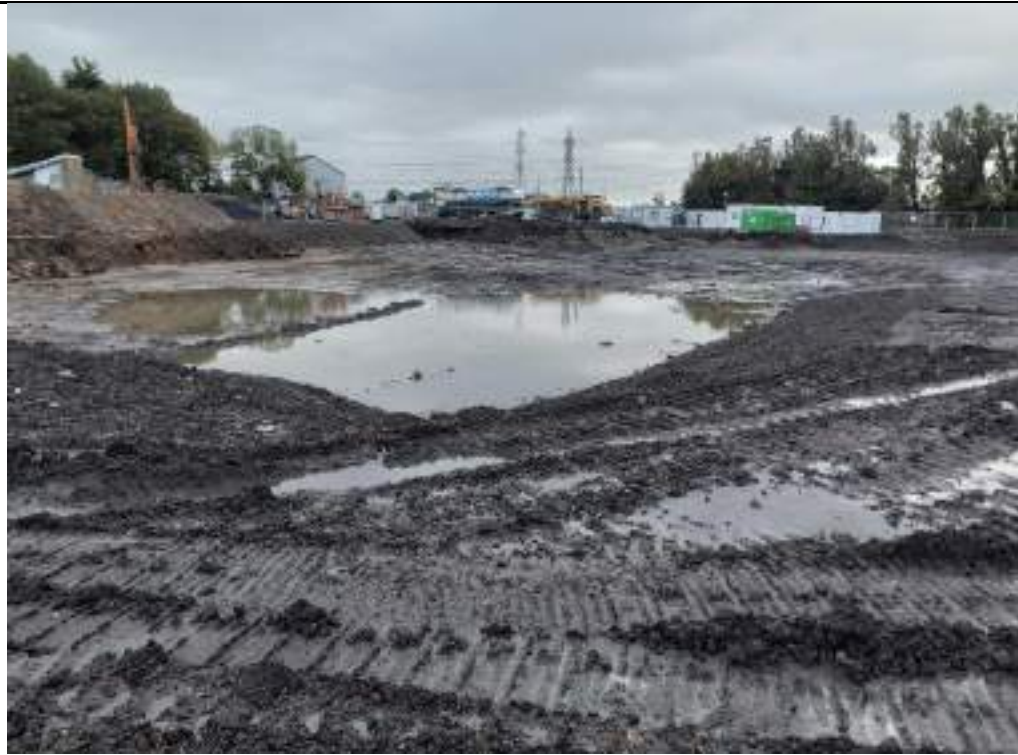
Photograph 12: Standing water in southeast of the site.

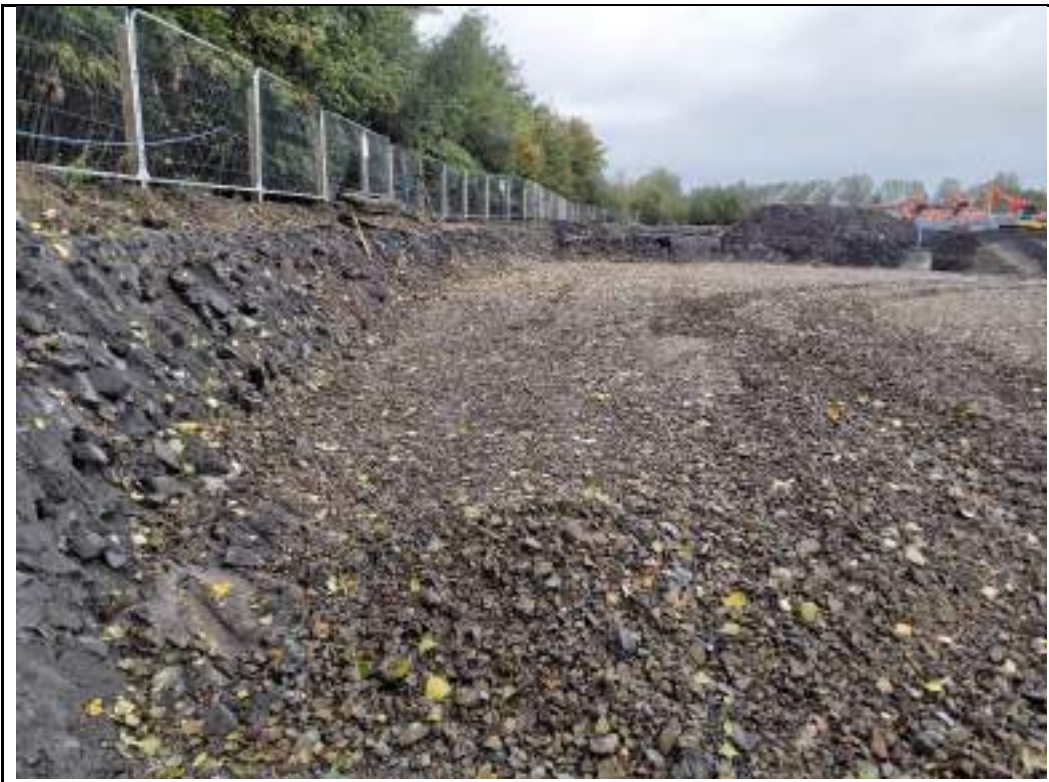
Photograph 14: Western boundary of the site. Looking towards the north.

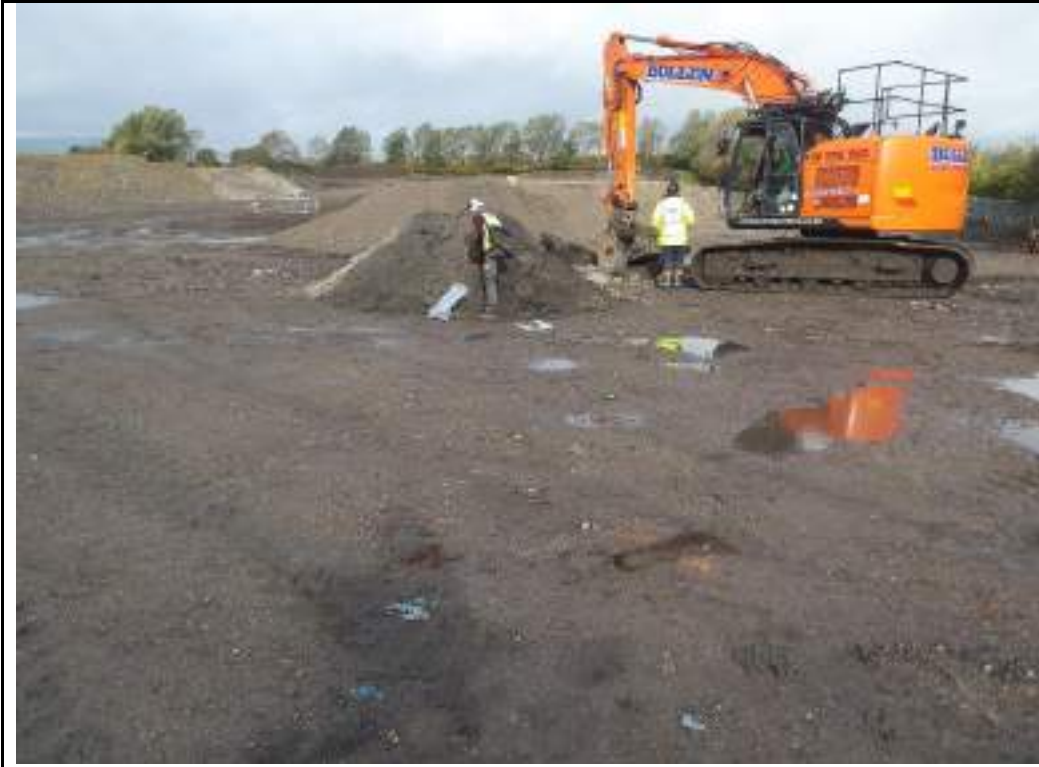
Photograph 21: Sample collection from excavated material from trial pit in eastern part of the site.

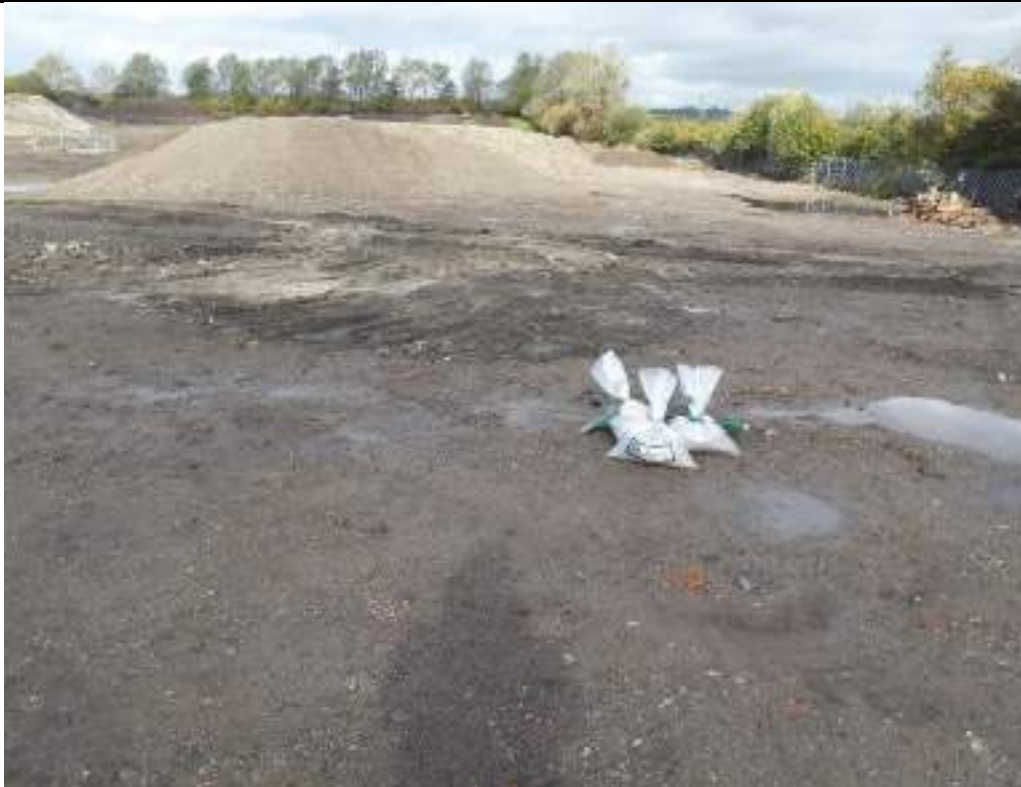
Photograph 22: Samples and backfilled trial pit in eastern part of the site.

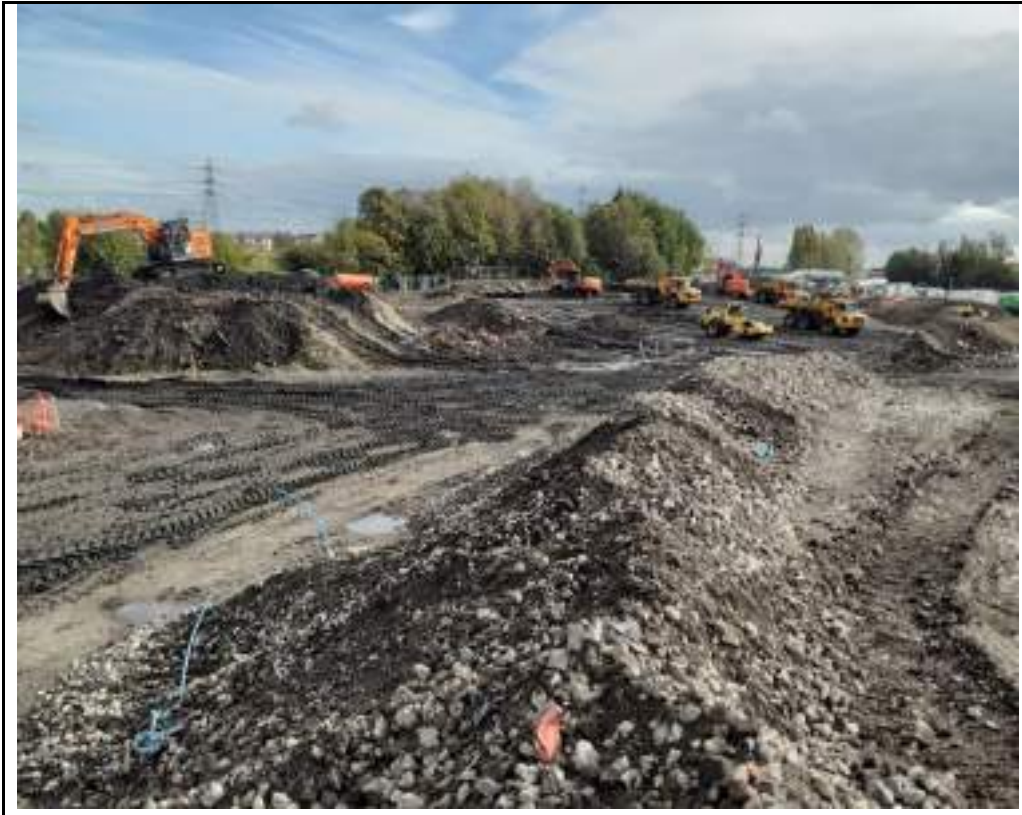
Photograph 1: Overview of the site. Looking towards the south.

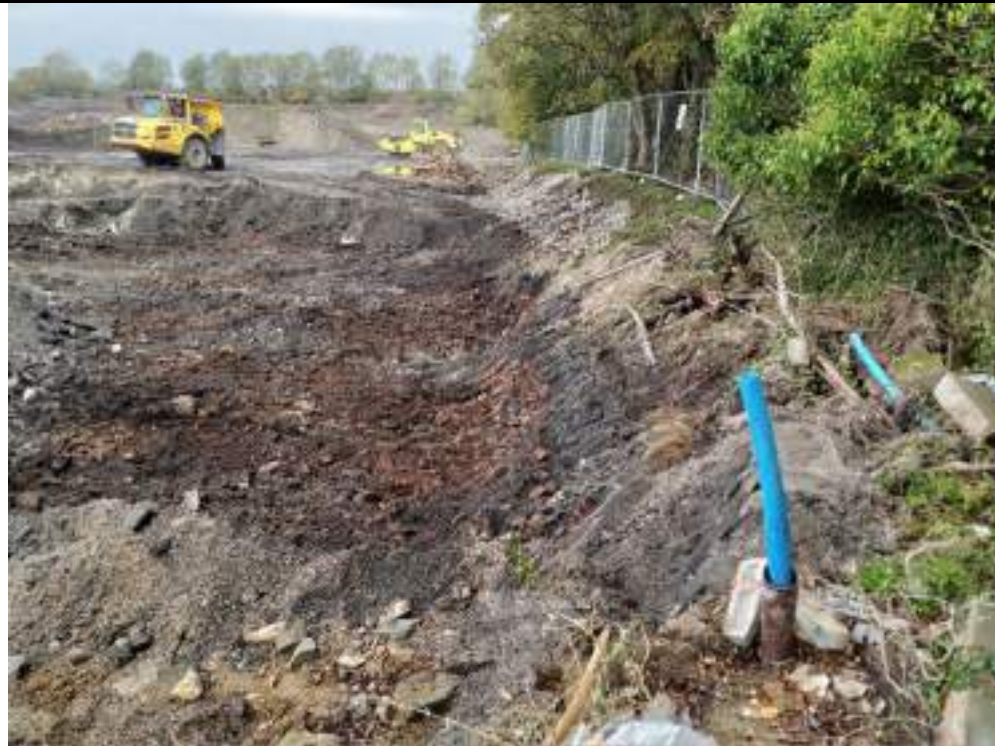
Photograph 5: Eastern boundary of the site. Looking towards the north.

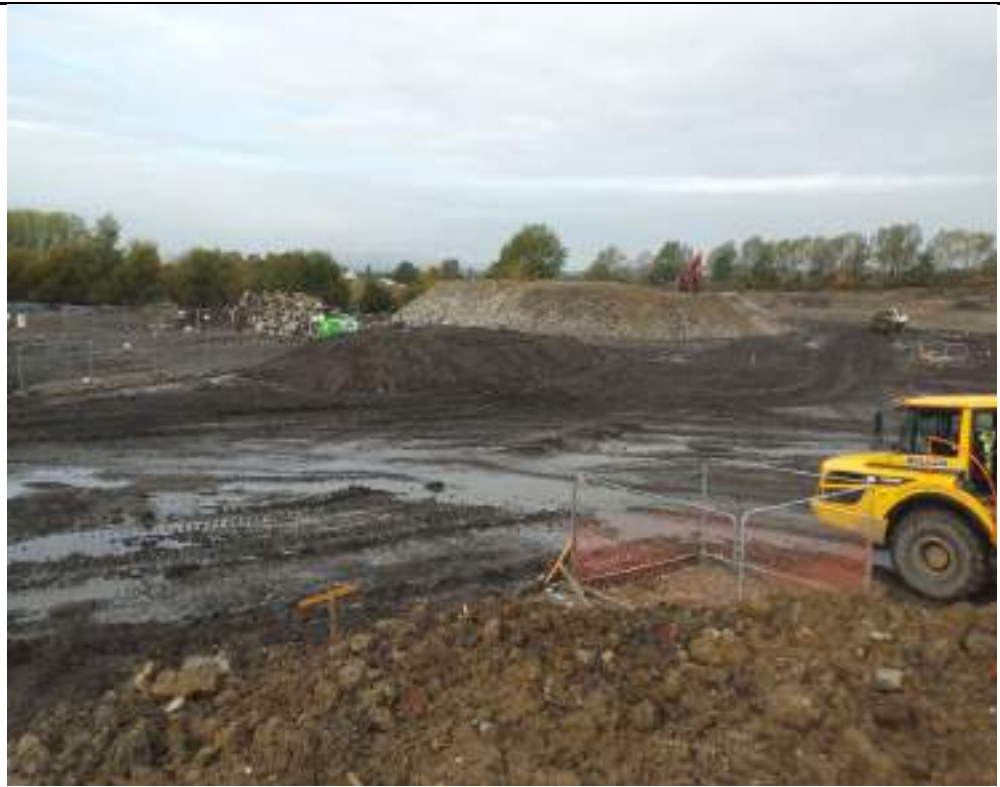
Photograph 8: Overview of northwestern stockpiles.

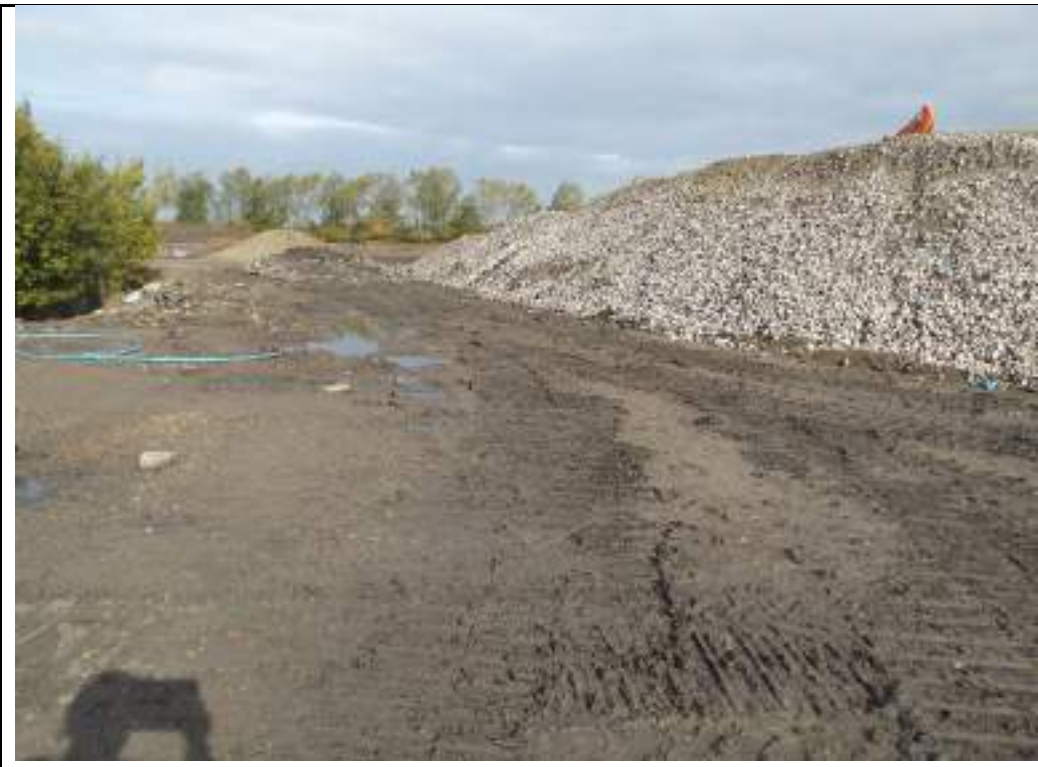
Photograph 12: Stockpile of bricks and crushed materials in northwestern part of the site.

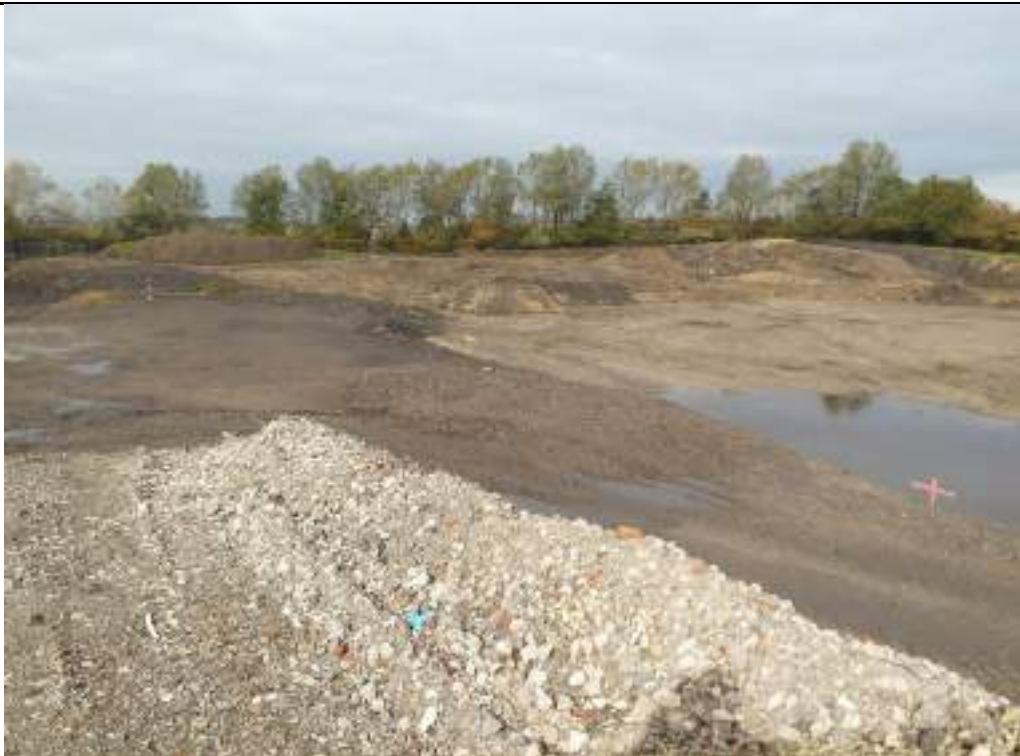
Photograph 20: Overview of northern stockpiles. Looking towards the north.

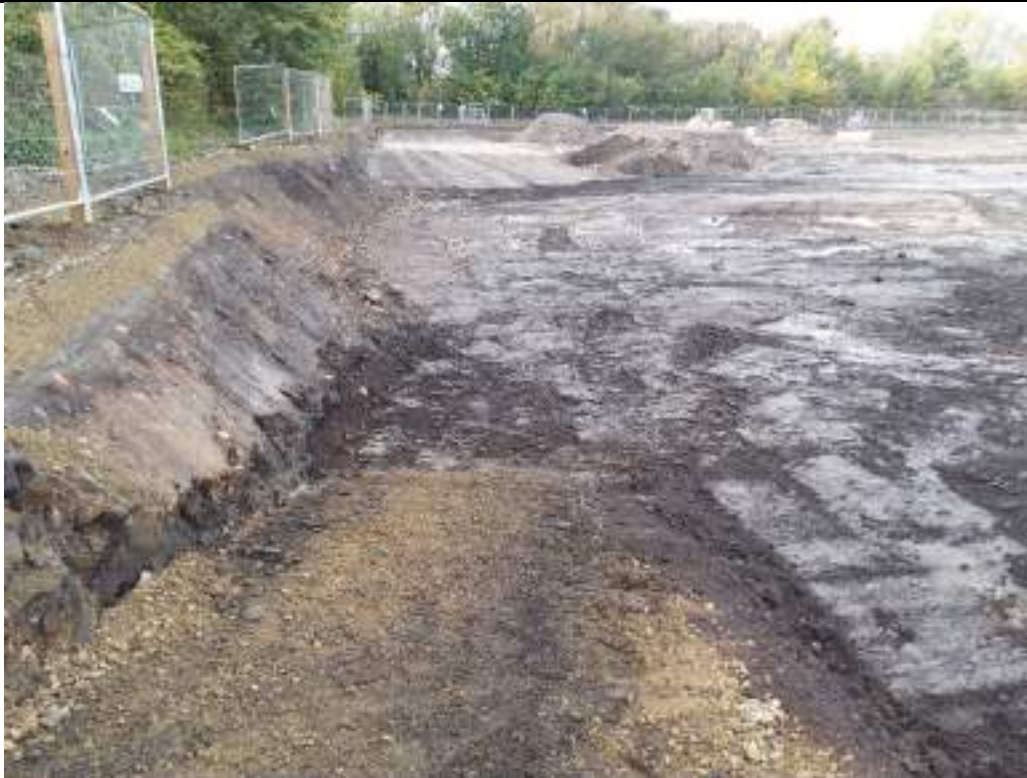
Photograph 22: Southern boundary of the site. Looking towards the west.
