**SITE VISIT REPORT 15220-HYD-XX-XX-SVR-GE-1018**

**SHEET NO.: 6 of 18**

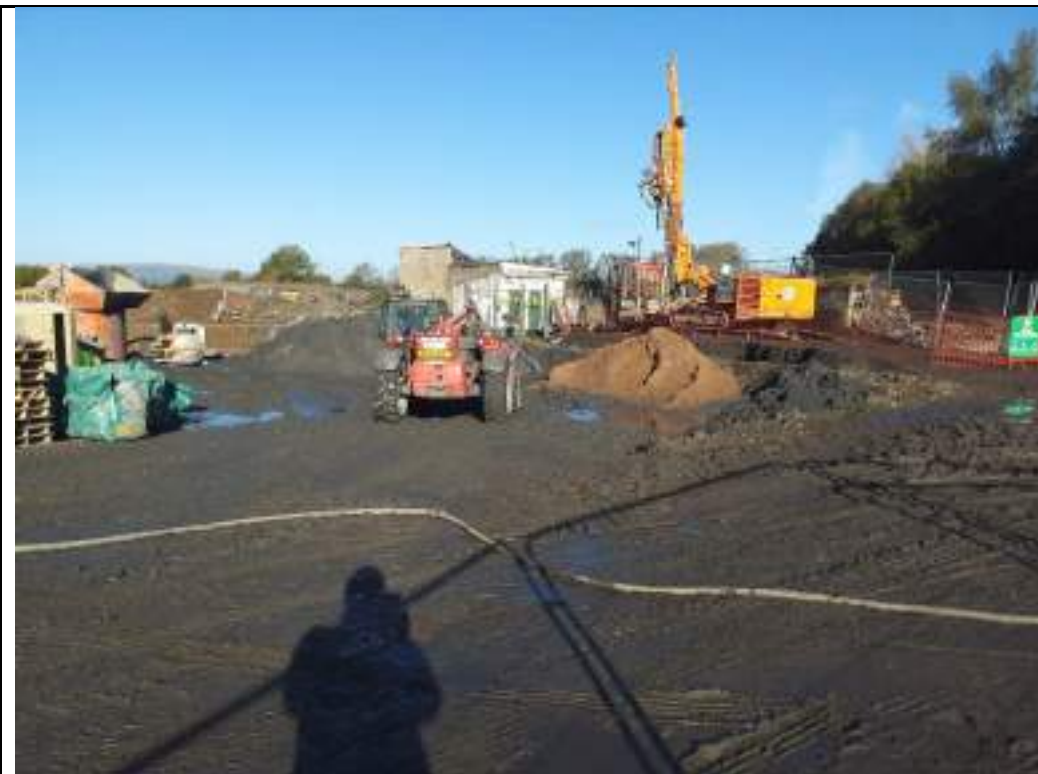
Photograph 2: Grouting shaft no.6 in eastern part of the site.

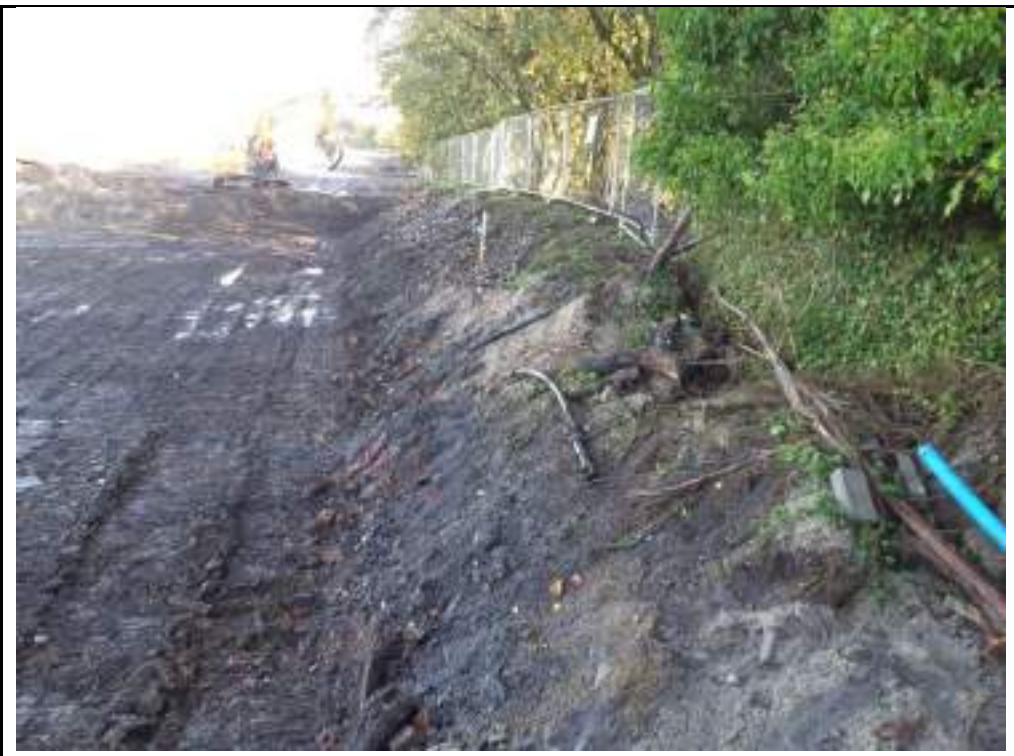
Photograph 4: Eastern boundary of the site. Looking towards the north.

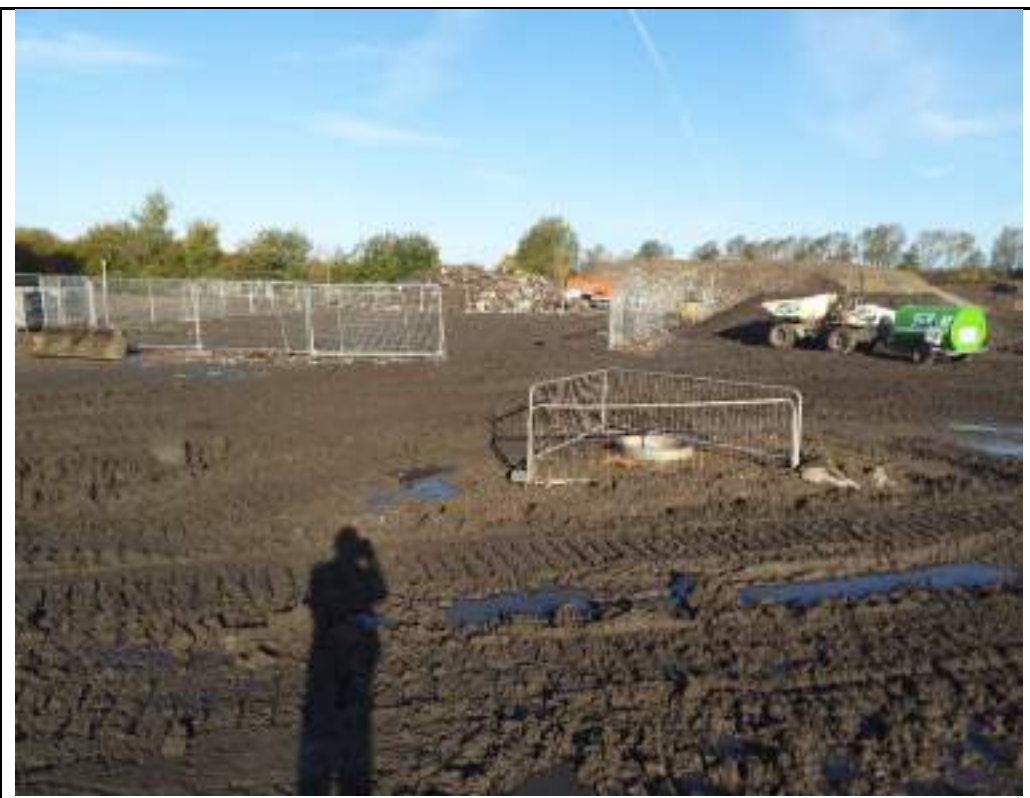
Photograph 10: Stockpiles in northwestern part of the site.

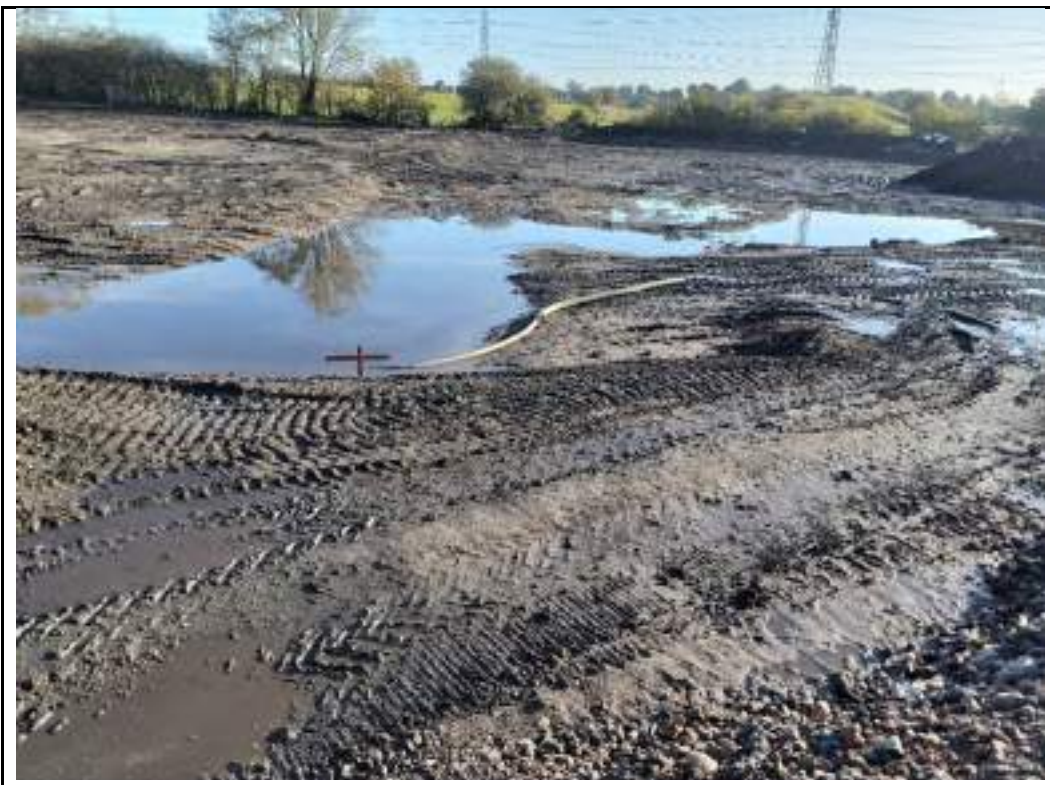
Photograph 14: Standing water in northern part of the site.

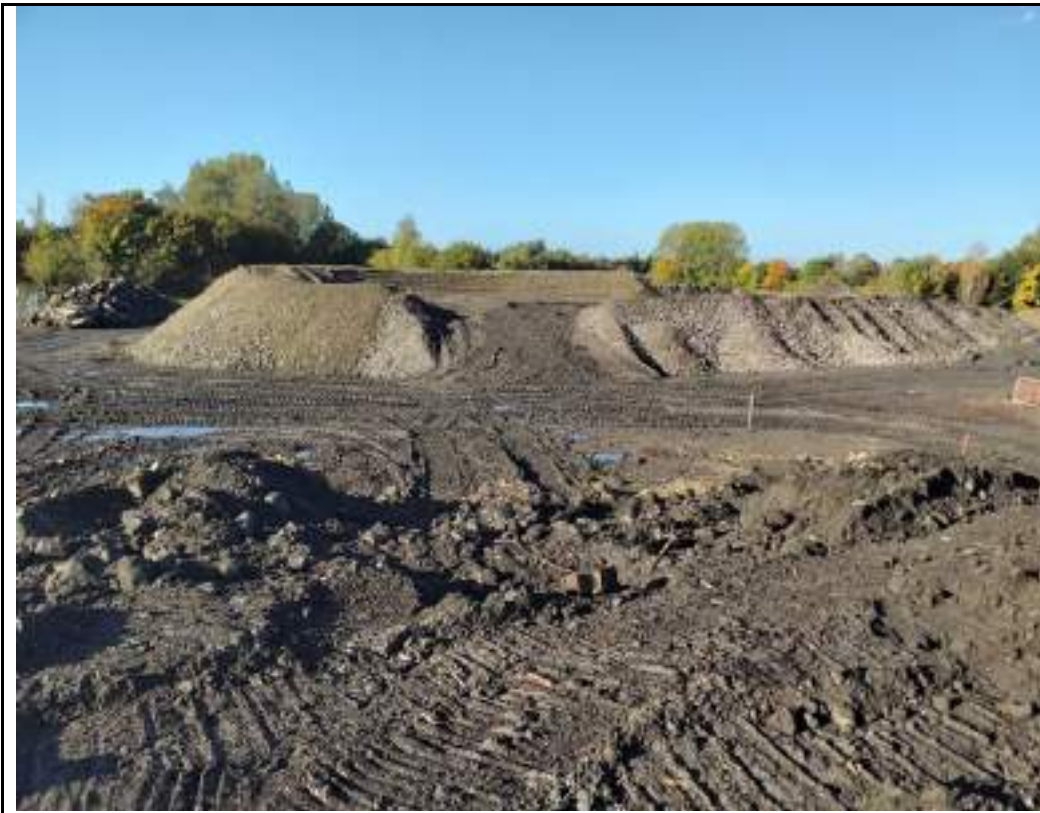
Photograph 17: Stockpile of crushed materials in northwestern part of the site.

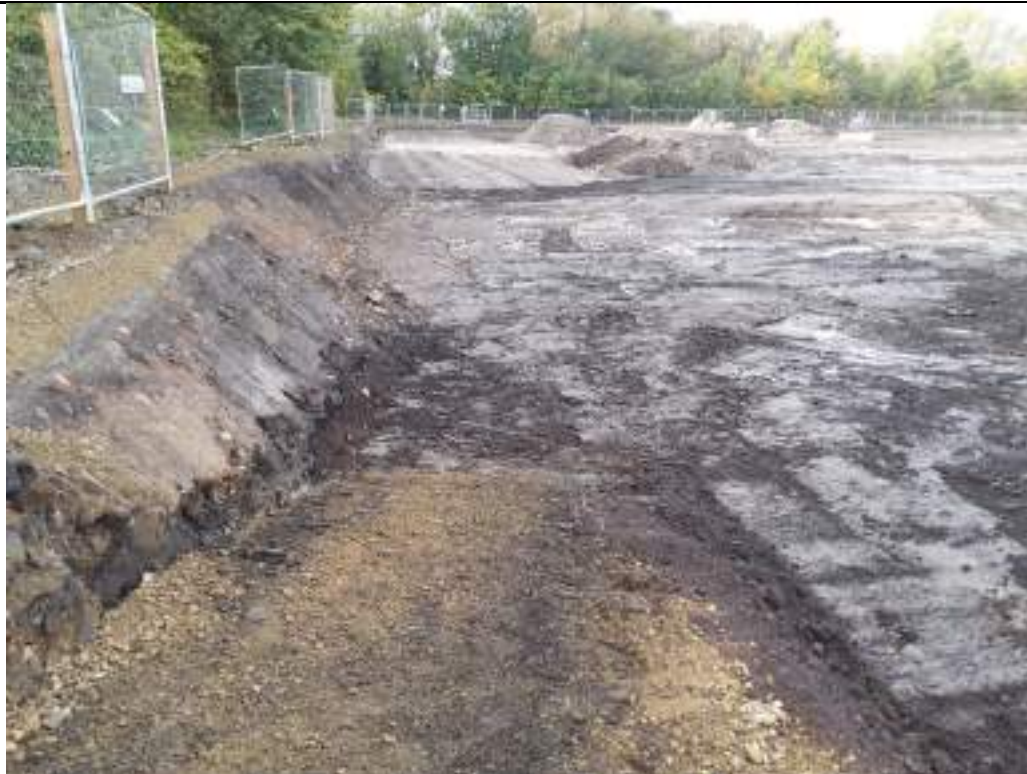
Photograph 22: Surveying of southwestern boundary of the site.

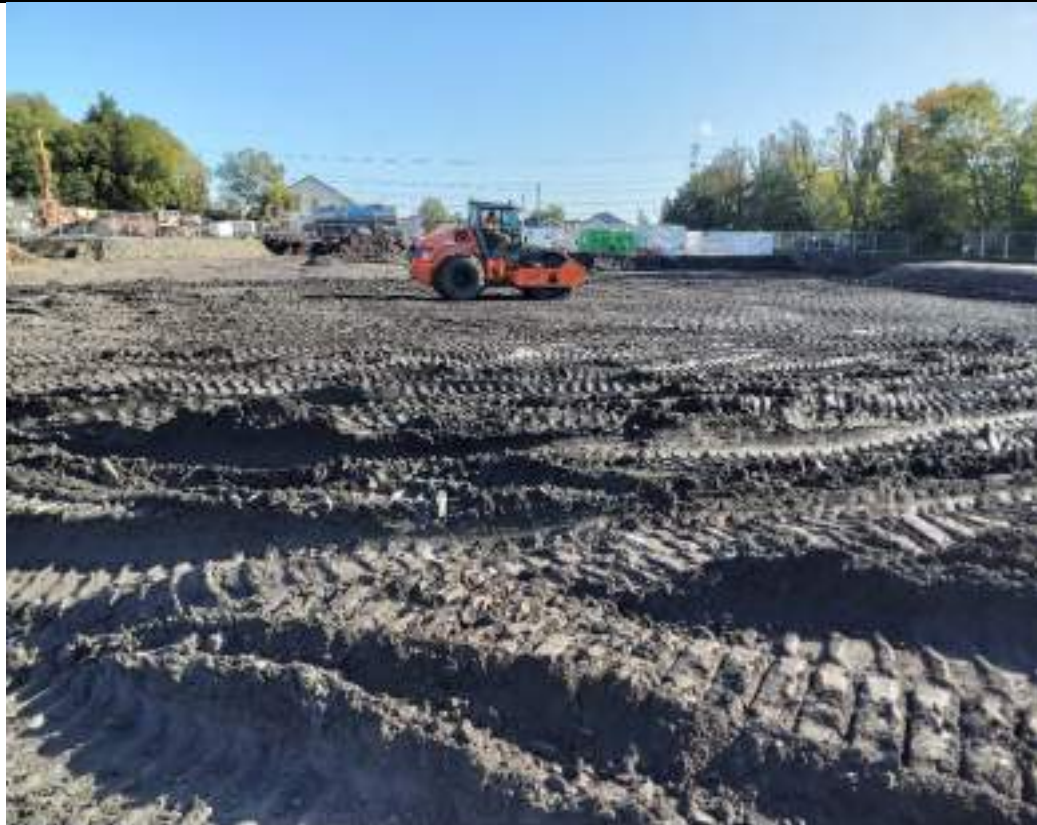
Photograph 23: Proof rolling over fill materials using sheepfoot roller in southern part of the site.

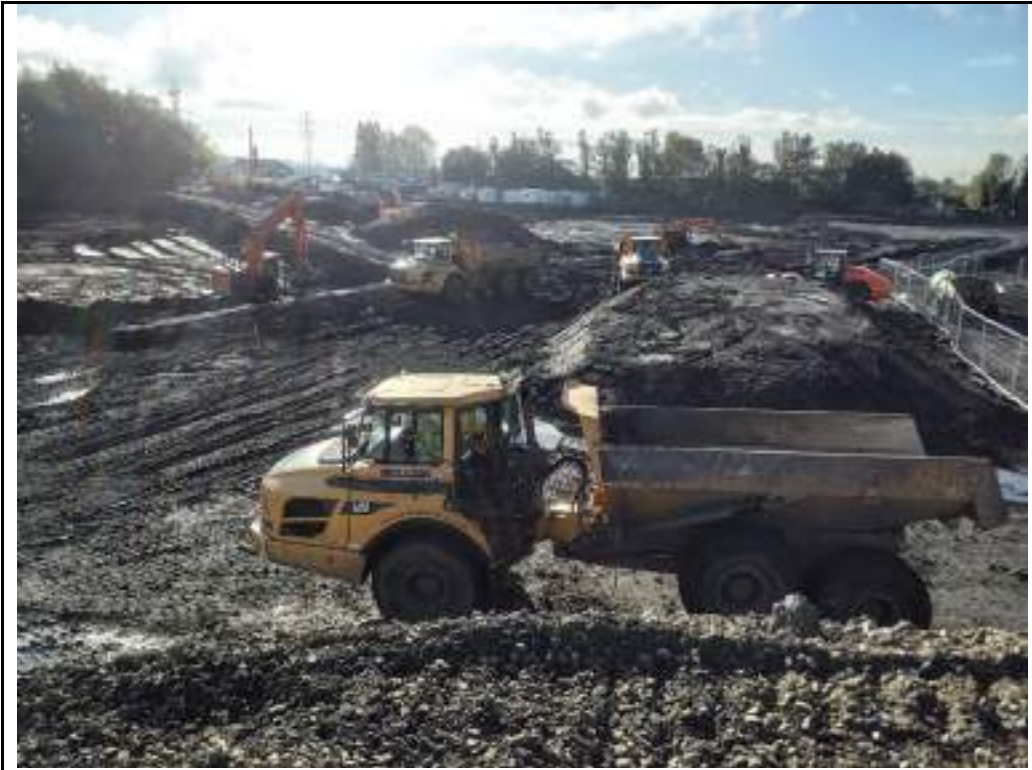
Photograph 1: Overview of the site. Looking towards the south.

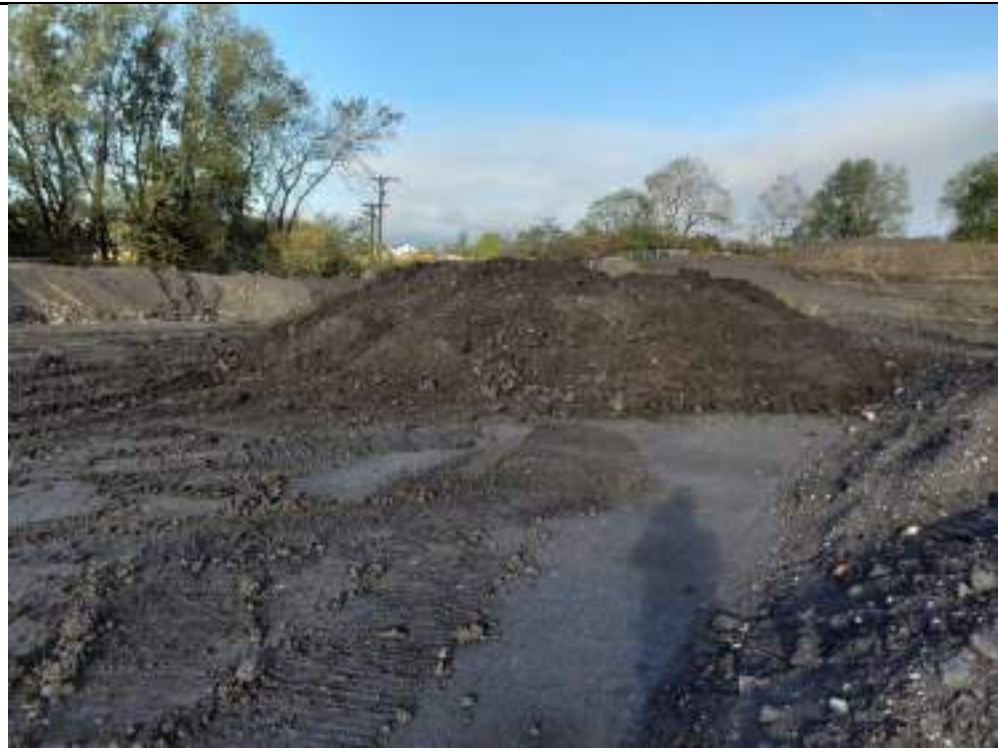
Photograph 6: Excavated peat stockpile in northwestern part of the site.

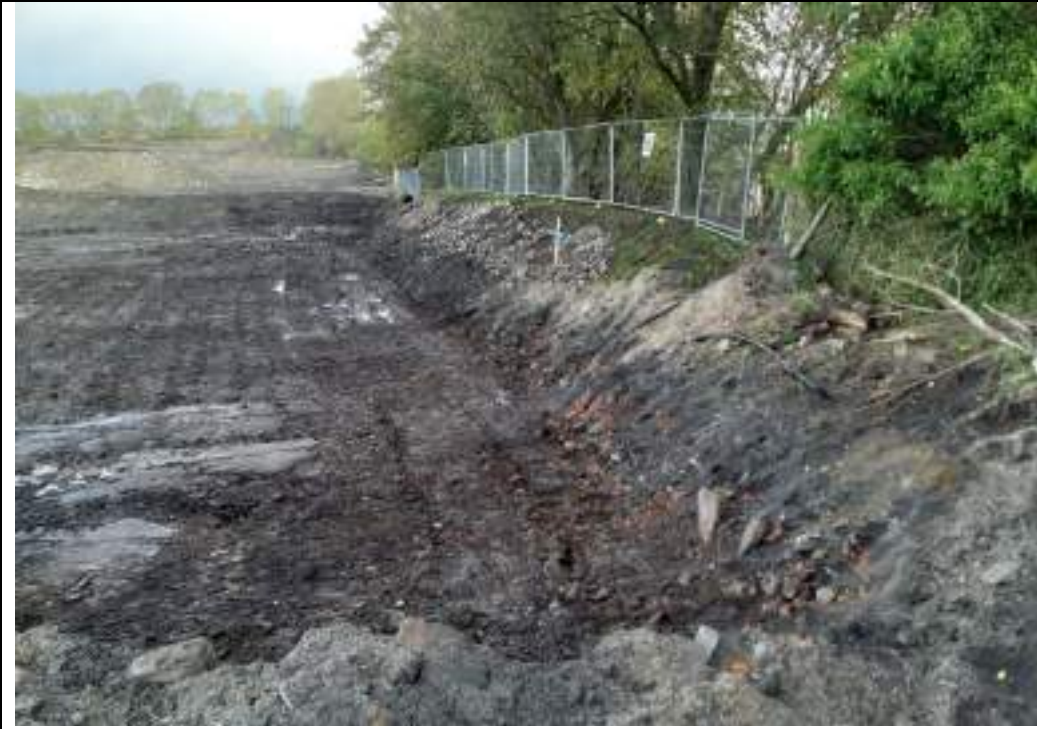
Photograph 11: Eastern boundary of the site. Looking towards the north.

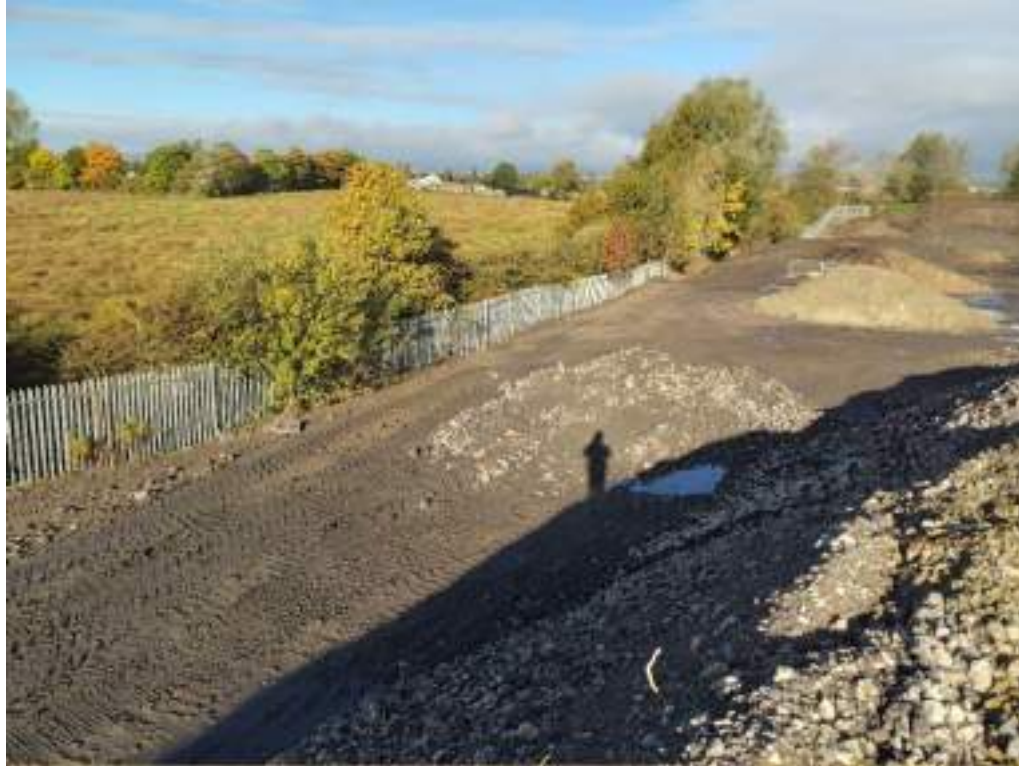
Photograph 15: Bricks and granular materials stockpiles in the northwestern boundary of the site

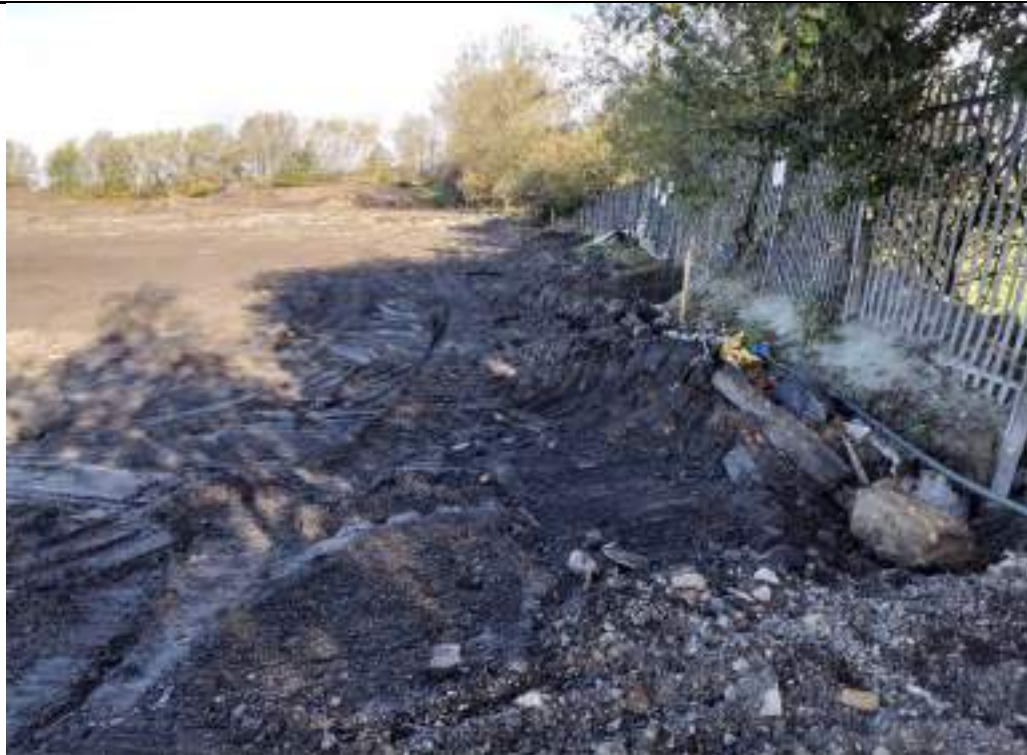
Photograph 16: Northeastern boundary of the site. Looking towards the north.

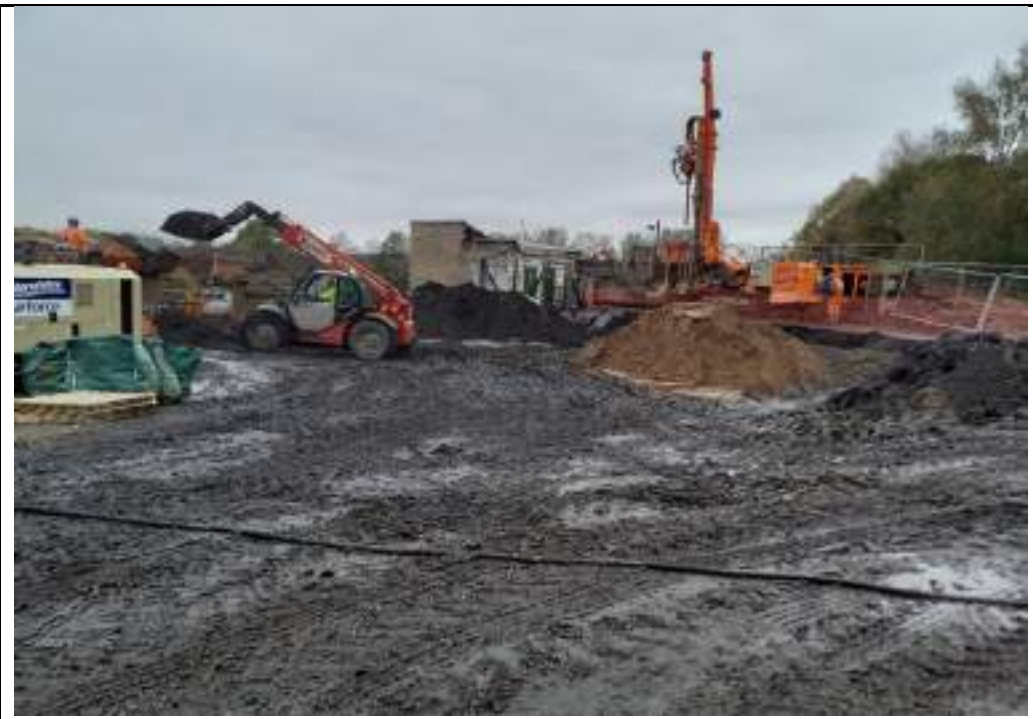
Photograph 2: Grouting shaft no.6 in eastern part of the site.

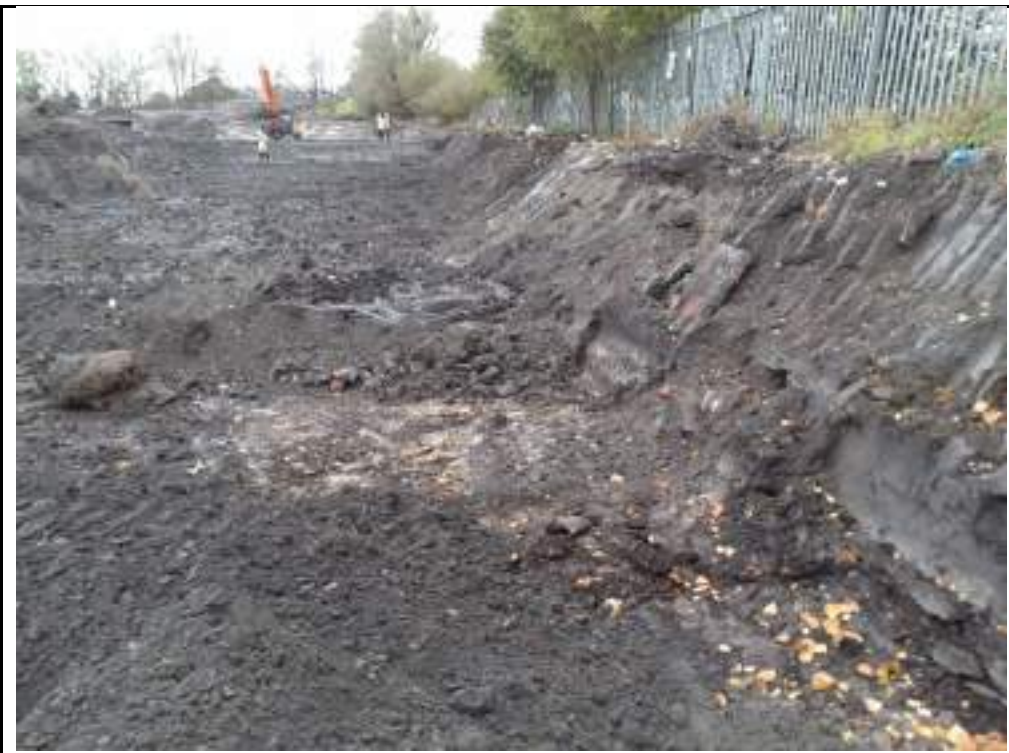
Photograph 4: Northeastern boundary of the site. Looking towards the north.

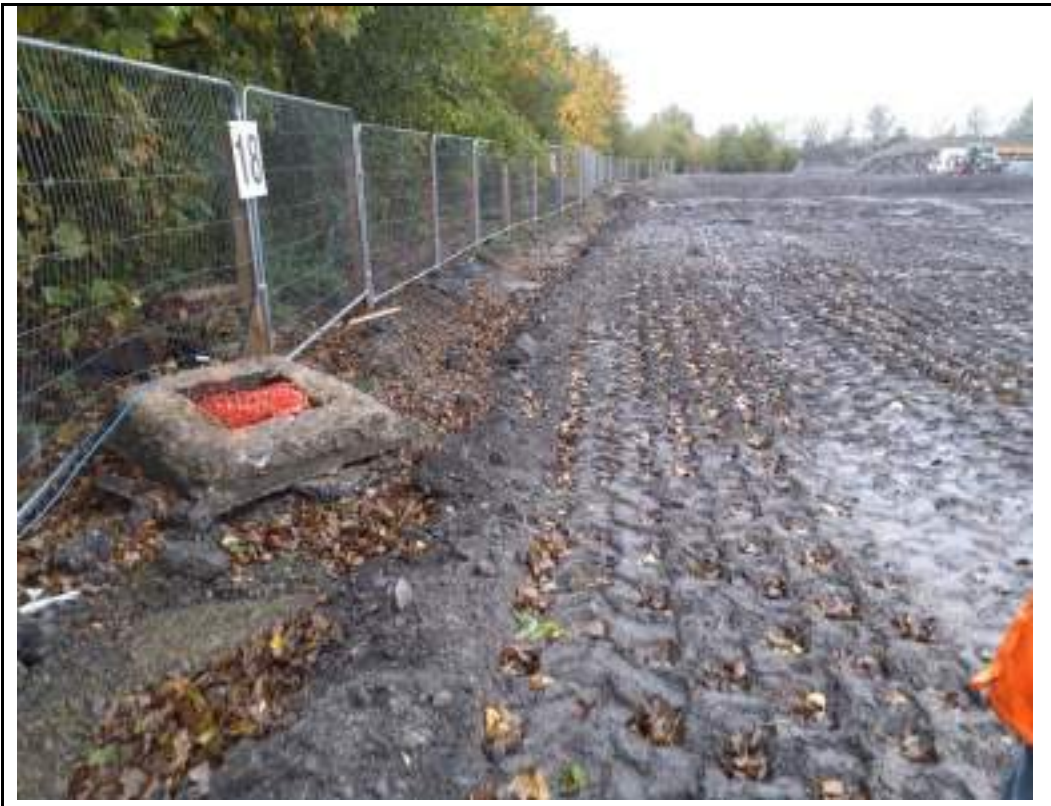
Photograph 11: Western boundary of the site. Looking towards the north.

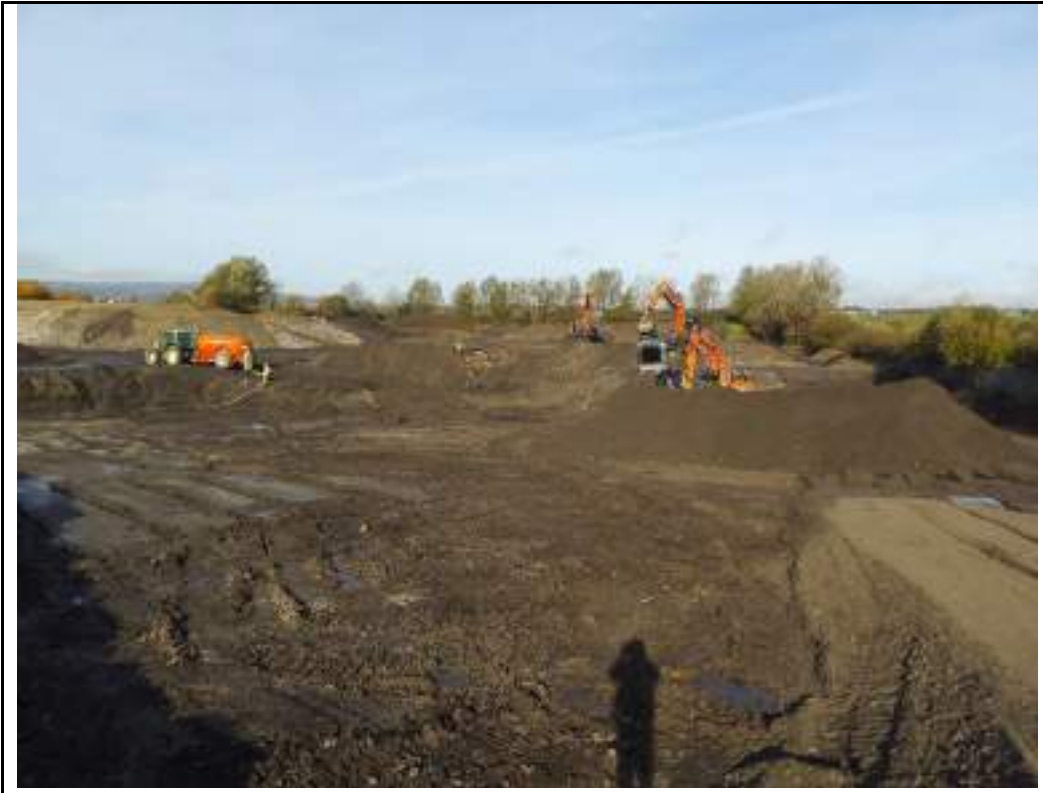
Photograph 1: Overview of the site. Looking towards the north.

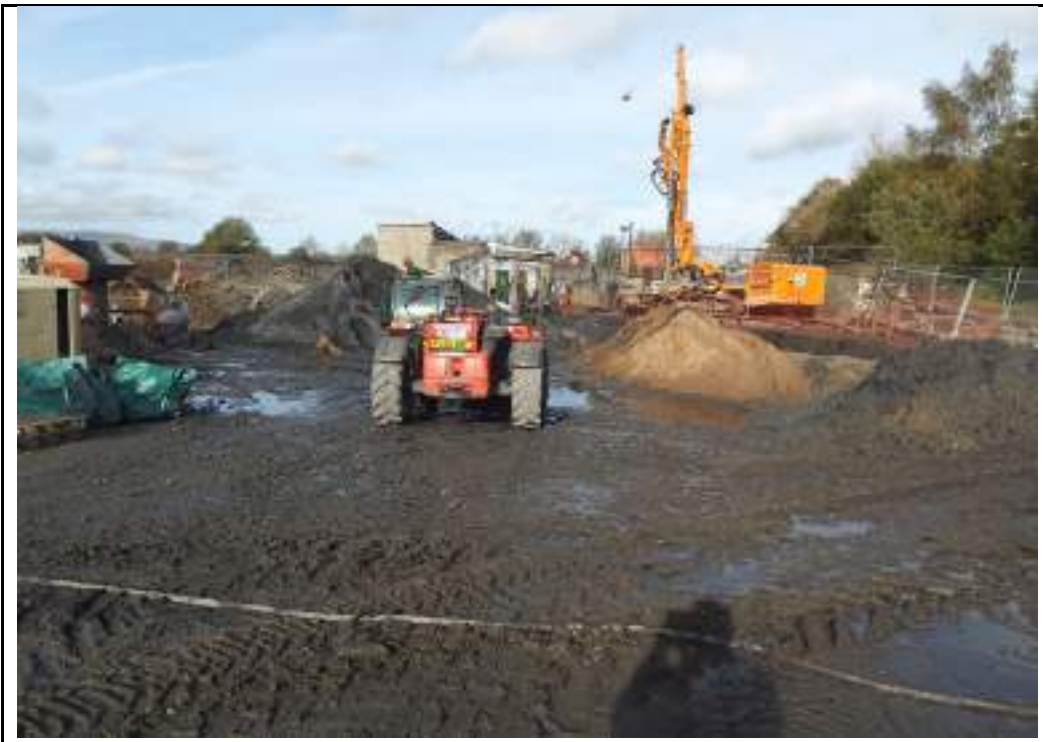
Mine shaft treatment of shaft no.6 is ongoing. VHE stated that Van Elle is experiencing grout loss. Van Elle has been injecting a PFA : Sand : OPC mix at 8 : 2 : 1 ratio. The Coal Authority agreed to use sand buffer to increase thickness of grout. No improvement has been reported so far.

Photograph 2: Grouting shaft no.6 in eastern part of the site.

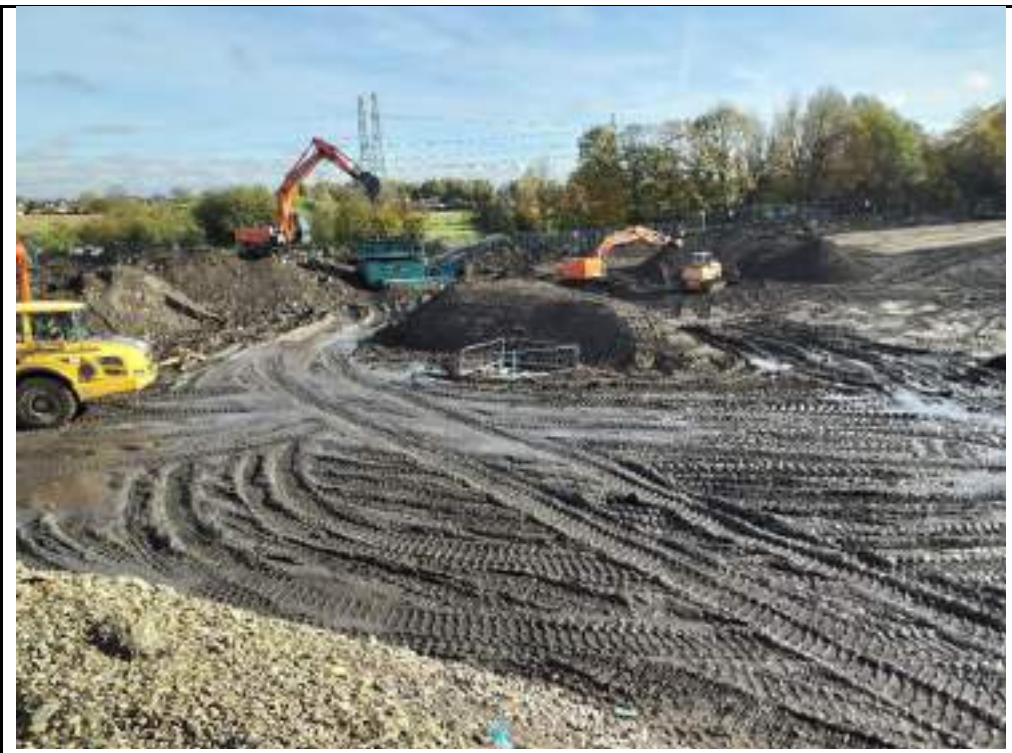
Photograph 4: Processing northeastern stockpile using screener.

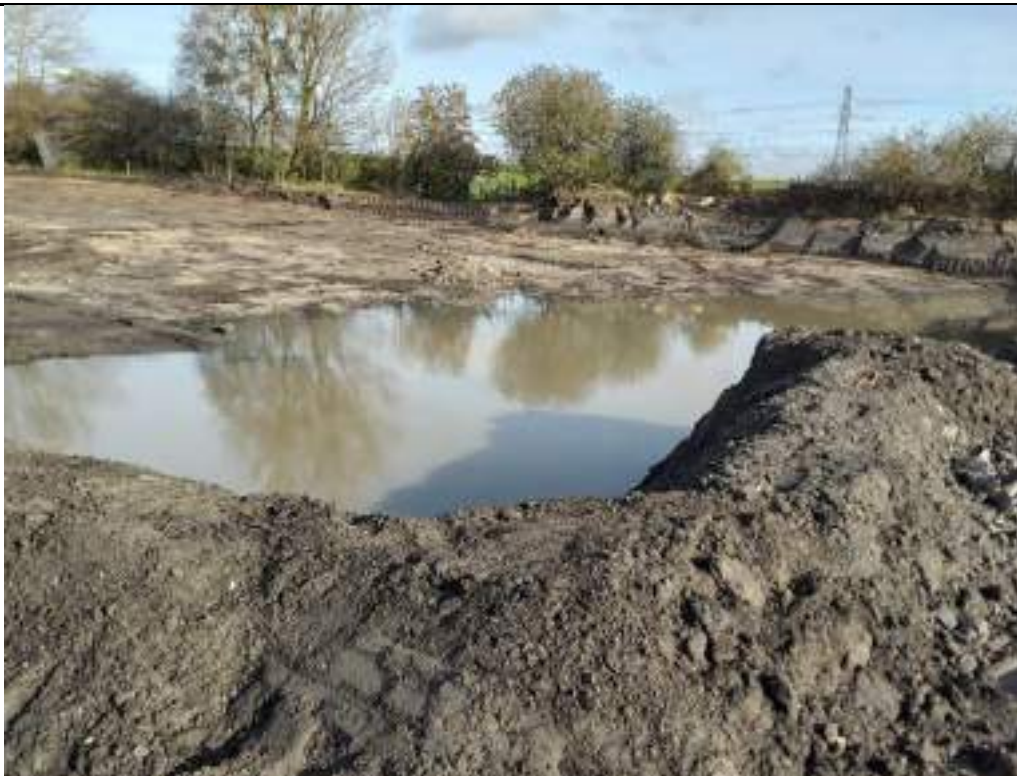
Photograph 18: Standing water in excavation in northeast of the site. Looking towards the north.

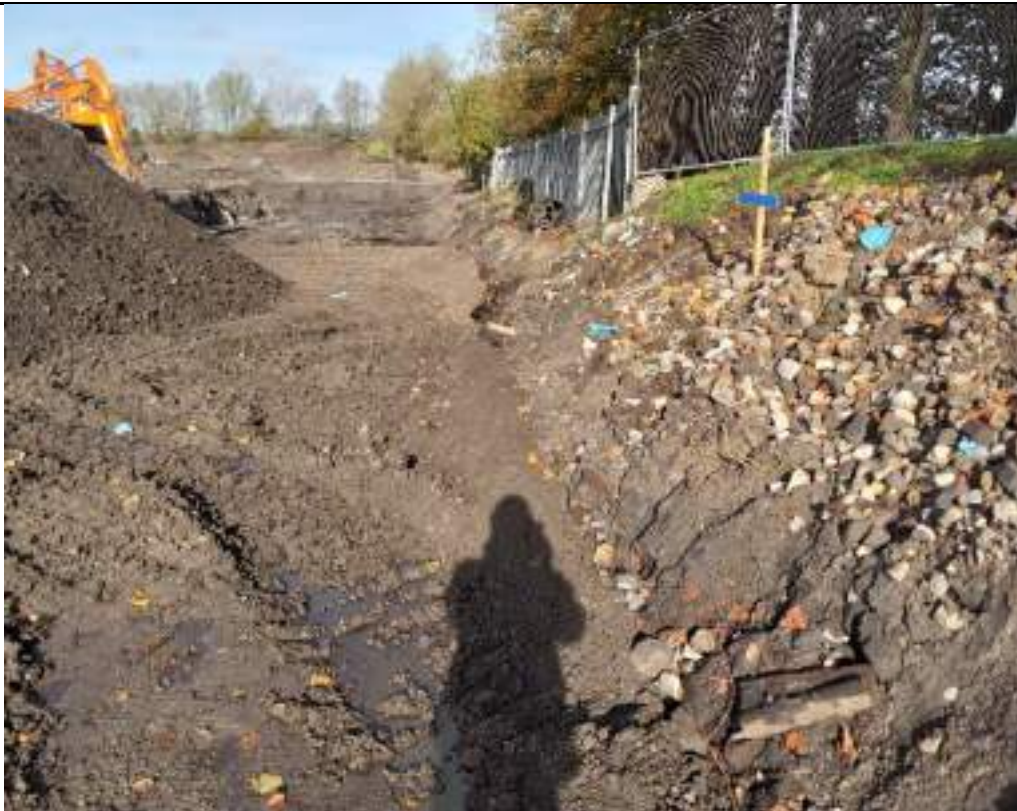
Photograph 20: Northeastern boundary of the site. Looking towards the north.

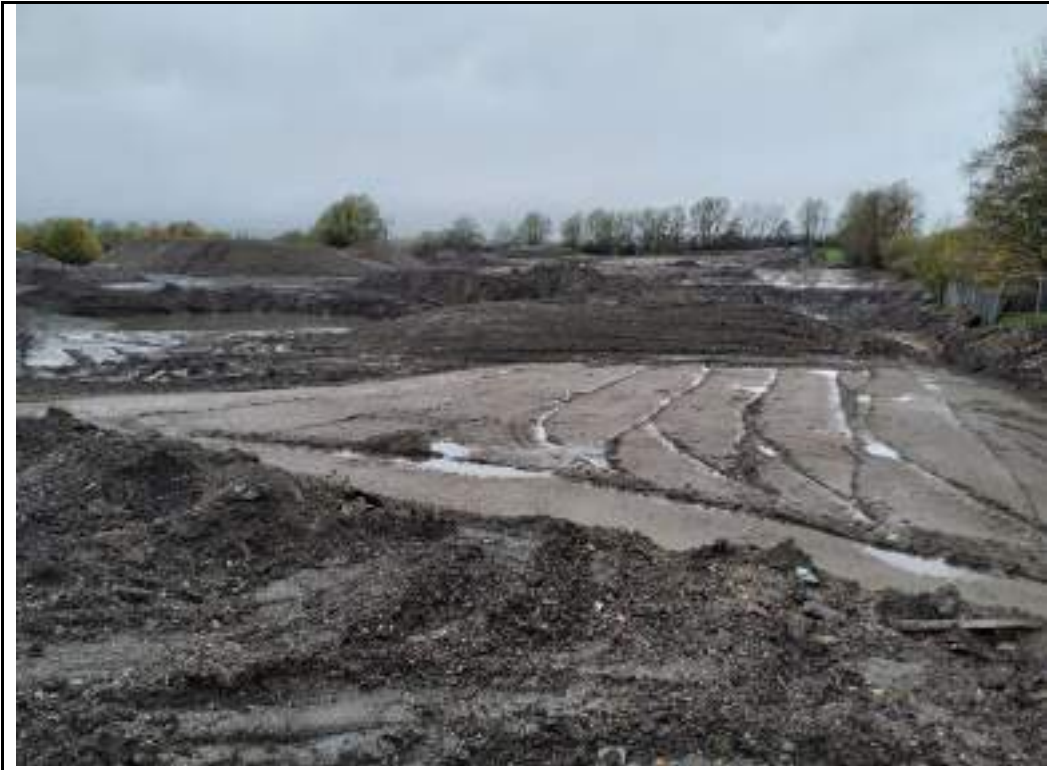
Photograph 1: Overview of eastern part of the site. Looking towards the north.

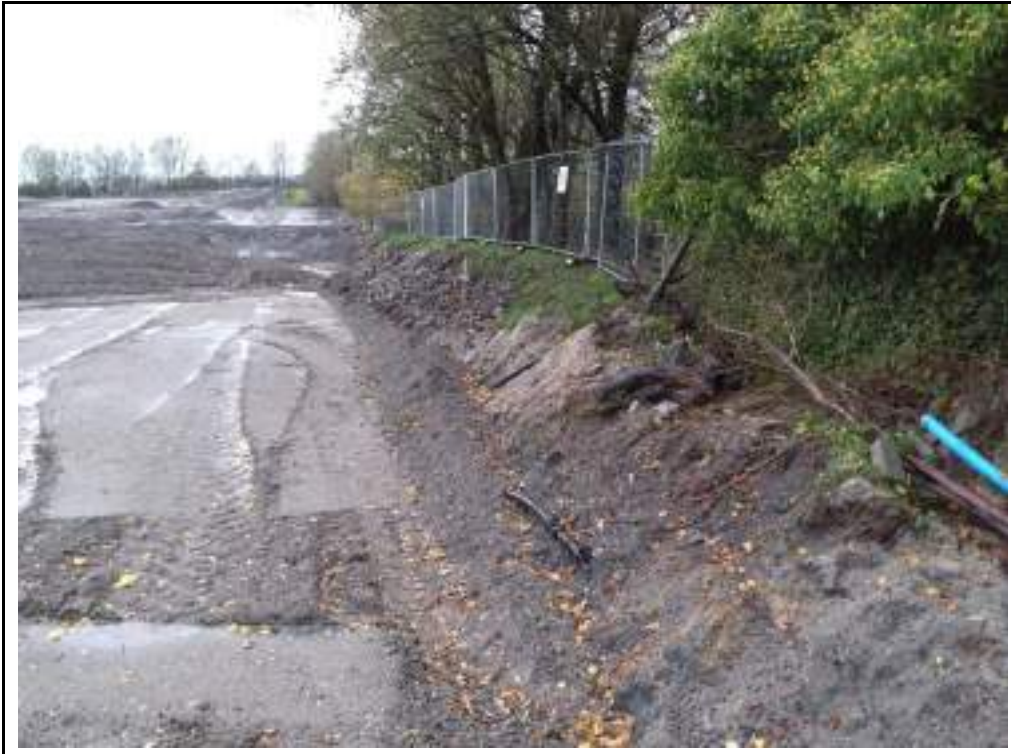
Photograph 3: Eastern boundary of the site. Looking towards the north

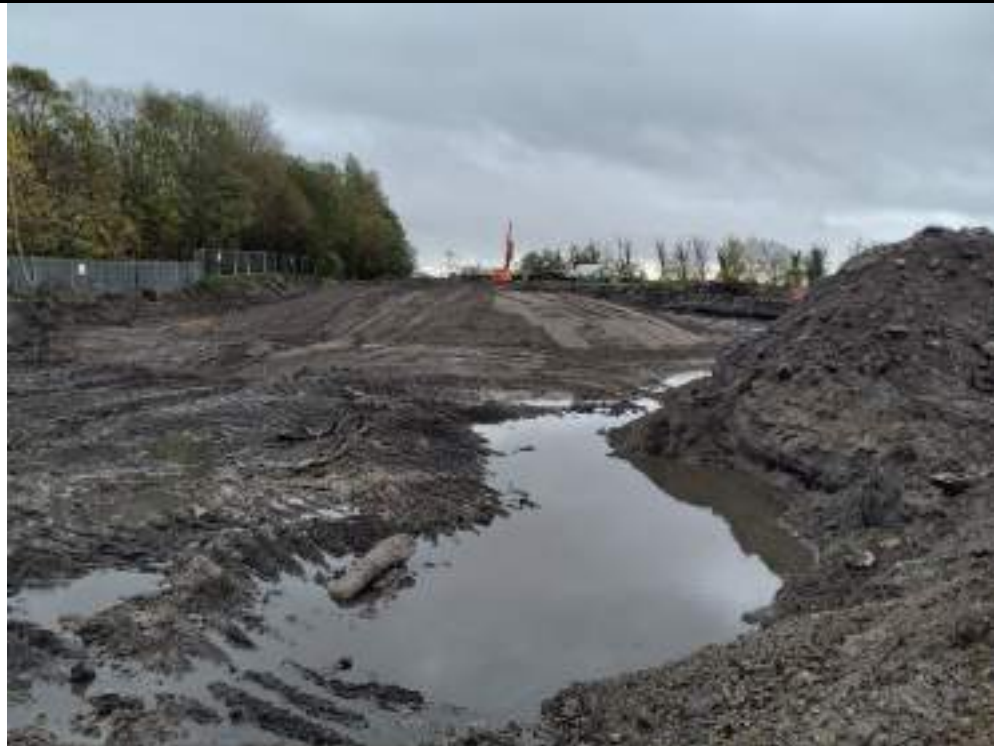
Photograph 5: Stockpile of processed material in eastern part of the site.

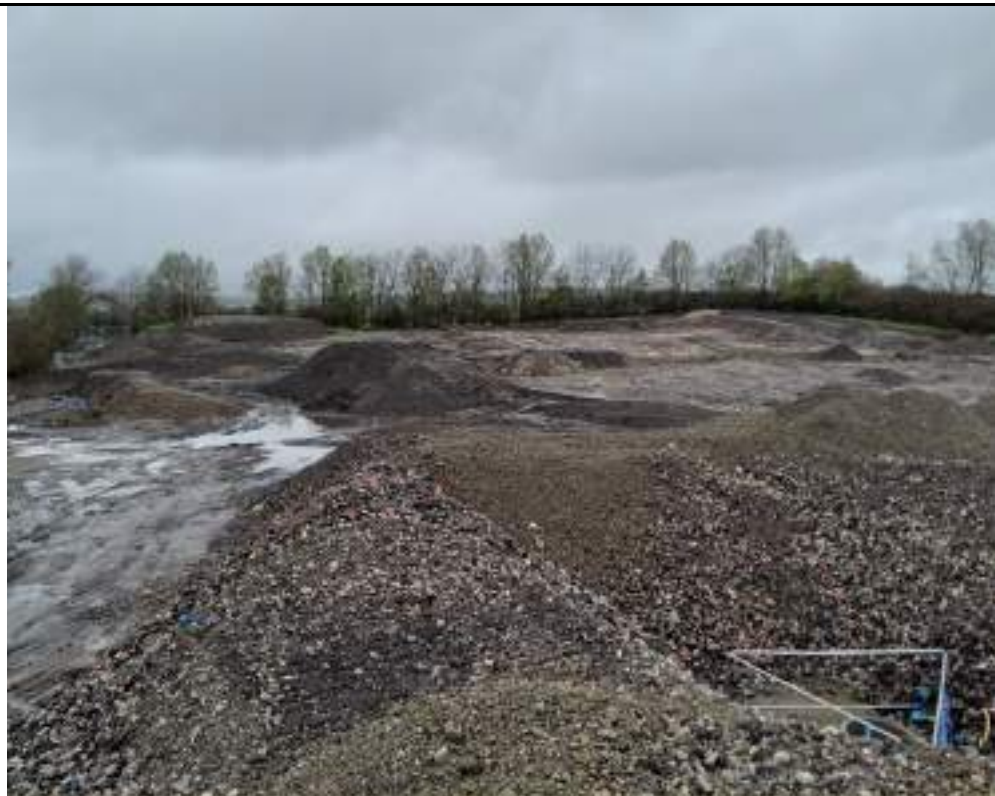
Photograph 8: Overview of northern stockpiles.
