| SITE VISIT REPORT 15220-HYD-XX-XX-SVR-GE-1035 | | SHEET NO.: 1 of 20 | |
| Project: Stopes Road, Bolton | | Date: 09/11/22 | |
| Client: Harworth | | Weather: Cloudy | |
| Doc Ref: 15220-HYD-XX-XX-SVR-GE-1035 | | Status & Revision: S2 – P1 | |

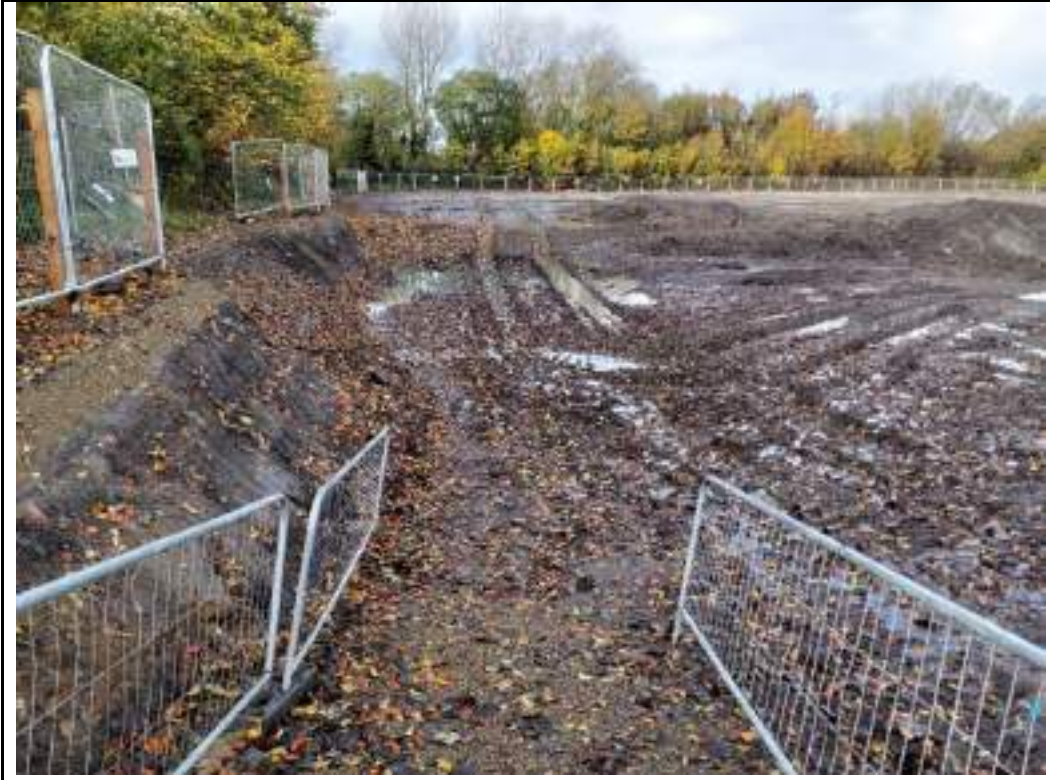
Photograph 93: Southern boundary of the site. Looking towards the west.

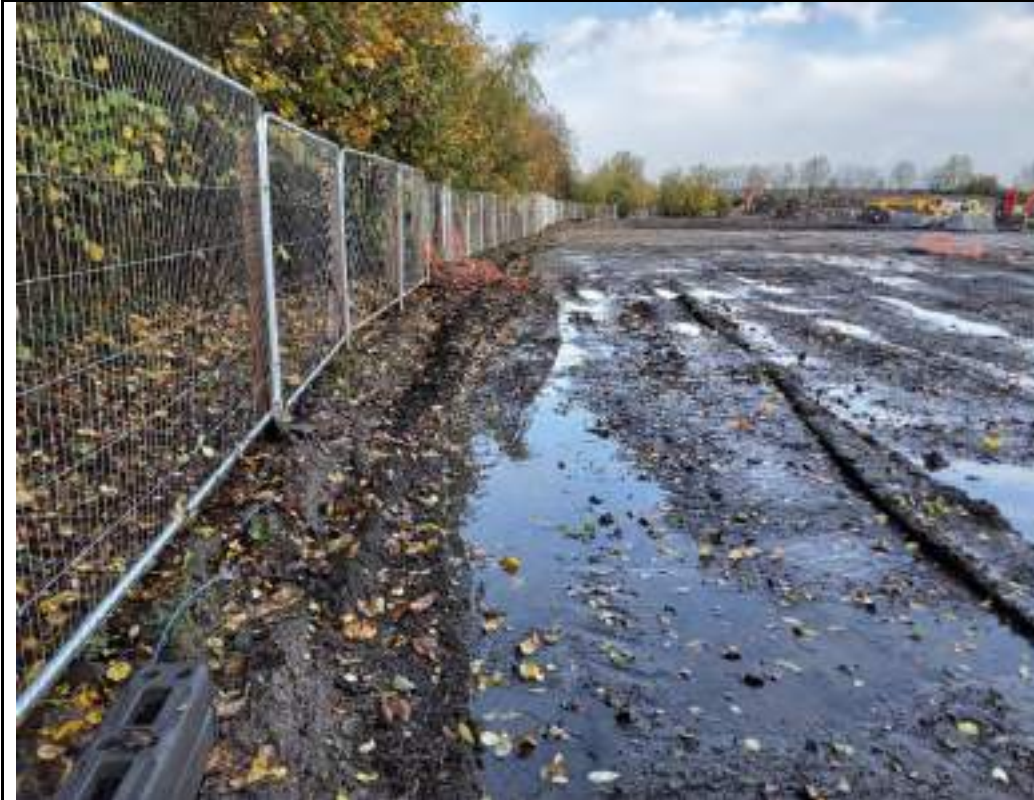
Photograph 17: Western boundary of the site. Looking towards the north.

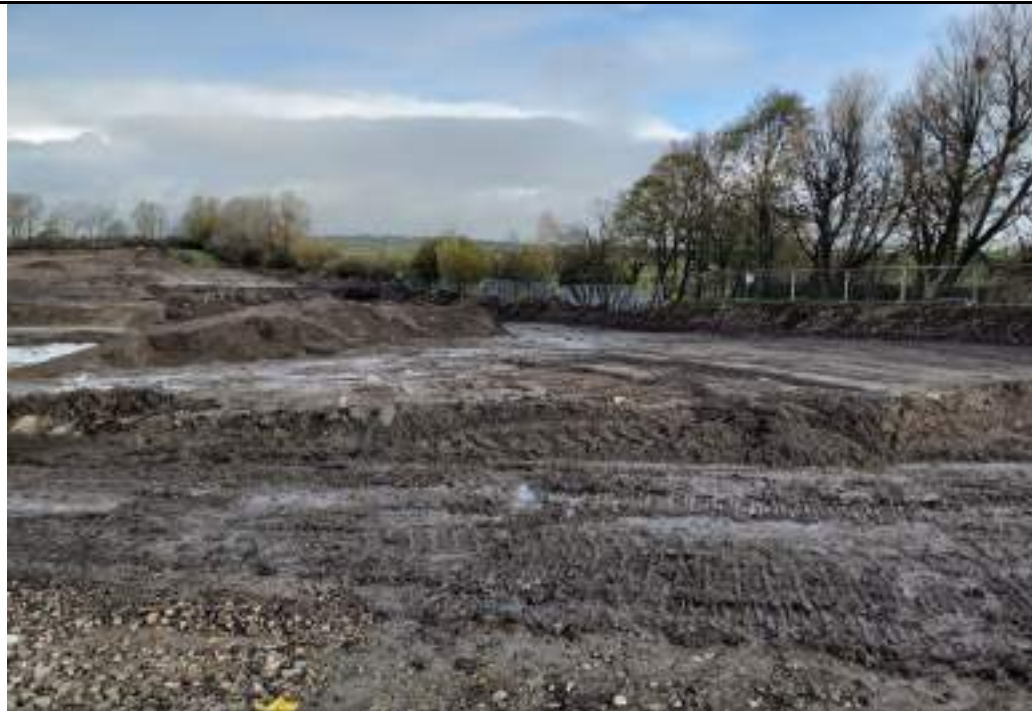
Photograph 1: Overview of eastern part of the site. Looking towards the north.

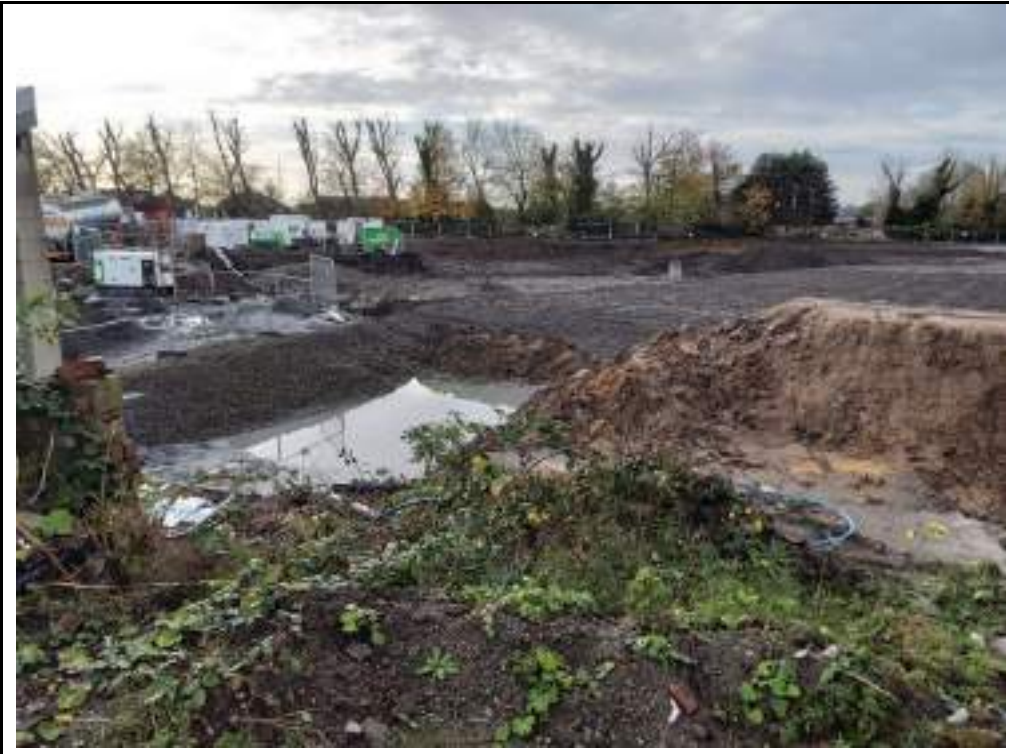
Photograph 3: Standing water in the southeastern part site.

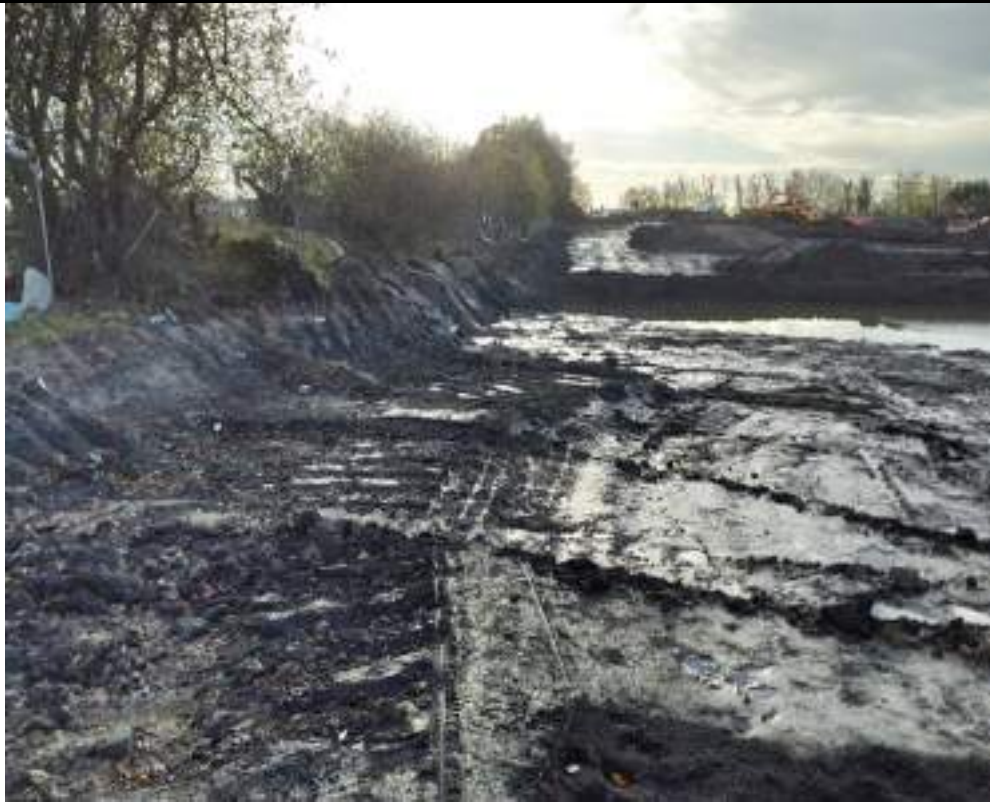
Photograph 7: Northeastern boundary of site. Looking towards the south.

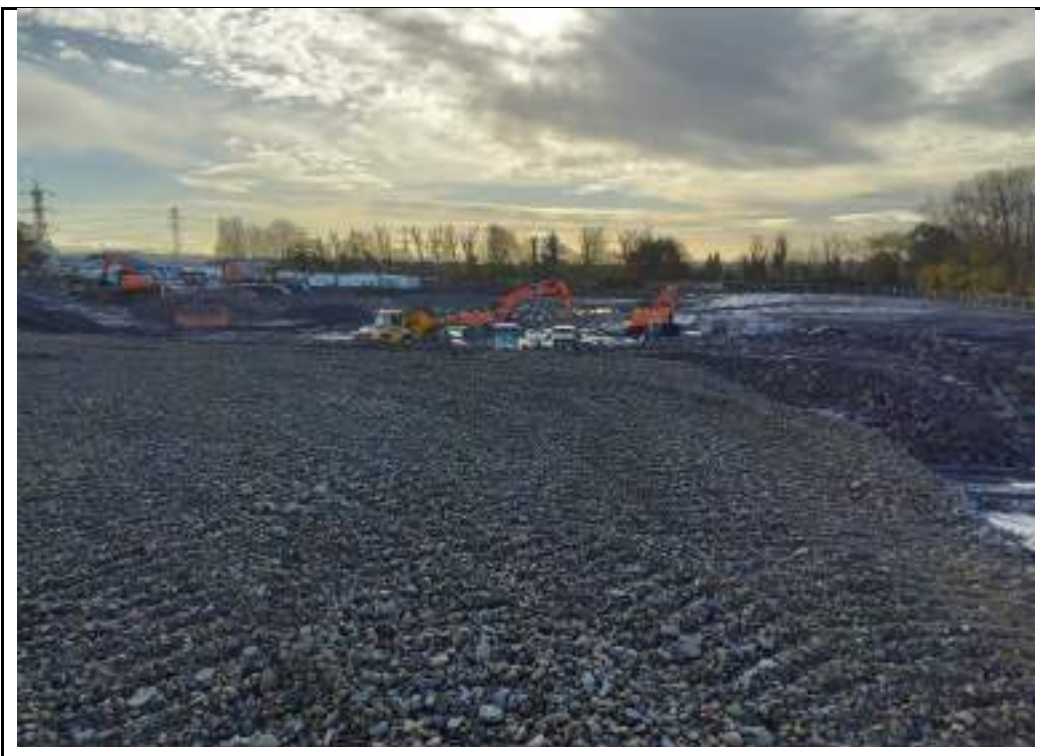
Photograph 12: Overview of the southern part of site.

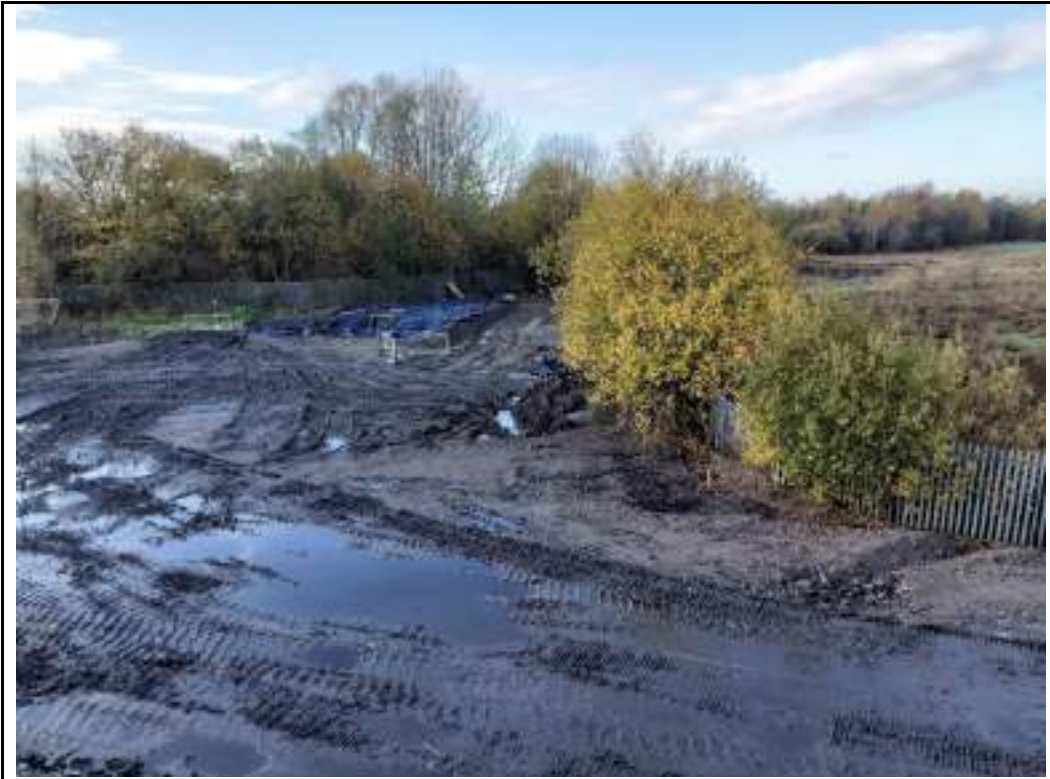
Photograph 93: Stockpile of TPH contaminated materials in the western boundary.

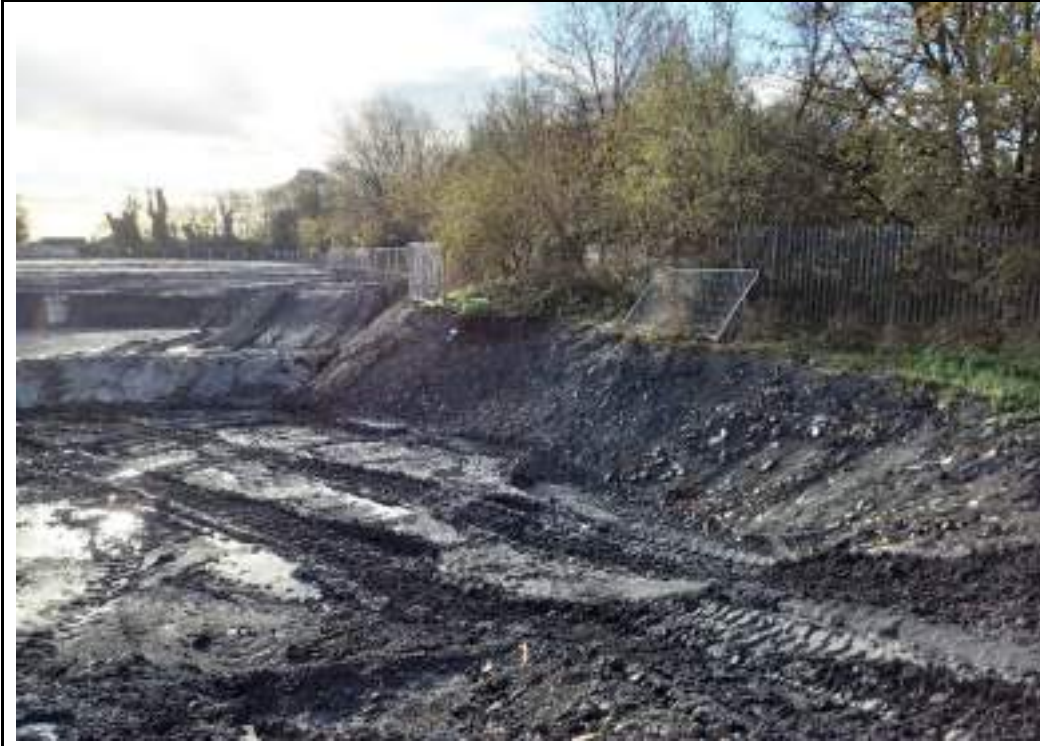
Photograph 15: Western boundary of the site. Looking towards the south.

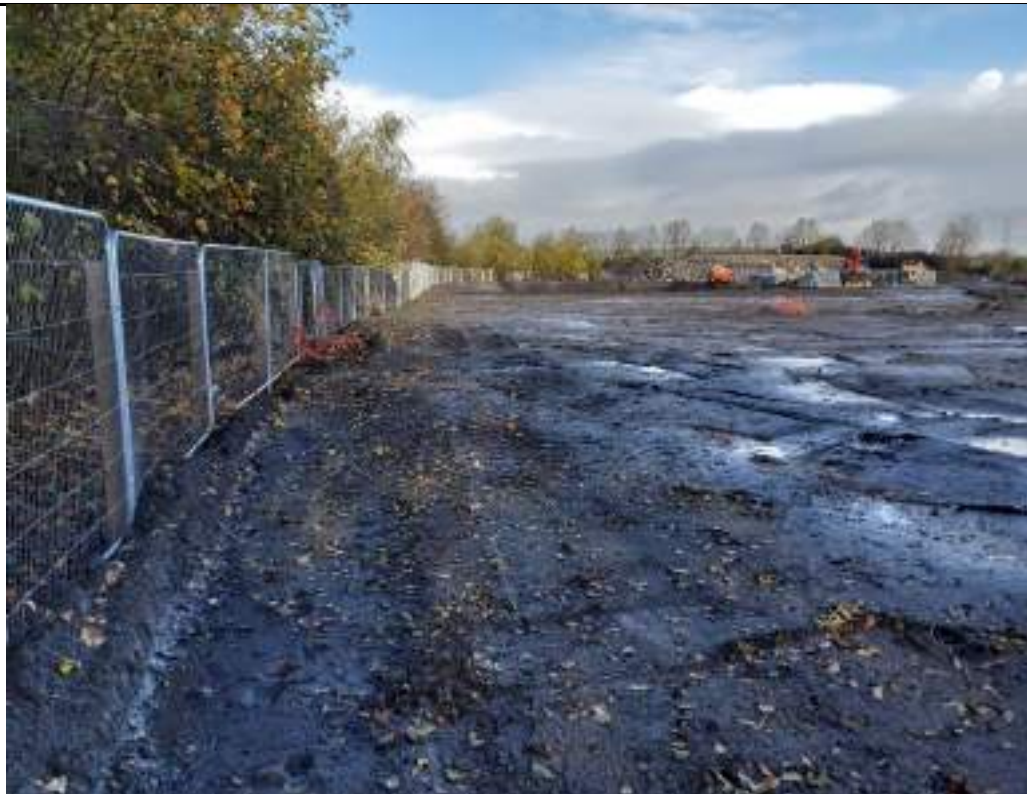
Photograph 16: Western boundary of the site. Looking towards the north.

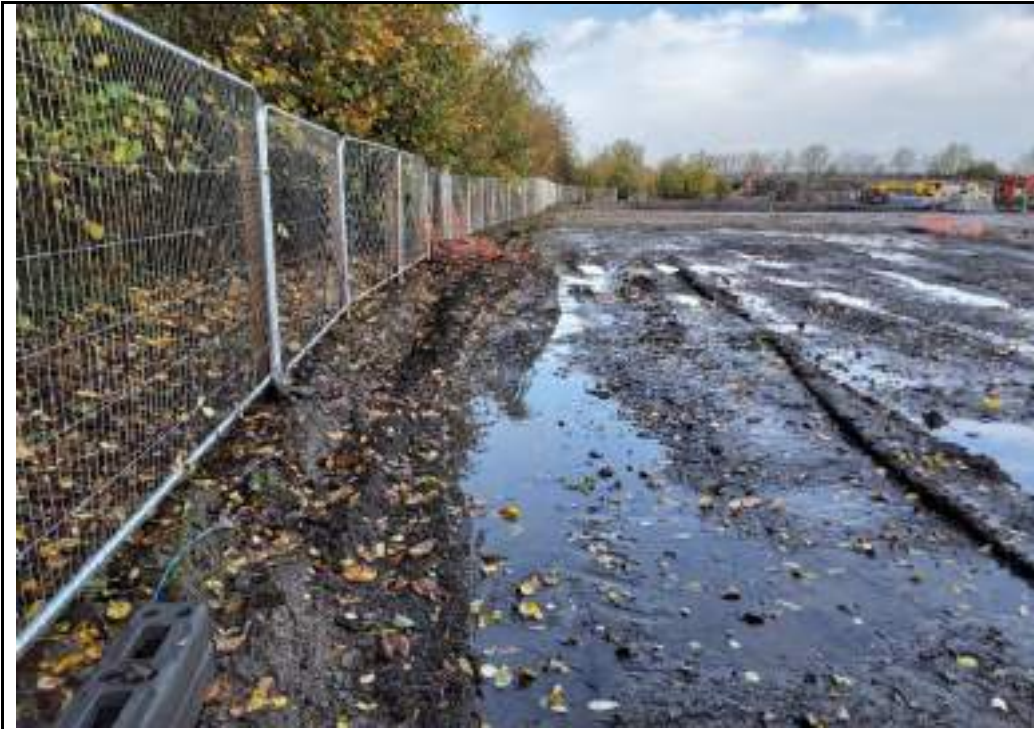
Photograph 17: Western boundary of the site. Looking towards the north.

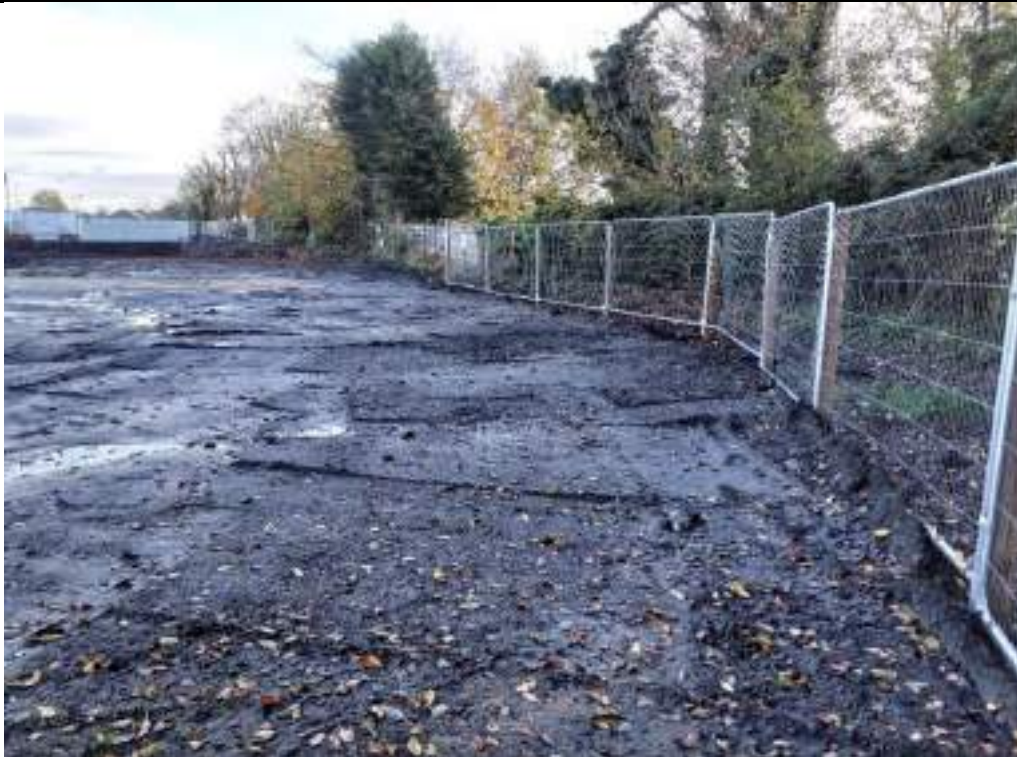
Photograph 18: Southern boundary of site. Looking towards the east.

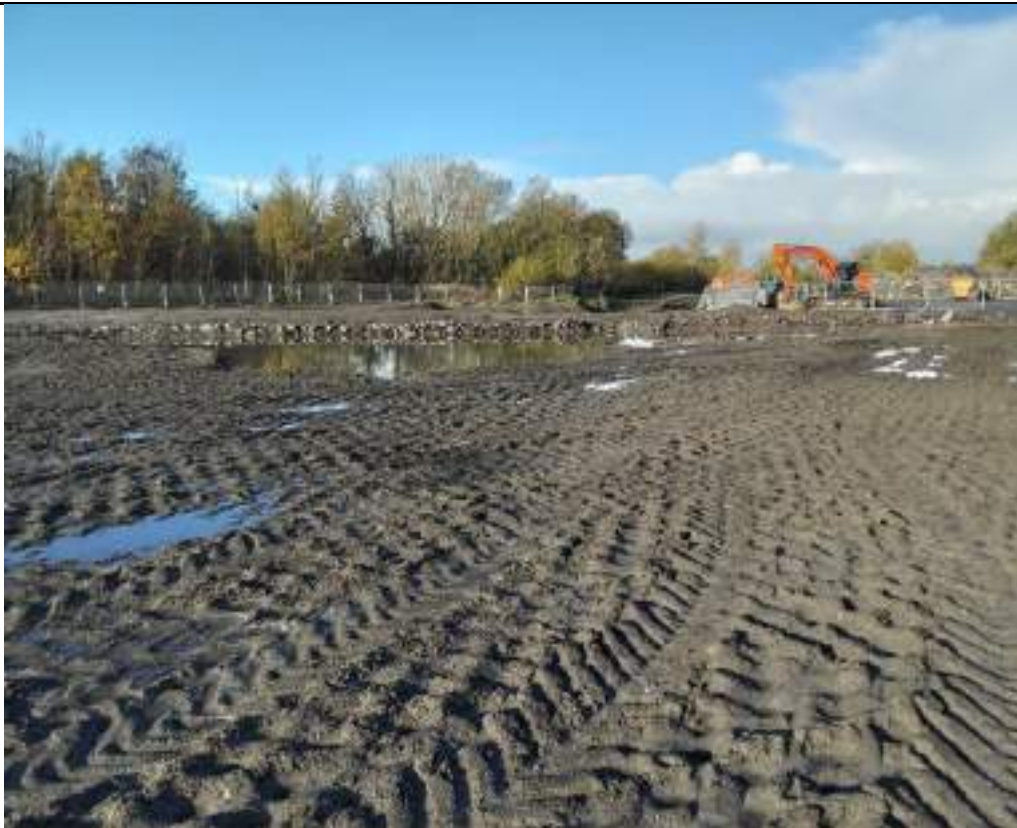
Photograph 20: Standing water in the west.

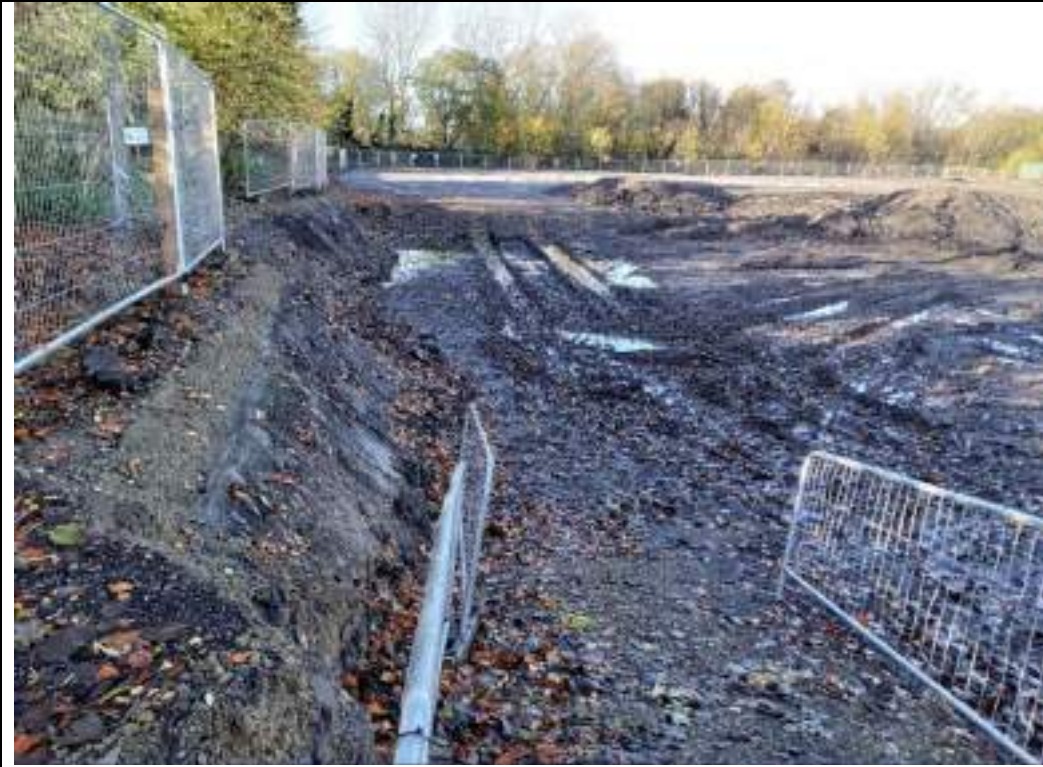
Photograph 23: Southern boundary of site. Looking towards the west.

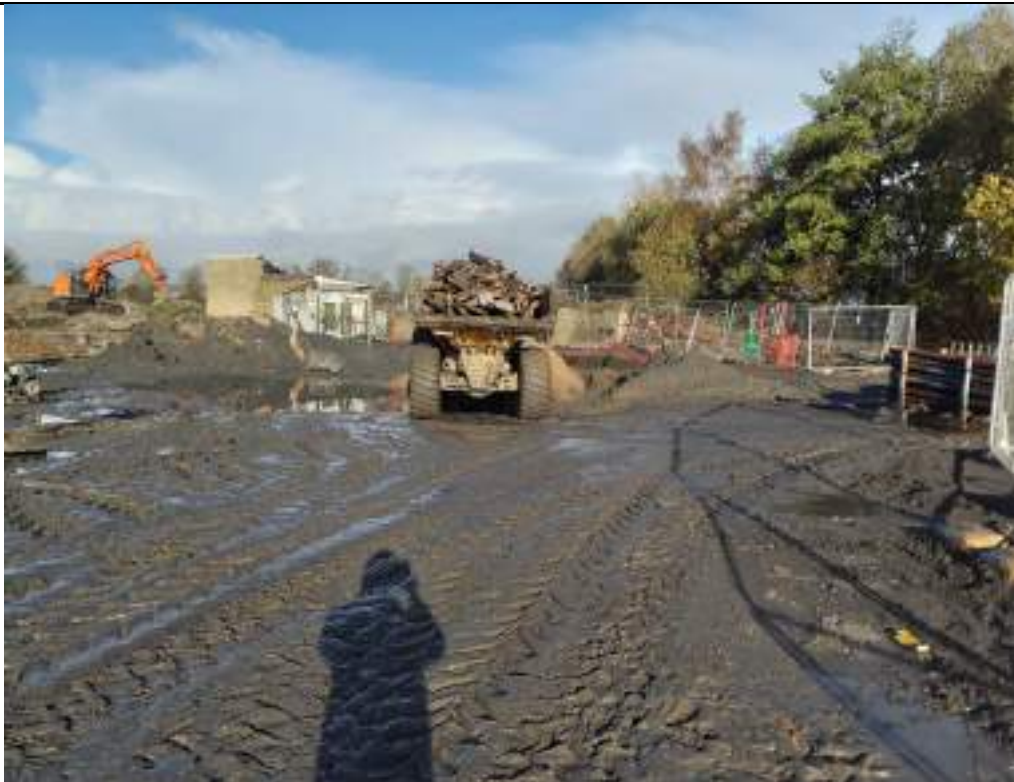
Photograph 26: Deleterious material on truck's bed.

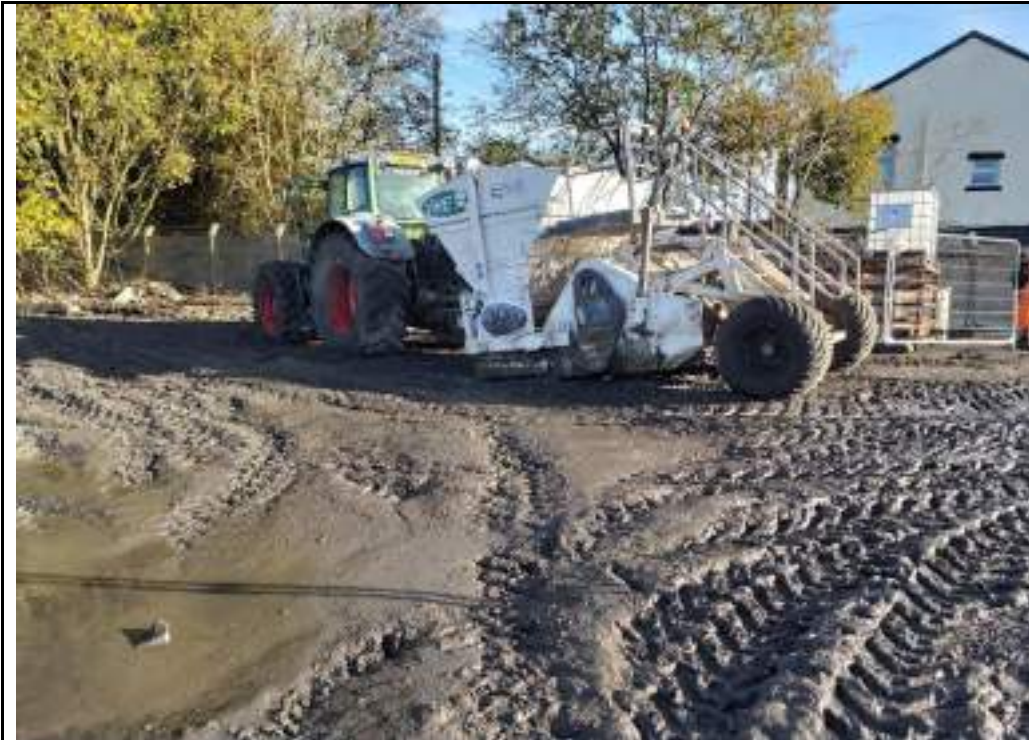
Photograph 27: Rotavator tractor with flat tyre in the southeast.

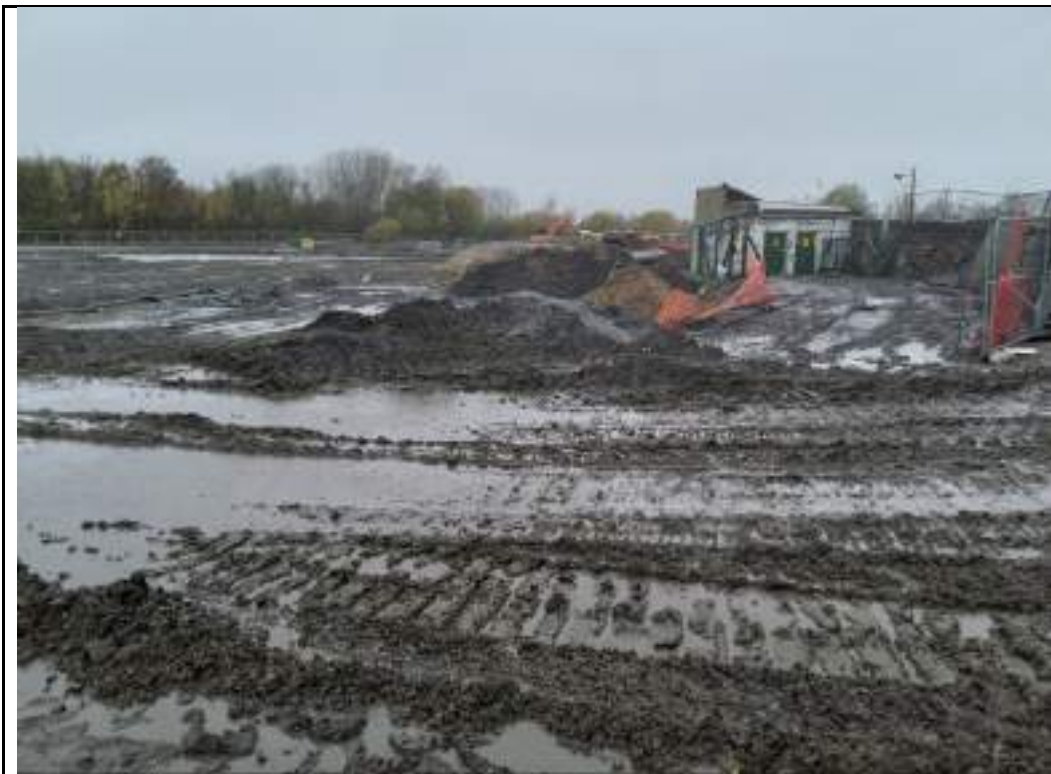
Photograph 2: Grouting platform after completion of grouting shaft no.6 in eastern part of the site.

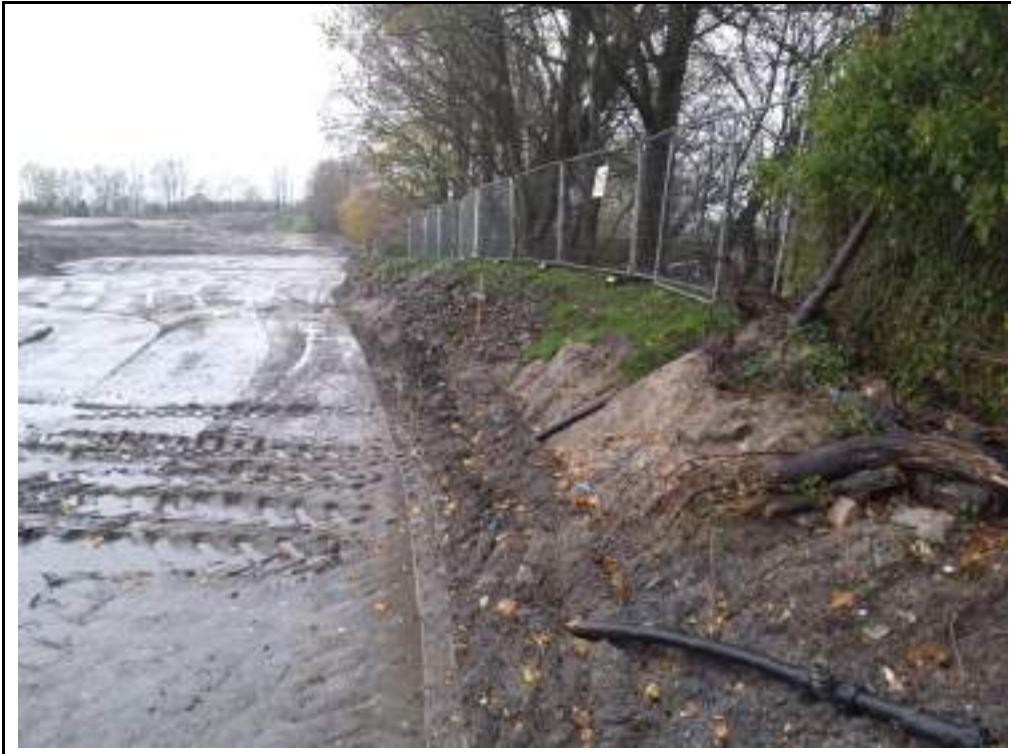
Photograph 3: Eastern boundary of the site. Looking towards the north.

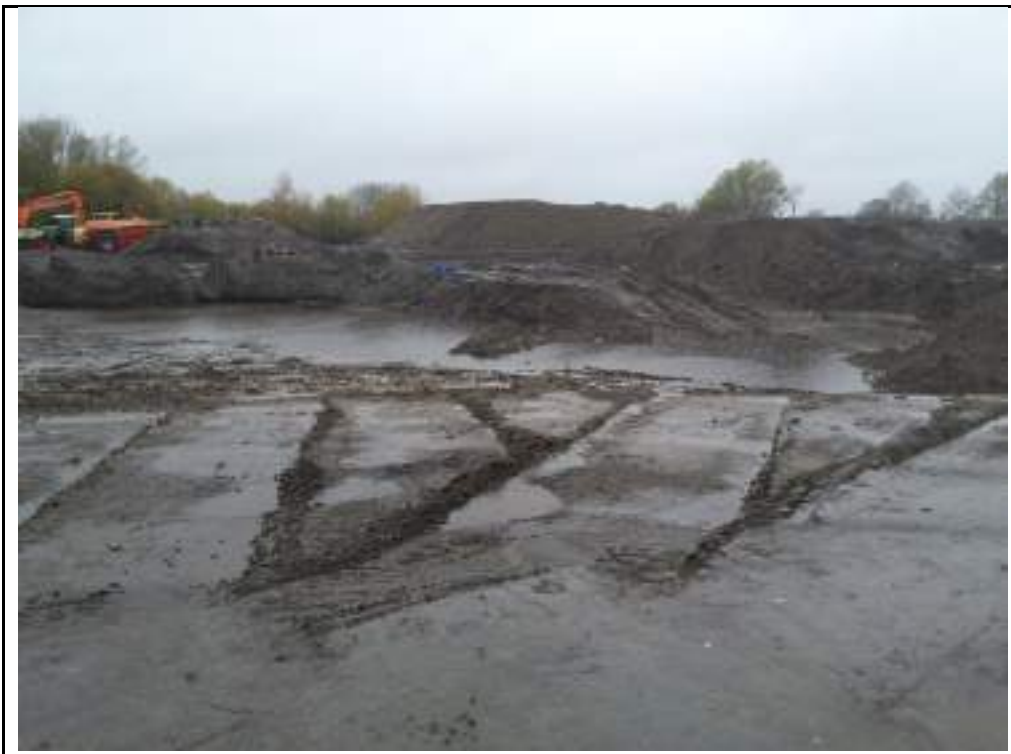
Photograph 4: Standing water in the east.

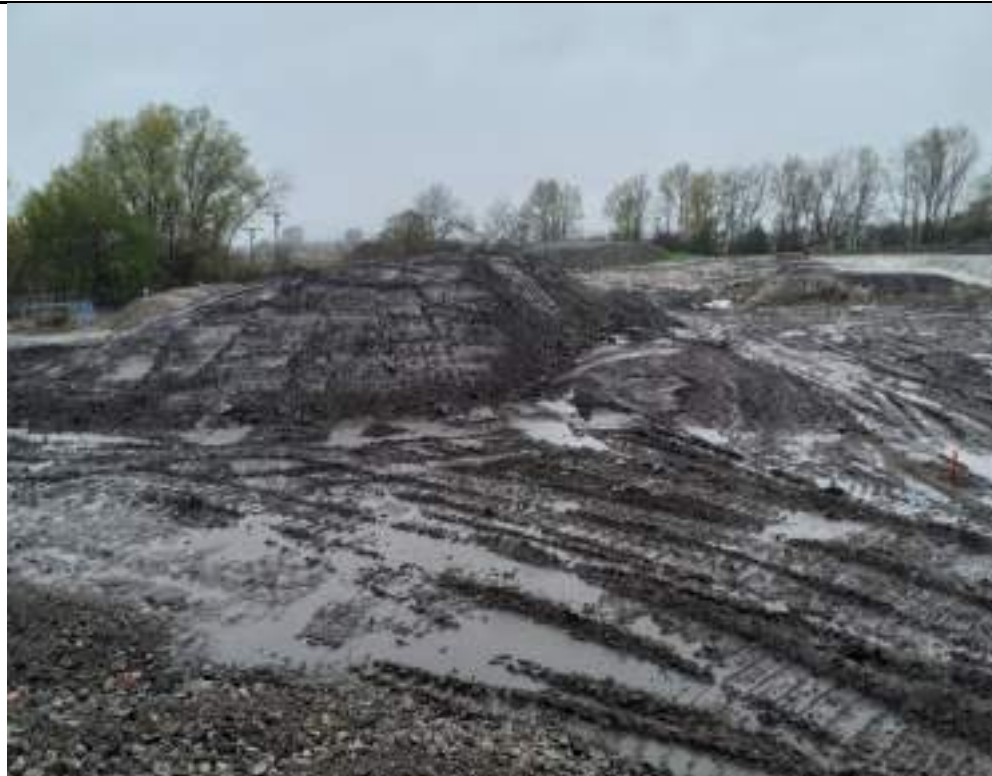
Photograph 8: Stockpile of peat in the northwest.

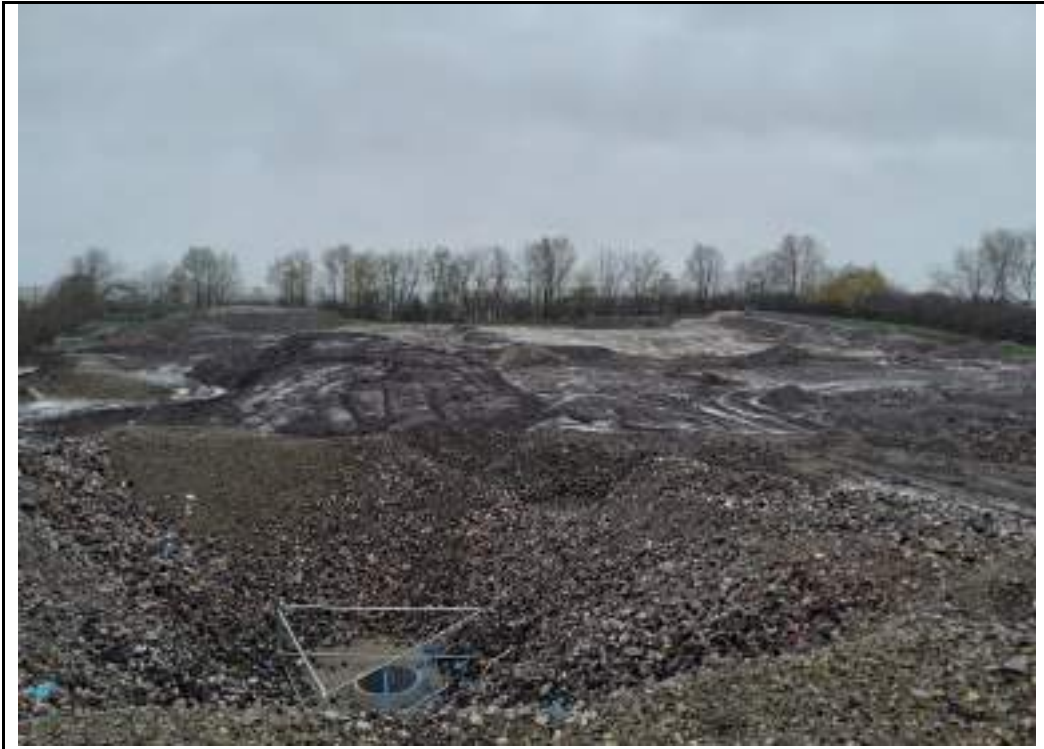
Photograph 9: Overview of stockpiles in the north.

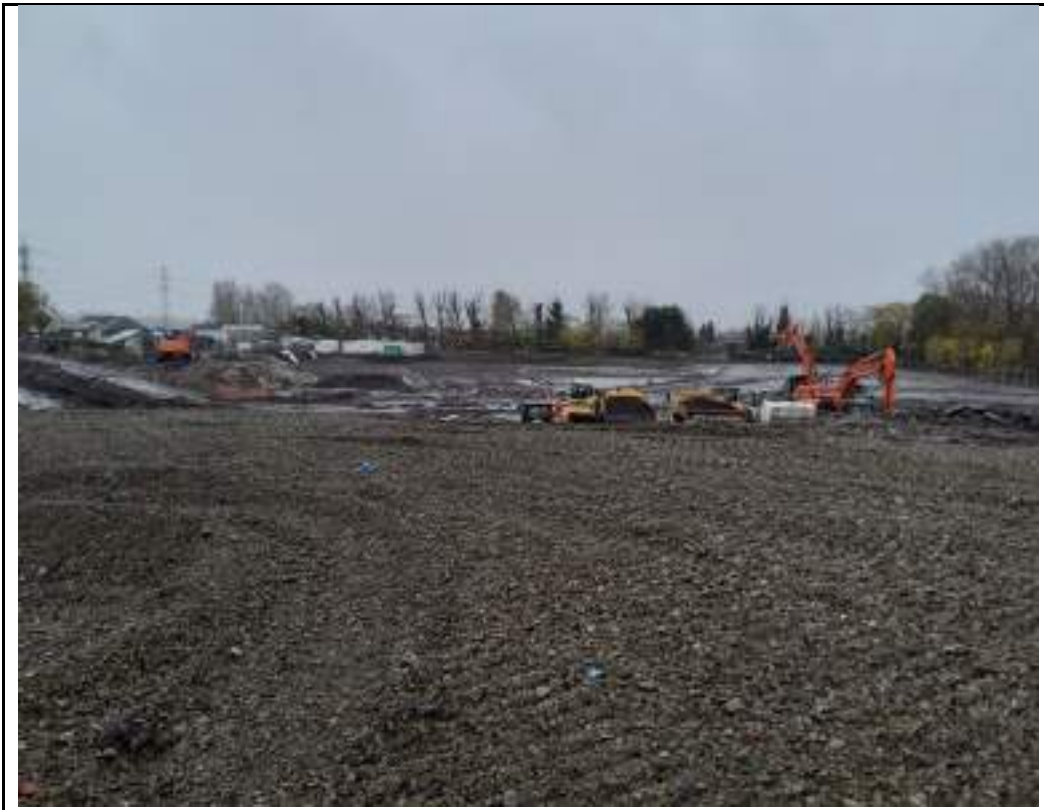
Photograph 10: Overview of the southern part of the site.

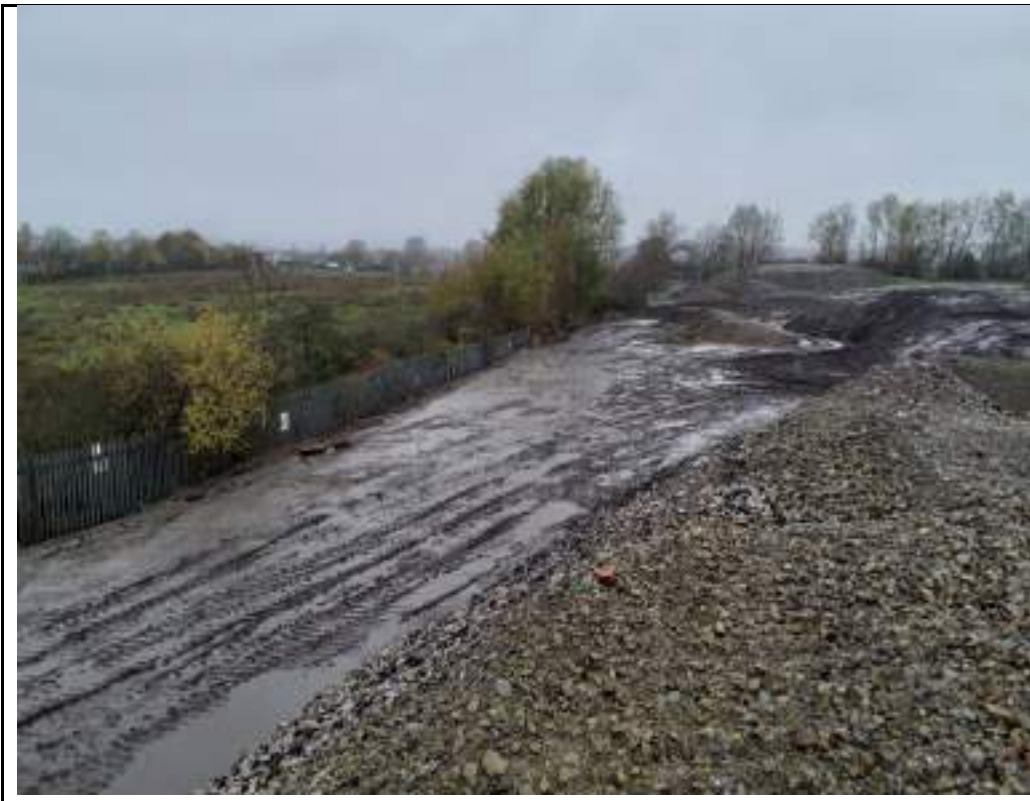
Photograph 12: Northwestern boundary of the site.

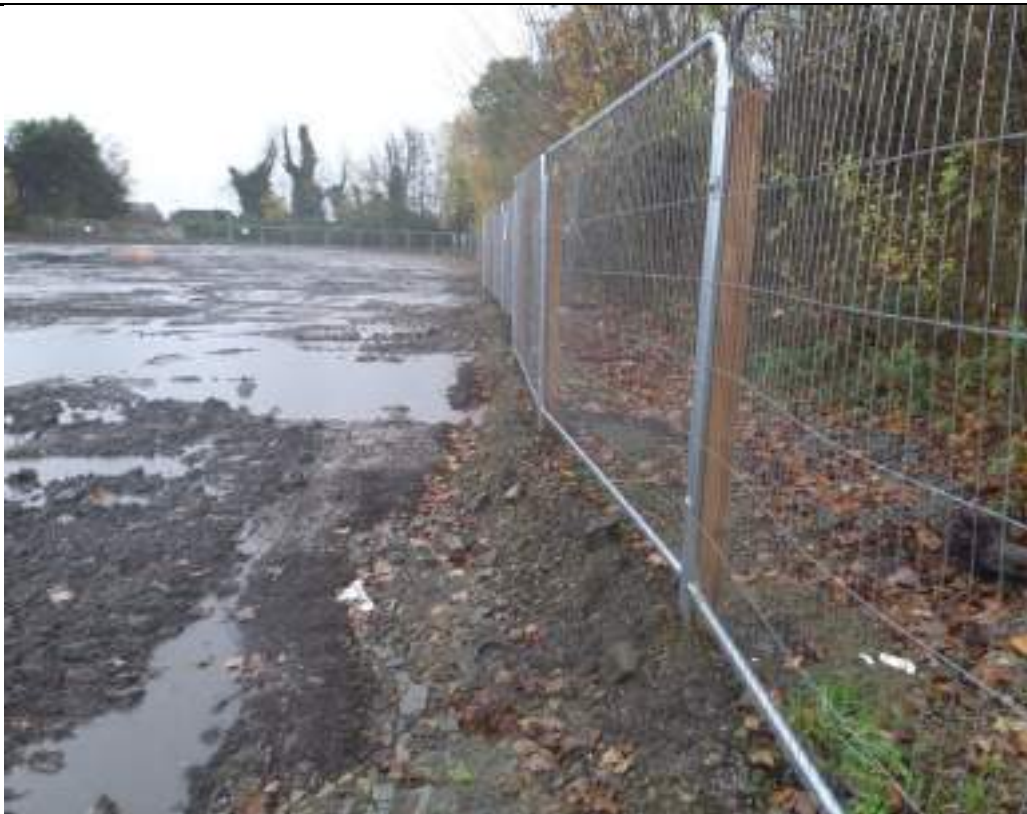
Photograph 16: Western boundary of the site. Looking towards the north.

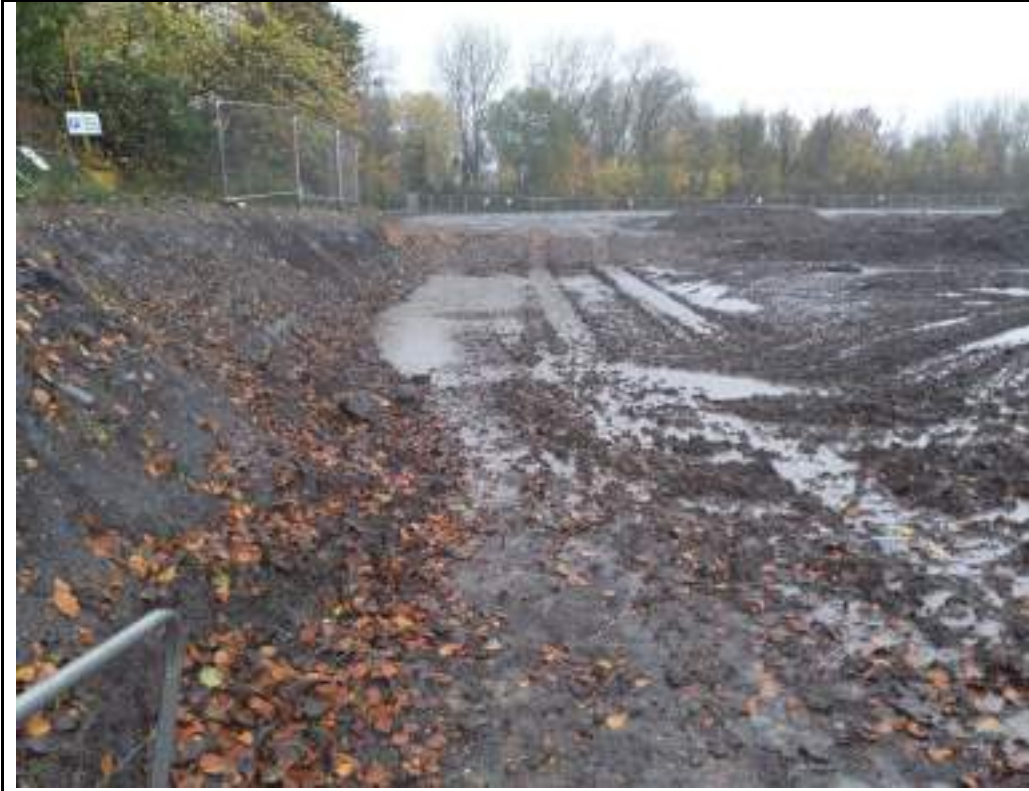
Photograph 17: Southern boundary of the site. Looking towards the west.

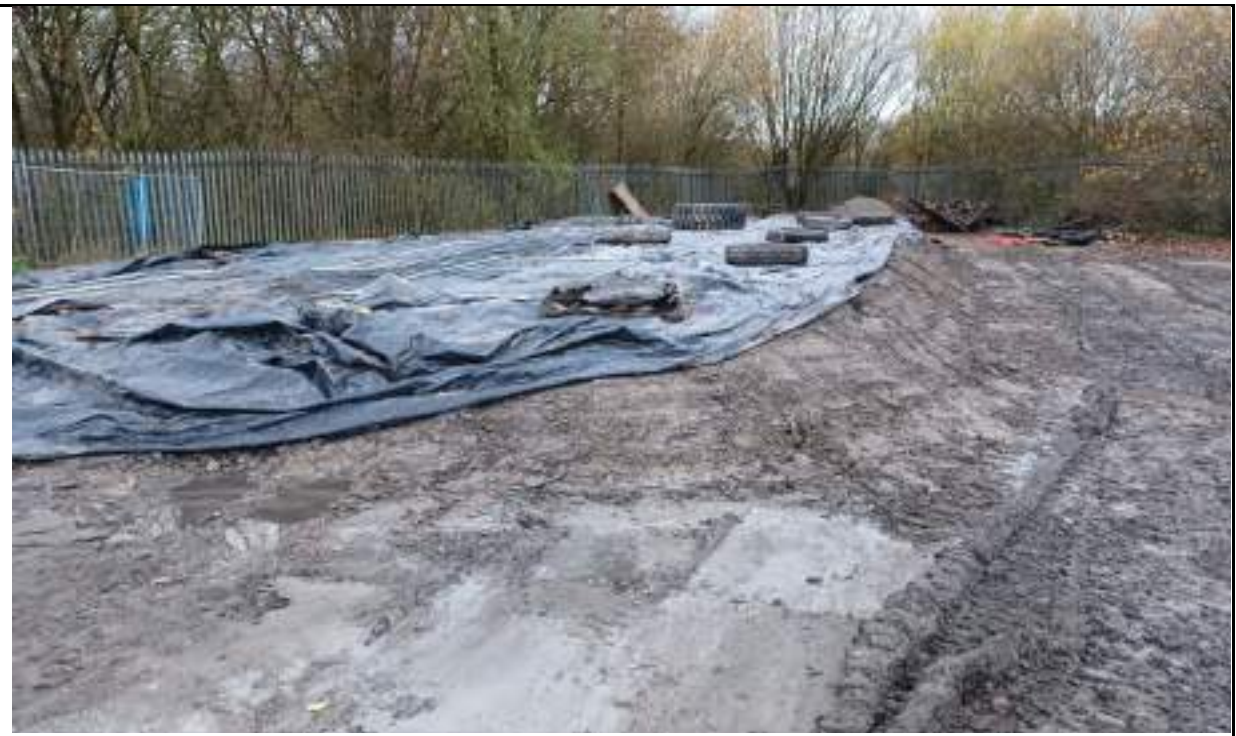
Photograph 10: Arisings from Hotspot 7 – testing on-going

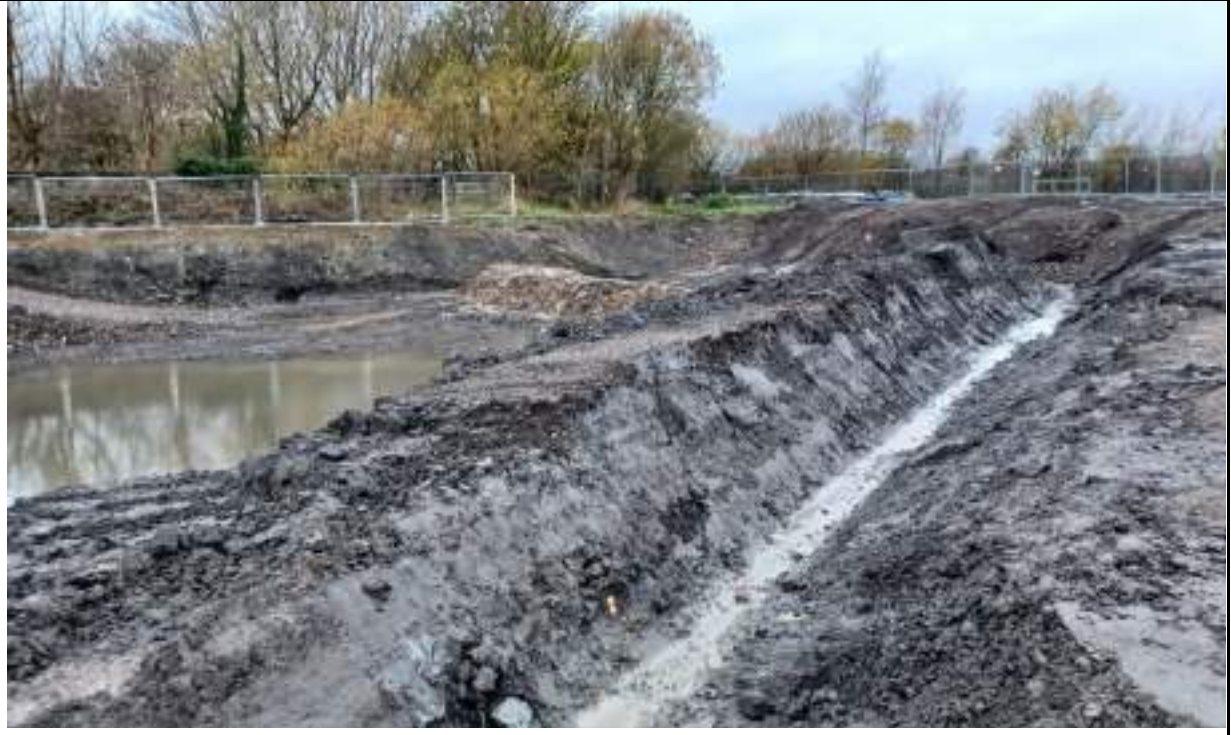
Photograph 11: Temporary drainage ditches to control surface water

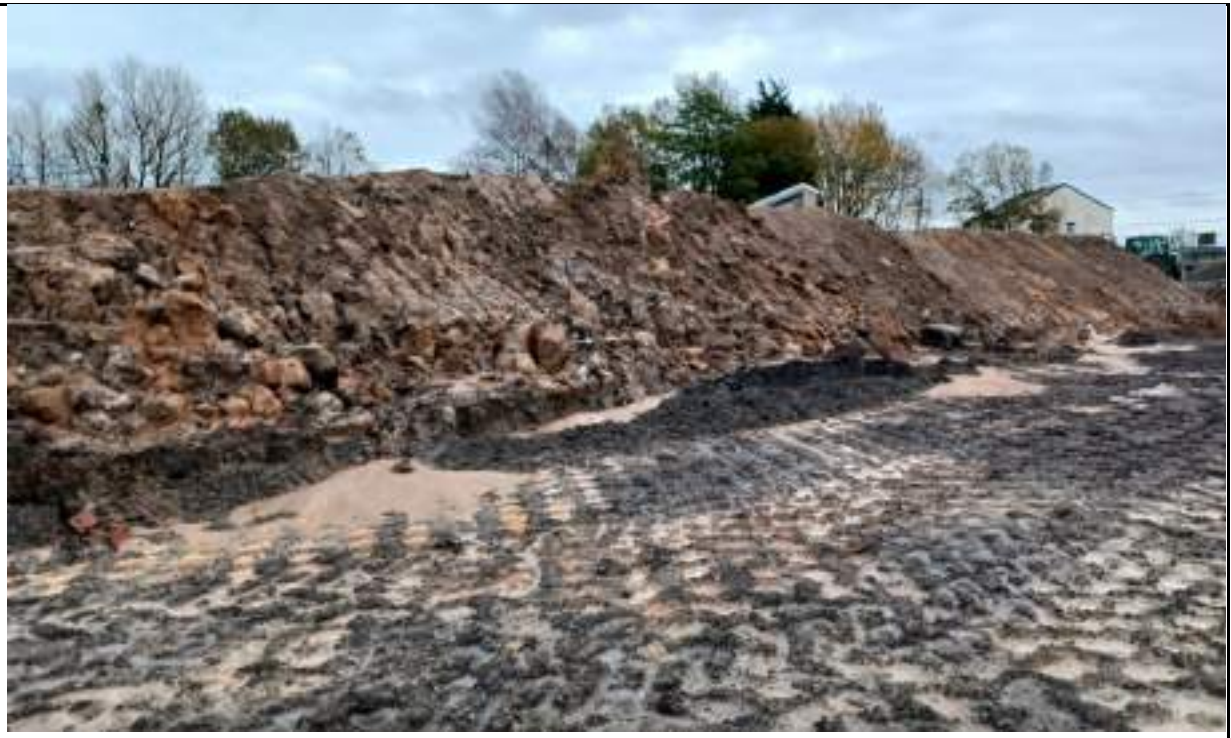
Photograph 12: Orange brown glacial clay – source testing outstanding

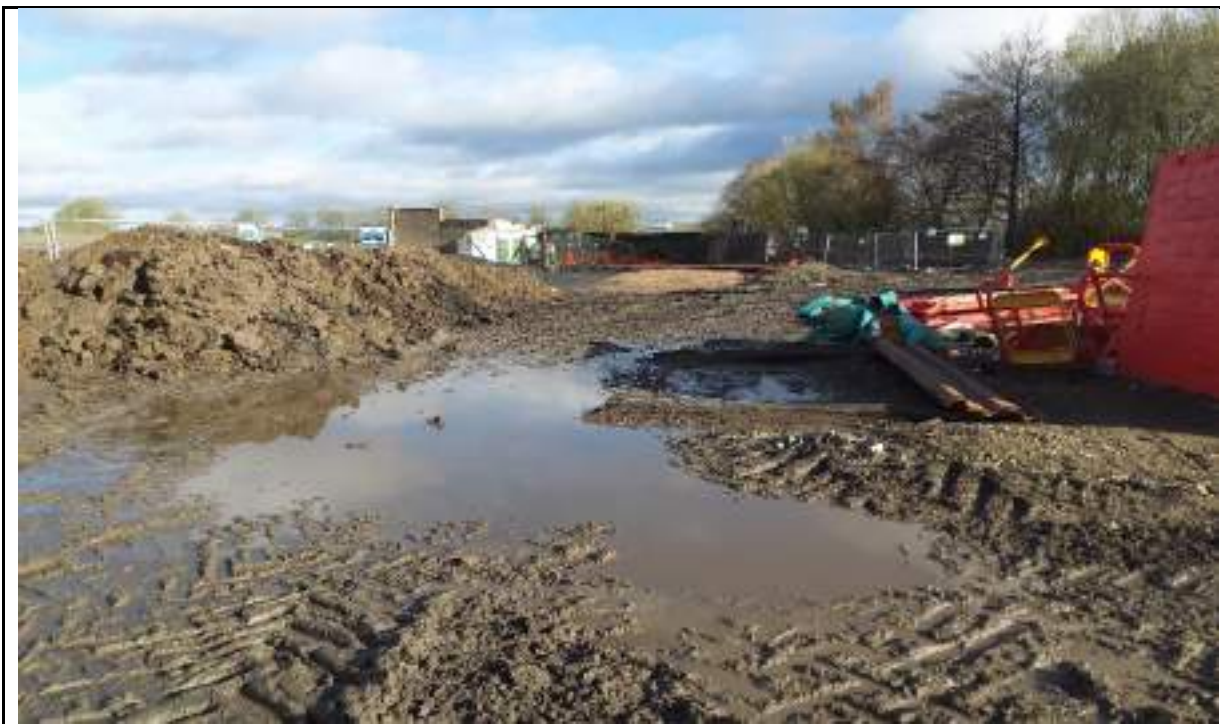
Photograph 2: Location of treated shaft no. 006 in the west.

| Hydrock Comment | Contractor Proposal/Solution | Action Status |
|---|---|---|
| Mine shaft 006 validation report | Van Elle to provide report | Van Elle completion report was sent 14/12/2022. Report to be updated based on Hydrock comments. |
