| SITE VISIT REPORT 15220-HYD-XX-XX-SVR-GE-1035 | | SHEET NO.: 1 of 20 | |
| Project: Stopes Road, Bolton | | Date: 09/11/22 | |
| Client: Harworth | | Weather: Cloudy | |
| Doc Ref: 15220-HYD-XX-XX-SVR-GE-1035 | | Status & Revision: S2 – P1 | |

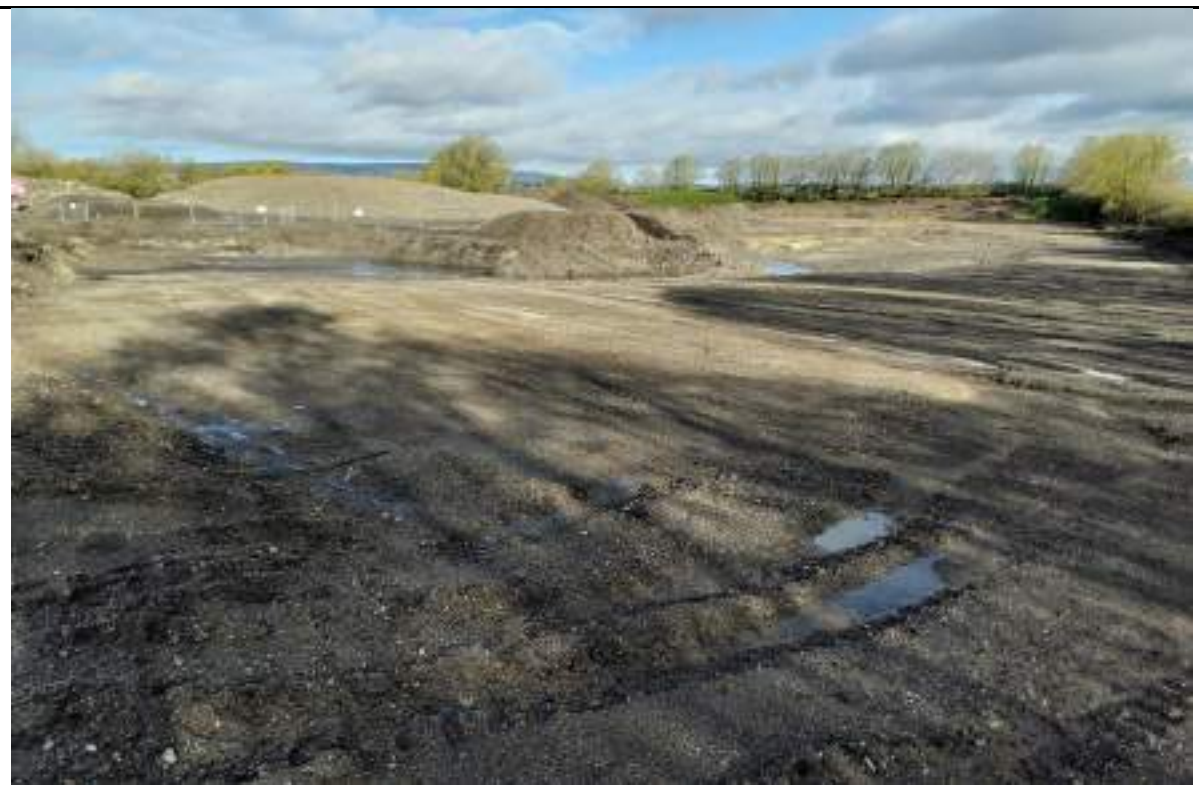
Photograph 4: Standing water in the east.

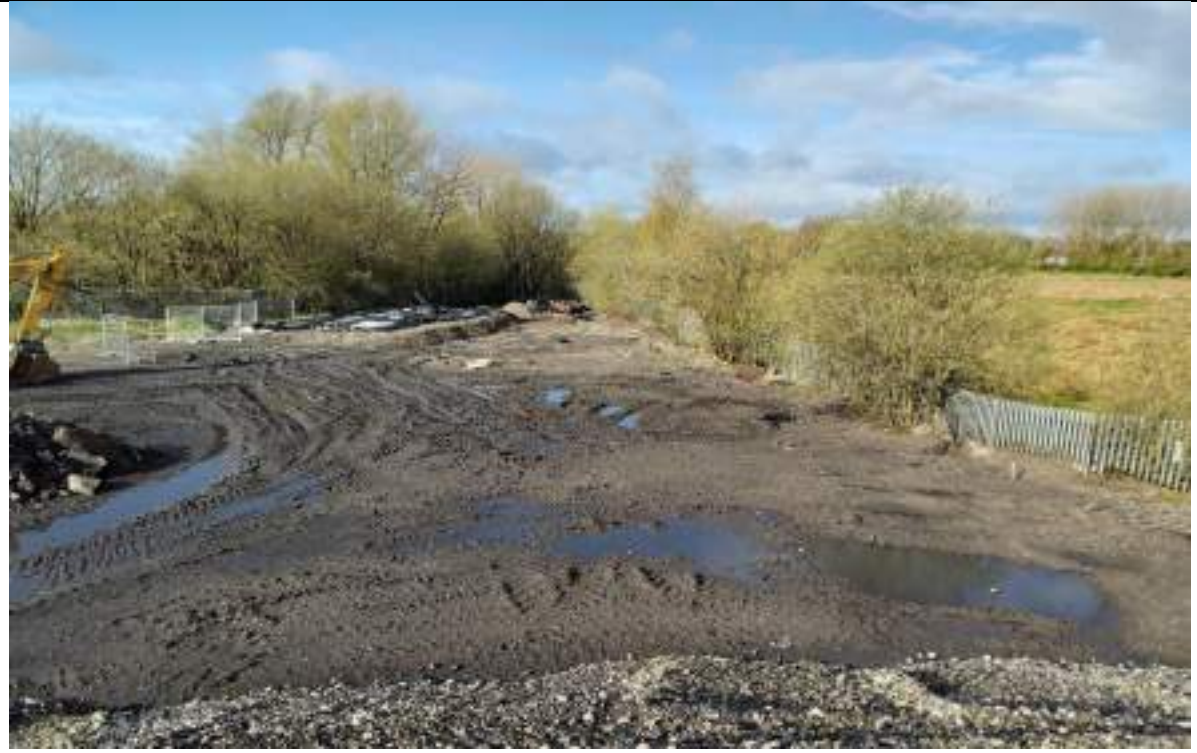
Photograph 7: Stockpile of TPH contaminated material arising from Hotspot 7.

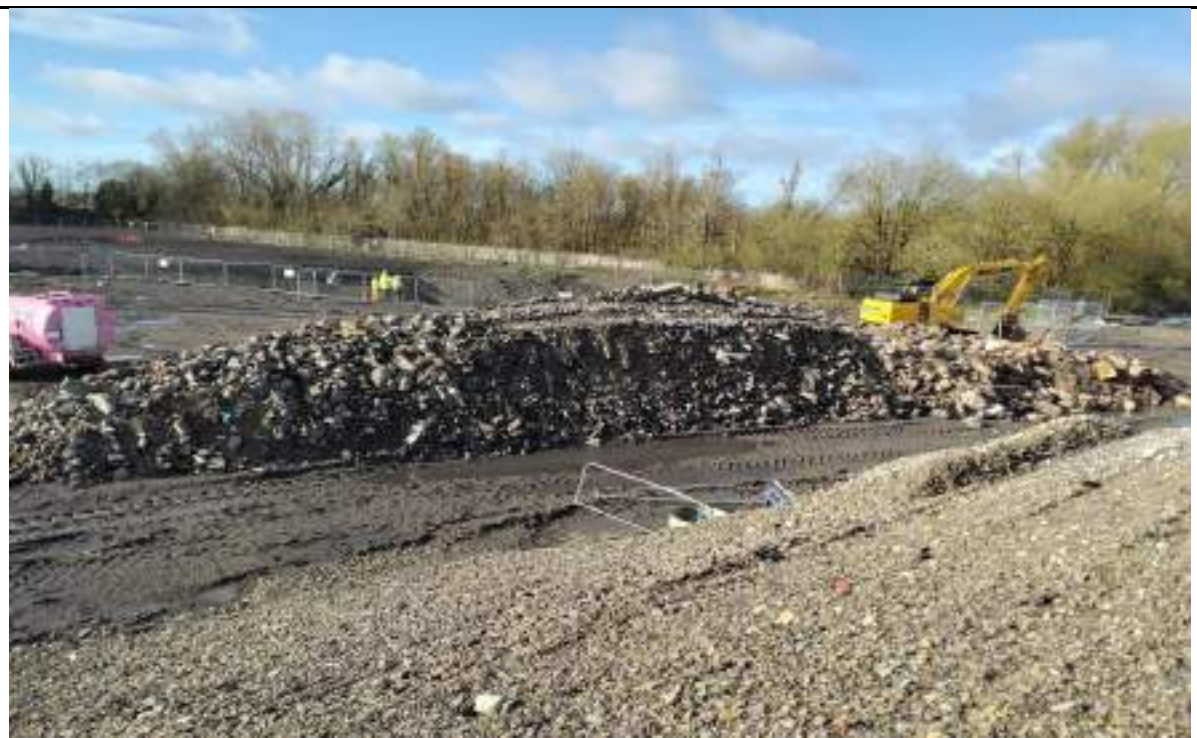
Photograph 8: Stockpile of oversize material in the west. Material to be crushed and processed.

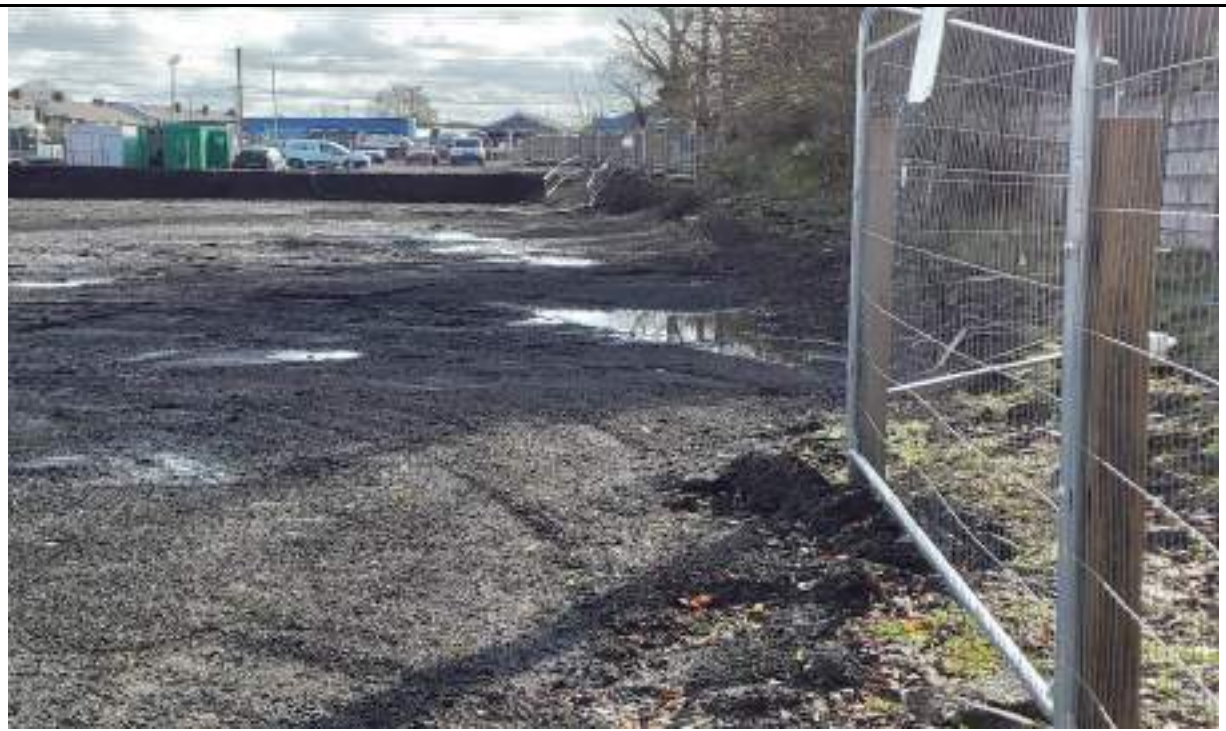
Photograph 10: Southern boundary of the site. Looking towards the east.

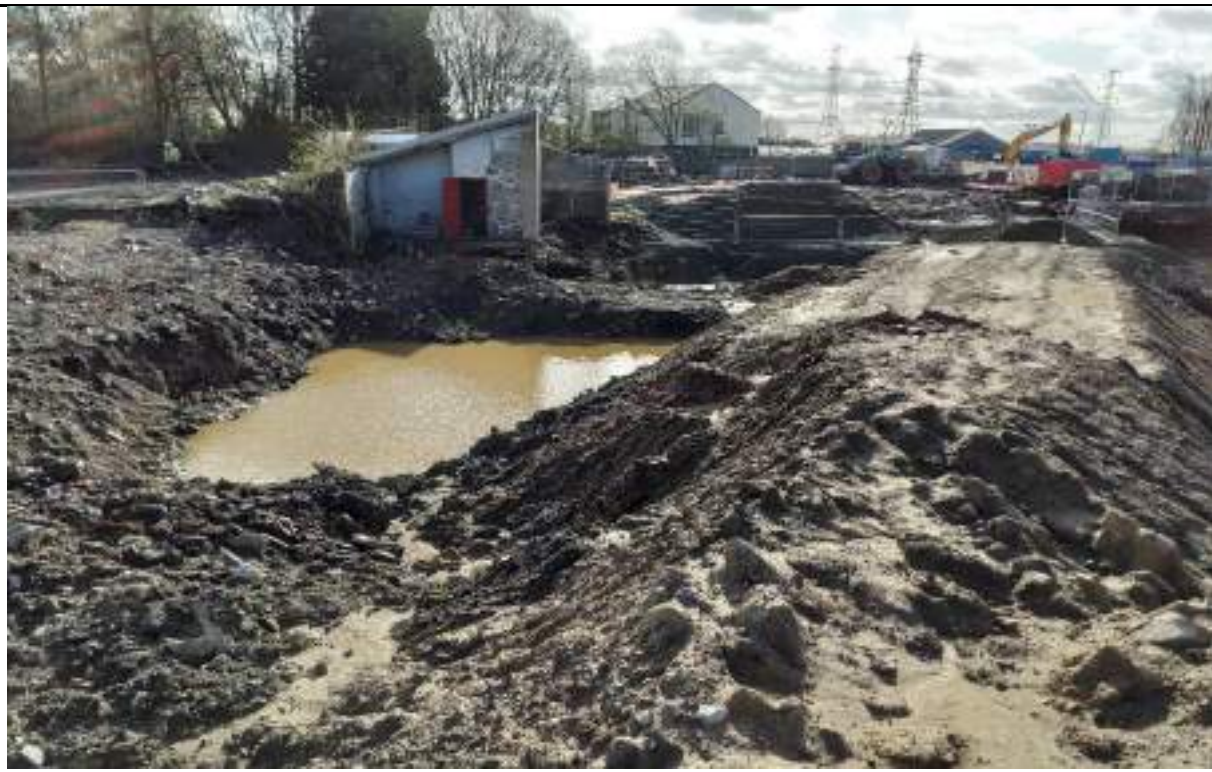
Photograph 14: Standing water behind stockpile of brown glacial clay in the east.

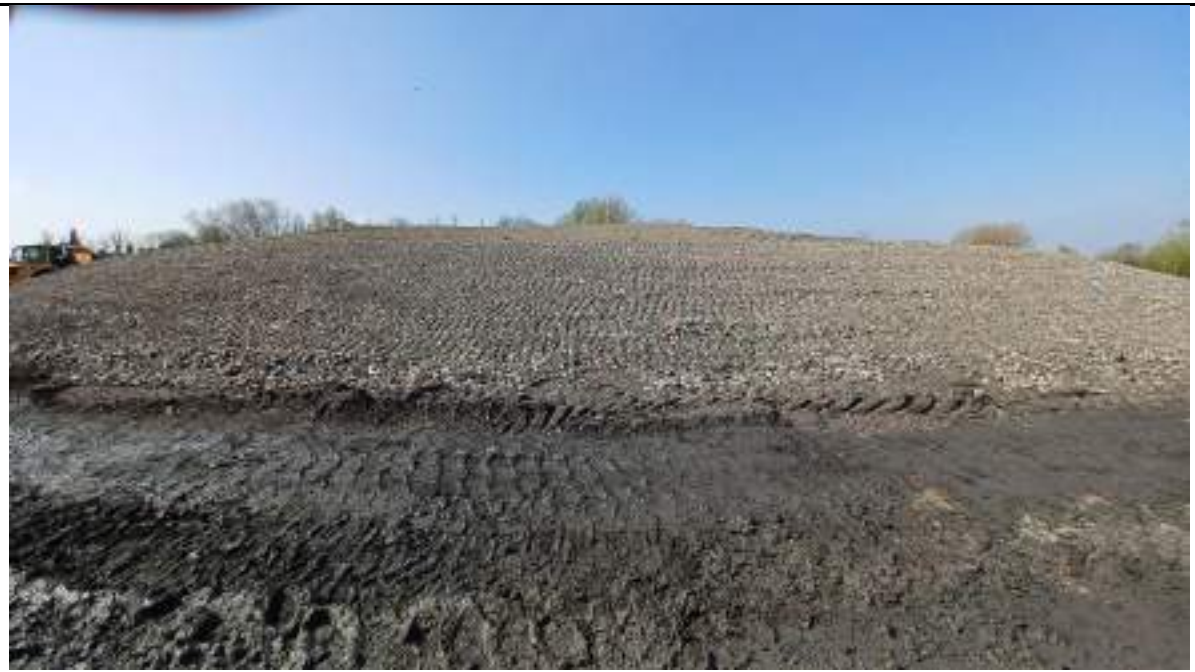
Photograph 4: Stockpile of 6F2 in centre north of the site

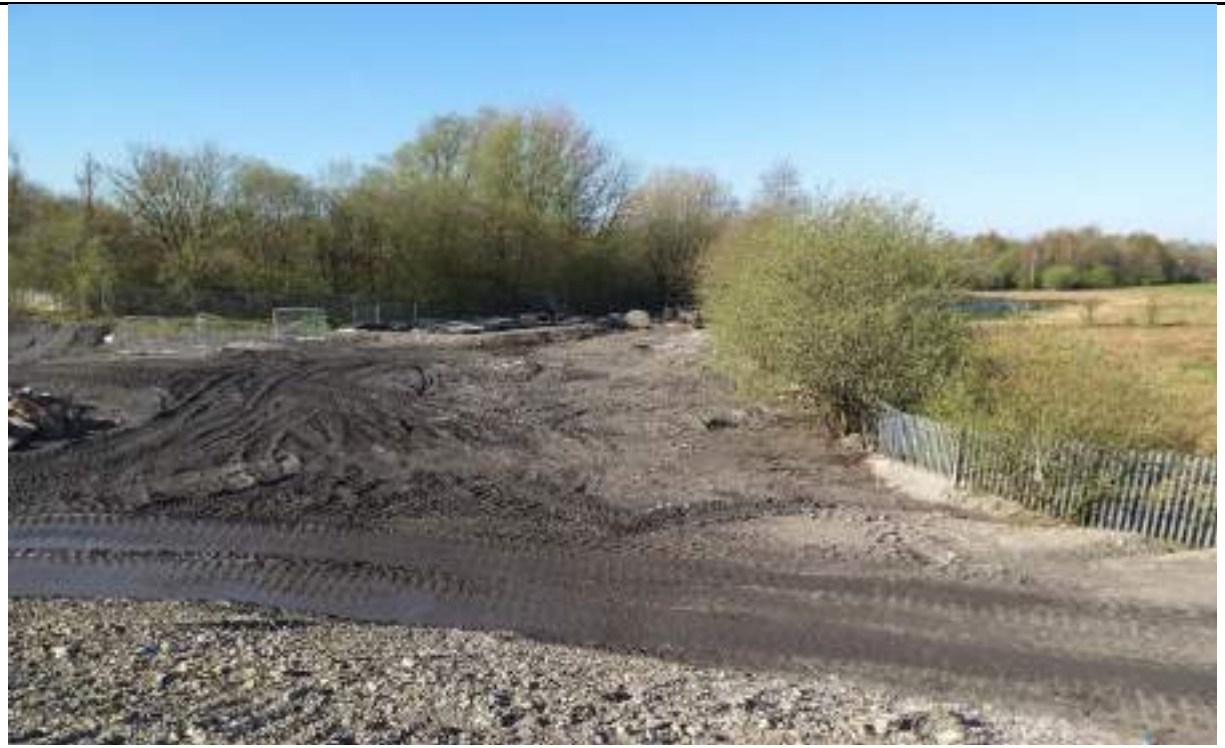
Photograph 6: Hotspot 7 stockpile in eastern corner of site. Testing results confirm suitability.

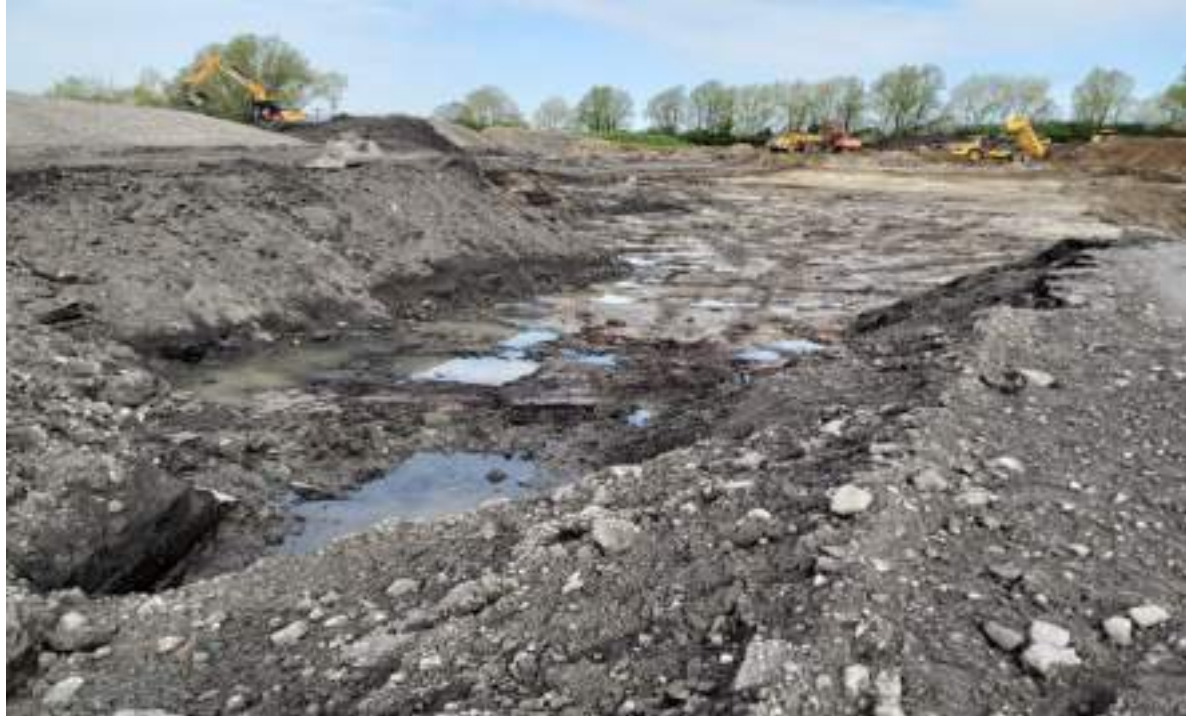
Photograph 3: Peat excavation in the centre east.

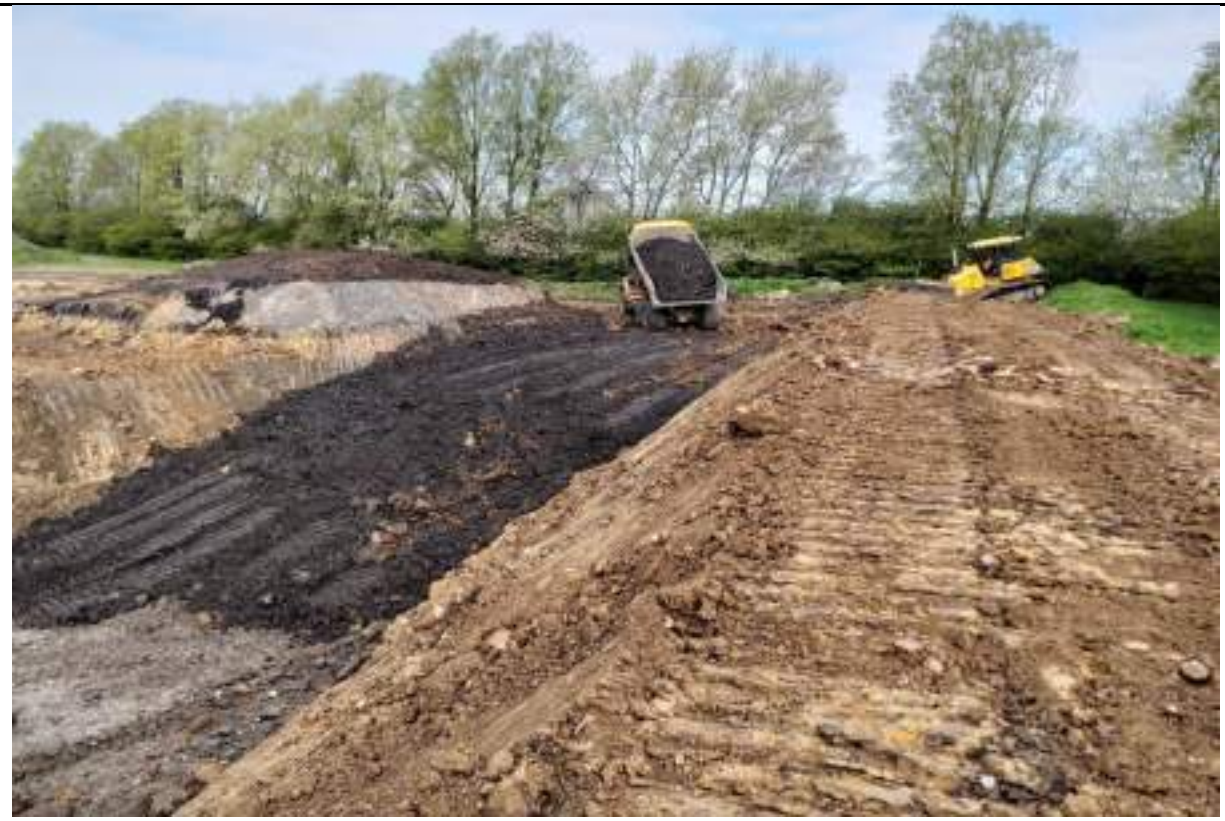
Photograph 6: Unloading peat inside the borrow pit in the north.

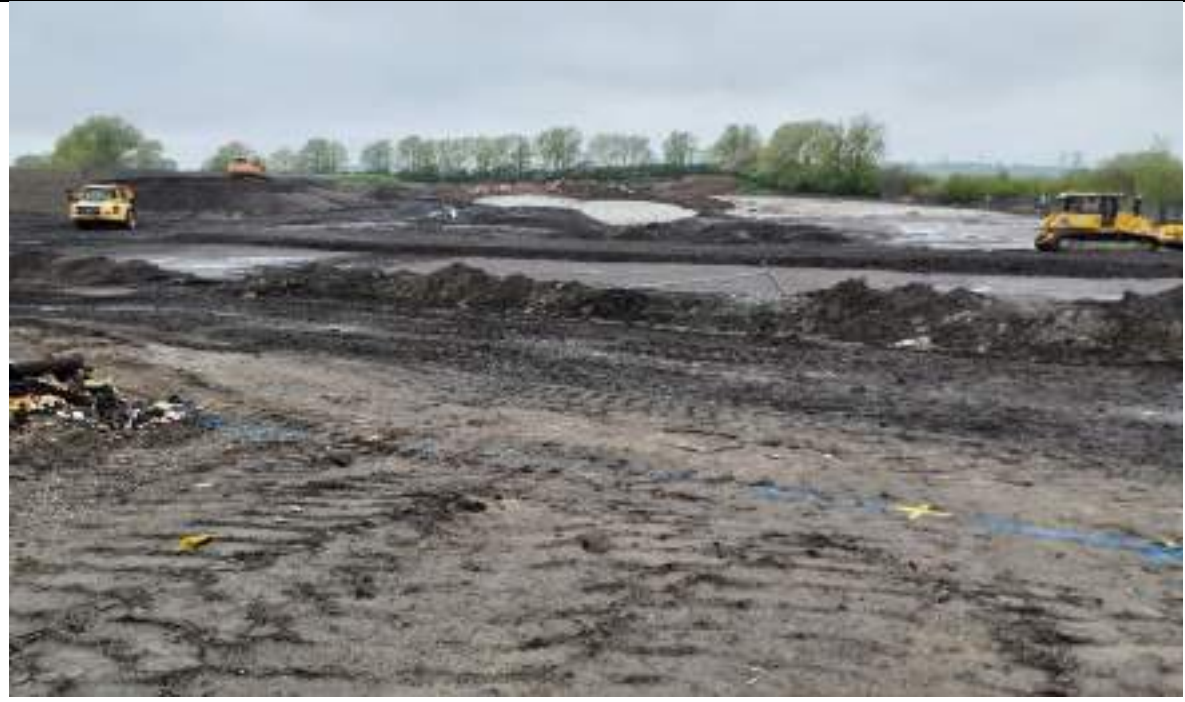
Photograph 3: Overview of the site. Looking towards the north.

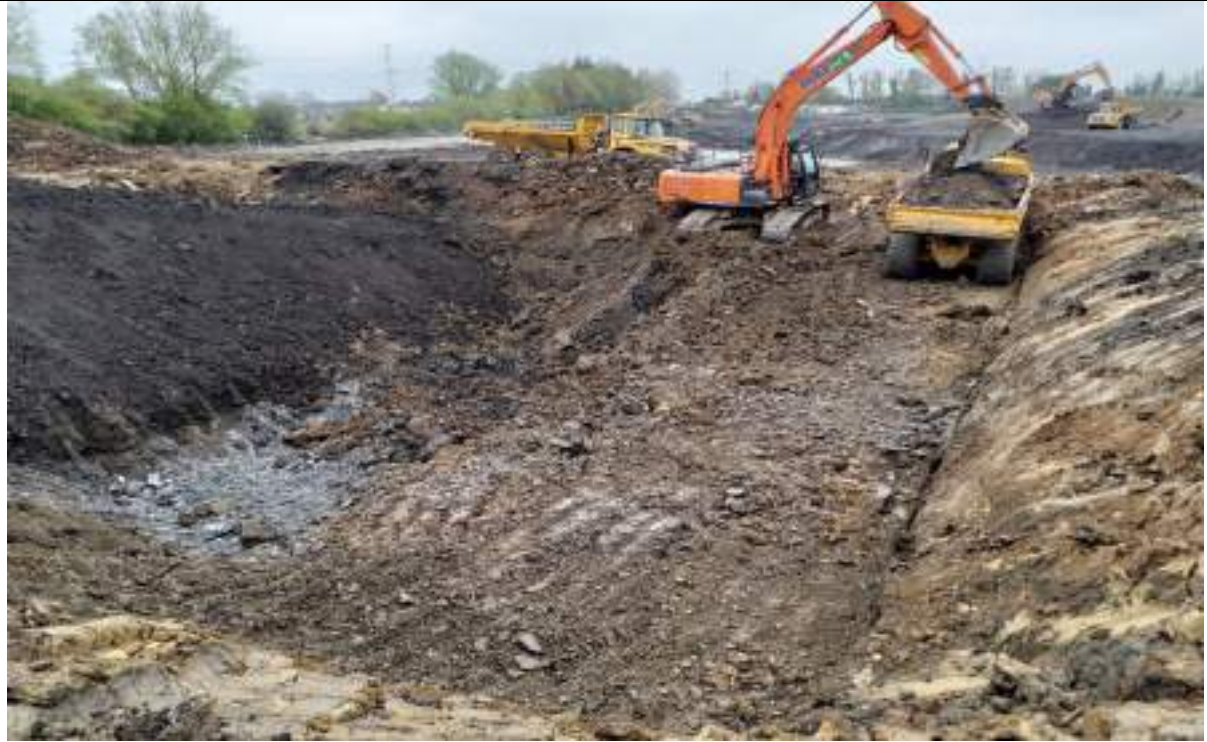
Photograph 7: Excavation of Glacial Till from the borrow pit in the centre north.

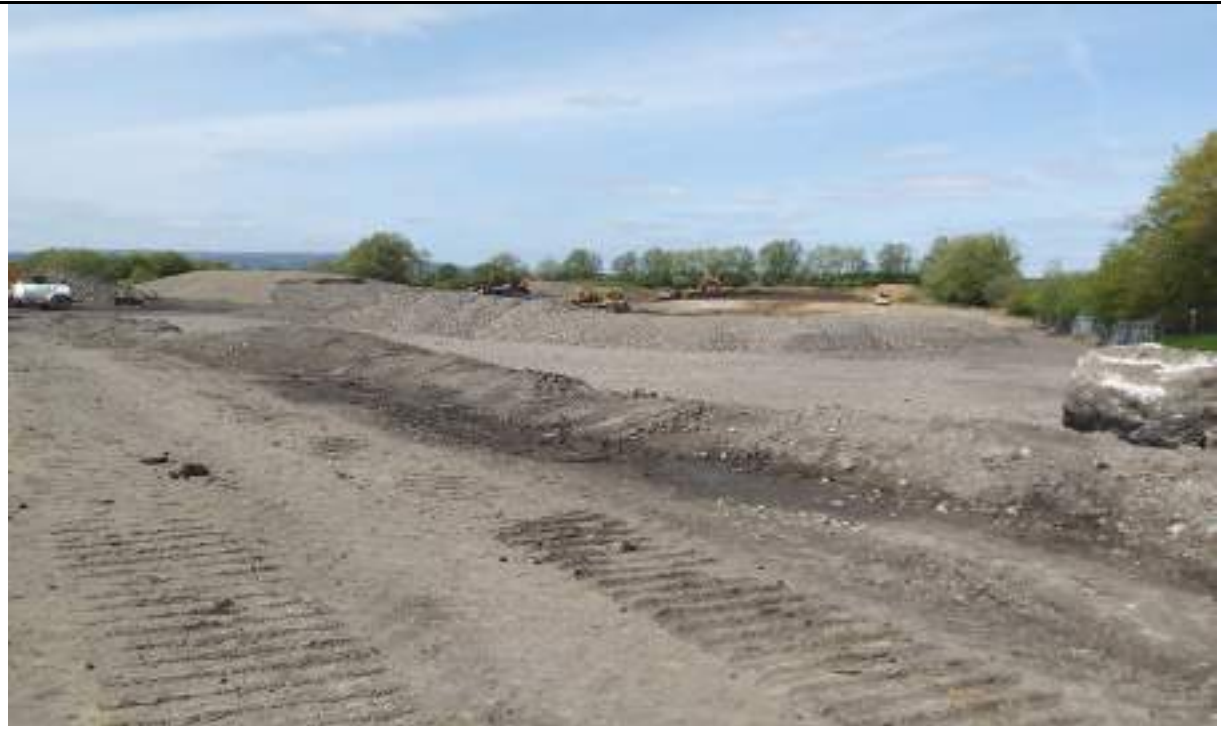
Photograph 1: Overview of the site. Looking towards the north.

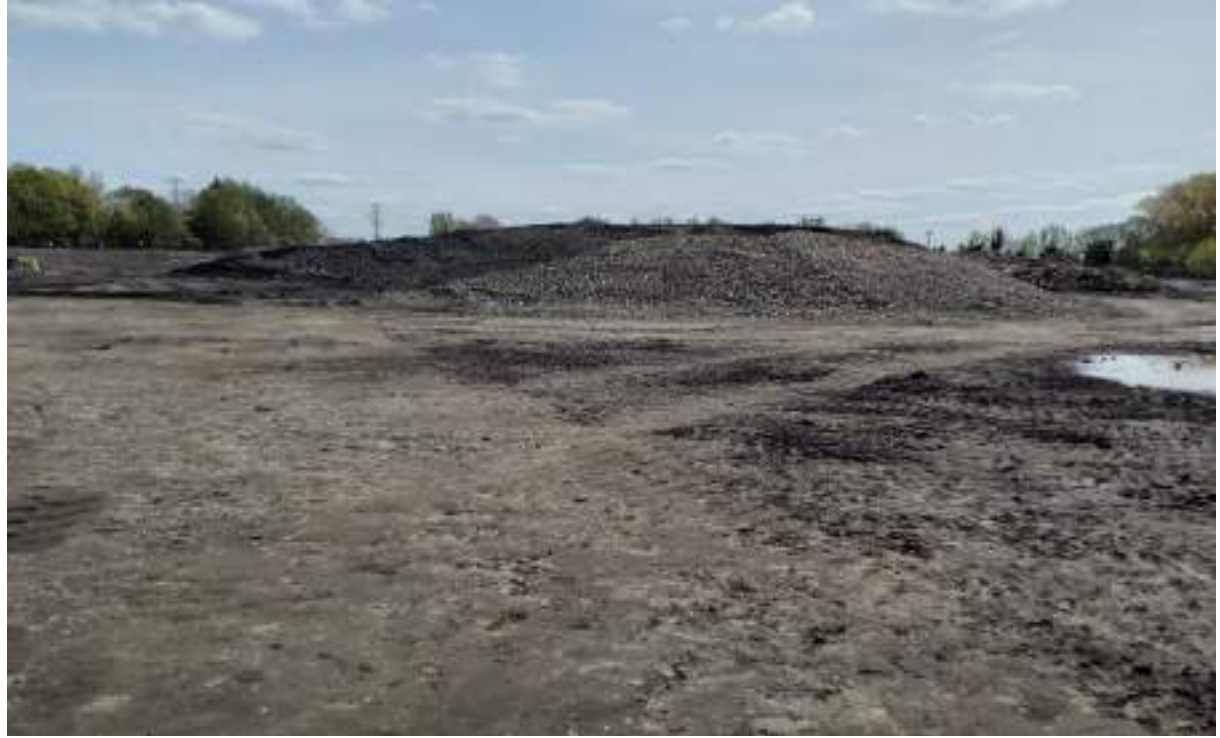
Photograph 9: Stockpile of 6F2 material in the northwestern part of the site.

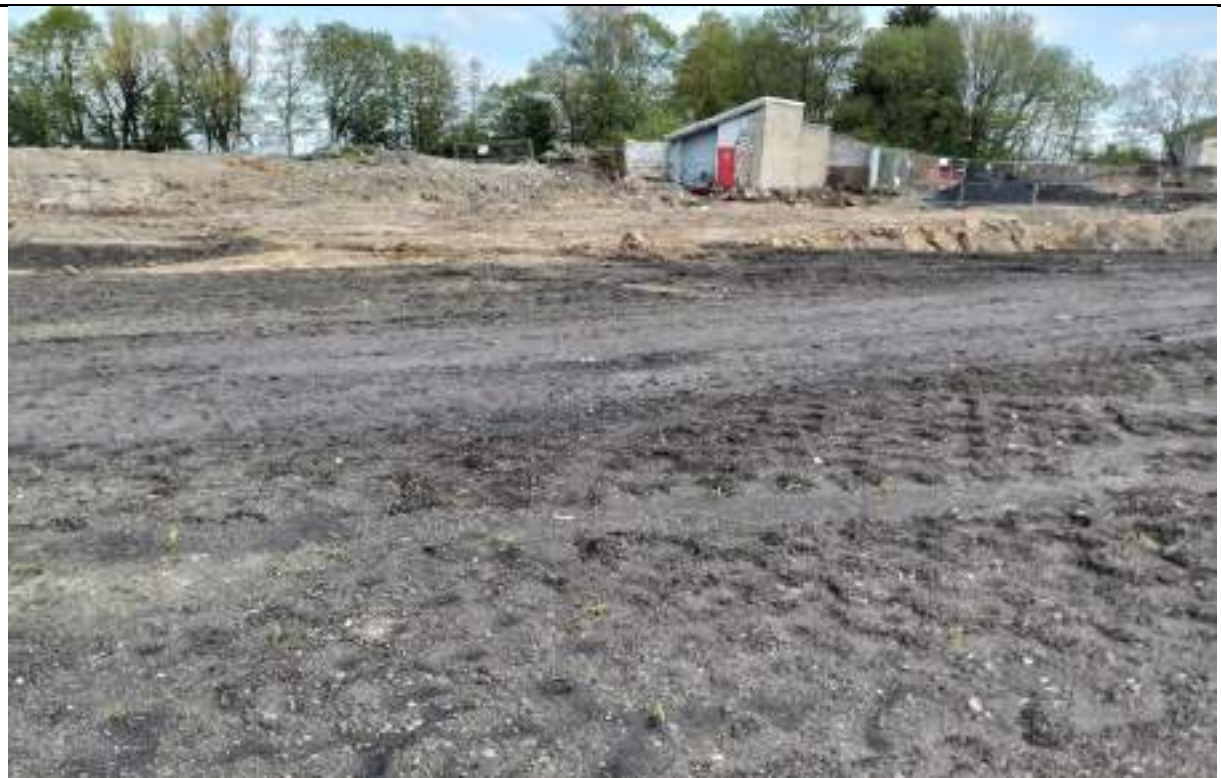
Photograph 14: Stockpile of low strength Glacial Till in the southeast.

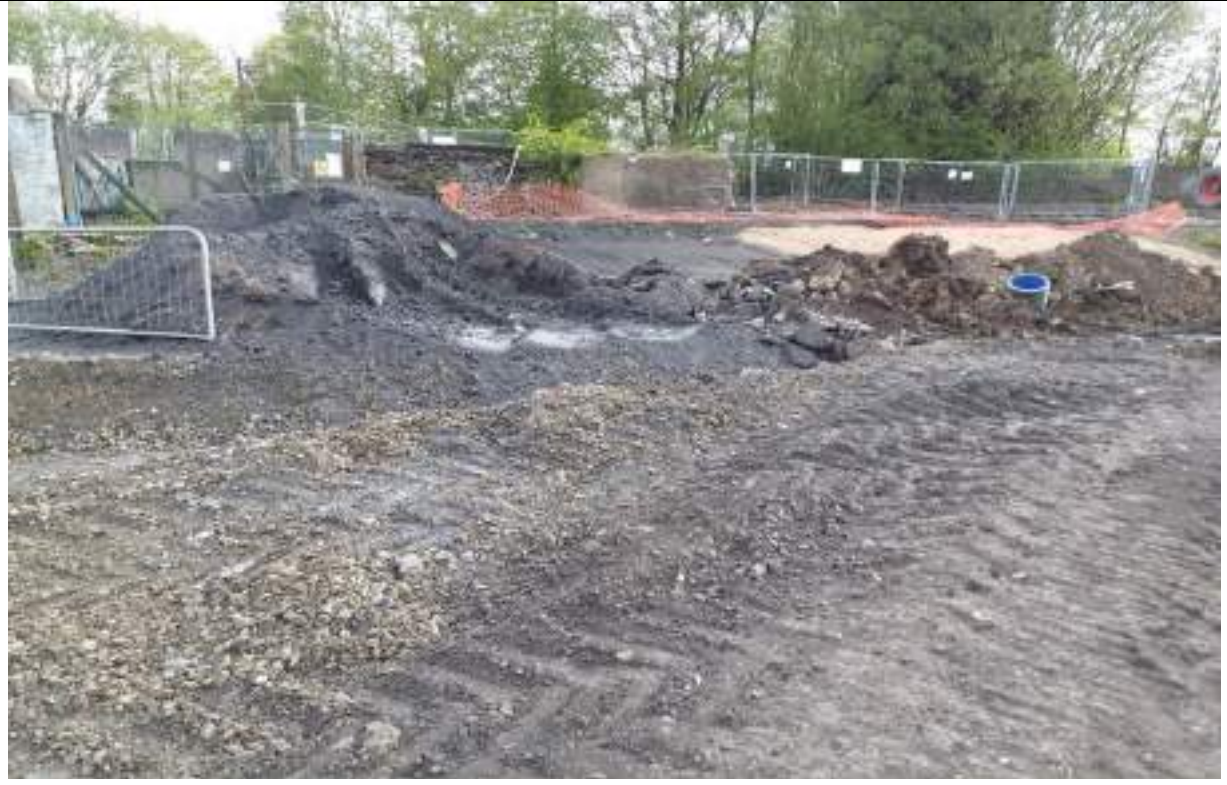
Photograph 1: PAF and sand left over from mine shaft no. 006 treatment in the southeast.

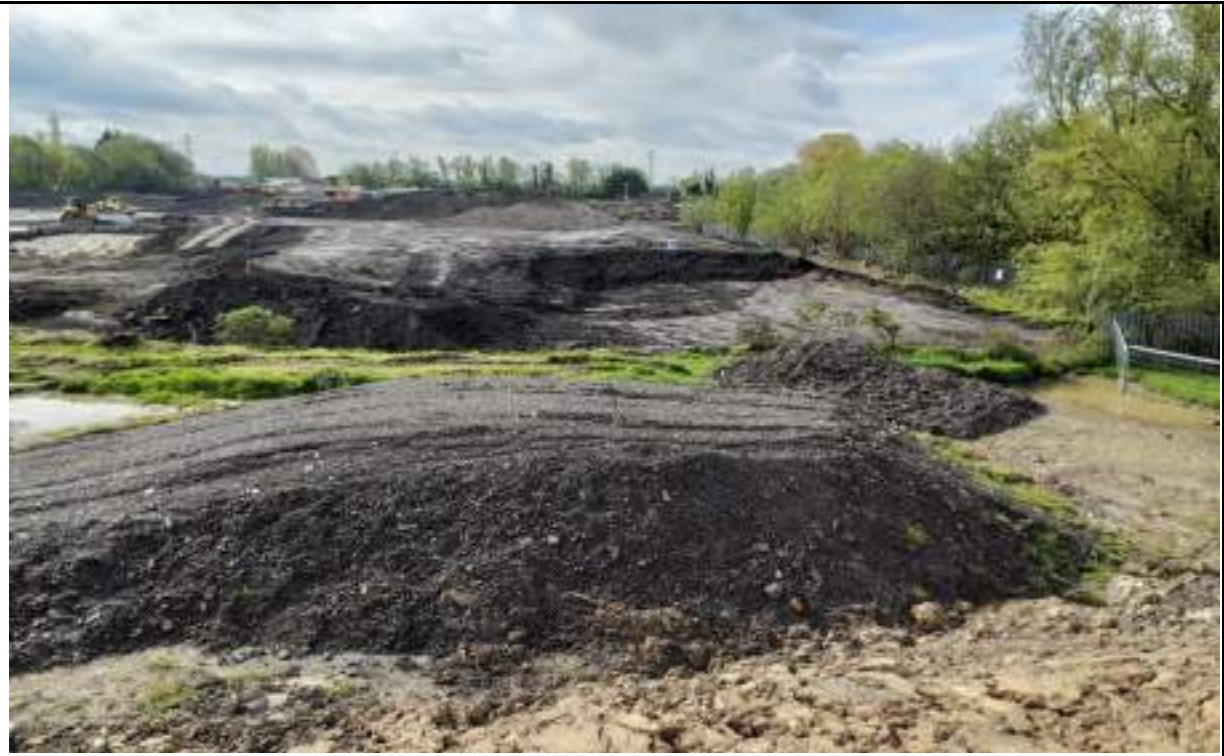
Photograph 9: Western boundary of the site. Looking towards the south.

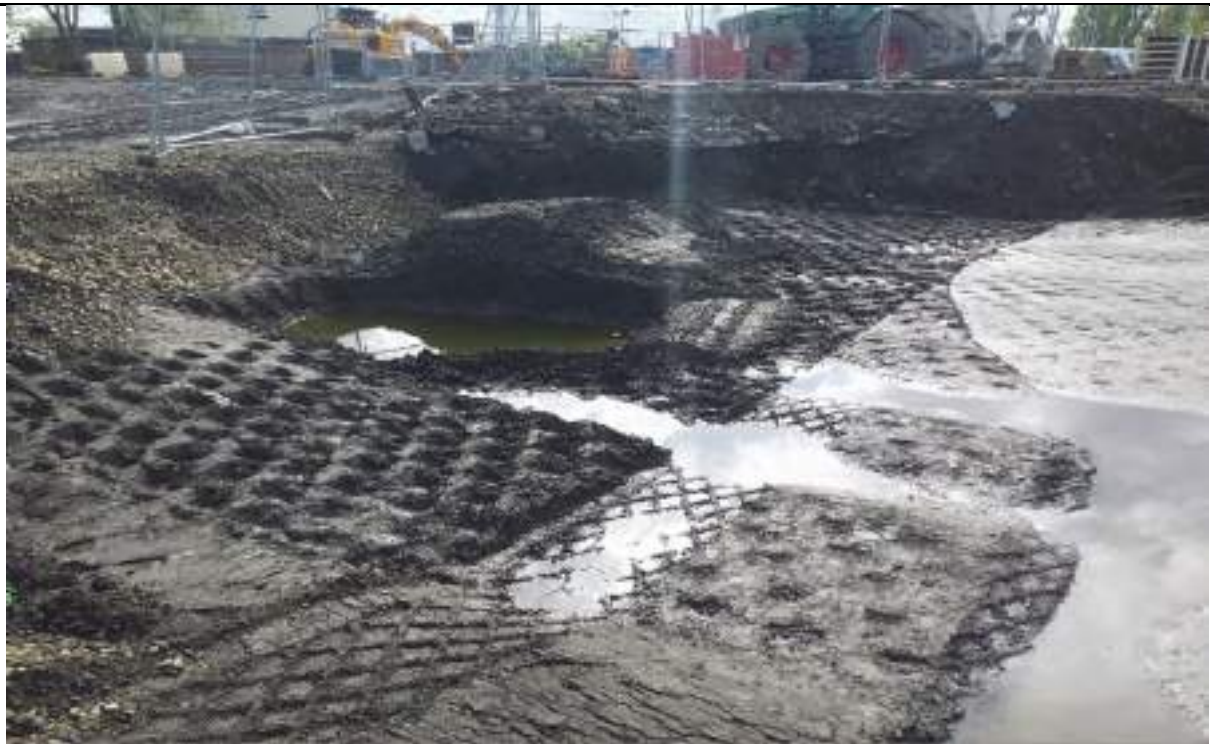
- VHE is waiting for dozer equipped with GPS to trim areas that need trimming.
- Crusher will be on site as soon as the structure is removed from the eastern part of the site to begin processing of oversize material stockpiled in the northwest.
- Water observed in three monitoring pits in the centre south.

Photograph 10: Water collected in the monitoring pit in the centre south.

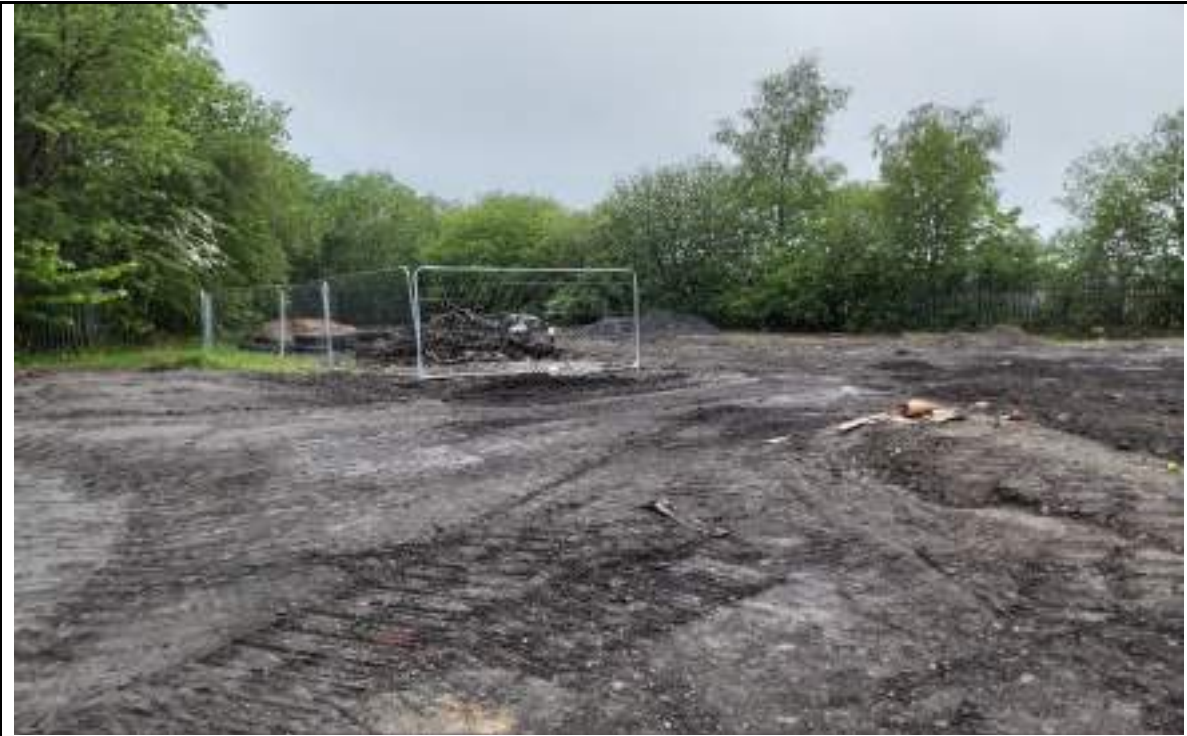
Photograph 5: Stockpile of deleterious materials in the northwest.

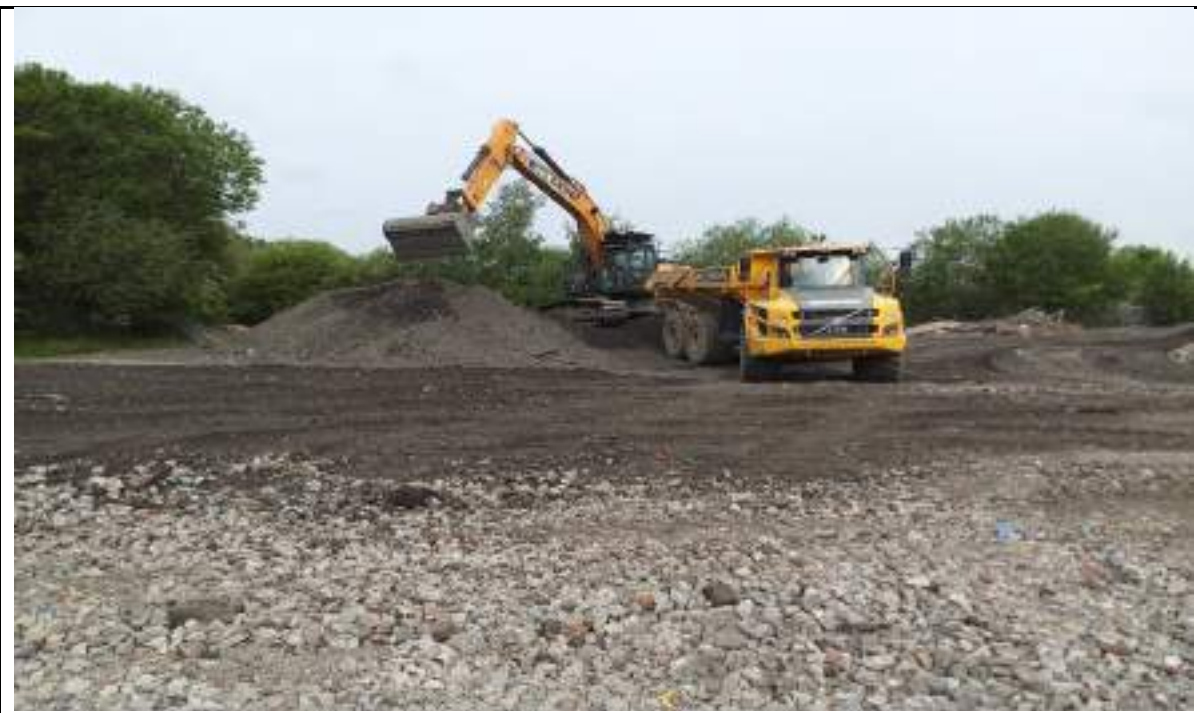
Photograph 2: Stockpile of fine material from crusher and stockpile of deleterious materials in the northwest.

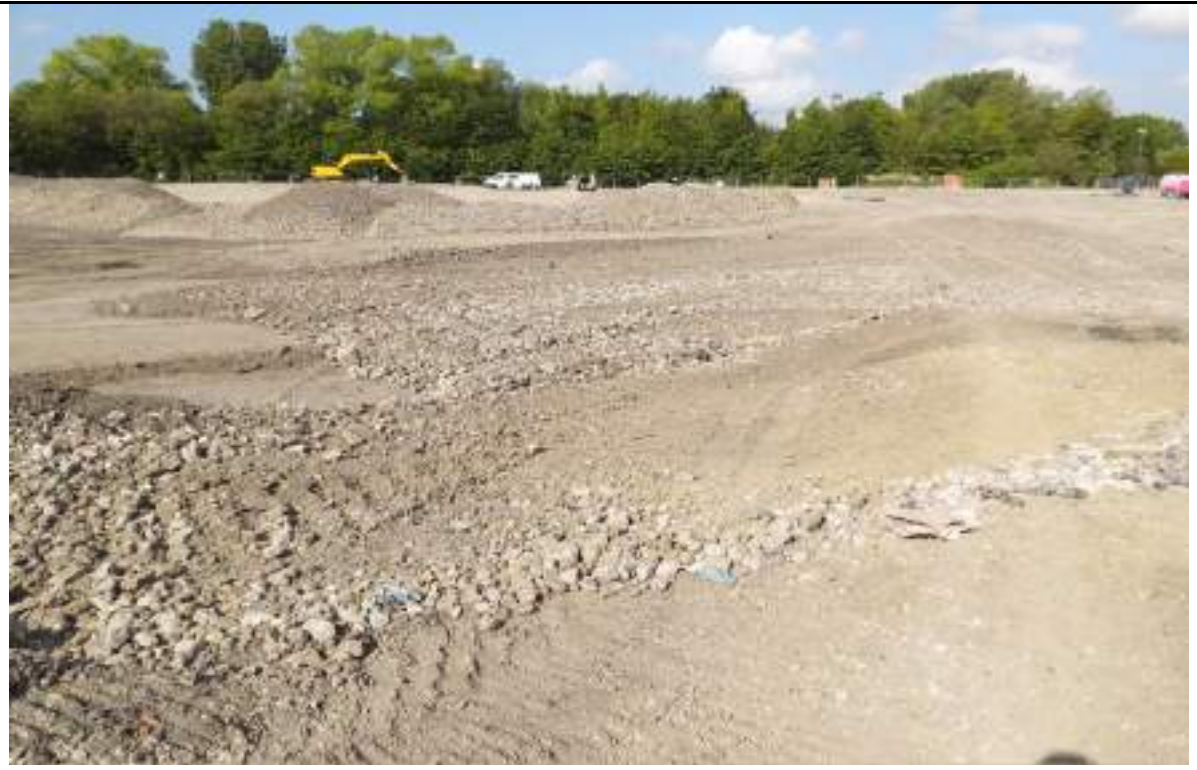
Photograph 9: 6F2 material placed in the southeast.

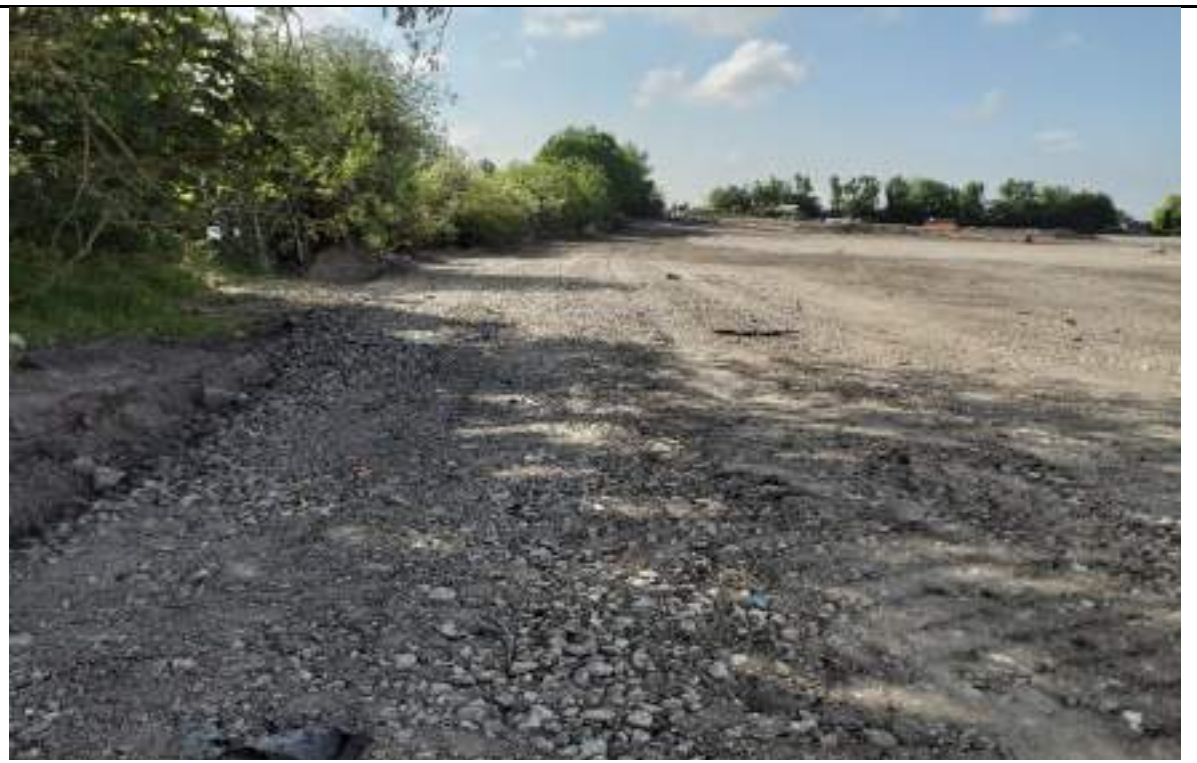
Photograph 10: The eastern boundary of the site. Looking towards the south.

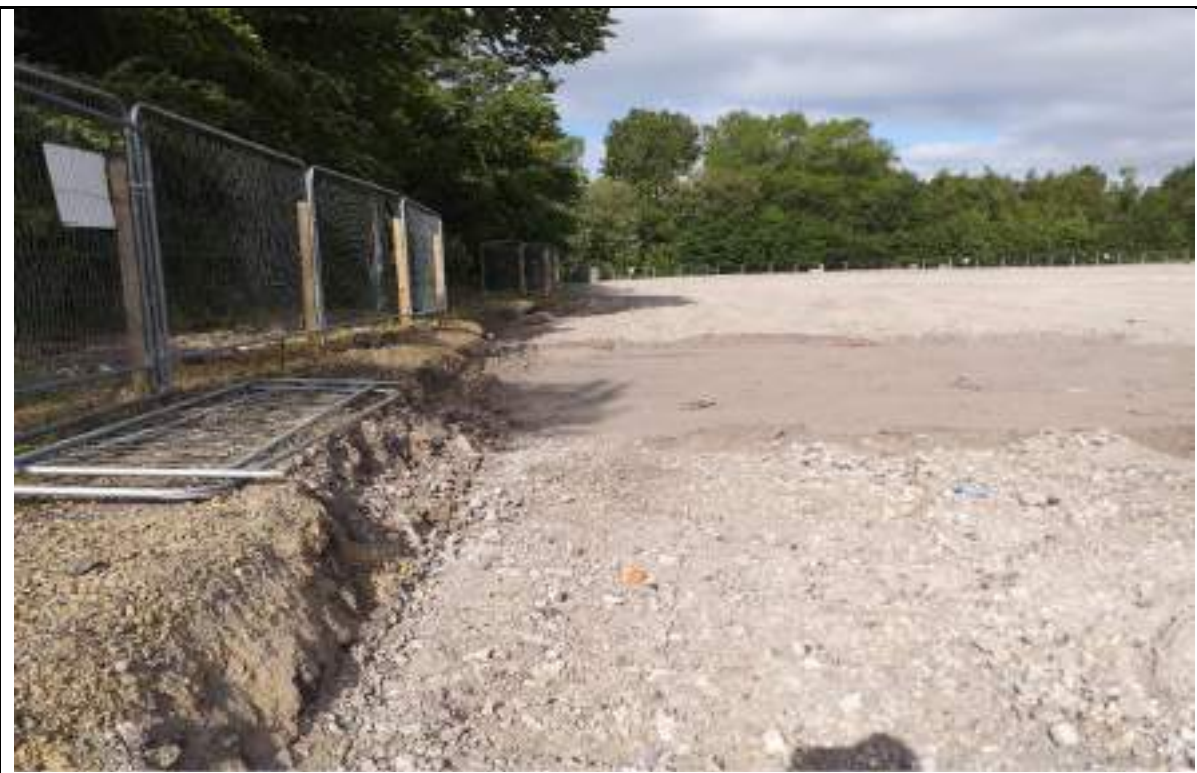
Photograph 2: The southern boundary of the site. Looking towards the west.

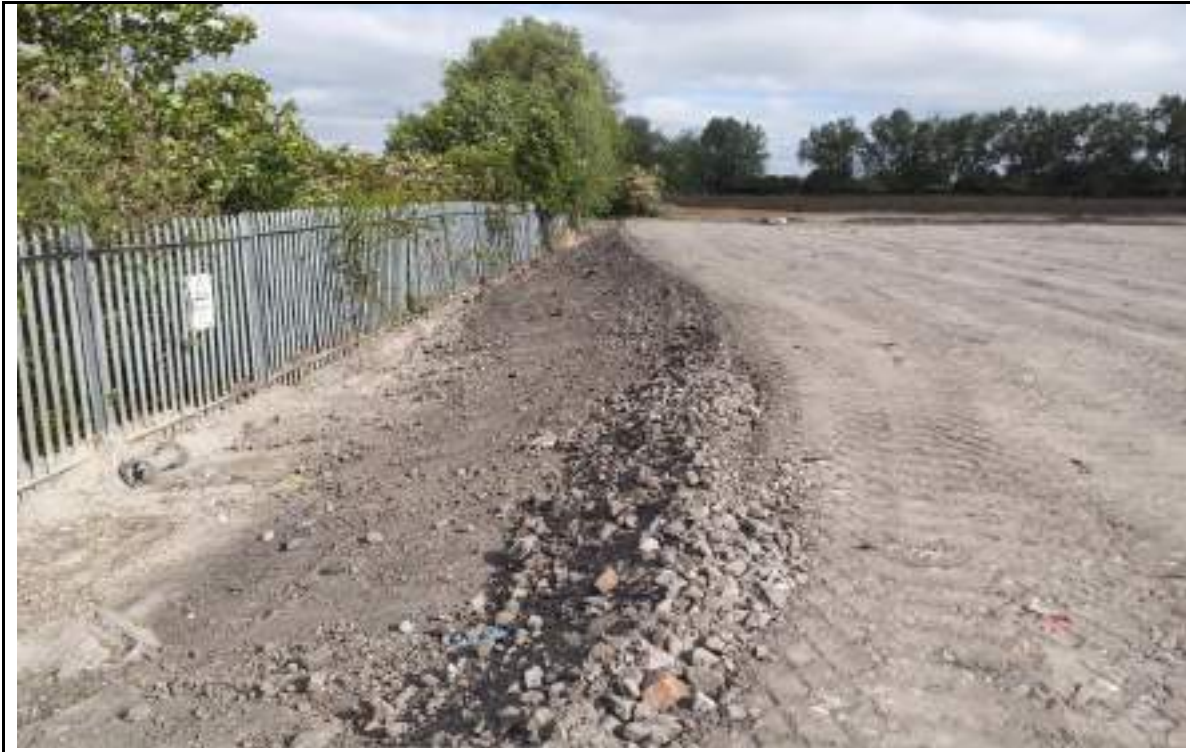
Photograph 5: Rectified boundary in the northwest.

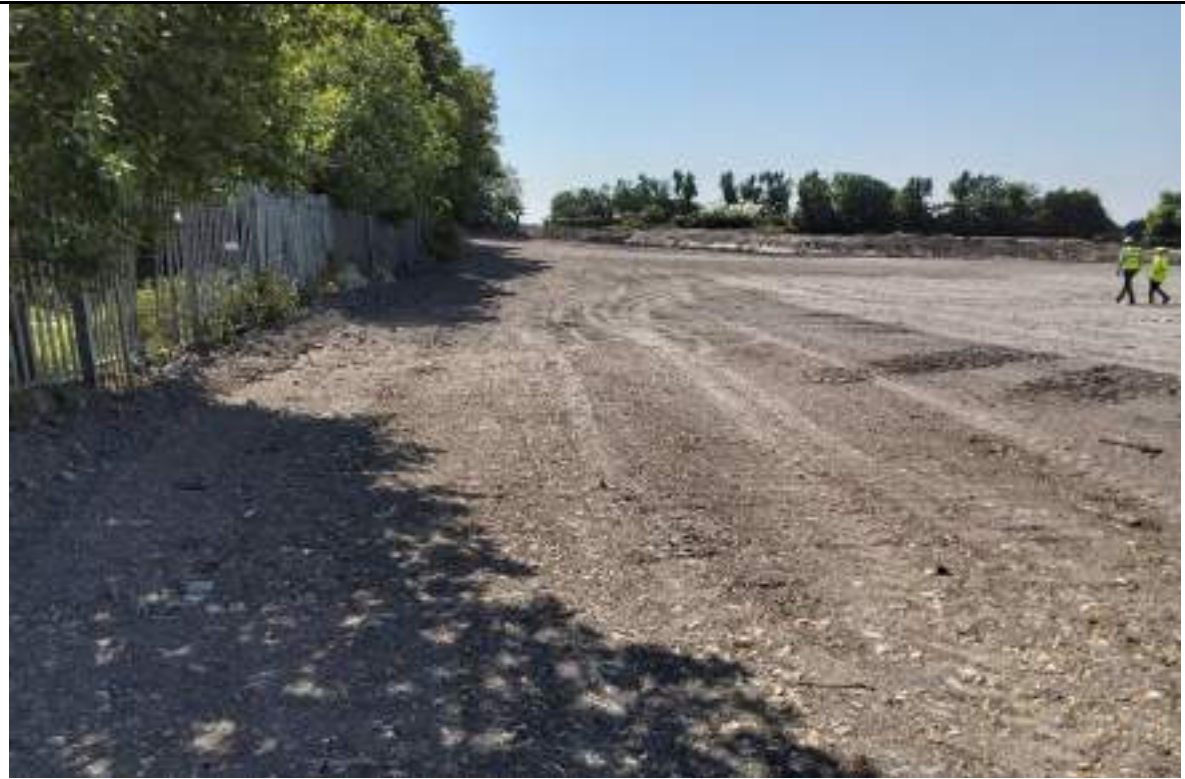
Photograph 9: The eastern boundary of the site. Looking towards the south.

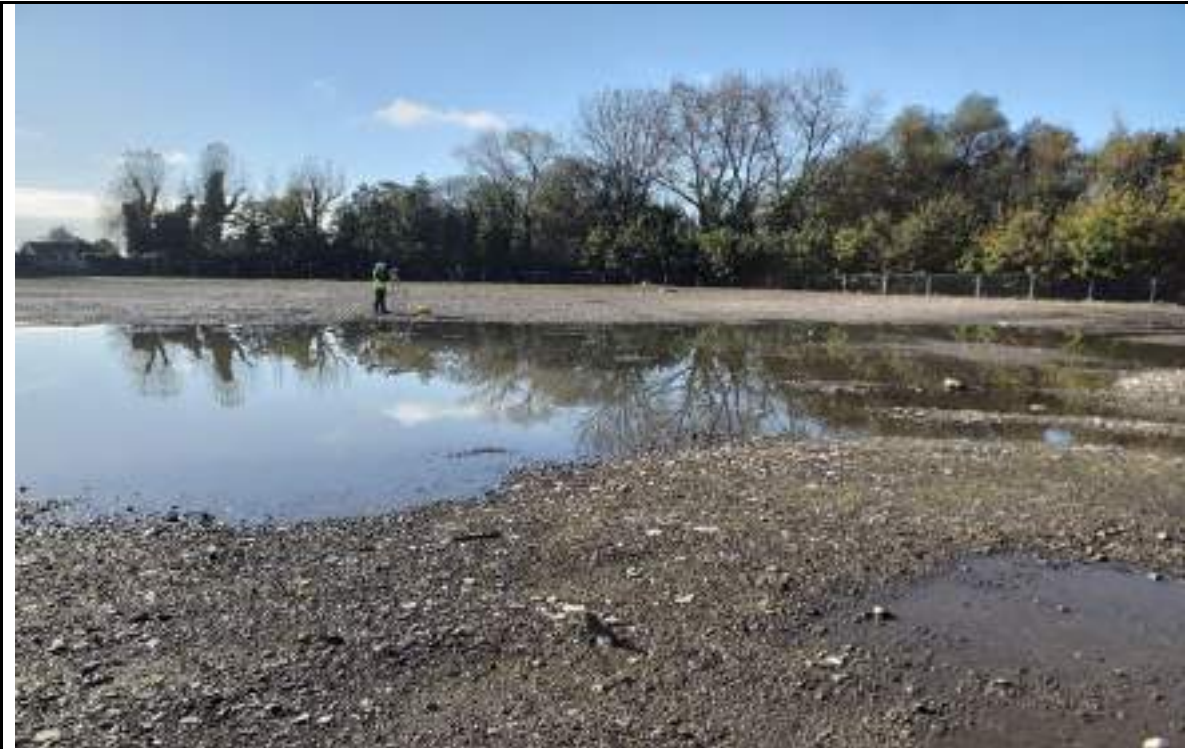
Photograph 5: Surveyor monitoring the RSGs.
