**RE: NX418 PLOTS 1, 2, 3, 4, 5, 6 & 7 GAS & COVER SYSTEM VALIDATION REPORT –  
LAND AT RECTORY LANE, EAST LANCASHIRE PAPER MILL ISLAND SITE, RADCLIFFE**

NX418 Land at Rectory Lane, ELPM Radcliffe

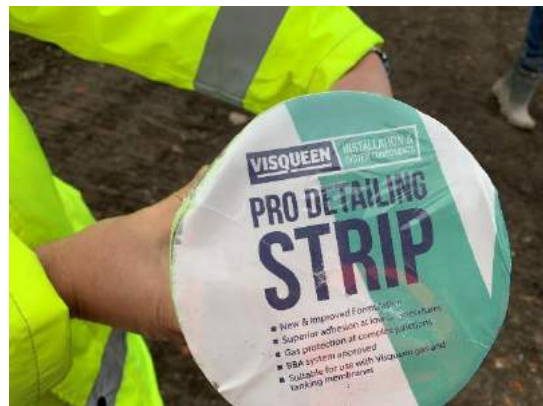
**PLATE 5: Membrane Coverage and internal Wall lapping**

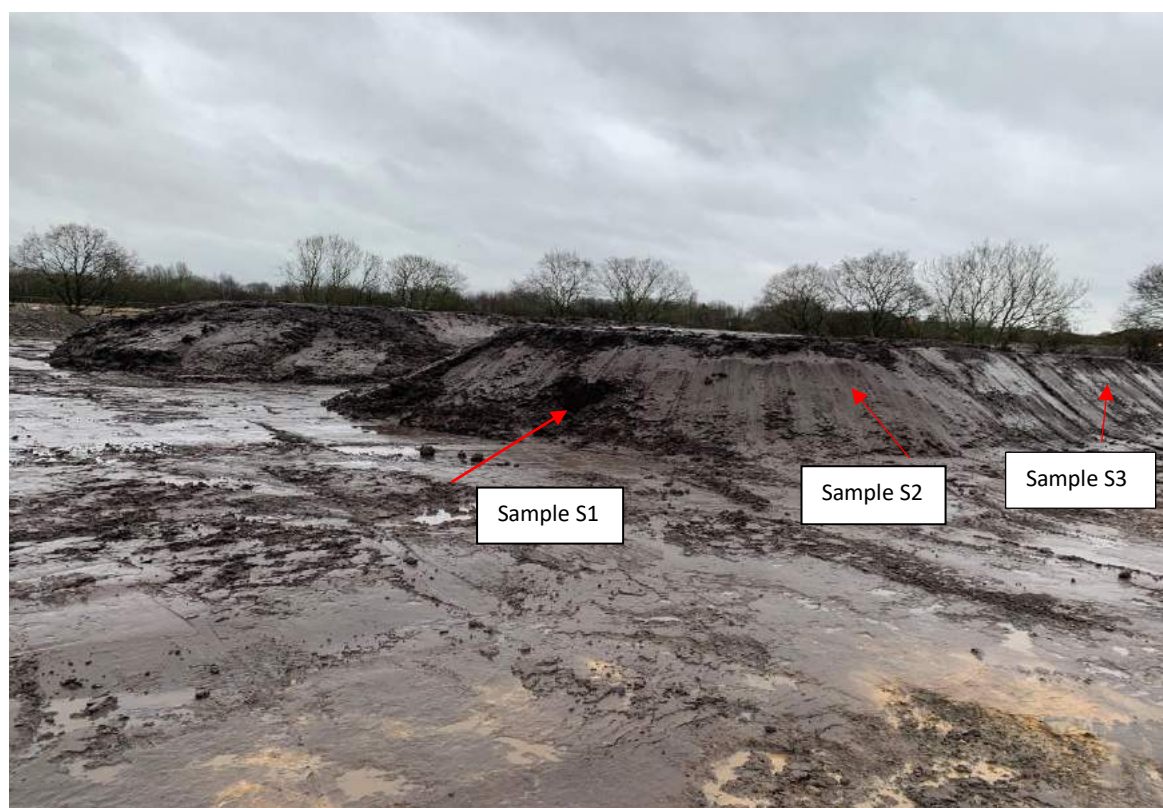
**Plate 1 – Millar Homes Topsoil Source, Widnes. NX Inspection 1<sup>st</sup> March 2024**

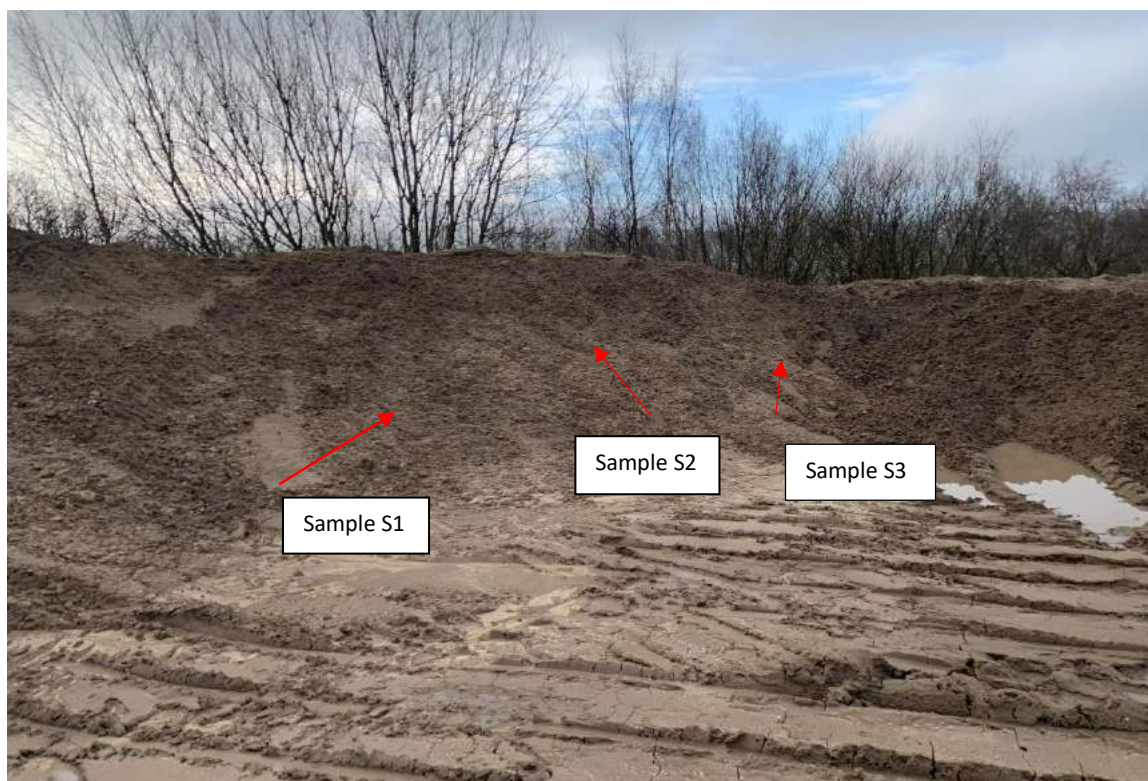
**Plate 1 – Marchington Quarry, Glossop. NX Inspection 20<sup>th</sup> March 2024**

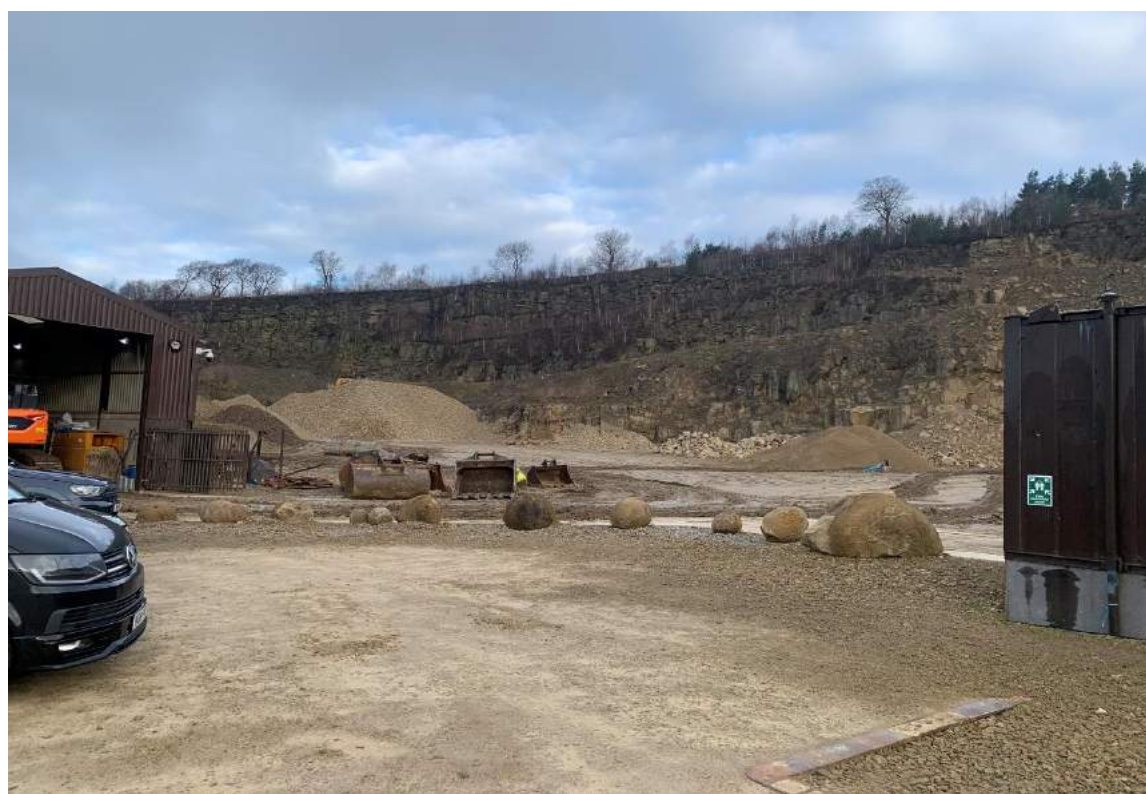
**Plate 2 – Marchington Quarry, Glossop. NX Inspection 20<sup>th</sup> March 2024**

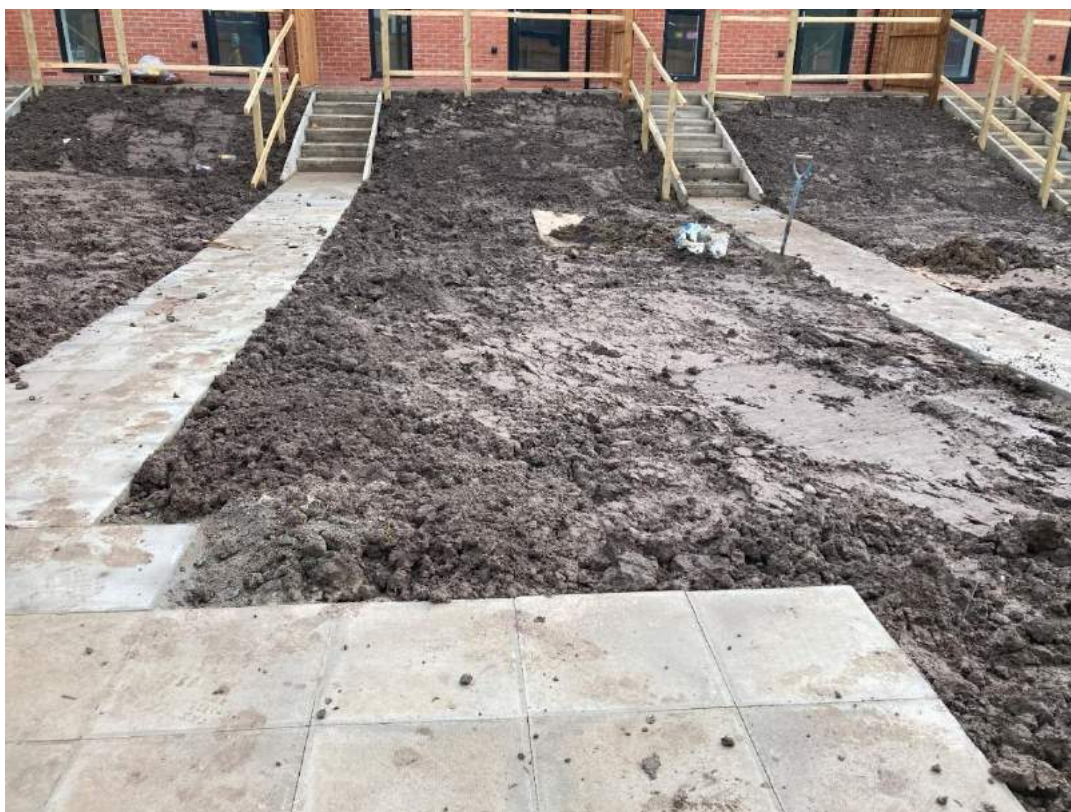
**Plate 18 – Plot 4 front garden cover system GL to 0.60mbgl with 0.15m of topsoil.**

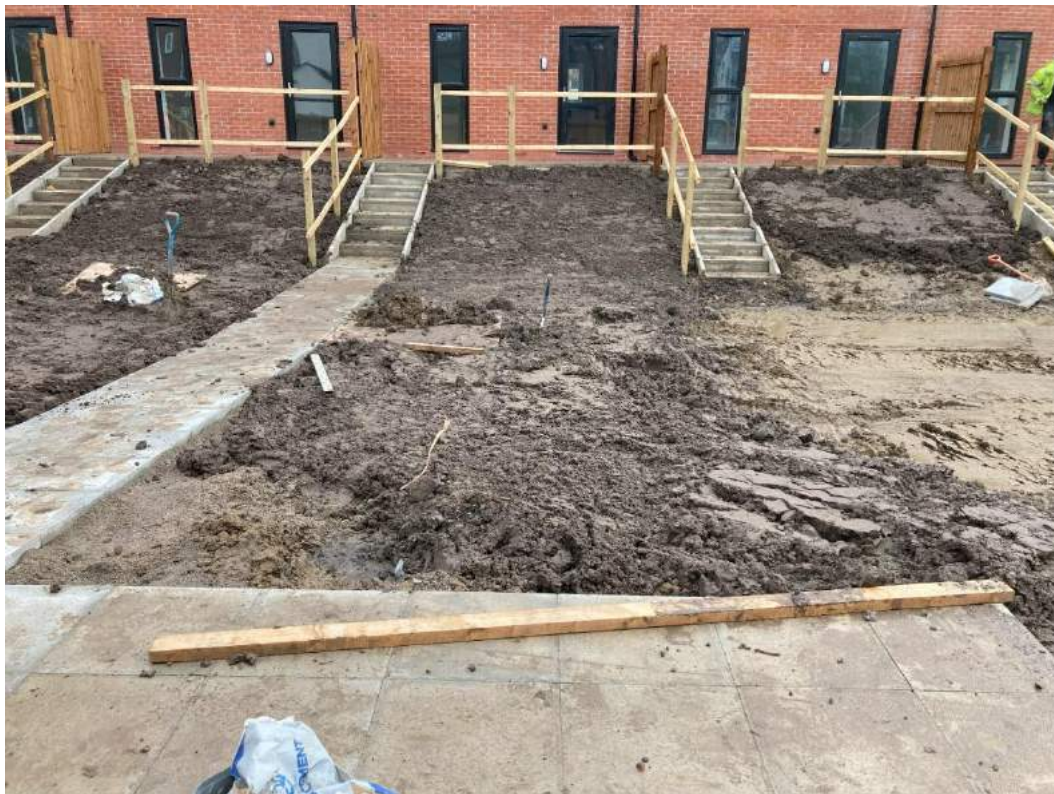
**Plate 23 – Plot 5 front garden cover system GL to 0.60mbgl with 0.15m of topsoil.**
